## A RECONNAISSANCE OF

## A CHANNEL DAM SITE AND FLOOD AREA

ON THE SAN SABA RIVER, MENARD COUNTY, TEXAS

Joseph H. Labadie

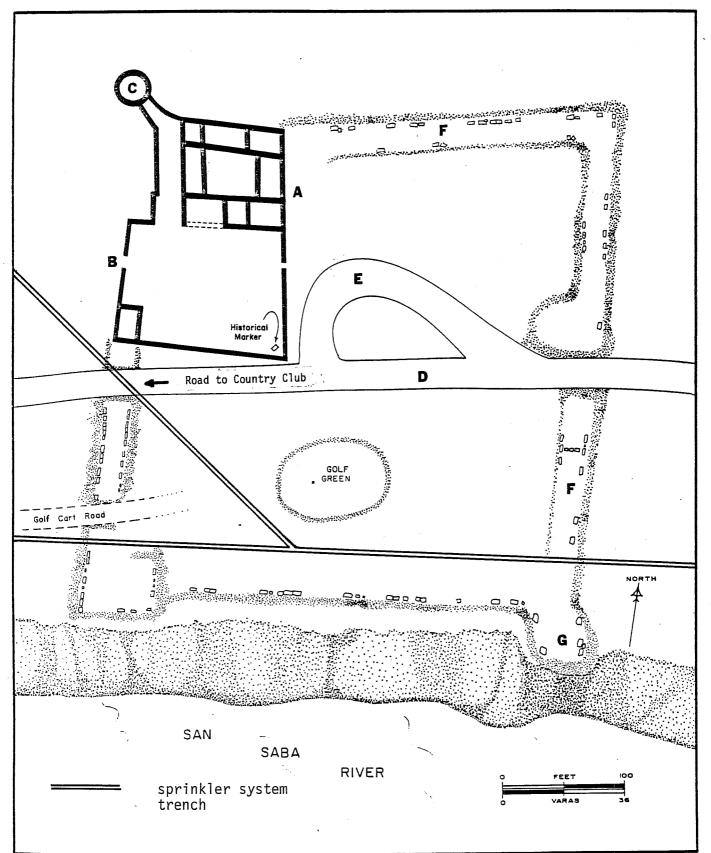
Figure 2. Plan Drawing of the Presidio San Sabá Indicating the Approximate Locations of Machine-Excavated Sprinkler System Trenches Examined by this Reconnaissance (map adapted from Ivey 1981:5). The entire area shown here, from the river bank north, was examined by the field team. A, walls reconstructed in ca. 1932 by the WPA; B, main gate as reconstructed; C, northwest bastion as reconstructed; D, road to the Menard Country Club; E, turnout for visitors to the Presidio; F, mounds of wall ruins; G, mound covering southeast bastion.

The golf course (owned by Menard County) is currently installing an underground sprinkler system to water all nine golf greens. The entire golf course, at present, has a near gridlike series of open trenches (60 cm wide x 50 cm deep) that contain one inch and three inch diameter PVA piping; each golf green has been encircled by a trench which contains a one-inch PVA pipe with four sprinkler heads. The raised linear features that denote the location of Presidio walls have been trenched through in three places.

All of the trenches at the Presidio were walked over, and a selective collection was made from a trench in the area of the southwest wall. This trench, which cut through the buried Presidio wall, revealed a well-defined, gray-ashen lens 30 cm below the present-day ground surface. The lens (20 cm thick x 1.2 m long) is located immediately outside the wall and extends away from the wall. Still visible in the ashen lens were bits of charcoal, small pieces of burned limestone, and several burned mussel shell fragments. Examination of the backdirt from the trench provided additional materials. In all, a selective collection was made in this area, consisting of 11 pieces of bone (four large rib bone sections and seven unidentifiable bone fragments---all well preserved and not burned), eight unburned mussel shell fragments (one with the umbo still attached), a rusty piece of iron, a modified chert cobble, and a large, unglazed, sandy paste pottery sherd. Investigation of the other two open trenches and associated backdirt failed to identify any additional cultural materials. A small sherd of Spanish Colonial period majolica and a tertiary chert flake were found on the surface near the Presidio's northeast corner.

We also noted that the machine excavations of sprinkler system trenches across the southern part of Presidio San Sabá have impacted the cultural resource, including the partial destruction of at least one midden feature. Since no subsurface study of this area of the Presidio has been undertaken in the past, it should be protected from further impact. Should any future disturbances be planned at Presidio San Sabá (a National Register Historic Site and a State Historic Landmark), this should be preceded by a carefully designed project of investigation and documentation to include controlled subsurface excavations.
