ARCHAEOLOGICAL INVESTIGATIONS OF PORTIONS OF THE
SAN PEDRO AND ALAZAN ACEQUIAS
IN SAN ANTONIO, TEXAS

Anne A. Fox

Center for Archaeological Research
The University of Texas at San Antonio
Archaeological Survey Report, No. 49

1978

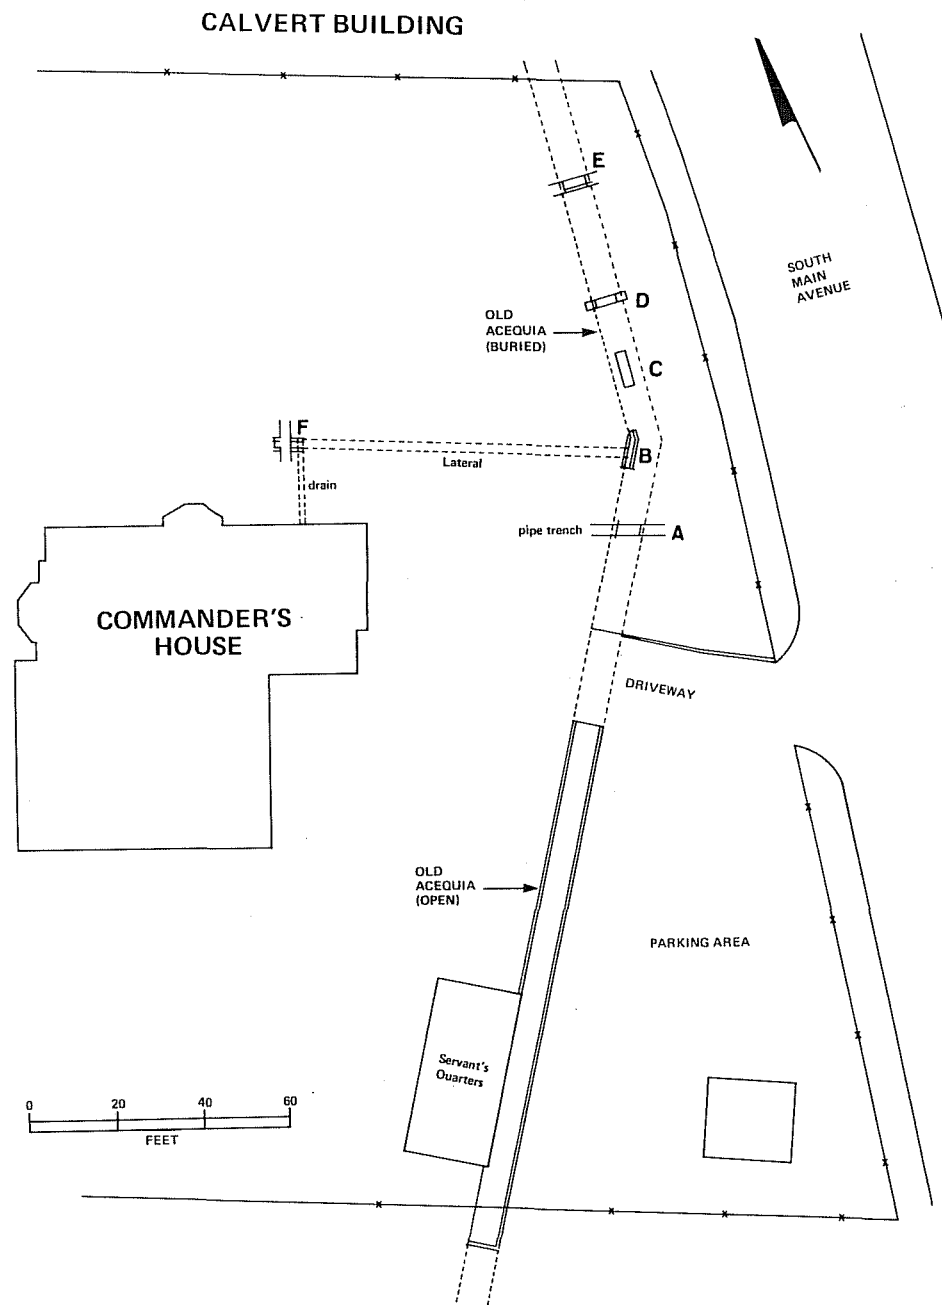
The first area examined (Fig. 2, Area A) was a section of the acequia which had been exposed in a plumbing trench. At this point the acequia measures 150 cm in width, with cut-stone walls 50 to 60 cm in thickness.

Encouraged by this bit of information, the crew then cleaned out the bottom of a backhoe test pit (Fig. 2, Area C) to determine the depth and construction of the bottom of the acequia. At this point, the floor of the acequia is 105 cm below the present top of the walls, which have been capped by a thin layer of cement. Unfortunately, there is no way to determine the original height of

Figure 2. San Pedro Acequia on Grounds of Old Arsenal. Areas of excavations (Areas A-F) are shown.

Continuing along the acequia, an area to the north (Fig. 2, Area D) was cleared sufficiently to check the wall lines and to confirm their angle. Area E was cleared off with the same intent, but it soon became apparent that a number of things were different in this excavation (Figs. 5 and 6). A cross wall appeared which apparently was built to enclose the portion of the ditch to the south, as it is covered on its south side with the same layer of cement which lines the ditch further south (Fig. 6,a). Clearing to the north of this wall revealed another stone-lined lateral gate leading to the east. A significant part of the frame of the wooden gate was still in place, though quite fragile (Fig. 6,b). Although its construction was identical to that of the first gate, this one was a bit wider.

The section of the main acequia appears to have been cut off at some time by a poured concrete wall. Another identical wall was found just south of the fence behind the Servants' Quarters, southeast of the Commander's House (see Fig. 2). It seems likely that this section of the acequia may have been turned into a fish pond after the acequia was no longer in use, as part of the landscaping scheme of some commanding officer. This could also have provided a reservoir for the rainwater from the roof. In such a case, the concrete plug

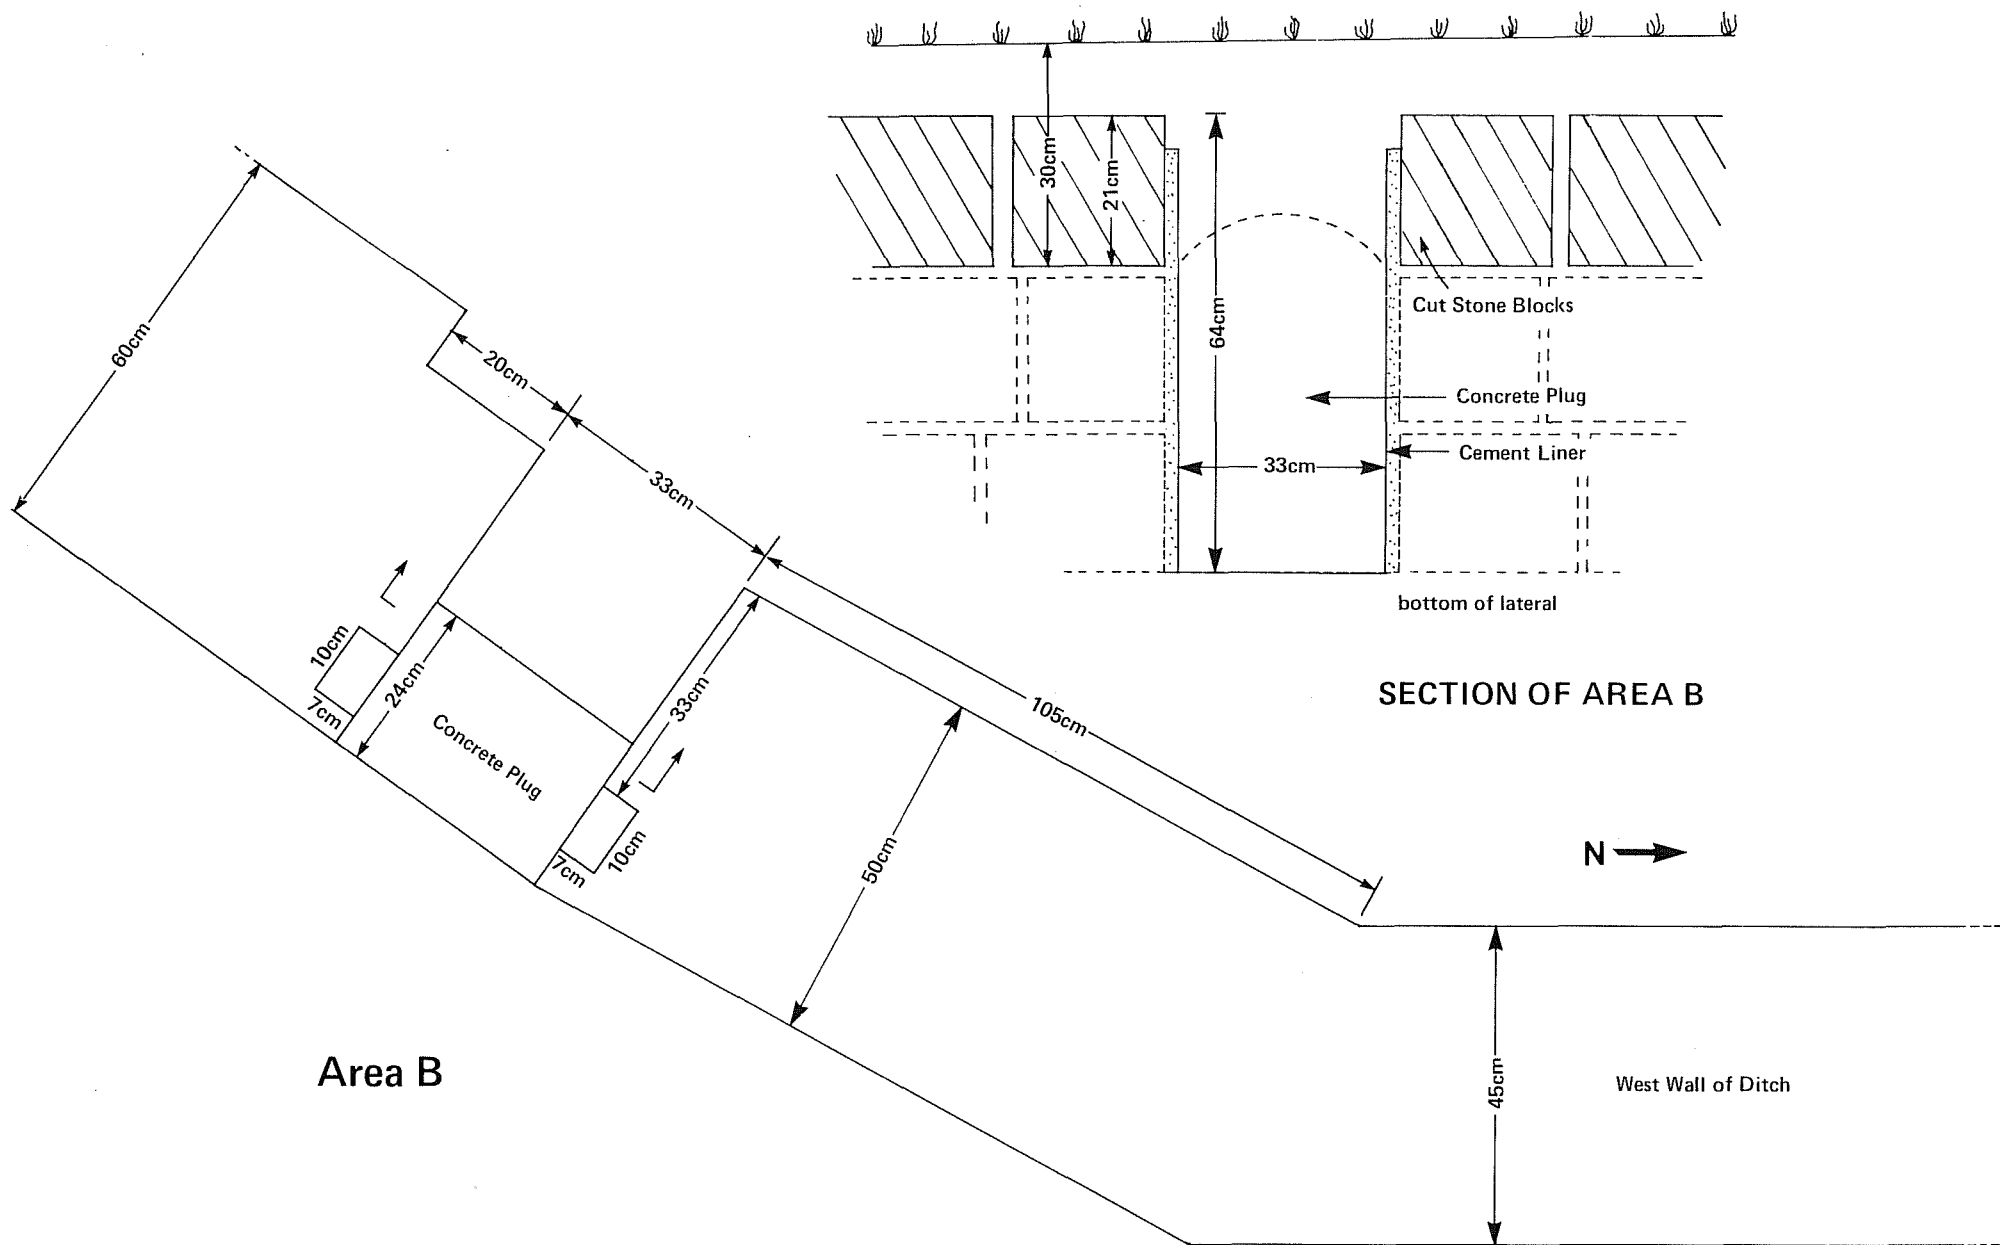
Following the line of the ditch to the north, Area B was opened up to expose the west wall and to attempt to determine the construction at a point where there was a bend in the acequia (Fig. 4,a). An interesting bonus was the discovery of a gate which once opened into a stone-lined lateral ditch leading west from the acequia toward the area behind the Commander's House. Small fragments of the wooden water-gate posts still remained in the stones on either side of the opening (Figs. 3 and 4). A plug of concrete had at some time been poured into the opening of the gate in order to close it (Fig. 4,b).

Figure 3. *San Pedro Acequia, Area B.* Plan and section of lateral gate.

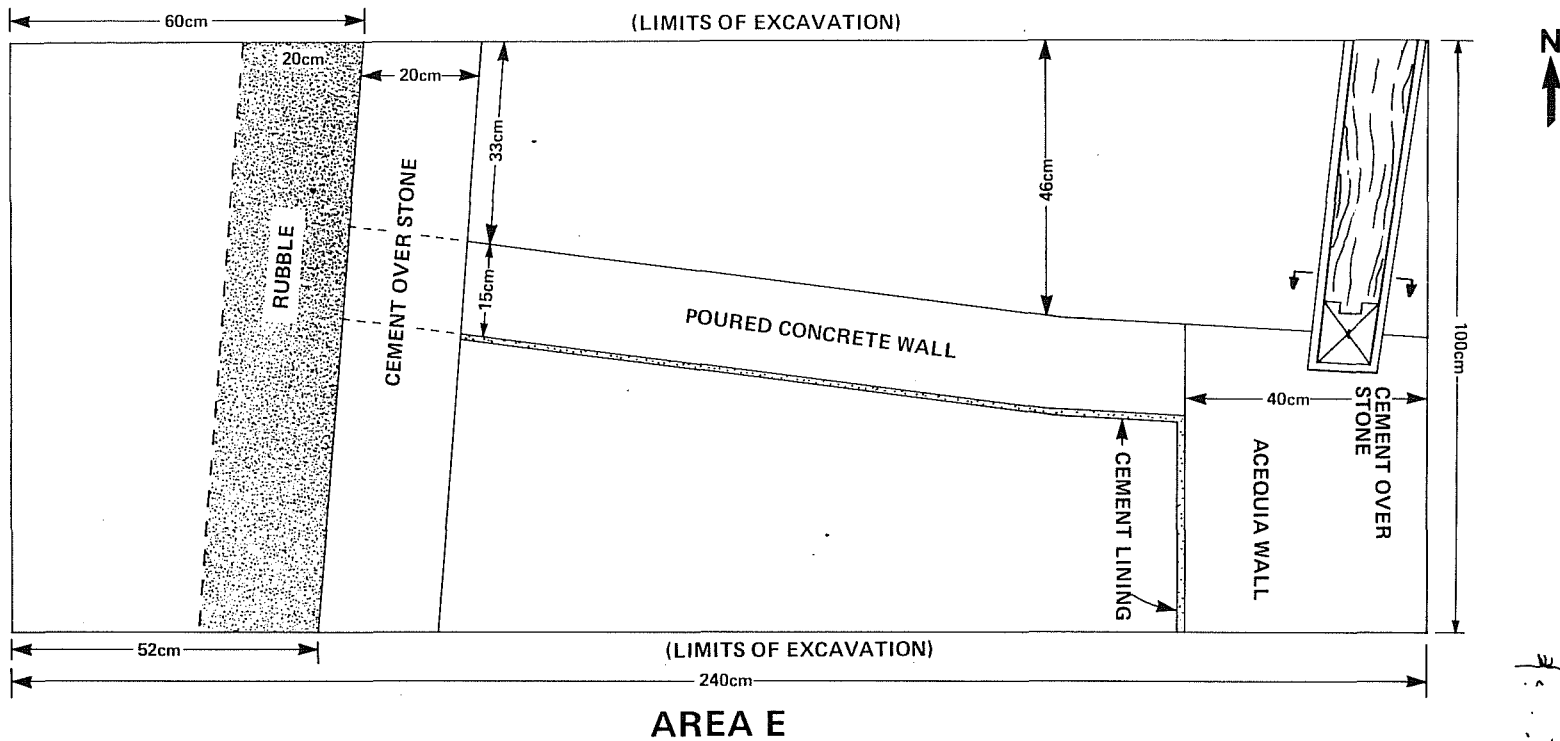
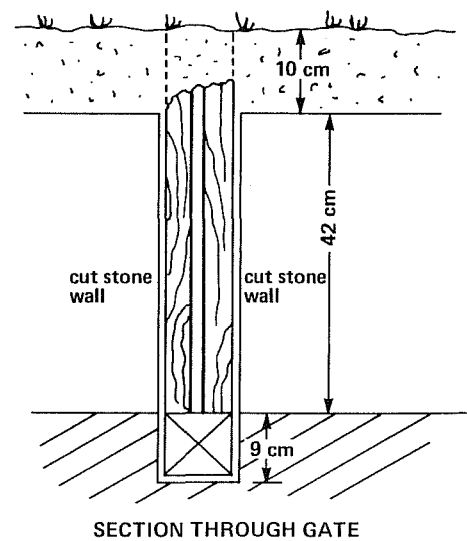
Figure 5. *San Pedro Acequia*, Area E. Plan and section of lateral gate.

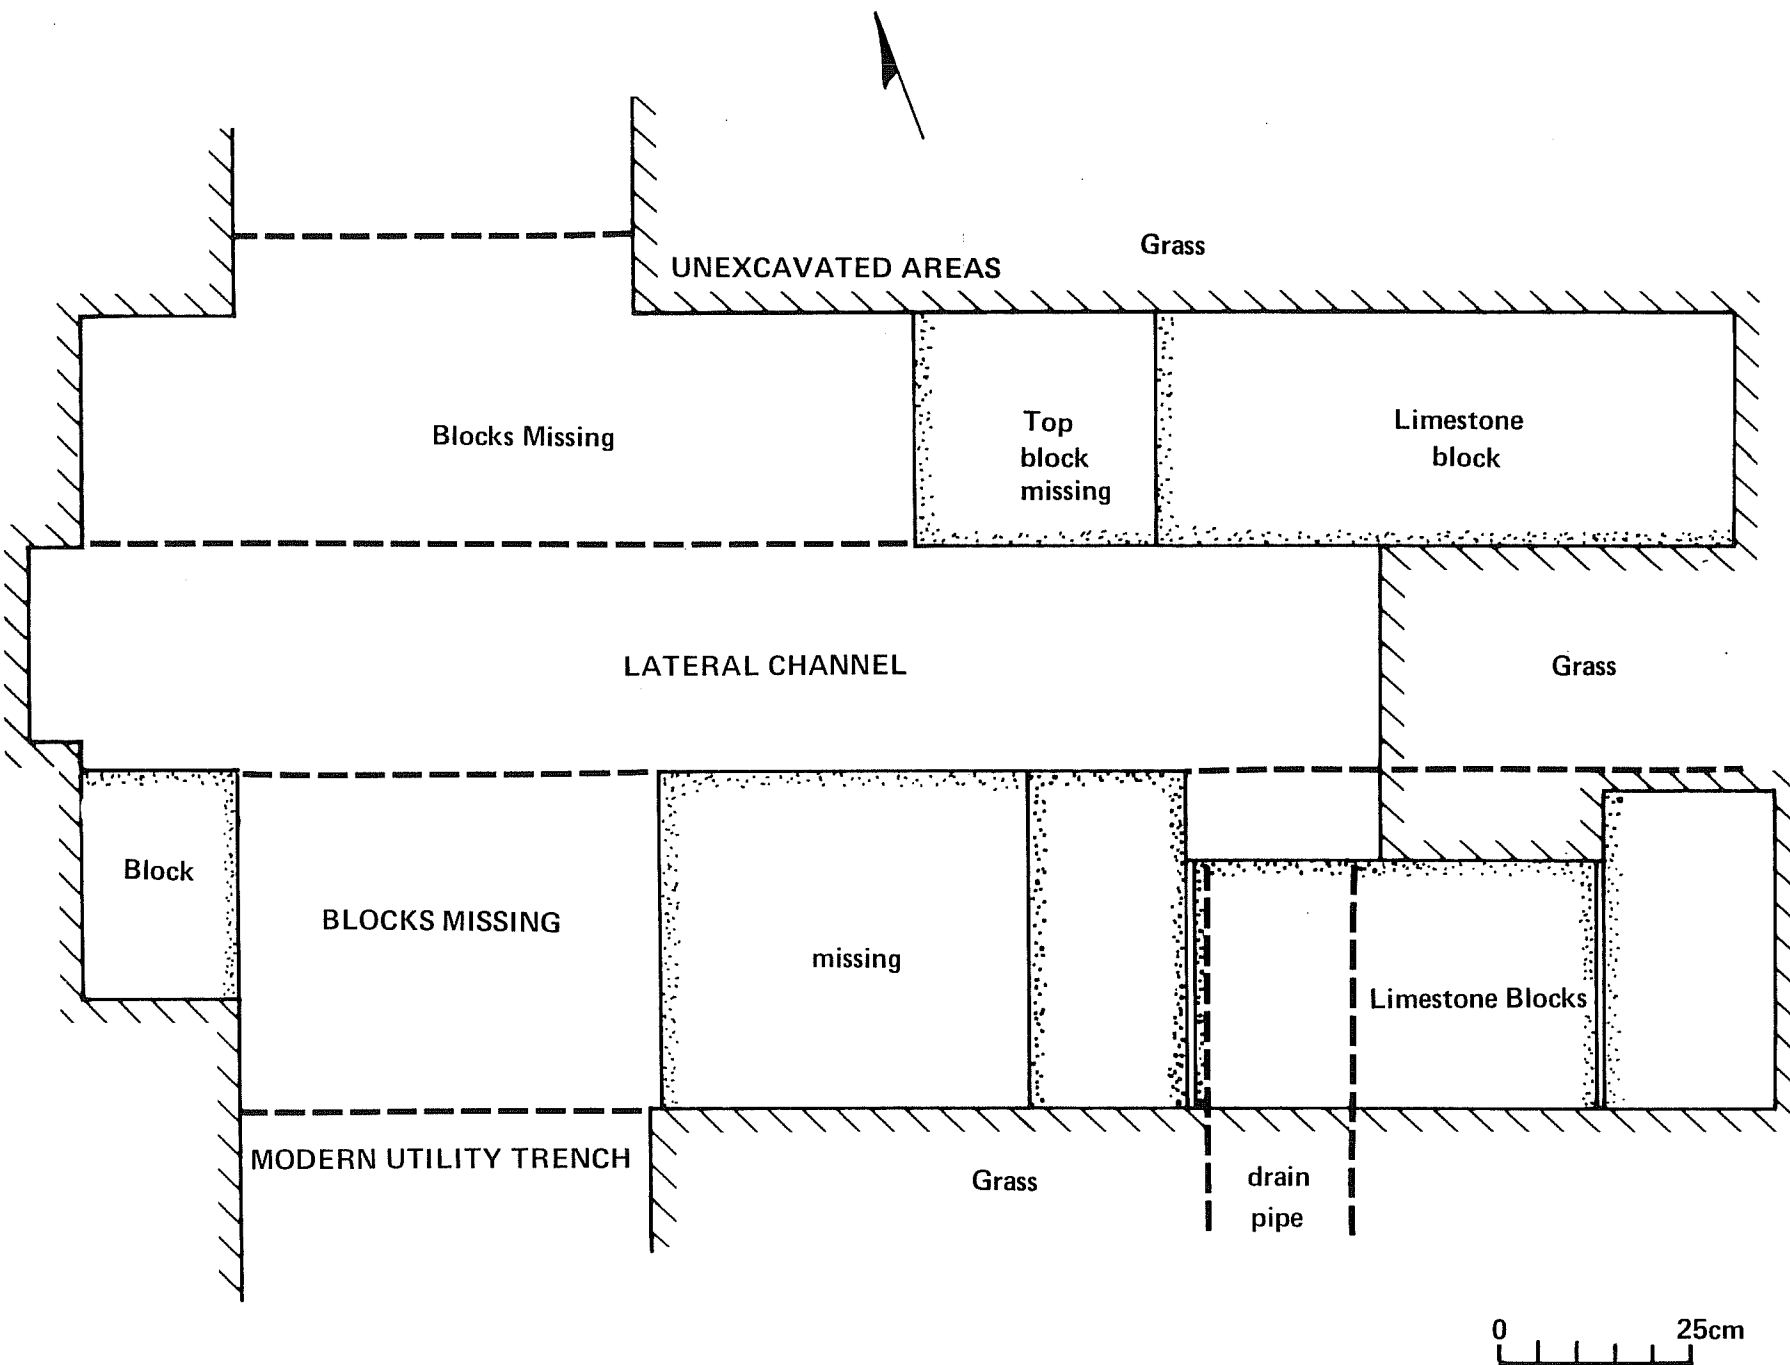
Also found in a pipe trench across this area was the continuation of the stone-lined lateral ditch of the acequia. Subsequent clearing and investigation uncovered a drain pipe leading from the house to an opening in the south wall of this lateral ditch (Figs. 2 and 7). Evidently the ditch was used at one time to dispose of rain water from the roof of the early section of the house, which was built in 1859 (Bert Whiteaker, personal communication).

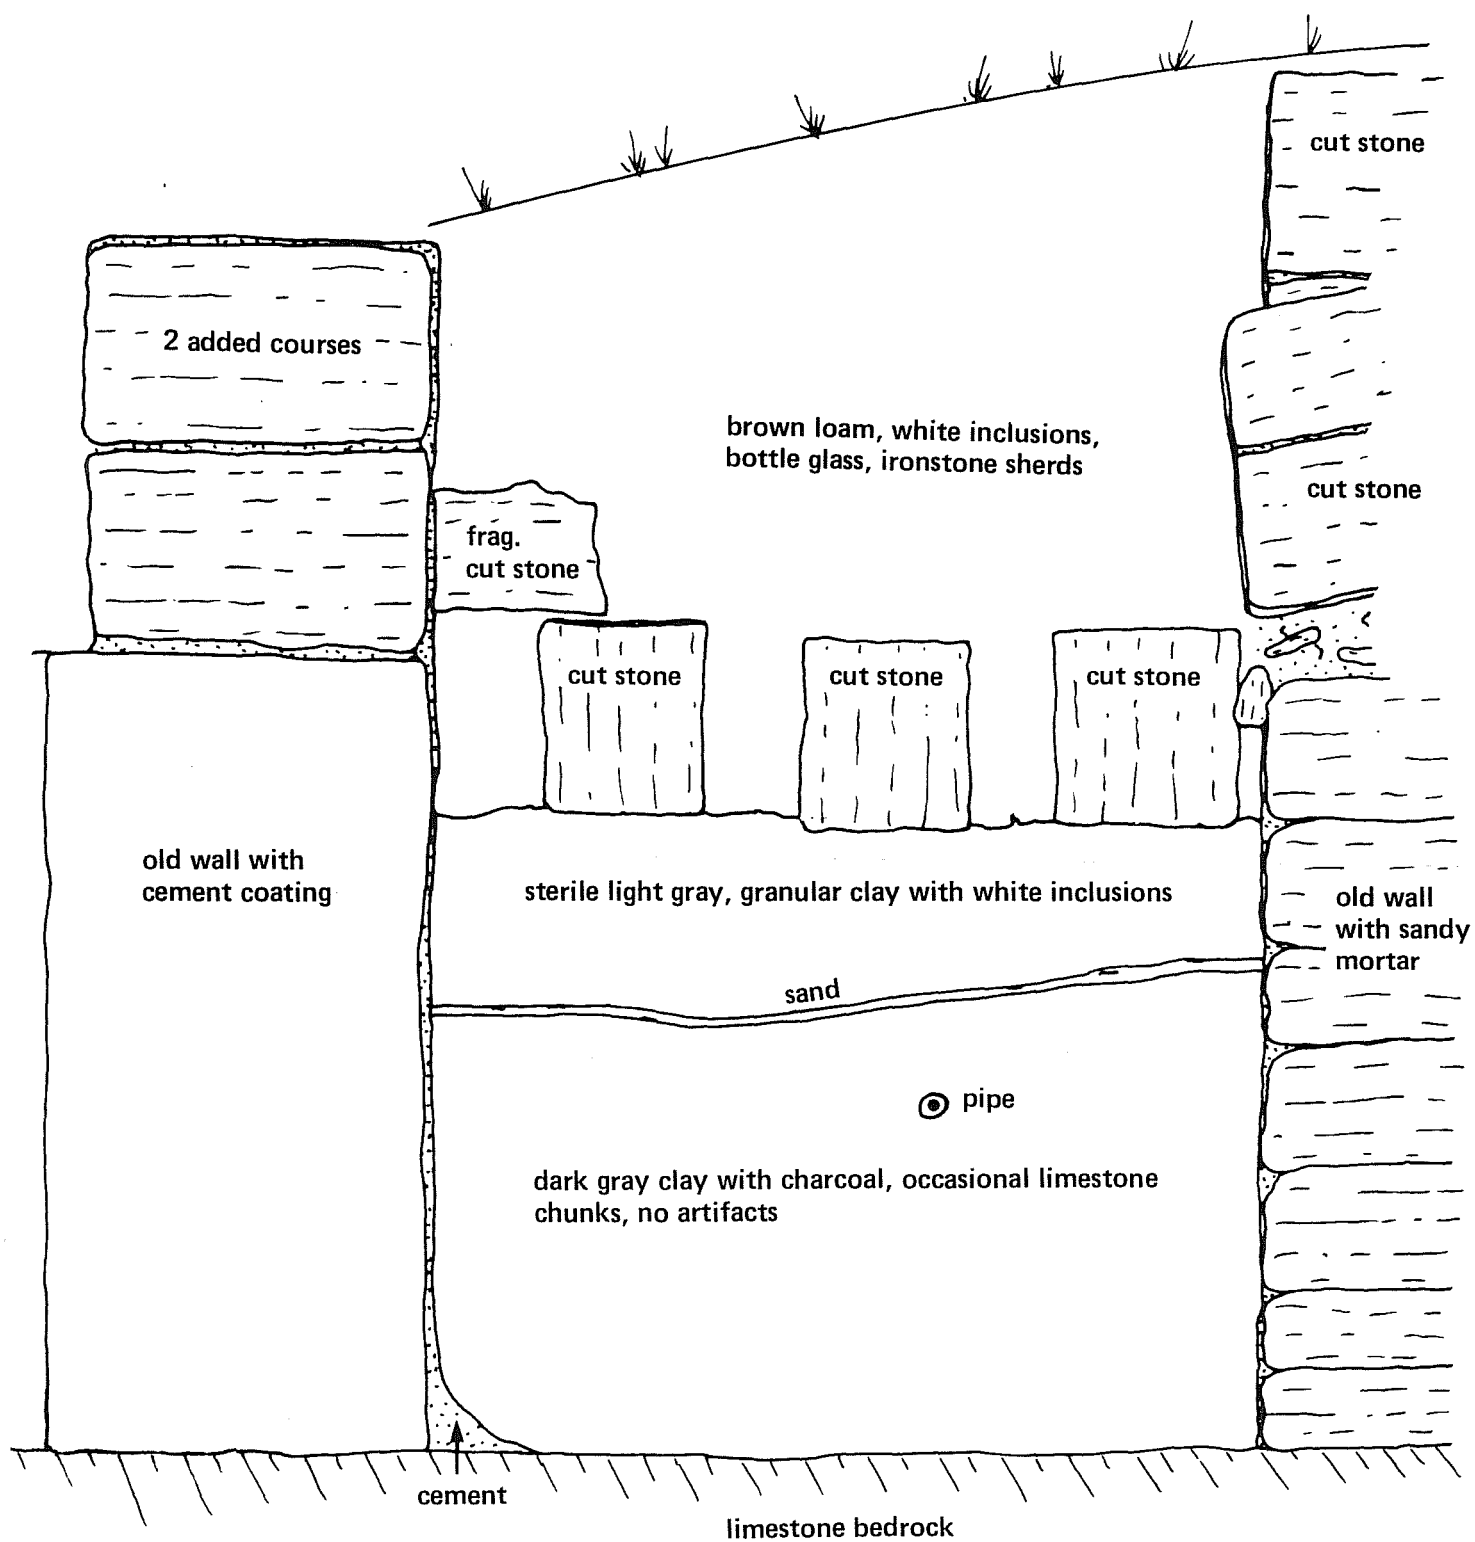
CROSS SECTION-ALAZAN ACEQUIA

The stonework of the original acequia is similar to that found in other acequias in San Antonio (Schuetz 1970). An additional two courses of cut limestone have been added to the south wall and three to the north wall at some time after the original ditch was built. A coating of cement has been applied to the south wall over the later additions and lapping onto the floor, which is bedrock. The older portion of the walls is set in a crumbling, sandy lime mortar typical of late 19th century stone construction in south Texas.

The acequia was first filled to the 3/4 level with gray clay, which apparently sat open to the weather for some time. On top of this a thin layer of water-borne sand accumulated. Then a layer of gravelly soil was added, into which were set a series of cut limestone blocks which appear to have been salvaged from another structure. Above this a fill of brown loamy topsoil containing late 19th century artifacts was added, to entirely cover and eliminate the ditch. Research into the history of park improvements would probably reveal the dates for these changes.

Figure 8. Alazan Acequia. Section looking west.
