**ARCHAEOLOGICAL INVESTIGATION OF THE SAN JUAN DAM,
41 BX 266, BEXAR COUNTY, TEXAS**

**Center for Archaeological Research
The University of Texas at San Antonio
Archaeological Survey Report, No. 179**

1989

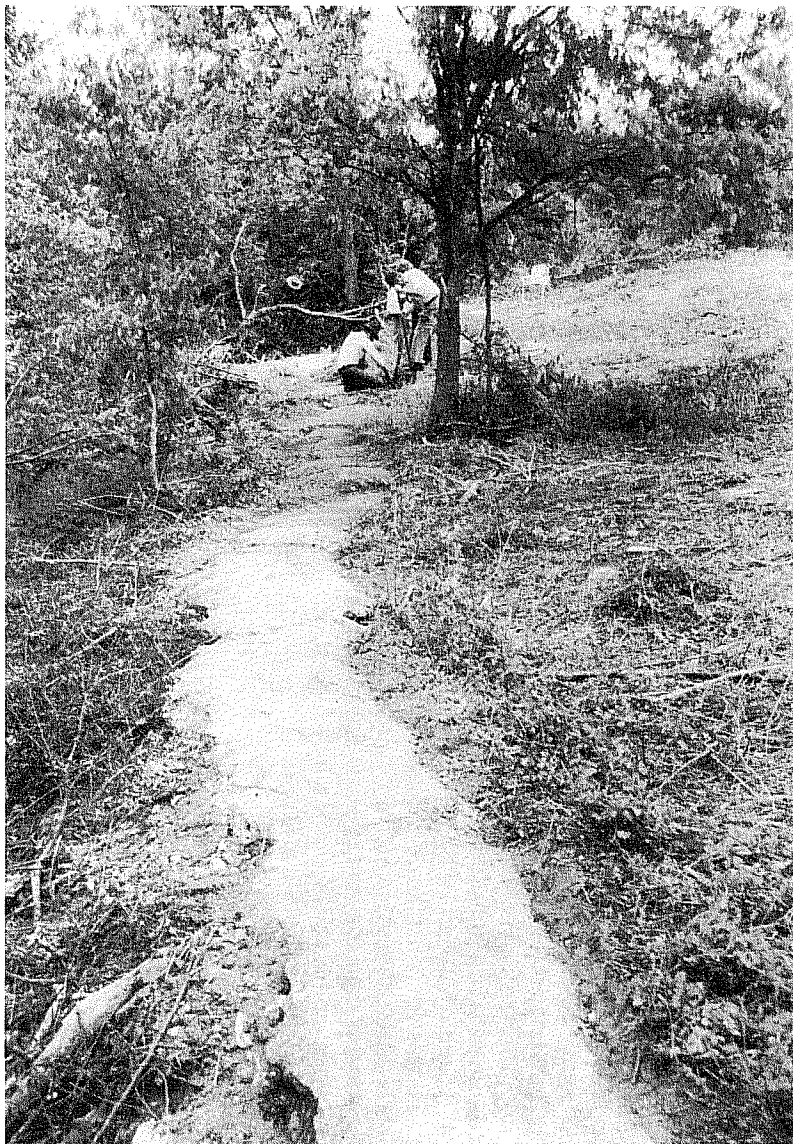
**a**

The first area exposed was the midsection of the dam. Trench 1 was located perpendicular to the dam structure and extended across the dam, exposing both sides of the structure. The upstream (eastern) face appears to be composed of river gravel and a caliche and lime mortar forming an early type of concrete. The top of the dam in this area has been capped with a modern cement (Fig. 2,a). Below (underneath) the modern cement cap the original dam can be seen. The western portion of this trench exposed the downstream (western) surface of the dam. With this portion cleared, it is possible to see that the modern concrete cap extends only six to eight inches below the top of the dam.

Figure 2. *Views of Excavations.* a, cement cap on dam looking south; b, end view of dam (Trench 5) showing construction.

The modern concrete cap that is present in Trenches 1, 2, and 6 appears to have been put on in an effort to preserve the original dam structure and prevent any additional deterioration. This modern work may have been done in conjunction with the improvements made in 1966 when the area became part of a park.

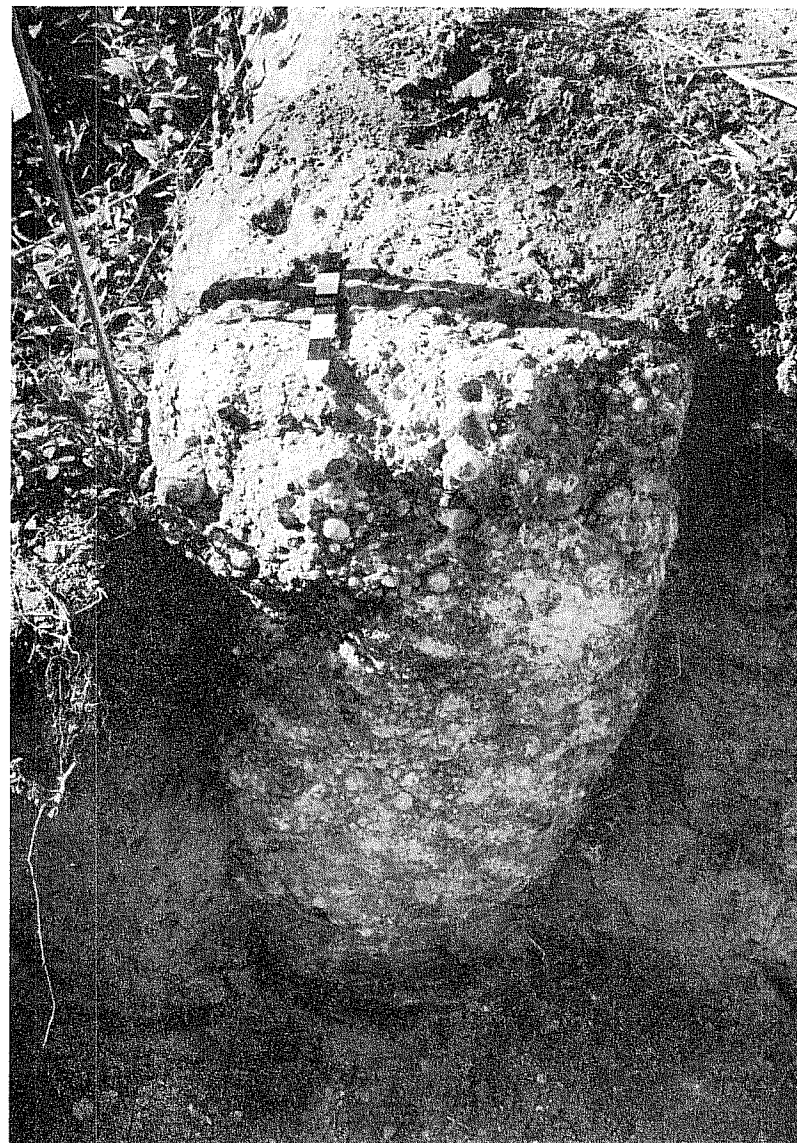
**b**

Trench 5 was located about 1 m to the south of Trench 4 and exposed the northern end of the original dam structure in its southern profile (Fig. 2,b). The soil deposits in this trench seem to differ somewhat from those of the first two trenches (Fig. 5). The first layer (A) in Trench 5 seems to be a continuation of the fill associated with the rechannelization of the river.

The original construction of the dam can be seen clearly from this trench. The front (upstream) side of the dam appears to have been straight, while the back (downstream) side seems to have sloped back from top to bottom. The material used in construction seems to have been the same as previously noted — a caliche and lime mortar with gravel forming an early type of concrete. The modern concrete cap visible in the first two trenches is not present in this profile.

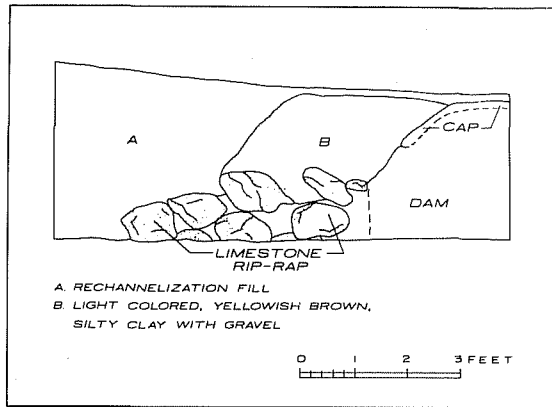
Figure 3. Trench 1, South Wall Profile.

The top of the dam currently lies two to four inches below the ground surface in Trench 1 (Fig. 3). At this point, below the ground surface, there is a distinct soil change. Above this point is a very dark gray brown clay (2.5Y 3/2) with large gravel. This soil deposit (A) is associated with the

rechanneling of the river that took place in the late 1950s. When the river was rechanneled and widened, the dirt that was removed was used to fill and raise this area. This deposit contained debris such as a plastic cigarette lighter, clear glass, screw top bottle fragments, shoe leather, and bricks. These are all artifacts that could have been deposited during the dredging of the river.

The soil layer (B) beneath is a light colored, yellowish brown silty clay (2.5Y 6/4) with some gravel. This layer appears to be associated with the overrun of the dam. Soil was carried downstream by the river and deposited in front of the dam. This soil continued to be deposited year after year causing this layer to be built up. Some of the artifacts found in this layer were ceramic sewer tile, fragments of a composition battery case, and clear glass.

A small lens (C) of a very compact, dark gray clay (10YR 3/1) was encountered next. Since there were no artifacts recovered from this deposit, and it did not appear to continue either north or south along the dam, it is difficult to be certain of the exact origin of this lens; however, it did appear to be sedimentary. It is possible that this lens is also associated with an earlier period of overrun of the dam. The lens is above a layer of large limestone boulders. The stones do not seem to be shaped and appear to be random in their placement, and also appear to be associated with the original construction of the dam. They form a foundation and rear rip-rap formation. These stones would have helped support the dam structure against the rushing water.

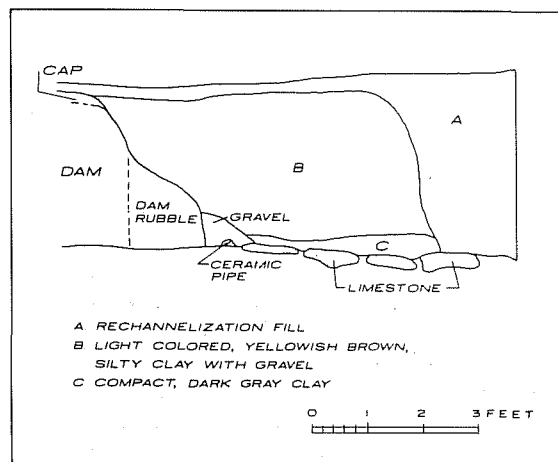
Figure 4. Trench 2, North Wall Profile.

the downstream (western) face of the dam (Fig.4). The dam structure and soil deposition here appear to be very similar to that in the first trench. The first two soil layers (A and B) are still present in this trench in very much the same configuration as in Trench 1. The third soil layer (C) in the first trench, however, does not seem to have continued this far south along the dam. Trench 2 does, however, provide a much better view of the limestone rip-rap support than does Trench 1. The modern concrete cap can also be clearly noted in this trench. Similar artifacts as noted in the first two layers of Trench 1 were also present in the corresponding layers of Trench 2.

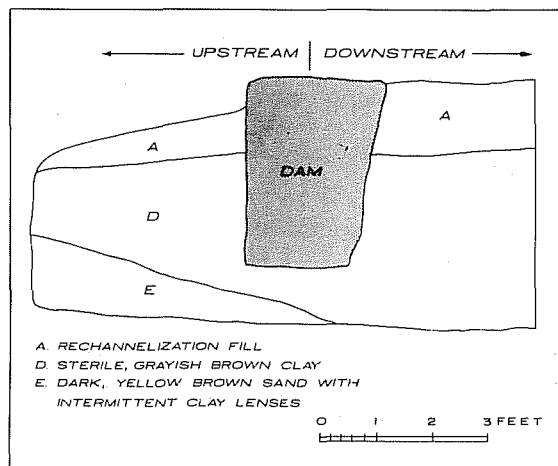
Figure 5. Trench 5, South Wall Profile.

Below this fill layer, however, is a thick layer (D) of sterile, grayish brown clay (10YR5/2). Since this clay is present on both sides of the dam and appears to be *in situ*, it is possible that when the dam was originally constructed it was cut down into this clay to provide additional support to the leading end of the dam. Below this thick layer (D) is dark, yellow brown sand (10YR 4/6) with several intermittent lenses of clay (E). This layer (E) is thought to represent the original riverbed in the channel. The intermittent lenses of sand and clay in this layer represent the periods of meandering and silting common to this part of the river. No artifacts were recovered from any of the layers in this trench, giving further support to the idea that layers D and E are intact soil deposits.
