ARCHAEOLOGICAL TEST EXCAVATIONS AT MISSION
SAN FRANCISCO DE LA ESPADA

Anne A. Fox and Thomas R. Hester

Center for Archaeological Research
The University of Texas at San Antonio
Archaeological Survey Report, No. 22

1976

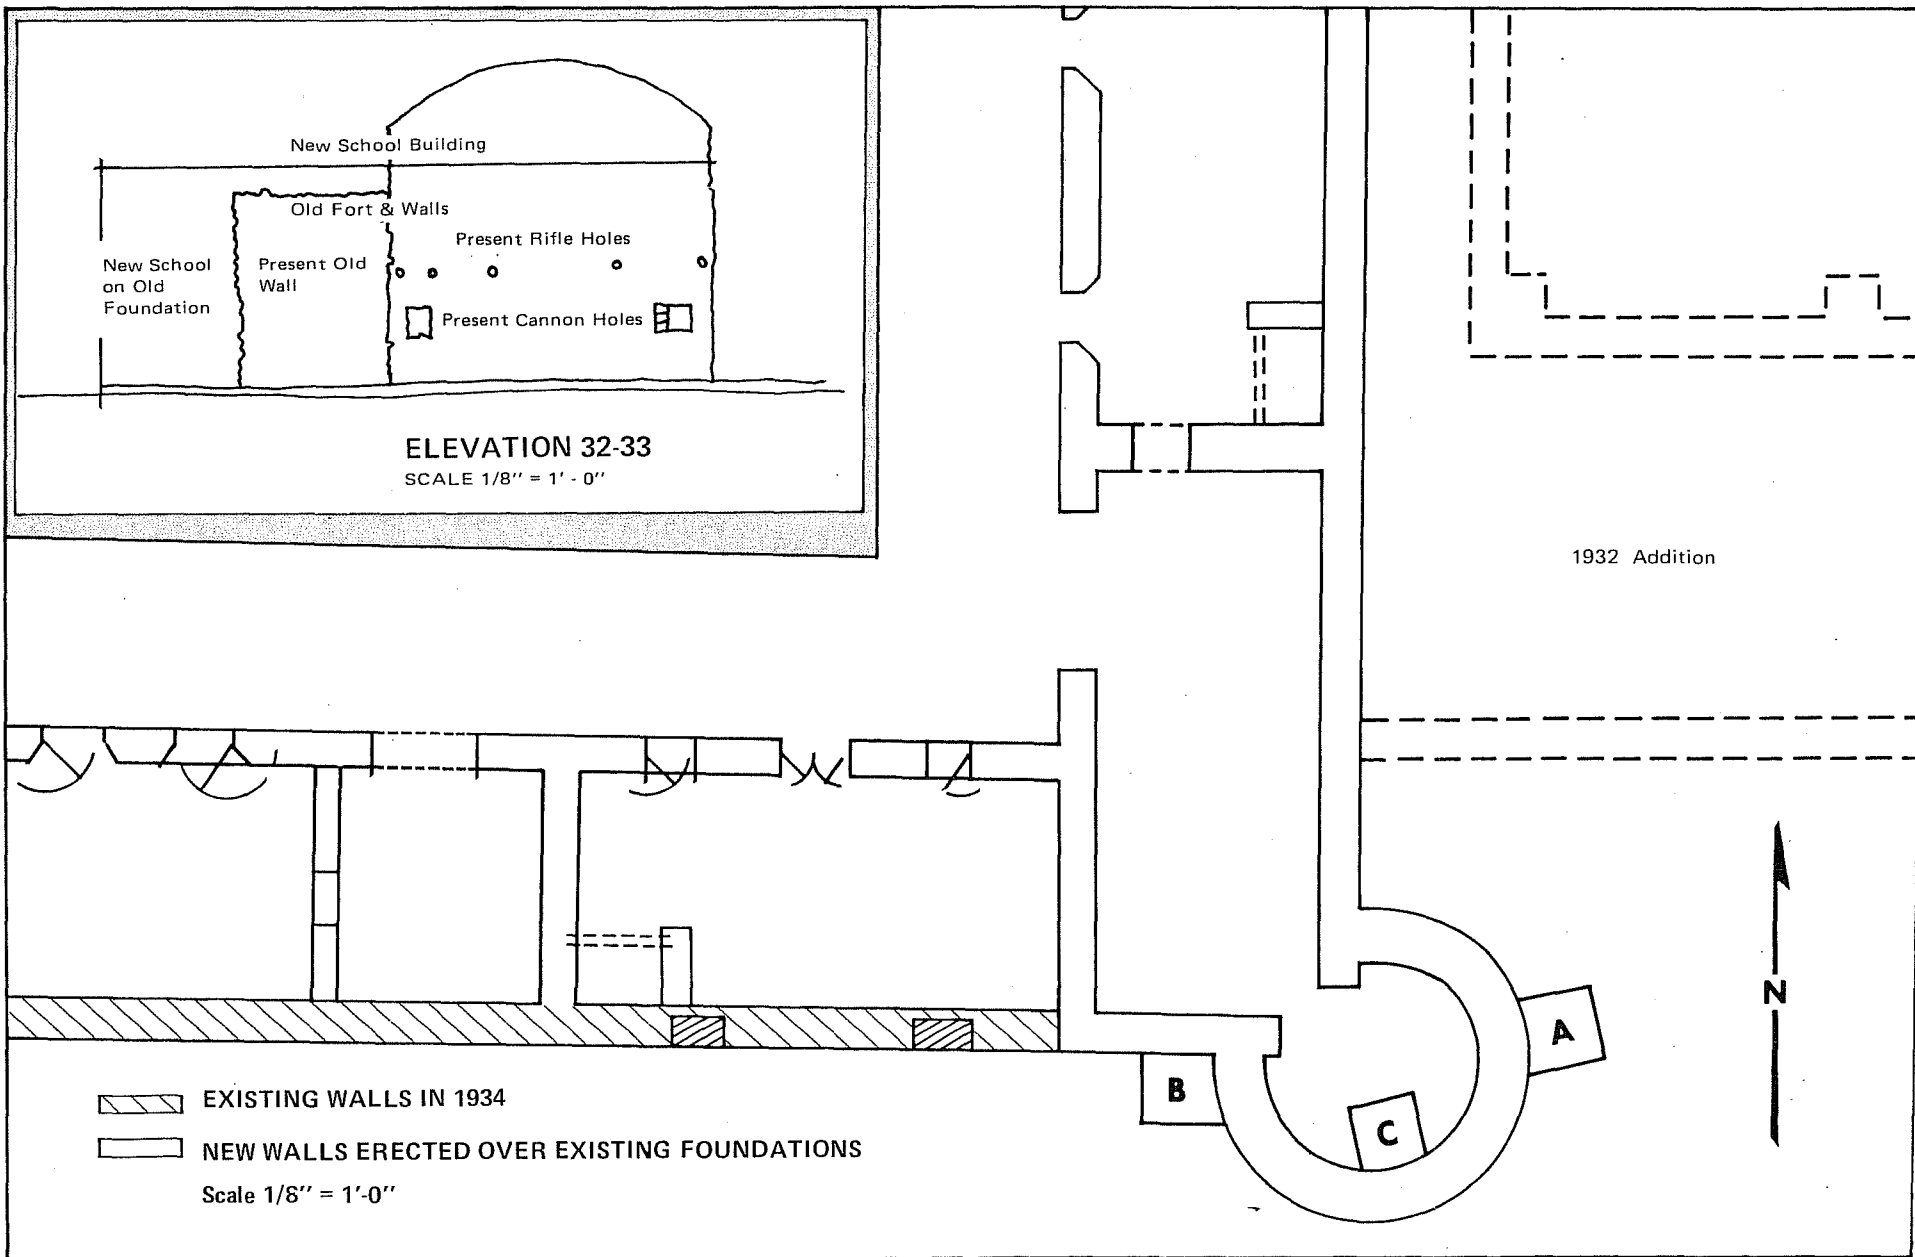
Figure 2. *Location of Test Pits.* Taken from restoration drawings of Harvey P. Smith, 1934.

Three one-meter square test pits were laid out adjacent to the walls of the tower (Fig. 2). Test pit A was located directly under the crack in the tower wall, in order to determine how far the weakness extended and whether there could be any subsurface factors involved in the deterioration. Test pit B was located on the west side of the tower at the intersection of the tower wall with that of the mission in order to examine the building sequence, since Smith indicated that this portion of the original wall was still standing in 1934 (Smith 1934: Sheet 8). Test pit C was located opposite the doorway on the inside of the tower, approximately half way between the other two test pits. A permanent datum from which all depth measurements could be compared was established on the bottom of the southernmost gun port in the tower wall. A temporary datum for each pit was set at its highest corner. All comparative elevations were then determined by alidade.

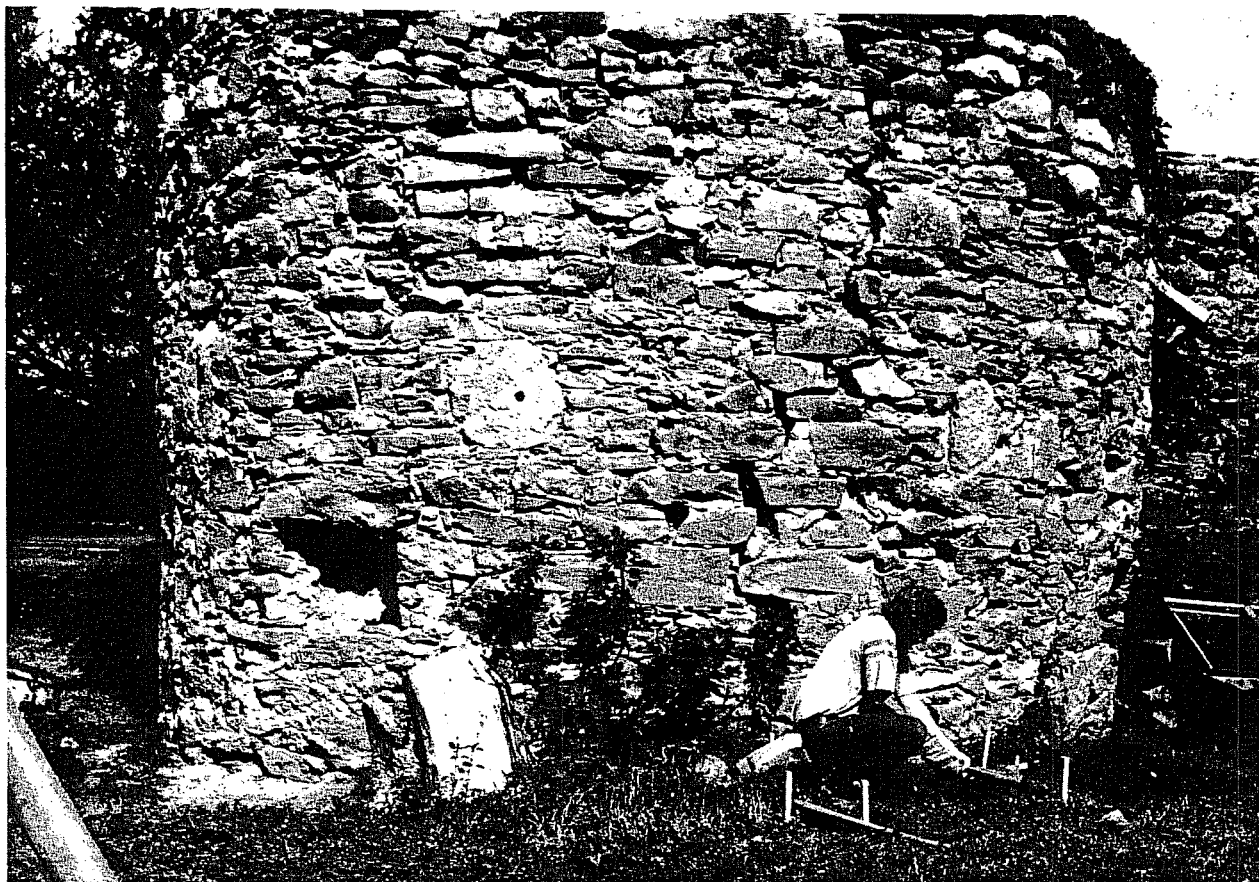
In recent times a large crack has formed in the east side of the tower and the surrounding wall bulges noticeably outward. The purpose of our brief investigation was to determine, if possible, the method of construction of the wall footings in order to aid in planning by architect Caroline Peterson (of Ford, Powell & Carson, Architects and Planners) for the stabilization and repair of the tower.

(upper) View of tower from east, showing crack in wall and location of Test Pit A.

tower wall. No sign of a pipe trench was visible in the walls or floor of the excavation. At 45 cm, beneath a level of slightly more concentrated chips of stone, the soil changed gradually to a dark brown sterile clay. Also at this point, the cut stone and mortar wall of the tower changed to rubble laid in a more casual manner, with occasional flat stones laid vertically against the face of the footing. No wall trench was present, the dark brown clay intruding into all cracks and crevices of the footing with no mortar discernible. The footing continued to a depth of 95 cm.

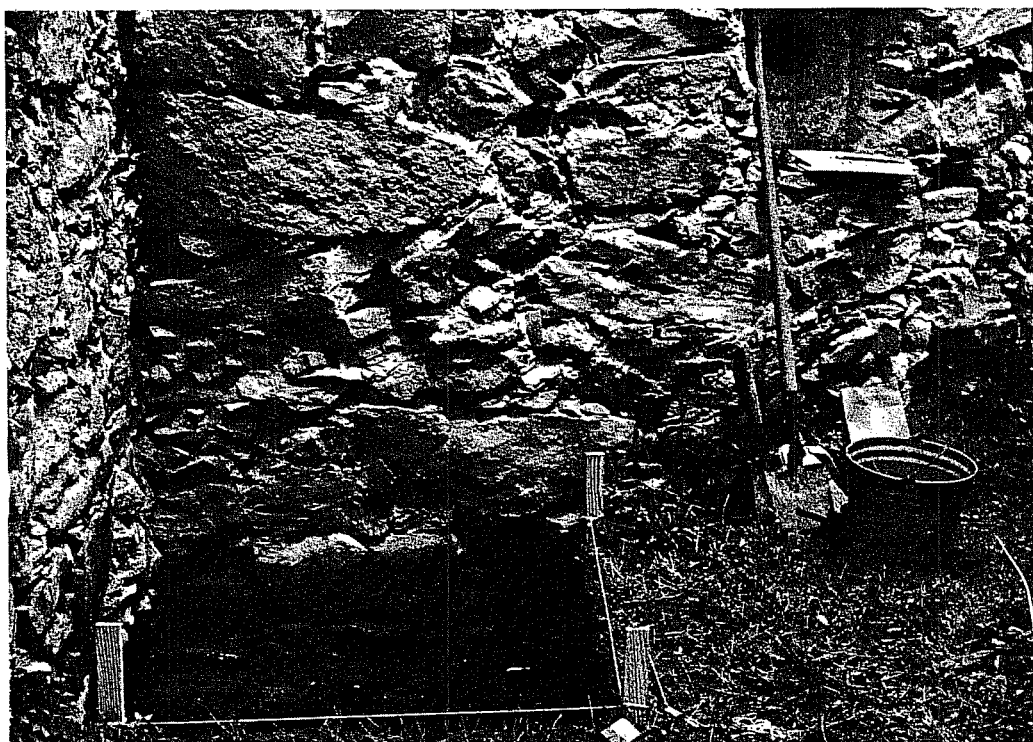
(lower) Test Pit B excavated to 40 cm, showing the junction of the tower wall with the mission building and the top of the wall footing.

Test pit B (Figs. 2,3,4,6) was excavated in the same manner as A. The sequence of soil and artifacts was also similar, though the soil change was difficult to observe due to the moisture in this area caused by a nearby roof drain. It was observed that the top of the footing for the mission wall began 10 cm deeper than that of the tower, and that it extended to the same depth. A close examination of the point where the tower wall joins that of the mission reveals that they were not tied together and may have been built independently of each other. The entrance into the interior of the tower is through an opening which appears to have been formed by removing the corner of the original building (see Fig. 2). However, the workmanship of the two are quite similar and the footings are similar, though not identical. It is interesting to speculate that the difference in level of the top of the tower wall footing might indicate raising of the surrounding ground level due to accretion through time, and that the tower might have been built considerably later than the wall. Archaeology has revealed a surprising consistency in the depth of overburden which has accumulated through time upon the 18th century living surfaces at all the San Antonio missions (see Greer 1967: Figs. 3 and 4; Schuetz 1968:238; Fox 1970:

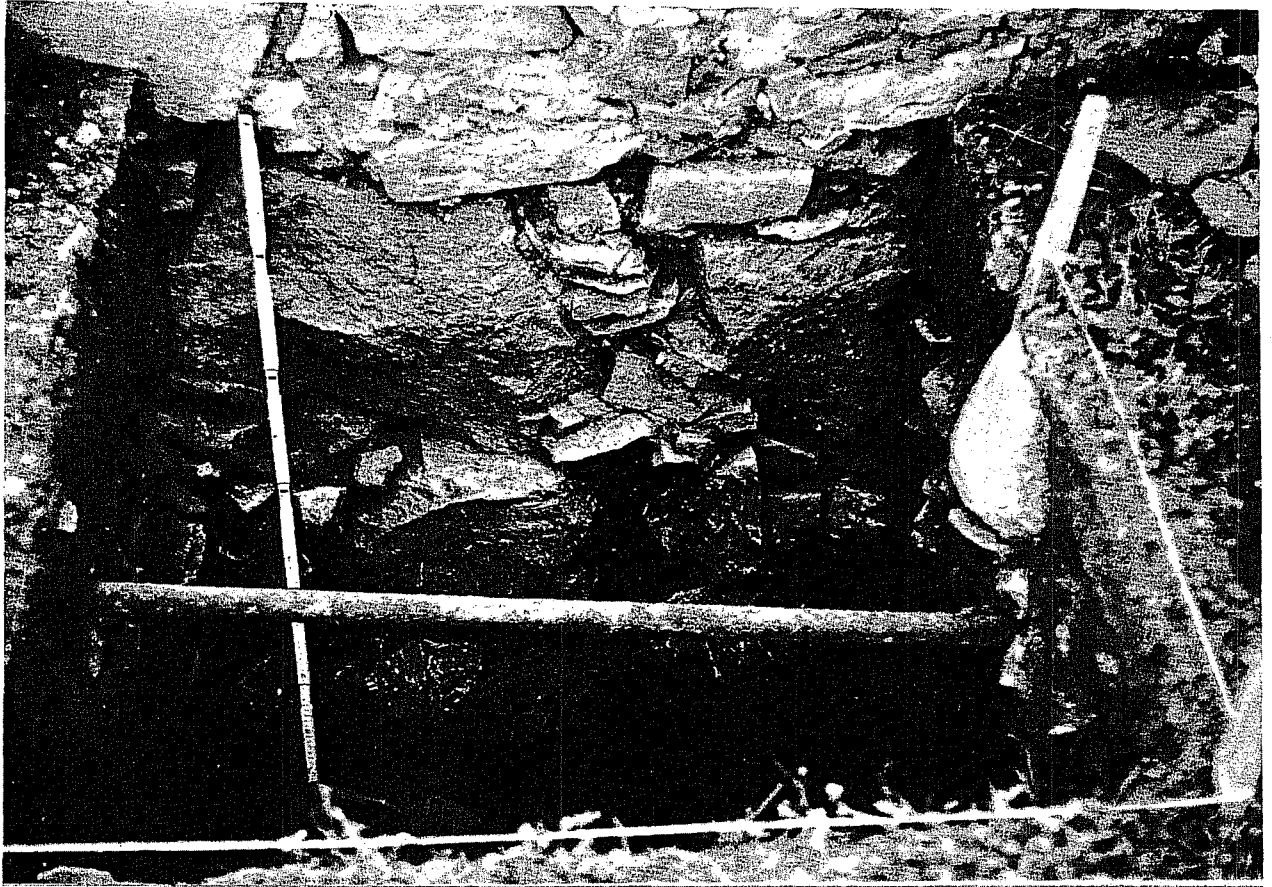
(upper) West profile of Test Pit A, showing wall and footing construction.

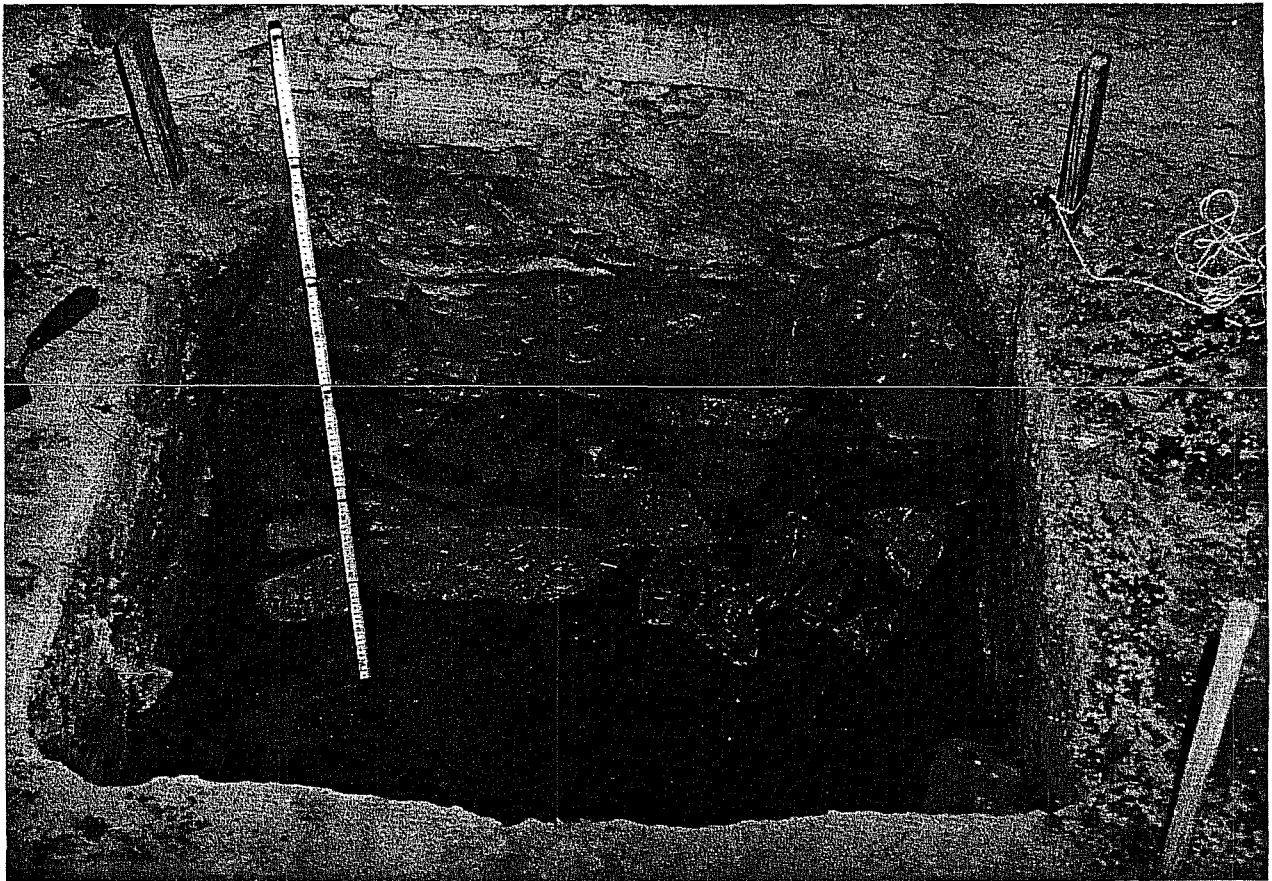
(lower) South profile of Test Pit C excavated to 48 cm, showing contrast between wall and footing construction.

Test pit C (Figs. 3,7), inside the tower, was excavated to 5 cm with trowels and the fine, dry soil screened for maximum artifact recovery. The artifacts in this level represented predominantly late 19th to early 20th century articles, with some more recent bottle fragments and plastic objects. From the 5 cm level to a depth of 45 cm the mottled brown and grey soil was sterile, except for fragments of wall stone. At 45 cm what appeared to be a solid layer of stone fragments was encountered. This was found to be only a few cm thick and directly beneath this began the same dark brown, sterile clay which had been encountered on the outside of the wall. At this same point began the wall footing, continuing to a depth of 85 cm.

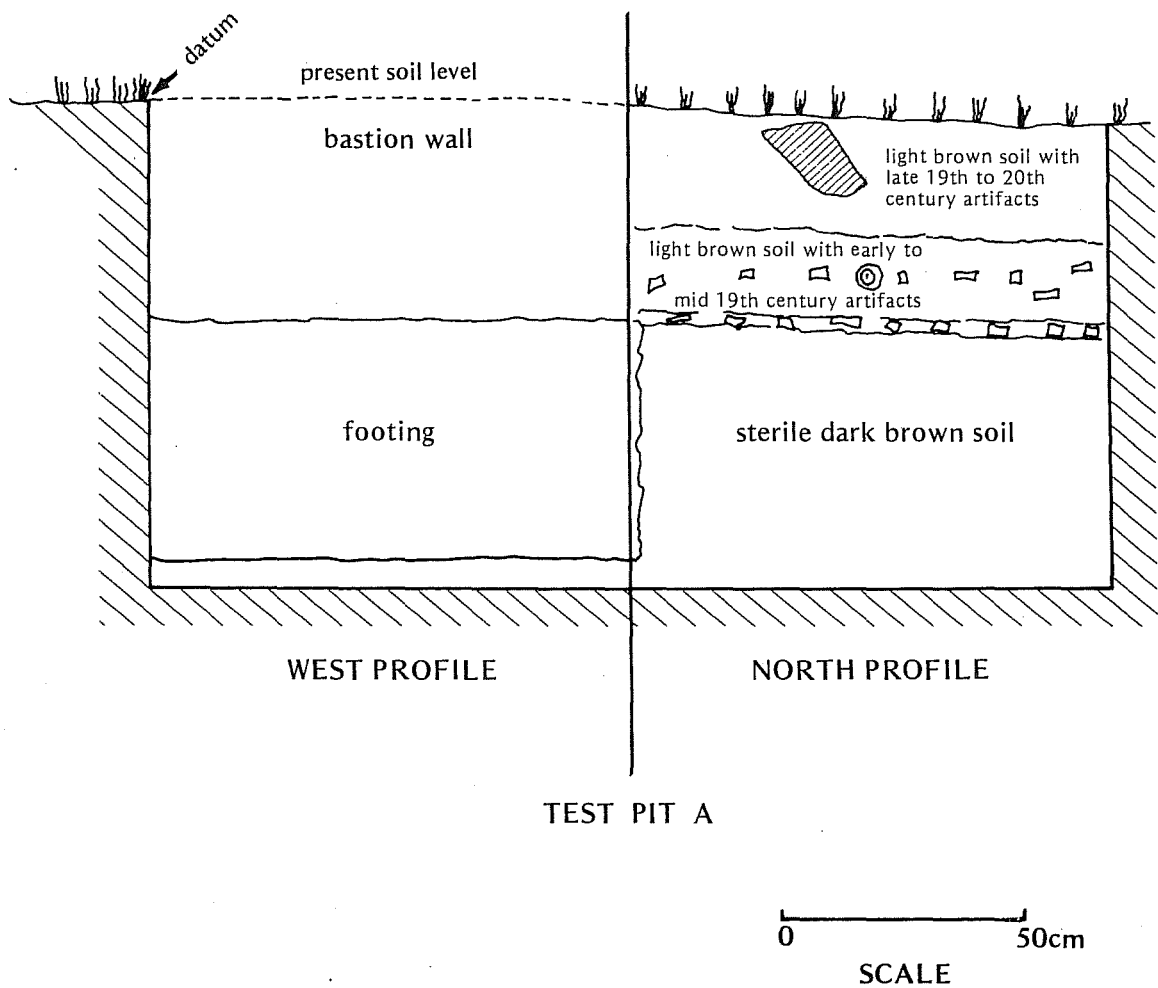
Figure 5. *San Francisco de la Espada*. Profile of Test Pit A.

Test pit A (Figs. 2,3,5) was excavated with trowel and shovel in 10 cm levels. The first 25 cm consisted of light brown soil which contained late 19th and 20th century artifacts. From 25 to 45 cm, earlier 19th century artifacts and small fragments of wall stone were recovered. At 35 cm, an iron pipe (three inches in diameter) was discovered, oriented north and south approximately 50 cm from the
