ARCHAEOLOGICAL INVESTIGATIONS

San Pedro Acequia

SAN ANTONIO, TEXAS

Center for Archaeological Research
The University of Texas at San Antonio
Archaeological Survey Report, No. 103

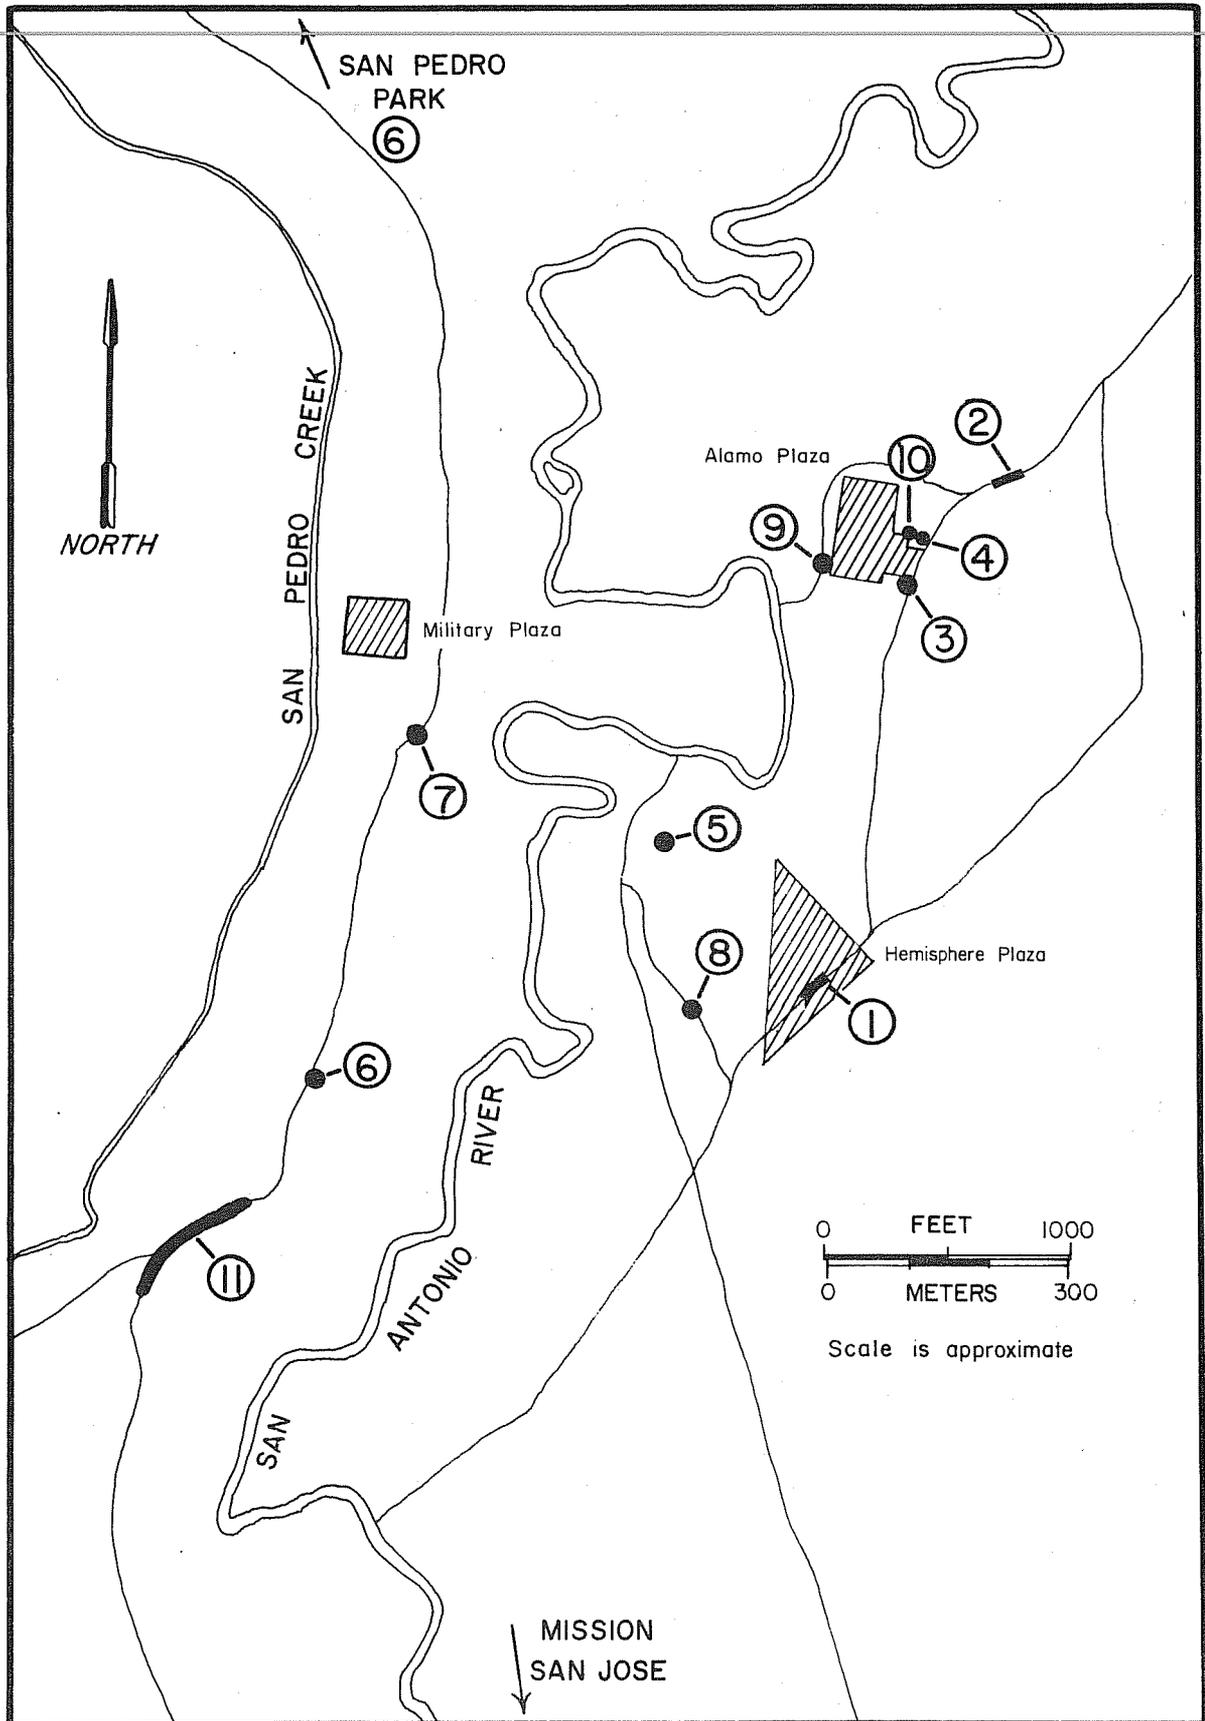
Figure 1. Map of the San Antonio Area Indicating the Locations of Previous Archaeological Investigations of Spanish Colonial Acequias. The circled numbers correlate with descriptions in the text.

There are literally miles of acequias (water ditches) criss-crossing and latticing the metropolitan area of San Antonio and lands to the south (Fig. 1:Locations 1-11). There have been comparatively few detailed archaeological investigations and publications dealing with these facts of pioneer engineering.

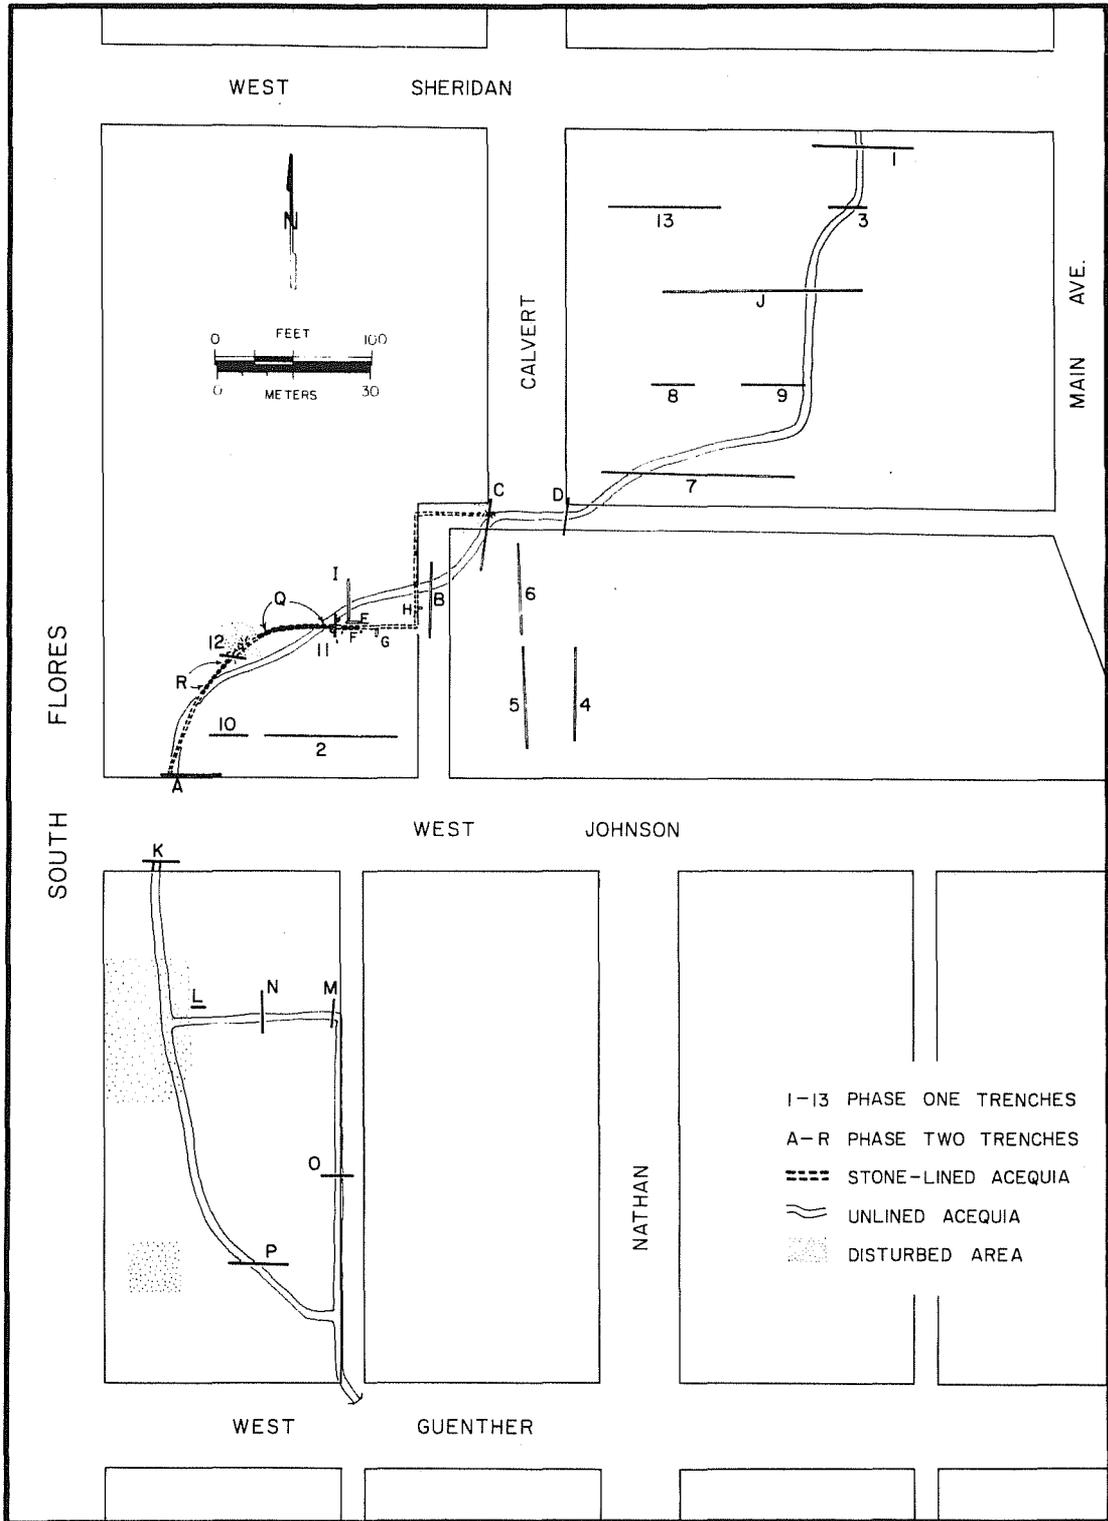
Figure 2. Plan of General Services Administration Property Indicating the Locations of Test Trenches and the Routing of the San Pedro Acequia.

This will be followed by descriptions of test trenches A-R which were dug under the supervision of Augustine Frkuska during Phase II of the investigations. Figure 2 indicates the locations of these trenches and the actual routing of the San Pedro Acequia through the GSA properties.

This trench was located about 25 feet from W. Johnson Street (Fig. 2). The trench was dug parallel with the street to a length of 98 feet and a depth of 2 feet. The trench profile revealed 16 inches of black topsoil covering 12 inches of a dark brown clayey loam. Below this was 8 inches of brown sandy loam which rested upon basal caliche. No ditch profile was noted in the trench walls.

This trench was located 31 feet south of Trench 1 (Fig. 2). The trench was dug to a length of 28 feet and a depth of 45 inches. A profile of a ditch was noted and recorded in the south wall of this trench (Fig. 3). The trench was cut through the same stratigraphy as noted in Trench 1. However, the widths of the deposits varied in this southern wall profile.

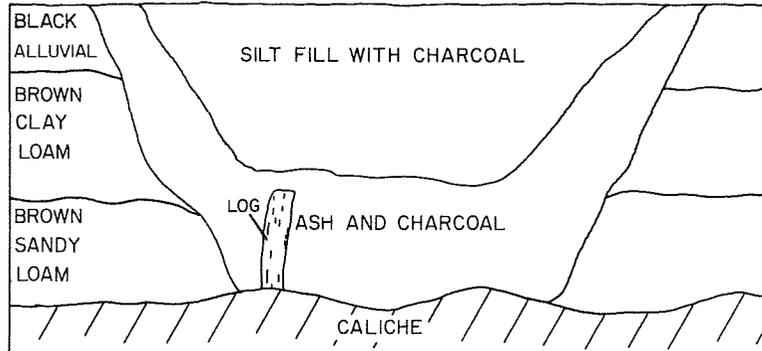
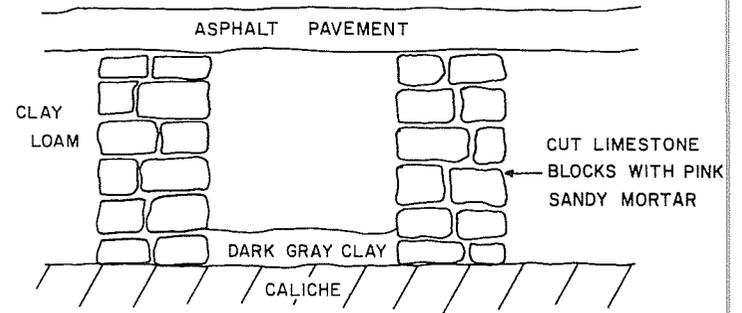
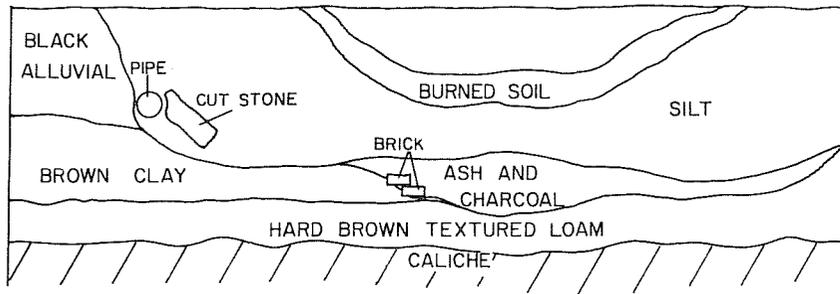
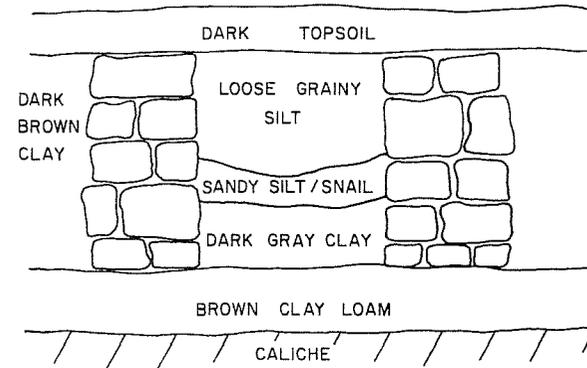
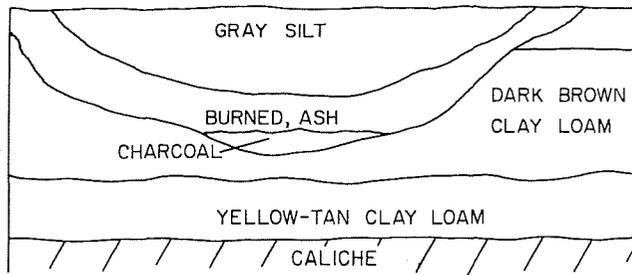
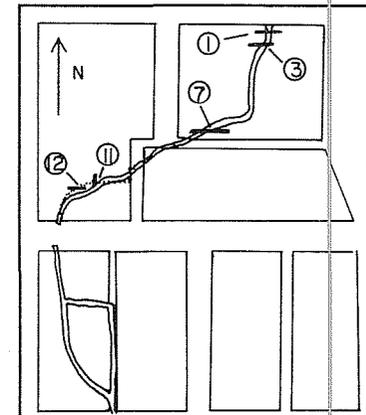
Figure 3. Soil Profiles Showing the San Pedro Acequia from Phase I. (After Valdez and Eaton 1979.)

The distinctive profile of a shallow ditch, beginning at the surface and extending 51 inches down to the caliche base, was noted (Fig. 3). The width of the ditch measured approximately 9 feet (the base of the ditch was at caliche bedrock as noted). The fill consisted of two major levels. The earliest deposit was a clayey ash and charcoal loam approximately 23 inches in depth. On the east side of the ditch (acequia) was a vertical wooden post. This post is possibly a remnant of a retaining wall structure built to slow the erosion on the east bank. The second major deposit was approximately 29 inches in depth and consisted of a silt fill with charcoal flecks. It was within this second layer that the majority of artifacts were found.

The south wall of the trench revealed the stone-lined acequia as described in Trench 11 (Fig. 3). However, the stone walls at this location were covered with 8 inches of dark topsoil, and there were three layers of deposits within the acequia walls. The bottom layer was 12 inches of dark gray clay of the same description as found in Trench 11. Upon the gray clay lies a 5-inch layer of sandy silt with snail shells throughout the level. The remaining 22 inches of fill was a caliche soil mix containing the majority of the cultural material collected. The acequia at this location did not rest upon the caliche bedrock.

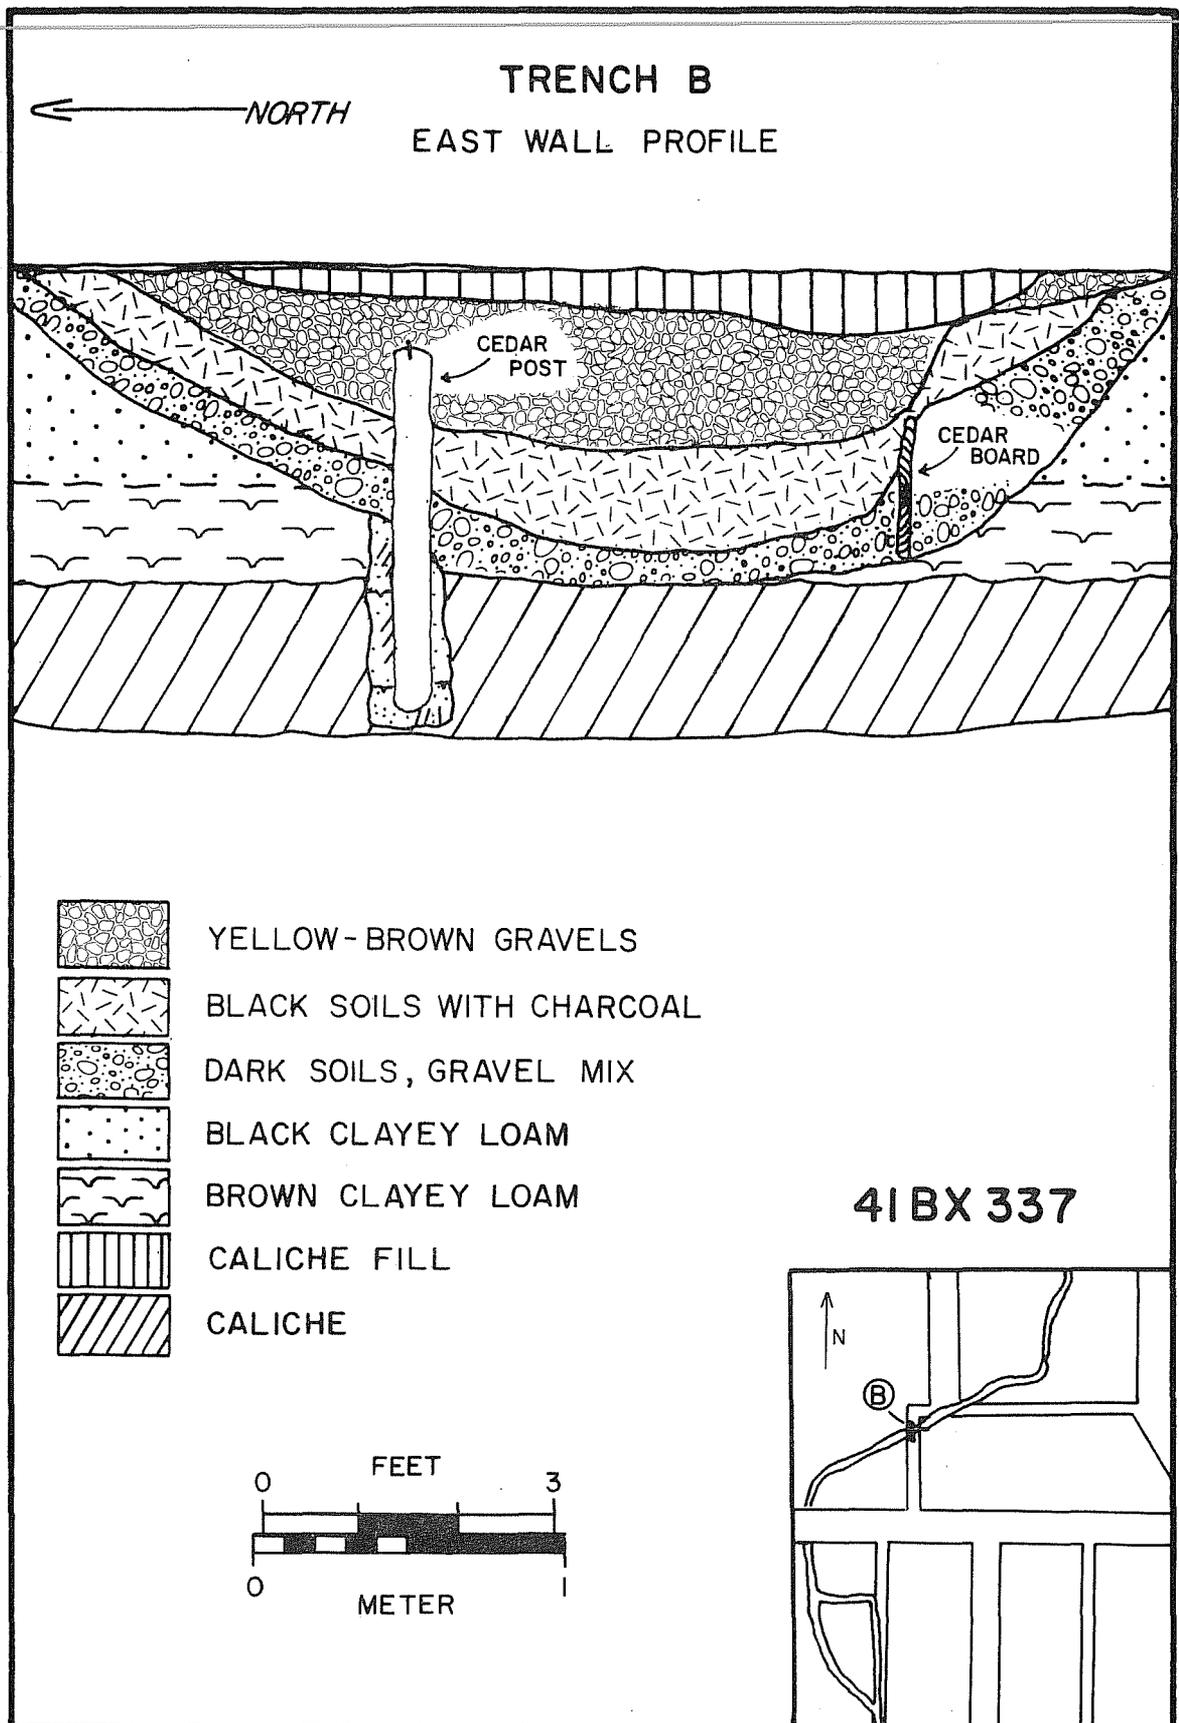
Figure 4. Soil Profile of Trench B.

Trench B was placed on an improved extension of Calvert Street. The trench was oriented north and south, in anticipation of the acequia's path between Trenches 7 and 11 (Fig. 2). The south end of Trench B was begun 95 feet from W. Johnson Street and excavated to a length of 48 feet. The trench was dug to a depth that revealed natural caliche. Both walls of the backhoe trench were cleaned to observe the characteristics of the acequia (Fig. 4). The acequia is approximately 8 feet in width with a depth of 3 feet. A cedar post was noted on the north half of the profile, and a cedar plank was noted on the south half of the profile. The cedar post and board suggested the past construction of a retaining wall along both banks of the acequia.

The acequia appears to have been dug through two layers of natural occurring soils. The top layer is 24 inches thick and grades from a black to a dark brown clay loam. This is overlying a lighter brown clay loam about 12 inches thick. As noted in the earlier trenches of Phase I, the thicknesses vary due to the gradation of the soils. The brown clayey loam overlies a white caliche layer on which the acequia bottom also rests. The interior of the acequia is surfaced by a caliche fill with limestone chips associated with the gravel road. Beneath this layer lies what appears to be intentional fill of yellow-brown gravels, with a maximum thickness of 18 inches. Beneath this layer was a dark clay loam with numerous pieces of charcoal and cultural materials. The maximum thickness of this cultural layer was about 12 inches. The deposit that lies beneath the cultural zone consisted of a silty clay loam with gravels. No cultural debris was noted in this level.

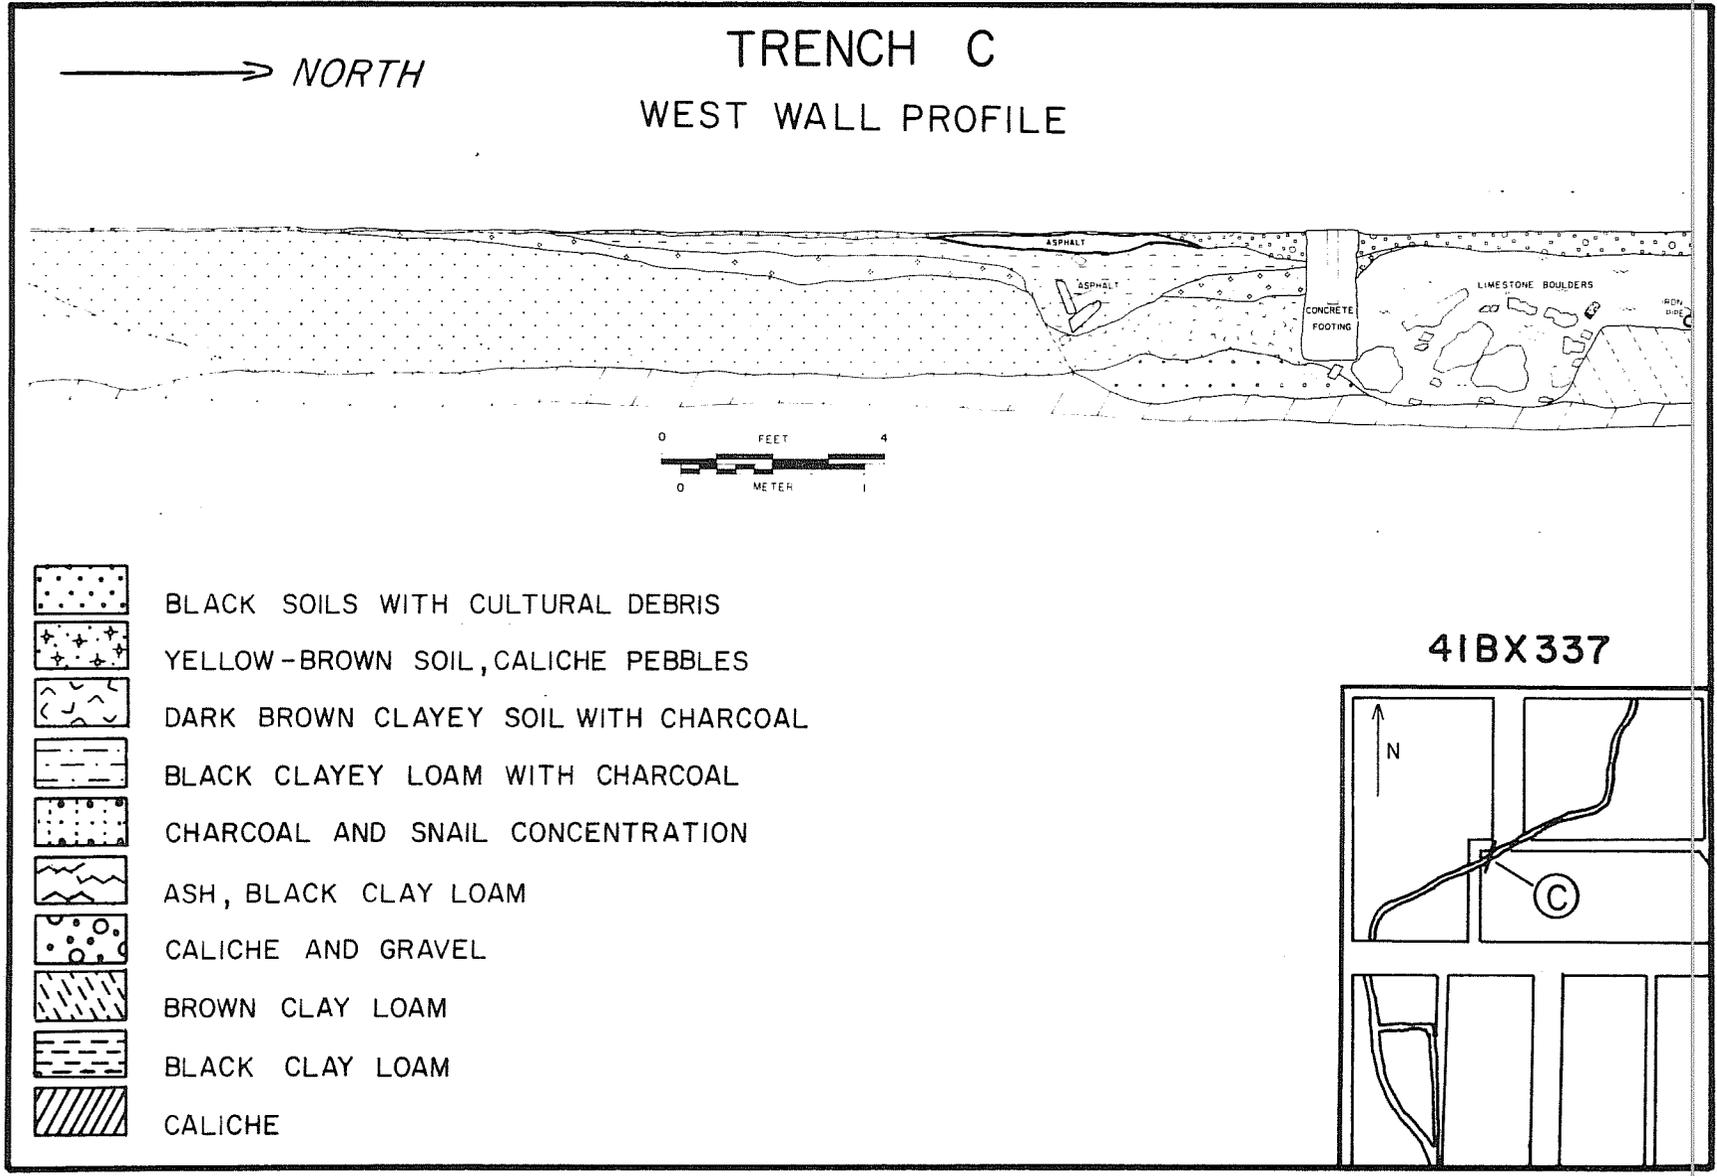
Figure 5. Soil Profile of Trench C. Note remains of limestone block fragments.

Trench C was located approximately 18 feet from Trench B (Fig. 2). The southernmost point of Trench C is 145 feet north of W. Johnson Street. The trench was oriented north and south with a total length of 45 feet. The west wall profile was cleaned and recorded (Fig. 5). The acequia in the profile was approximately 30 feet wide; however, this large width was due to the oblique angle in which the trench was excavated into the acequia's path. At the north end of the

trench was a large amount of fractured limestone and a few pieces of these stones contained chisel marks on one face. This might suggest that in this area a junction was made of the stone-lined portion of the acequia and the original unlined portion.

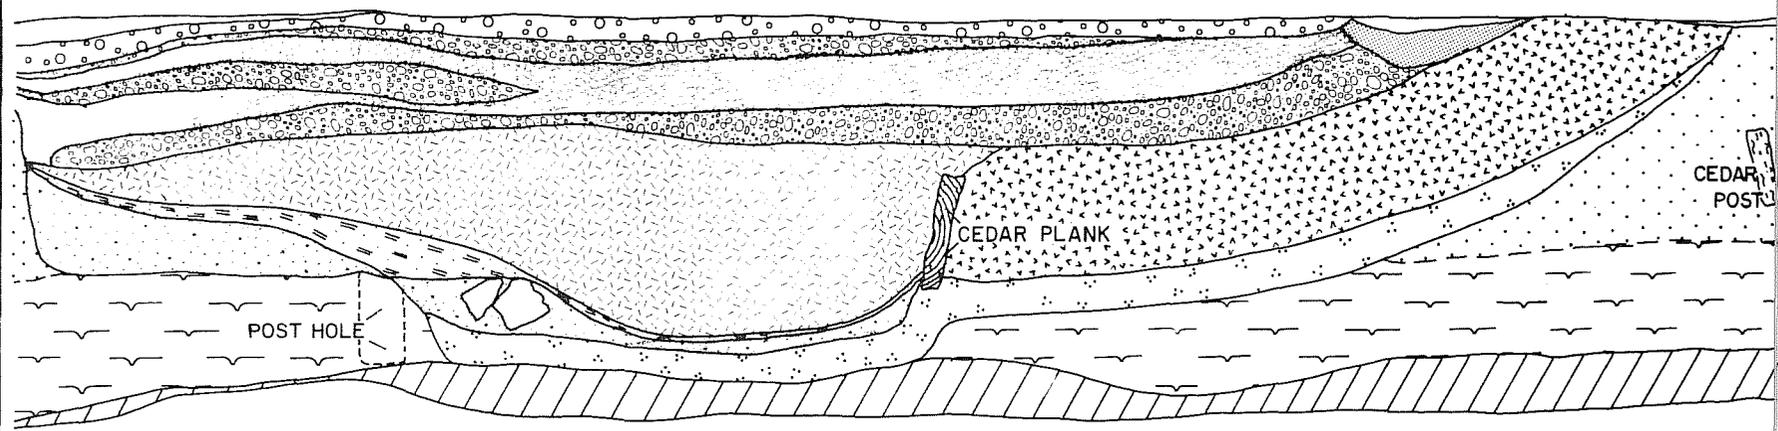
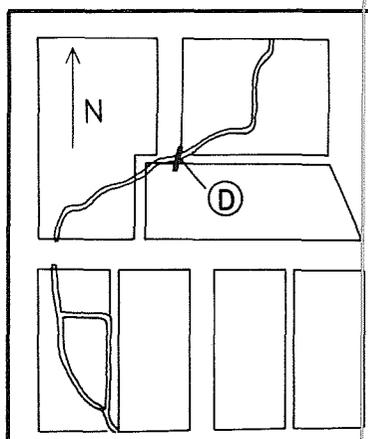
Figure 6. Soil Profile of Trench D.

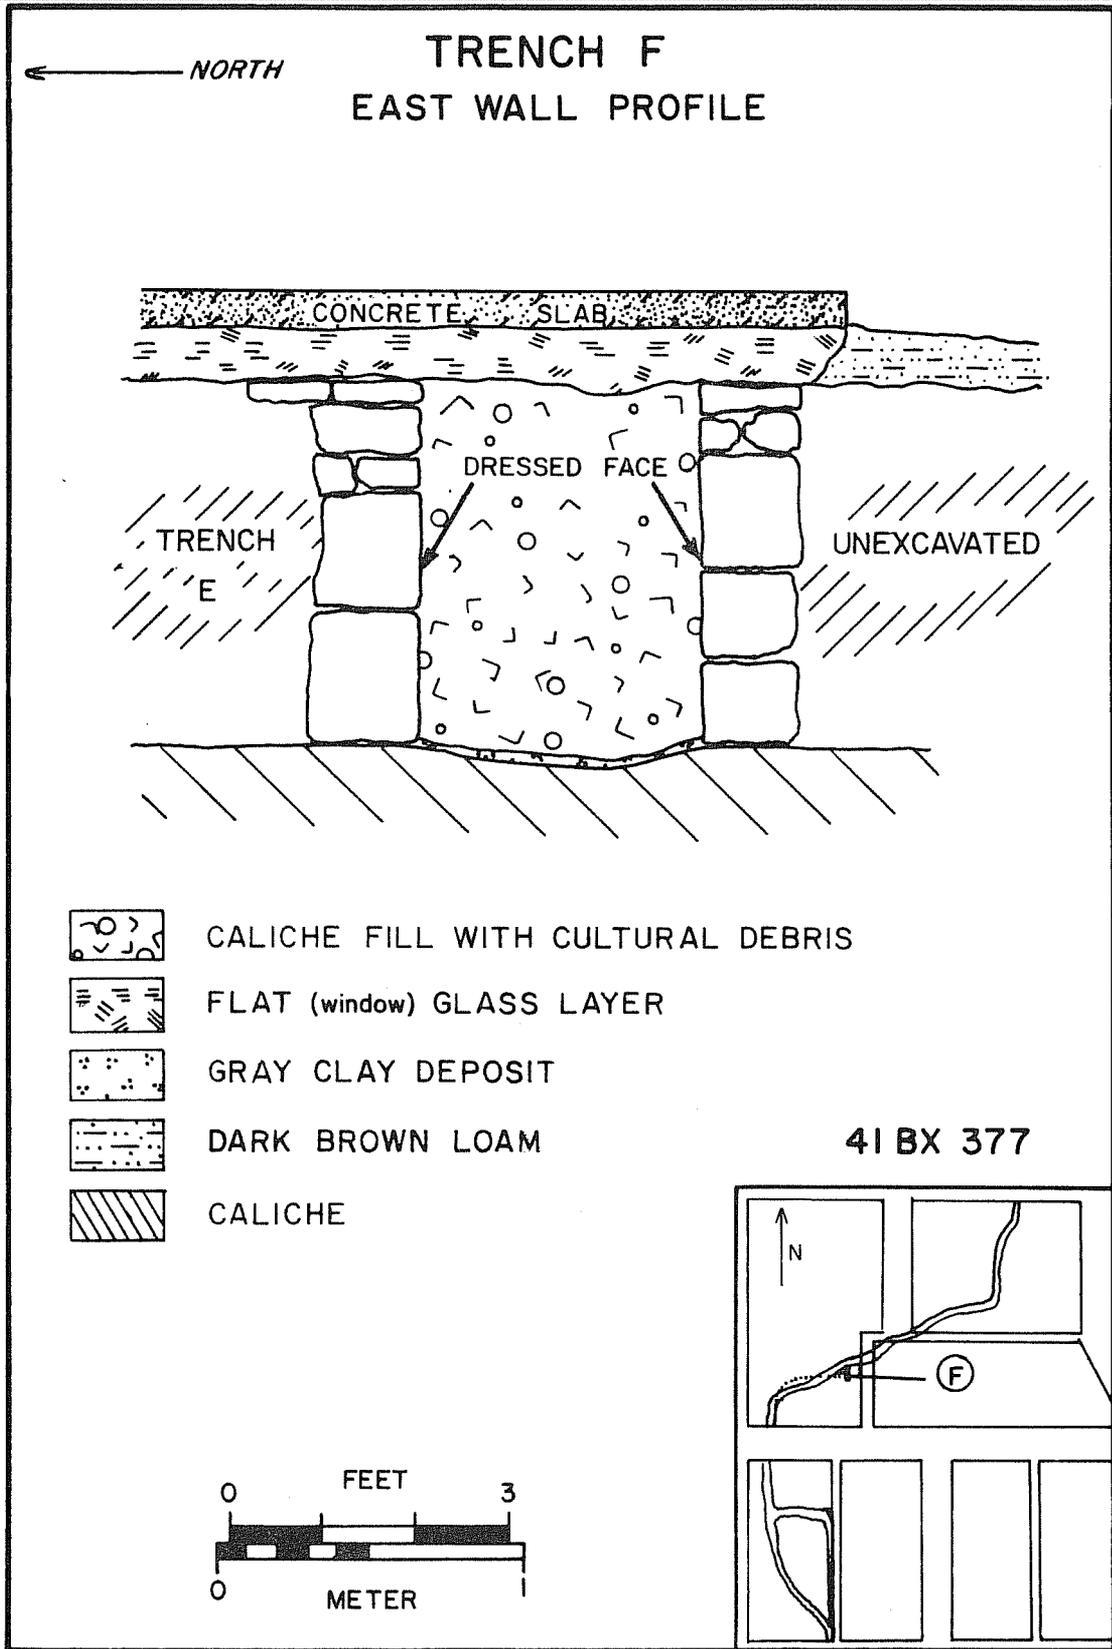
Figure 7. Soil Profile of Trench F Showing Masonry Work on Acequia.

Trench F was excavated inside the stone-lined acequia parallel with Trench E (Fig. 2). The length of the trench measures 10 feet from Trench 11 to a concrete building foundation under which the acequia continues. Portions of the trench were excavated to basal caliche at approximately 3 feet in depth (Figs. 7, 11,a). The interior face of the acequia was brushed clean and it was noted that the face was chiseled from top to bottom with a light brown sandy mortar between the blocks. The acequia interior fill was a homogeneous caliche soil with cultural artifacts. A thin layer of gray silt with a few snail shells and traces of charcoal lie beneath. Noted within this caliche fill were large fragments of limestone slabs. These slabs suggested that the stone-lined acequia was covered at one time. The deposit suggests that the acequia was intentionally filled with caliche and debris.

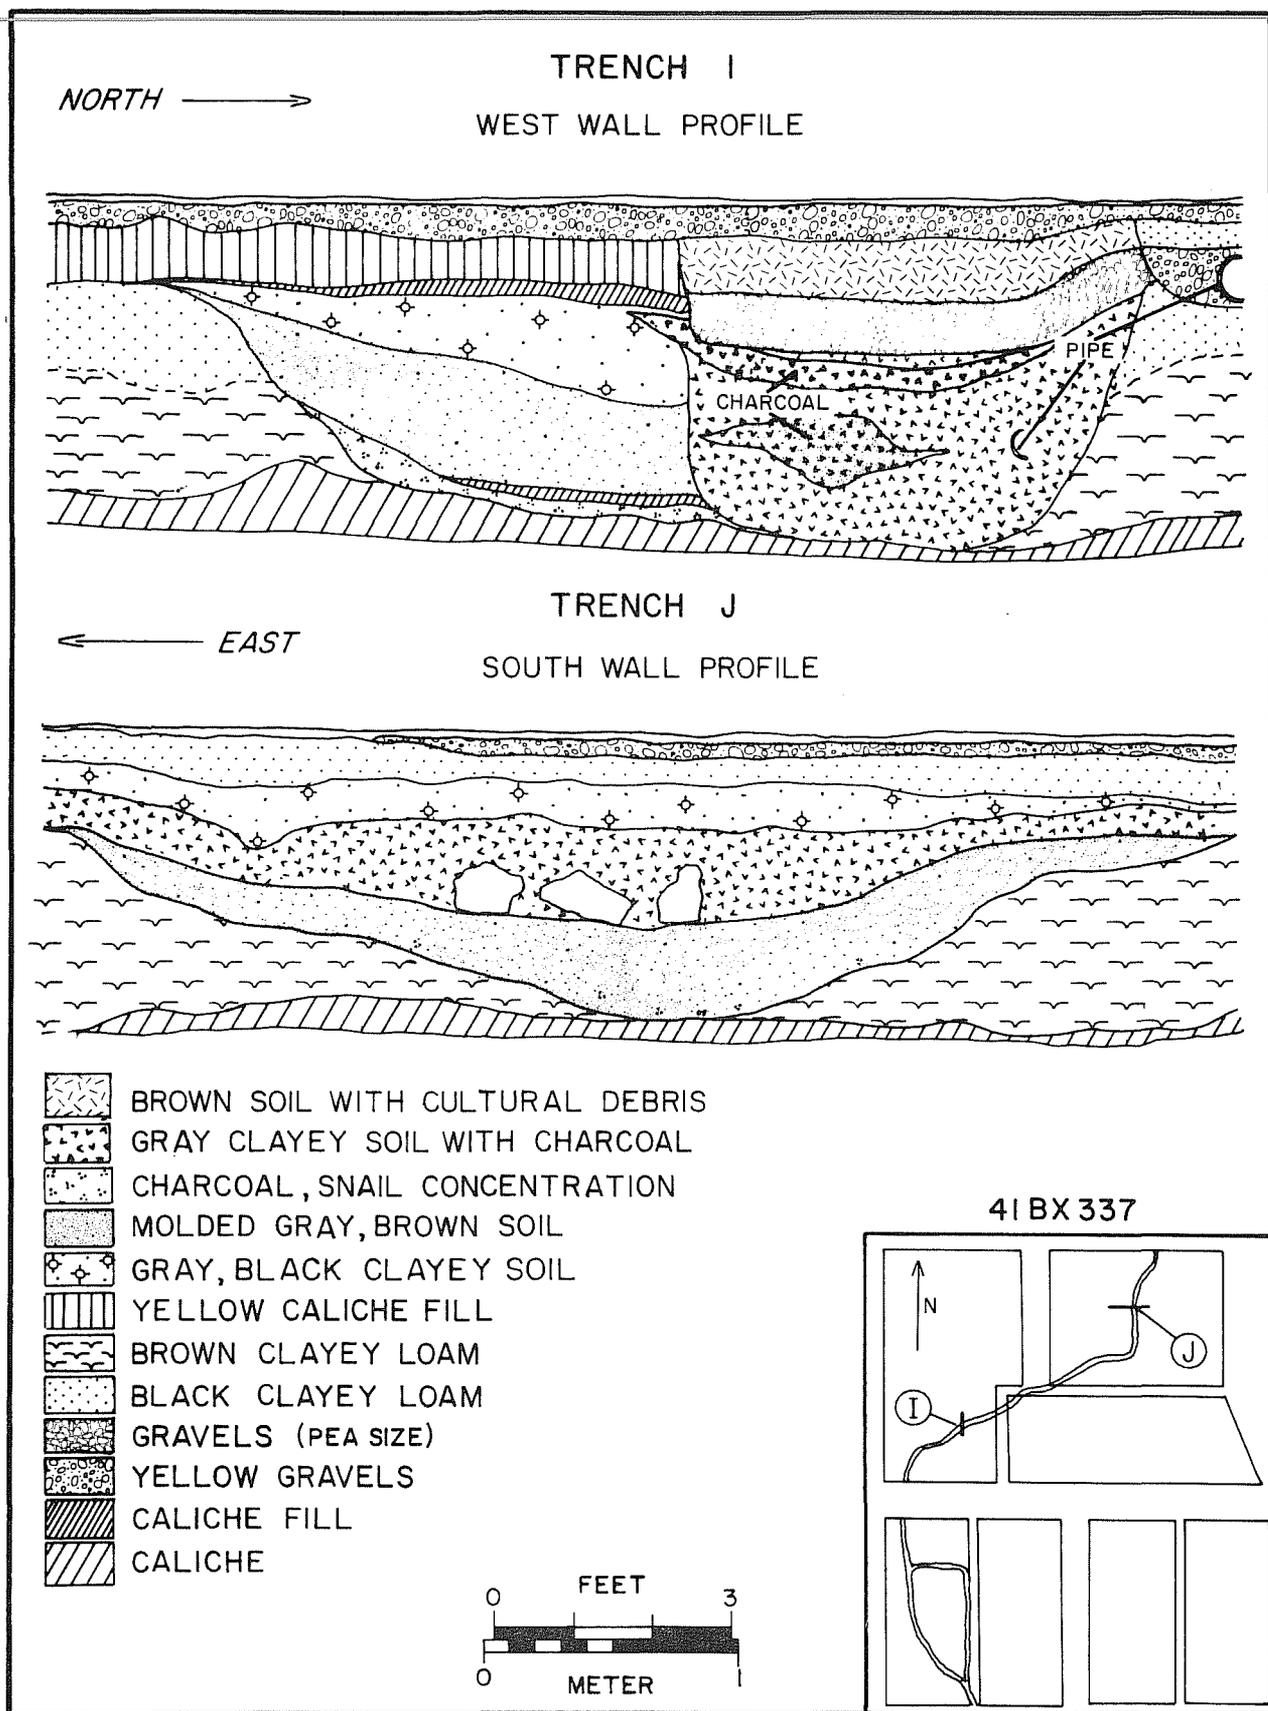
Figure 8. Soil Profiles of Trench I and Trench J.

The profile of Trench I depicts two separate ditching operations within the original acequia. The acequia was dug through two natural clay loam levels and the bottom of the acequia rested upon the caliche bedrock. Above the acequia was a 6-8 inch layer of yellow caliche underneath a 4-6 inch layer of yellow gravels.

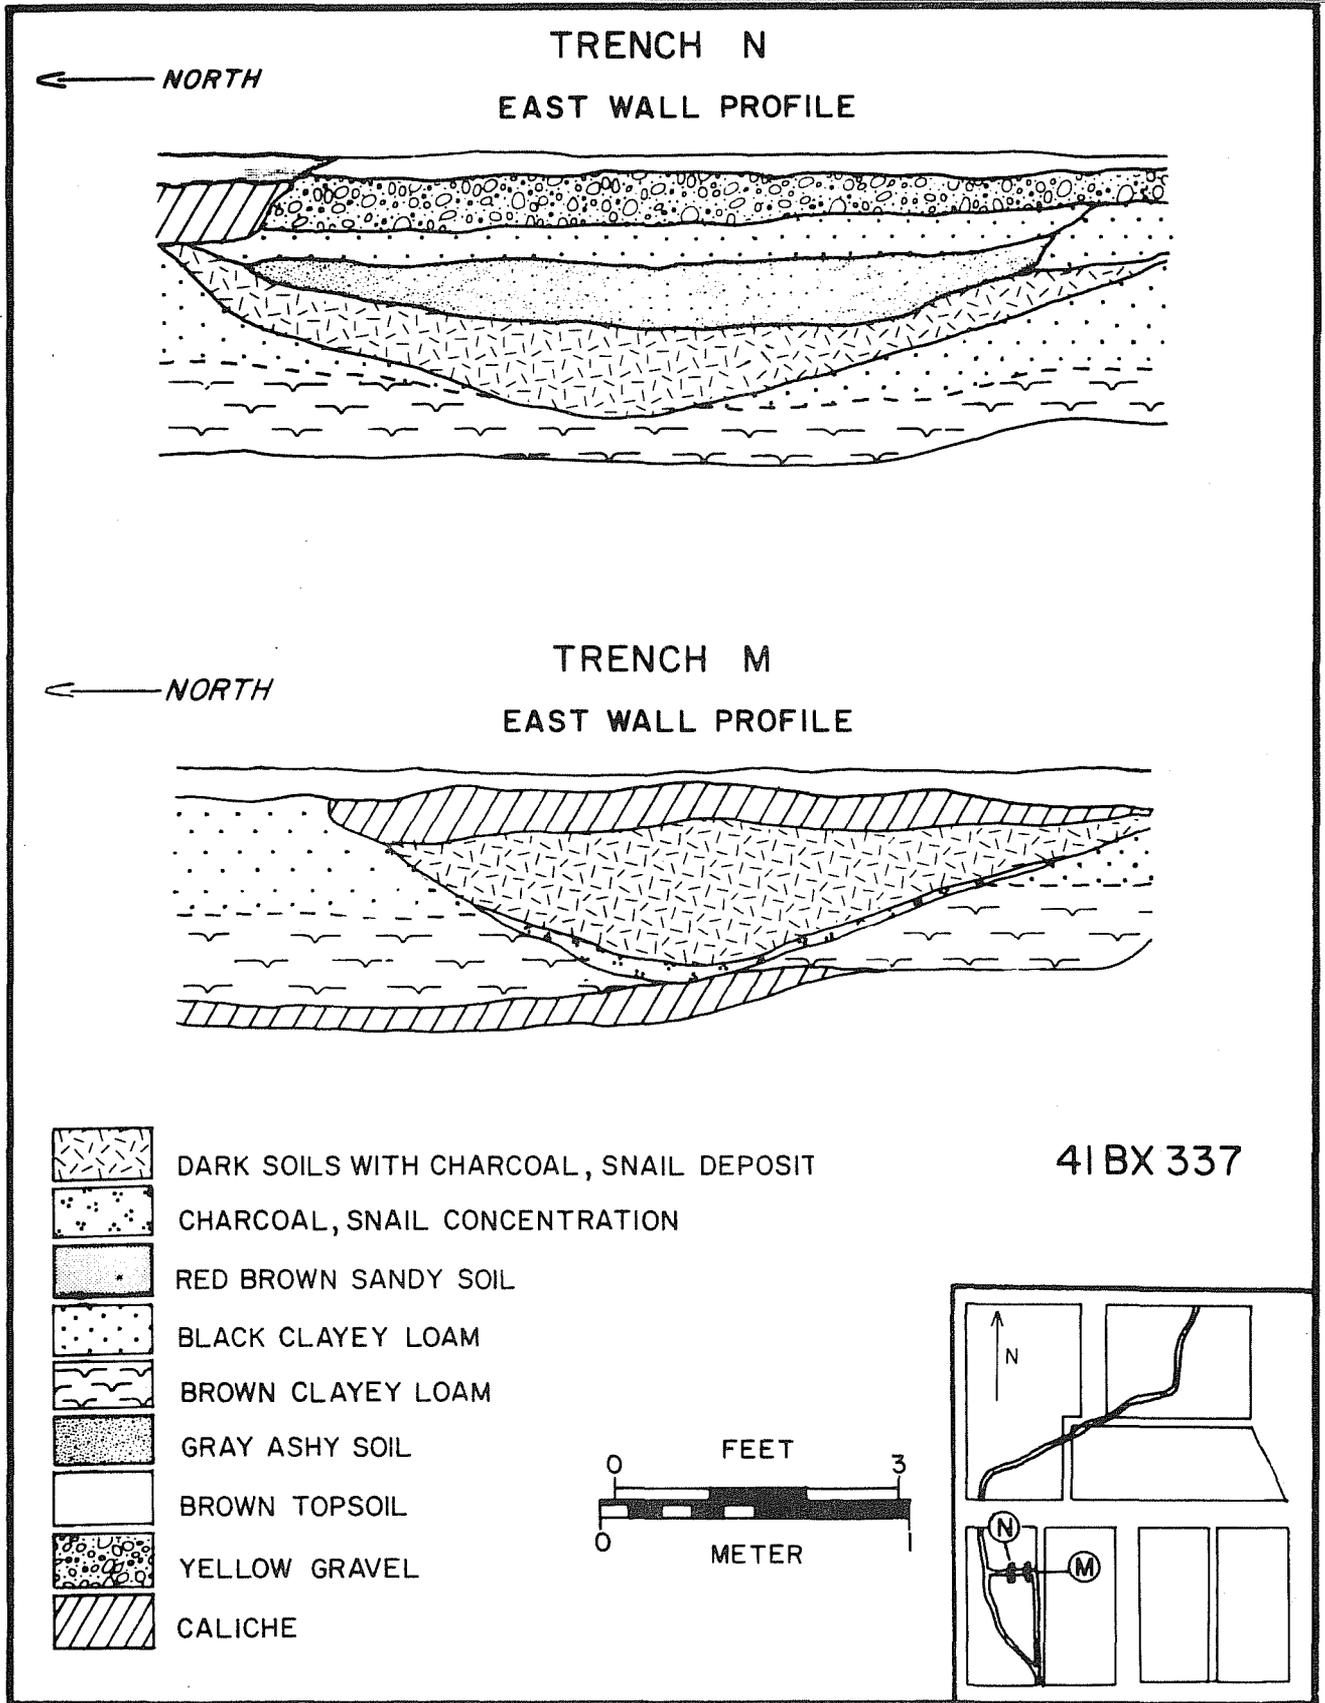
Figure 9. Soil Profiles of Trench M and Trench N.

Trench N was located between Trench M and Trench L in order to verify the acequia's location (Fig. 2). The trench was excavated to a length of 26 feet and a depth of approximately 4-1/2 feet. Unlike the previous trench, the acequia did not rest upon the caliche bedrock. It was, however, dug through the two familiar layers of clay loam. The acequia measured 10-1/2 feet in width and 24 inches in depth (Fig. 9).

The soils inside the acequia were made up of three major layers. The bottom and first layer measured 13 inches. This layer consisted of a dark soil intermixed with charcoal and snail shell. A gray ashy soil 10 inches thick rested upon the previous layer and together these first two layers held the few artifacts observed in this trench. The third layer consisted of a black clay. An 8-inch layer of yellow gravels and a thin layer of brown topsoil made up the

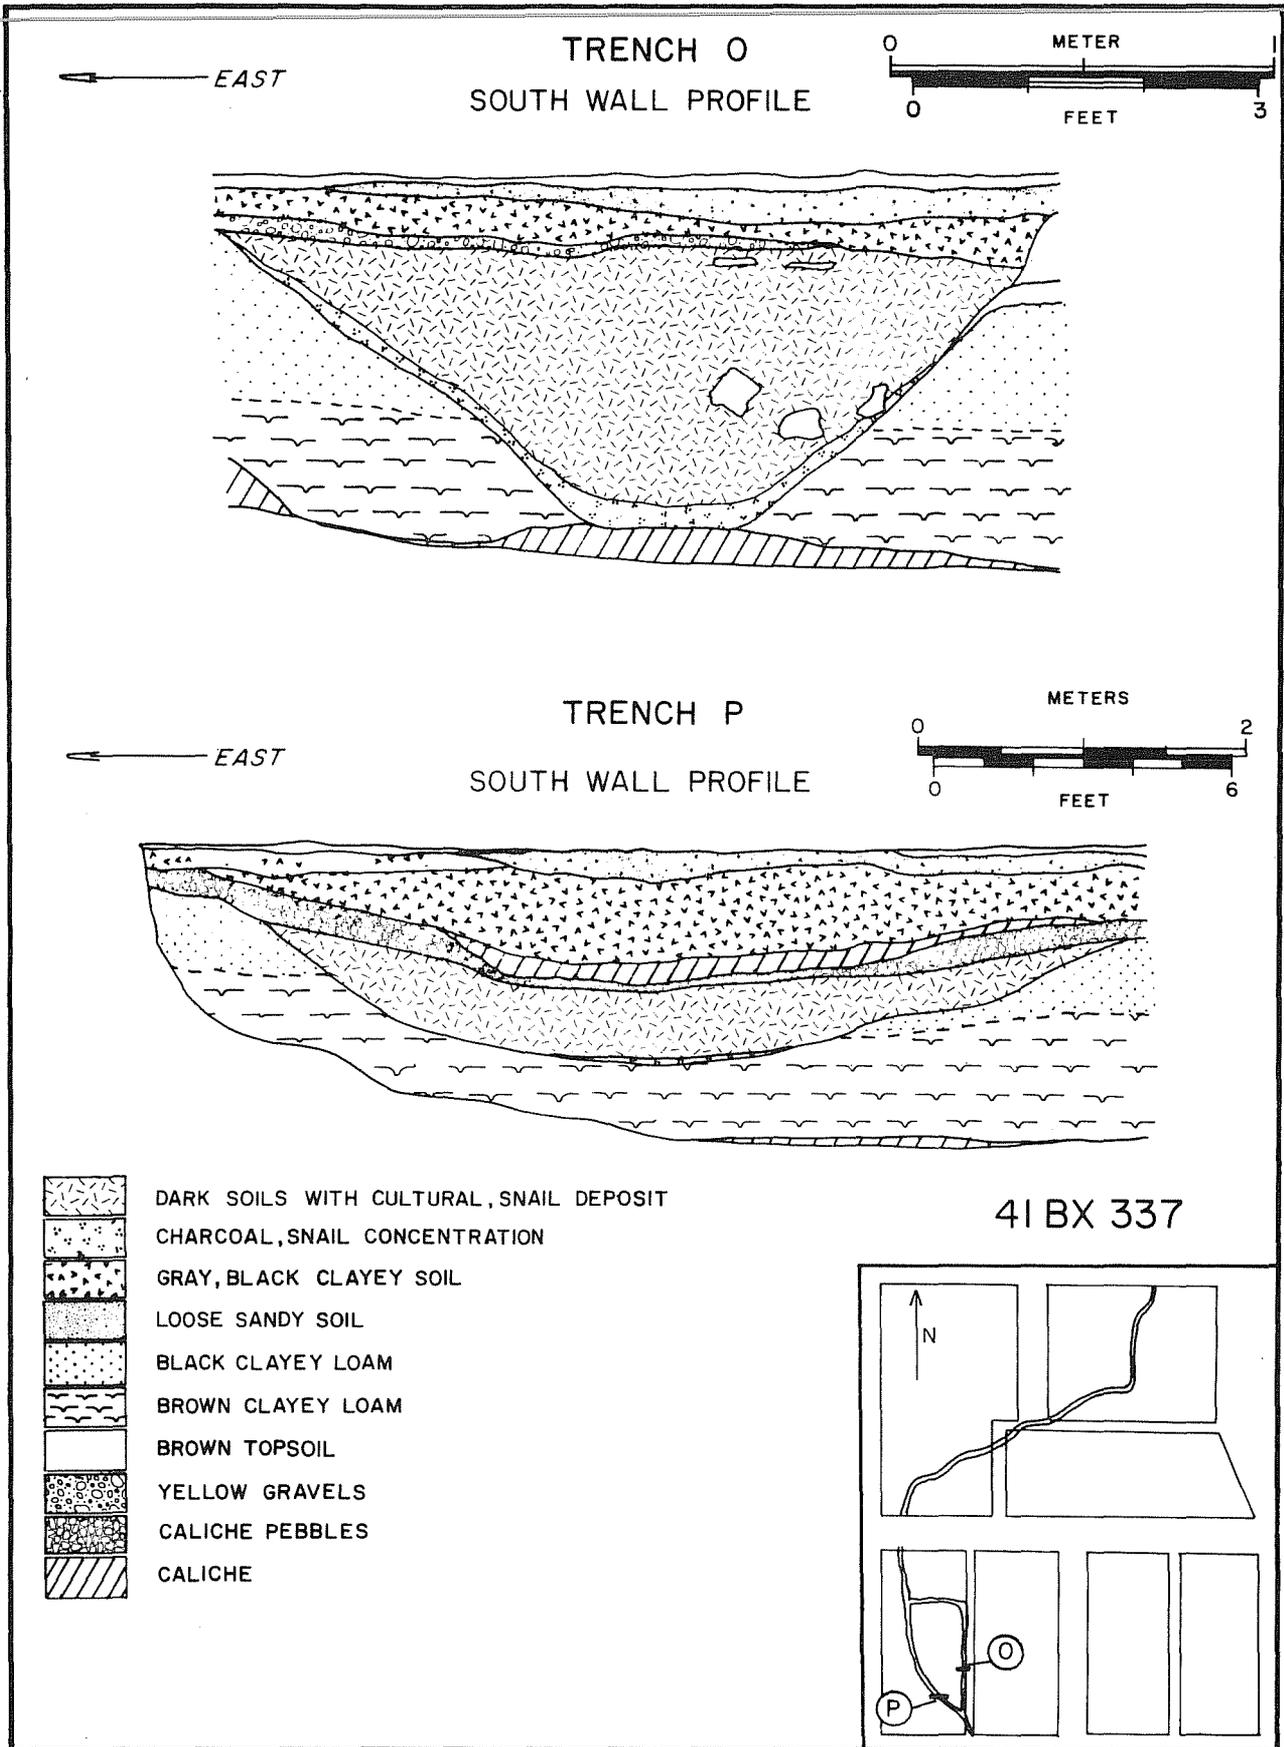
Figure 10. Soil Profiles of Trench O and Trench P.

The interior fill of the acequia consisted of three deposits. The bottom deposit was a thin concentration of snail shells and charcoal mixed with dark brown clay. A very thin layer of rusted metal covered this bottom layer. A loose layer of black loam 26 inches thick rested upon the bottom layer. Within this loose fill there were cultural artifacts, limestone rock, and small pockets of caliche. A thin layer of yellow gravels rested over the cultural layer. Four inches of grayish black clay, another 4 inches of loose sandy soil and mortar, and a thin layer of topsoil with grass made up the remaining accumulations overlying the acequia.

The stratigraphy inside of the acequia represents five distinguished layers of deposition. The initial deposit that lies on the bottom was a thin layer of charcoal and snail shells. Above this layer was an 8-inch layer of dark soil containing cultural artifacts. The soil was a dark clay loam with a loose consistency, and small snail shell fragments could be seen within this level. Upon this layer were two caliche layers that measured a total of 3 inches. A gray-to-black clayey soil level that measured 10 inches in depth and a 31-inch loose sandy soil level were the final two layers of soil accumulation over the acequia.

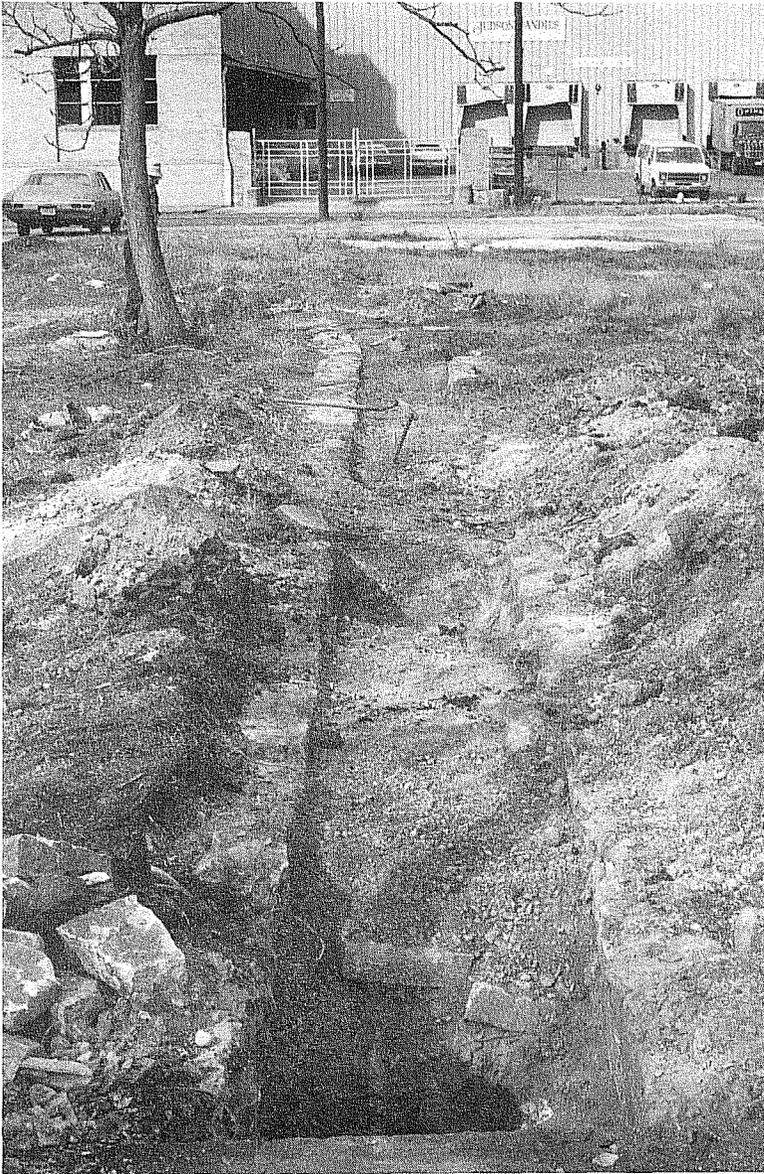
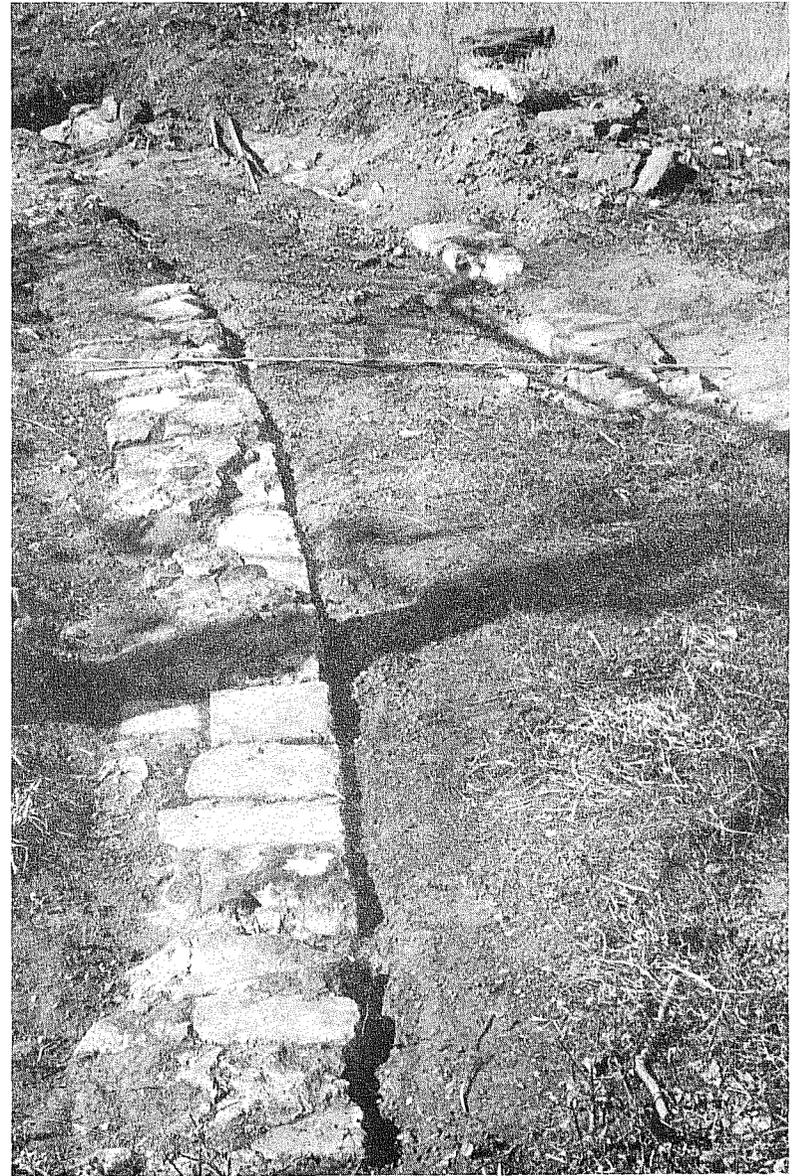
Figure 11. *San Pedro Acequia*. a, stone-lined portion of acequia in excavation Trench F; b, stone-lined acequia in excavation (surface) Trench Q.

photographed (Fig. 11,b), and it was noted that the stone masonry was a different style. A collection of small limestone blocks with occasional clay bricks were mortared together in different localities along the top; this later work could suggest that the wall height was raised to accommodate a higher water level.
