ARCHAEOLOGICAL INVESTIGATIONS

San Pedro Acequia

SAN ANTONIO, TEXAS

Center for Archaeological Research
The University of Texas at San Antonio
Archaeological Survey Report, No. 103

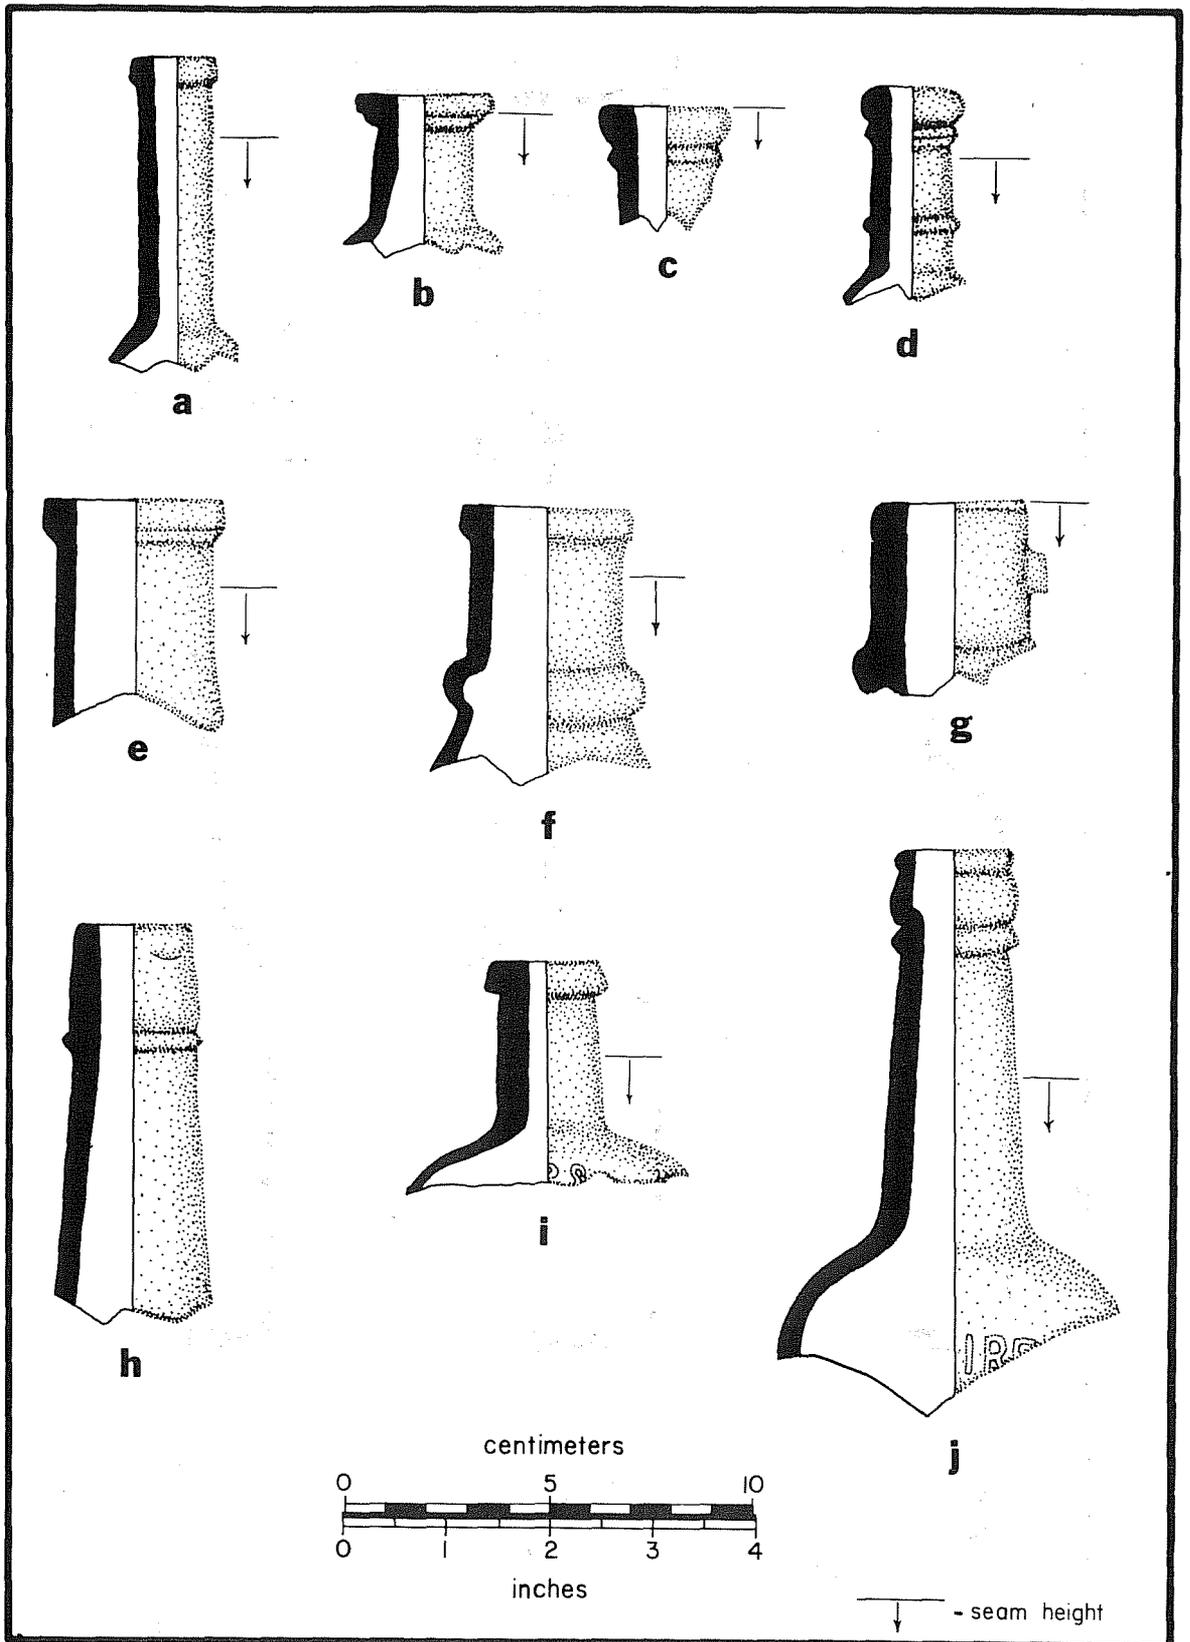
Figure 14. Selected Glass Artifacts Using Seam Height as a Time Period Indicator. a,c,i, Trench C; b, Areas C-D; d, Trench I; e, Trench D; f, provenience unknown; g, Trench 7; h, Trench 12; j, Trench P.

Other artifacts used by the archaeologists for dating are glass bottles. Soda water bottles of the late 19th century, for example, frequently had the name and address of the bottle maker embossed on the side or bottom (Fig. 12 and Fig. 16a,b). By using an old city directory, the approximate dates of when the business was established and when it was terminated can often be determined. A bottle found in an old refuse deposit, which can be identified by the markings, was probably discarded during the time the bottle maker was in business, thus giving an approximate date for the bottle and the associated debris. Other bottle indicators useful for dating include the color of the glass and the seam marks. The earliest bottles were hand-blown. Later the bottles were formed in a mold and the neck and mouth applied by hand. Eventually the entire bottle was molded in one operation. With the development of the molds, seam marks changed in length through time, providing additional indicators which are datable.
