Archaeology at the Alamodome: Investigations of a San Antonio Neighborhood in Transition

Excavations and Artifact Distribution Analysis

Center for Archaeological Research, The University of Texas at San Antonio
Archaeological Survey Report, No. 237, 1997

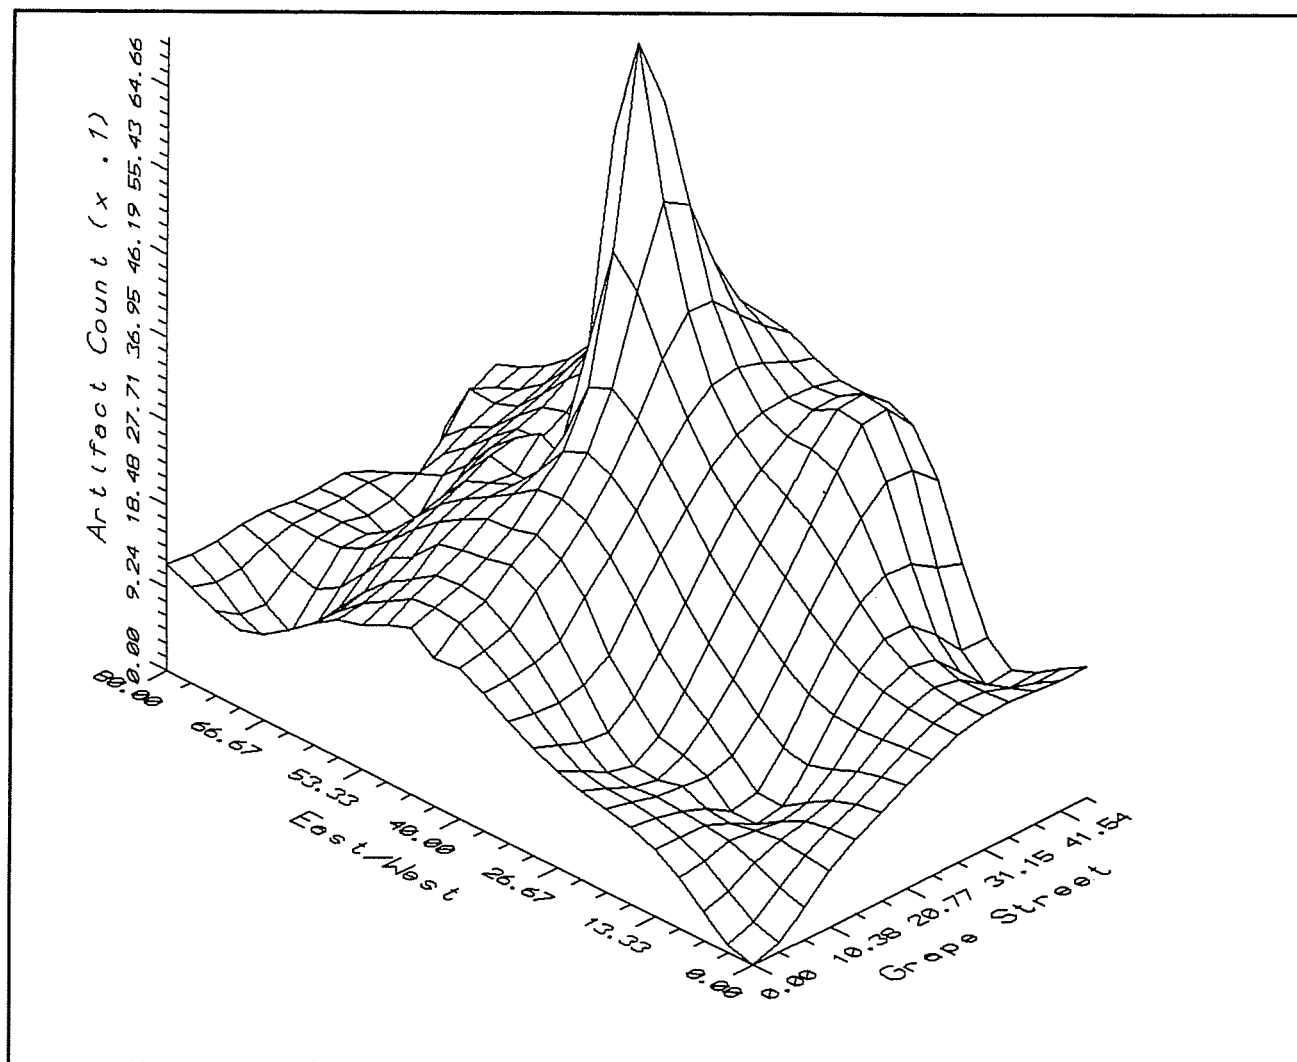
Figure 4-6. 41BX881, spatial frequency of artifacts across the site.

Table 4-3 shows the percentage of occurrence within artifact groups on this site. Figure 4-6 illustrates the spatial frequency of artifacts across the site. The highest occurrence of artifacts as depicted on the graph was the result of a trash disposal/burning feature present on that part of the lot. The graph also shows a higher incidence of artifact occurrence on the north side of the lot. This was the side of the lot which contained the dwelling.

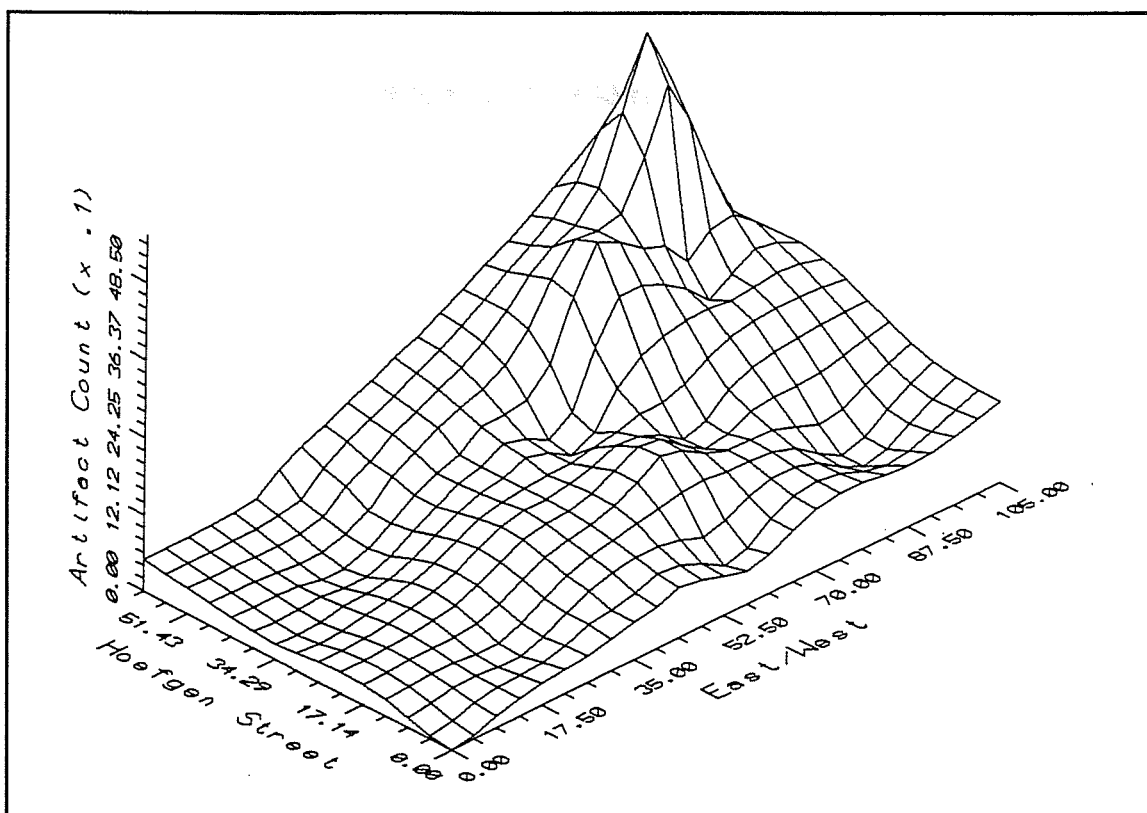
Figure 4-7. 41BX882, spatial frequency of artifacts across the site.

Table 4-4 shows the artifact percentage distribution from the site. Figure 4-7 illustrates the spatial frequency of artifact occurrence across the site. The northeast corner of the lot shows the heaviest deposits, many of which were associated with structures previously located there. The western half of the site exhibited abandonment patterns that were observed in several different locations throughout the project area. These patterns have several characteristics.

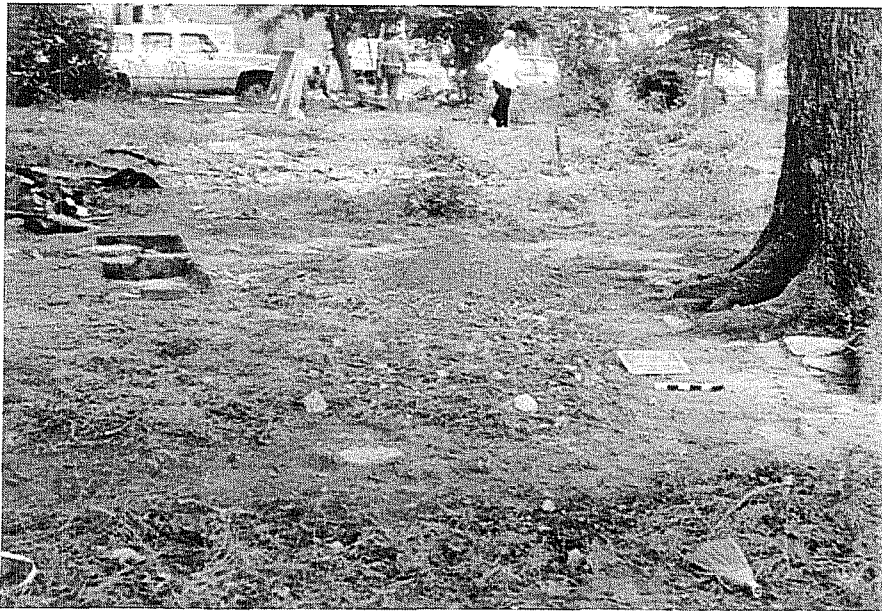
Figure 4-8. 41BX883 west.

Test excavations were carried out on this lot from July 27 to August 21, 1990 (Figure 4-5). The lot measured 63 ft north/south and about 200 ft east/west, with most of the initial work carried out on the western two-thirds of the lot (Figure 4-8). The Sanborn maps (Figure 4-4) indicated that since 1904 six major structures had been present on the lot. The primary residence faced onto Plum/Hoefgen Street (street numbers 320/520) and appeared to have been replaced between 1911 and 1952. A centrally located building was initially designated as a dwelling (320½) in the 1904 map and noted as an outbuilding in the other two maps. A large carriage house was pictured fronting onto Grape Street in the 1904 map, but with an address of 320⅓ Plum Street. This carriage house is still present in the 1911 map; however, by 1952 had been replaced by two shotgun-style dwellings fronting onto Grape Street (121 and 125 Grape Street).

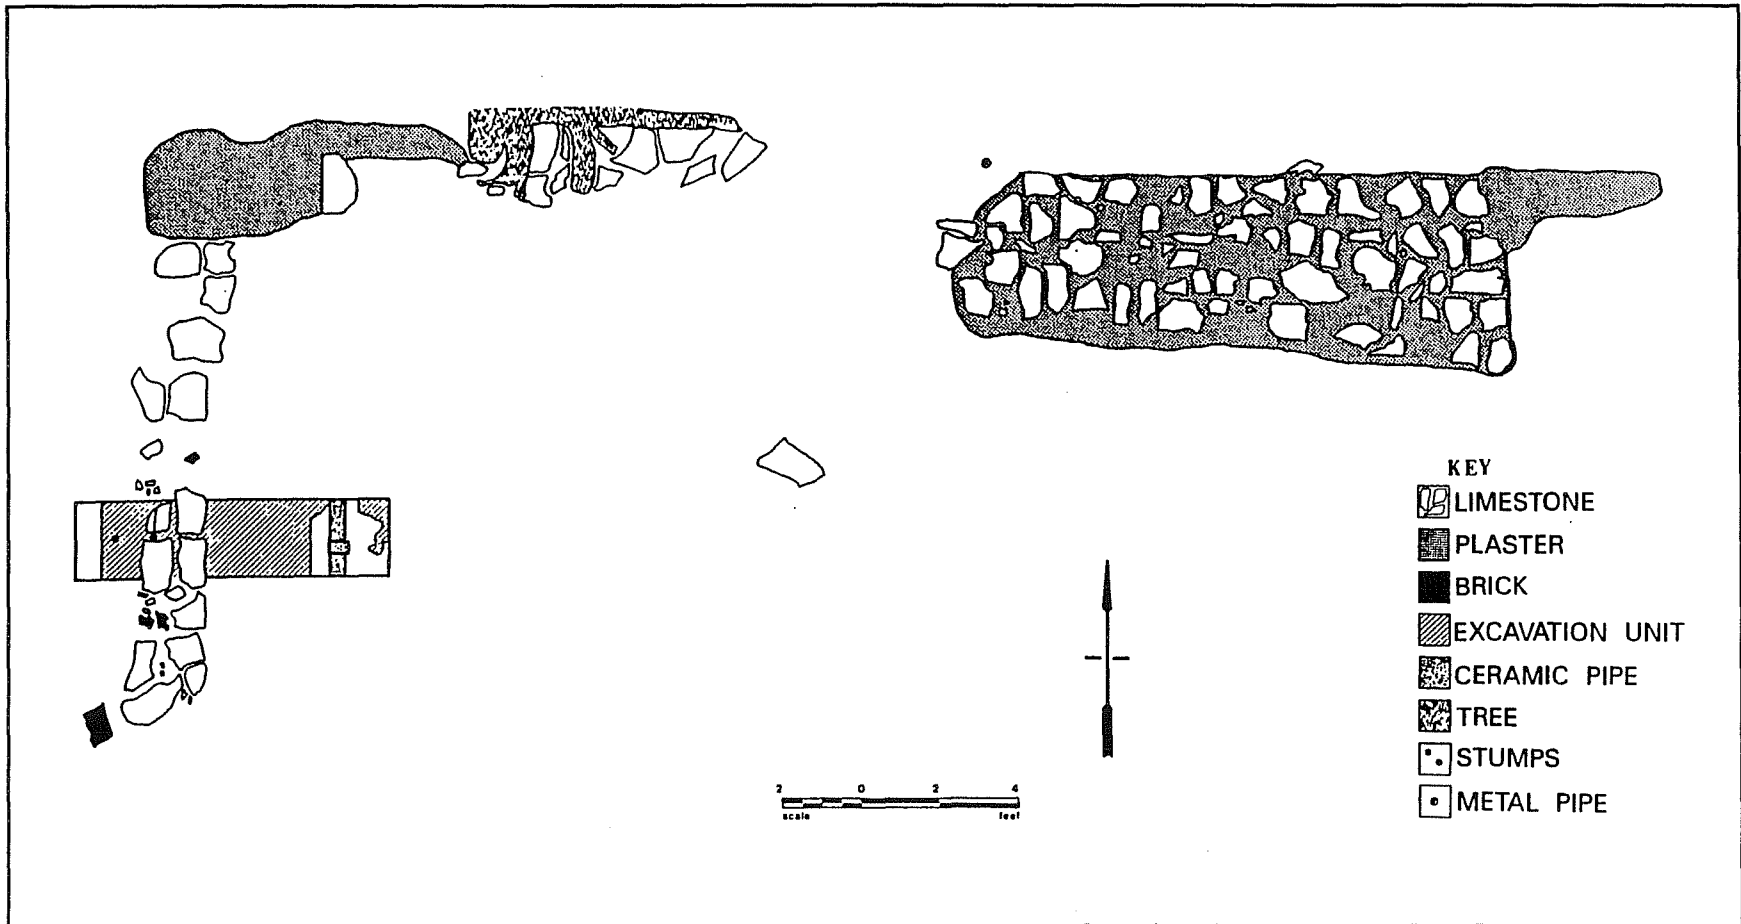
Figure 4-9. 41BX883, Structure B foundation.

Archaeological testing in this location revealed the presence of a limestone foundation measuring about 15 ft north/south and 32 ft east/west (Figure 4-9). The foundation contained two major elements. The western portion of the structure was represented by a limestone square, 18 x 15 ft. Approximately 60 percent of the structure was complete, the entire south wall and a portion of the east wall were missing. The stones composing the square averaged 1.5 x 2 ft in size and were laid in double thickness, creating a foundation averaging 2.5–3.5 ft thick. The interior floor of this square was dirt (Figure 4-10). The second major component of this structure was a limestone floor, approximately 5 x 15 ft, located immediately east of the stone square part of the building and justified to the

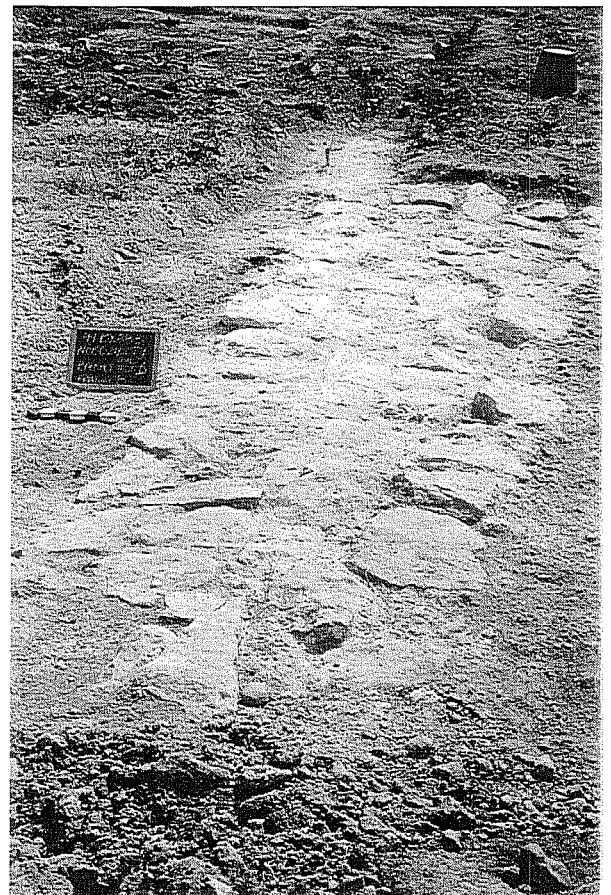
north side of the structure. The edges of the limestone surface appear to be well defined and no disturbance was noted (Figure 4-11). No cedar posts were found to indicate a superstructure to this foundation. The north wall of the limestone square part of the foundation was bisected by a very large pecan tree. Consultation with tree specialists indicated that this tree was between 50 and 75 years old (Wolfe Nursery staff, personal communication 1992). Since the tree bisects the foundation, the latter is most likely older. Since this was the first limestone foundation encountered during the testing phase, and since we were operating on such a limited historical base regarding this structure, we could not make any definite statement regarding its age.

Figure 4-11. 41BX883, Structure B east.

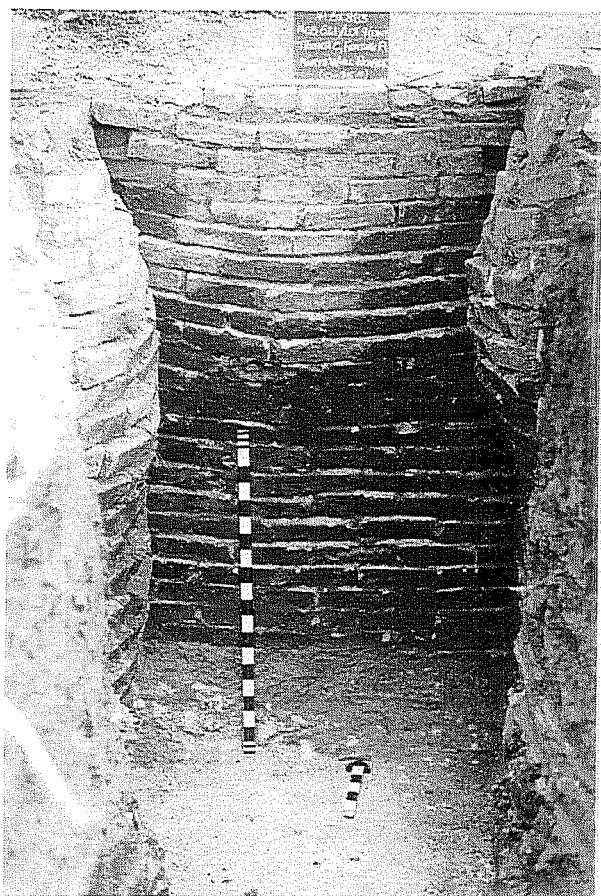
Located 138 ft east of Hoefgen Street and four feet inside the south boundary of Lot 9, what was originally started as Backhoe Trench C revealed the remains of a brick privy vault which was designated Feature A (Figure 4-12). The brick vault was square-shaped and measured 63 x 63 inches. The first course of bricks was encountered six inches below the ground surface, and from this first course extended to a depth of 63.25 inches below the surface. Although the brick vault had retained its structural integrity, it did display a marked "bowed in" aspect on all four walls. This was to be a common feature observed in almost all of the later privies encountered in the project area. In some cases pressure from the outside soil led to a total failure of a privy's structural integrity (see 41BX892 - Feature A). A cedar post was found 10 inches south of the center of the privy's south wall, at a depth of nine inches. It is likely that this post represents part of the original superstructure for the privy (for further detail on the privies and their contents see Brown and DeLaO, Volume III).

Figure 4-12. 41BX883, Feature A, brick-lined privy.

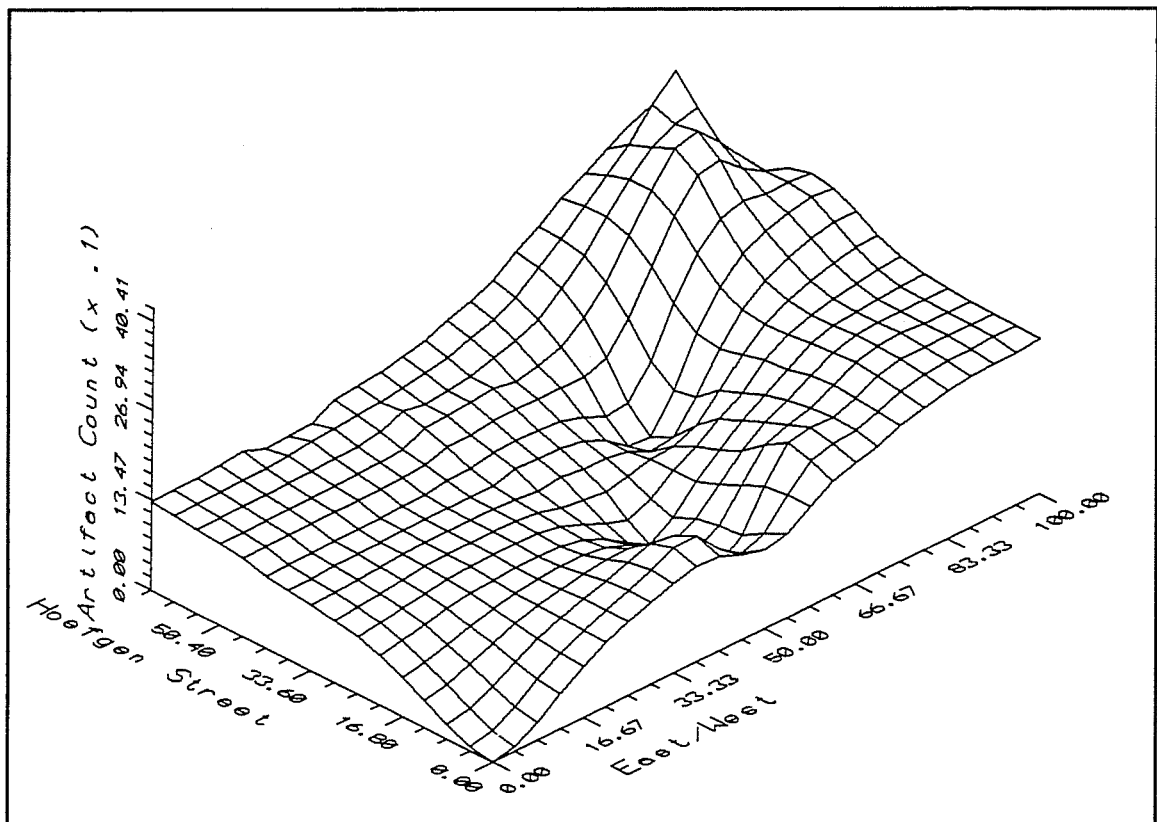
Figure 4-13. 41BX883 west, spatial artifact frequency across the site.

Table 4-5 shows the percentages of artifact group distributions from the site. Figure 4-13, which shows the artifact density of the west half of Lot 9, indicates the highest occurrence of artifacts is on the north-central part of the lot. This was within an area occupied by outbuildings built by the Webb/Deman family who lived on Lot 7 (41BX897). As has been previously noted, there is an overlap between the two sites. This overlap undoubtedly affected the artifact profile of this site.

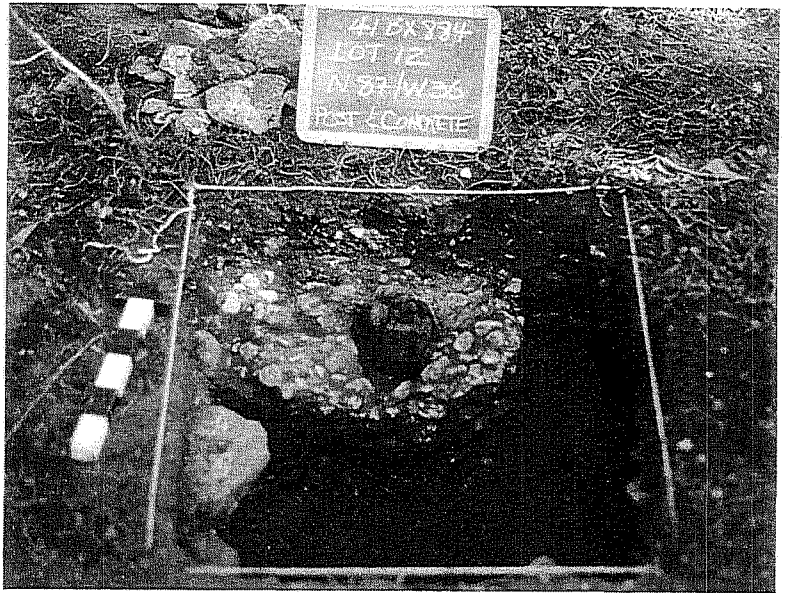
Figure 4-18. 41BX884, remnants of piers from former house annex.

Various structural elements were revealed by the test units and backhoe trenches. A series of cedar posts and concrete post molds confirmed the presence of a pier-and-beam annex to the stone dwelling (Figure 4-18). A large flagstone surface running to the east of where the annex would have been was also found. This flagstone surface was surrounded by a more ephemeral surface of brick and plaster (Figure 4-19). A possible prehistoric component was located at N107W27 and N107W29. This was evidenced by the presence of a layer of chert cobbles approximately 10.5 inches below the surface, with some showing evidence of testing. This was an isolated feature and did not show up in Backhoe Trench B just to the west or in N99W32.

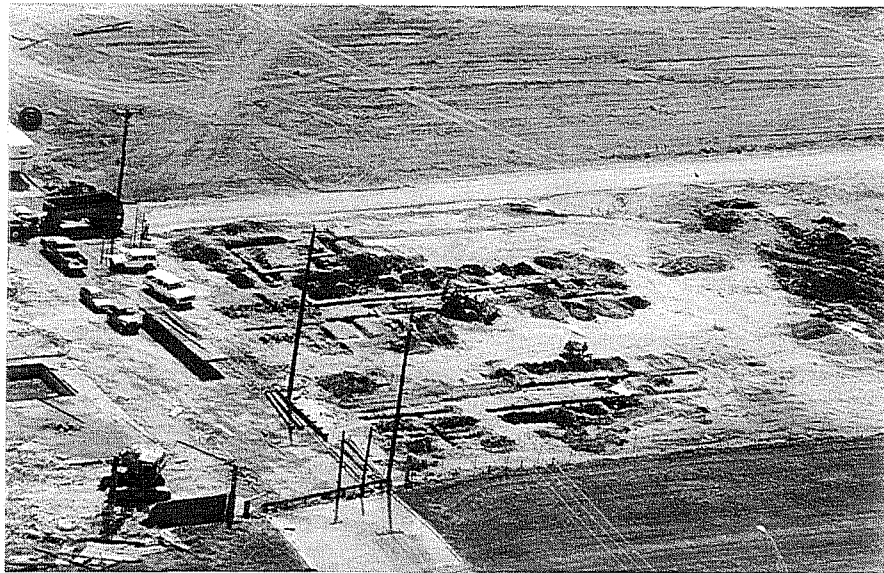
Of the structural foundations present on the north side of NCB 613 (Lots 4, 5, and 6), we decided only the foundation on Lot 6 would be fully exposed. Foundation elements for the early residence on this site (41BX890) were found approximately 12 inches below the existing ground surface, which was represented by the top of the heavy caliche base material. The foundation rested in a darker, thick clay soil just beneath the lowest level of the base material. Only about 18 inches of the foundation base remained vertically. No living surfaces were present and no artifacts were recovered during the foundation exposure process. It was obvious that the foundation had been cut off well below the original ground surface.

Figure 4-29. NCB 613, north excavations. Facing southeast.

Testing operations on 41BX892, NCB 613, Lot 6, 132 Wyoming Street, were carried out between August 8 and August 27, 1990. This was one of the three lots (4, 5, and 6) on NCB 613 north that was examined in a single operation (Figure 4-29). The documented history of this lot is slightly more complex than those of Lots 4 and 5 due to the fact that in a later platting, Lot 6 was further subdivided into two smaller lots: A-13 and A-14. Lot 6 (A-13) fronted on Plum/Hoefgen Street (215) and Lot 6 (A-14) fronted on Wyoming Street as the corner lot (132).

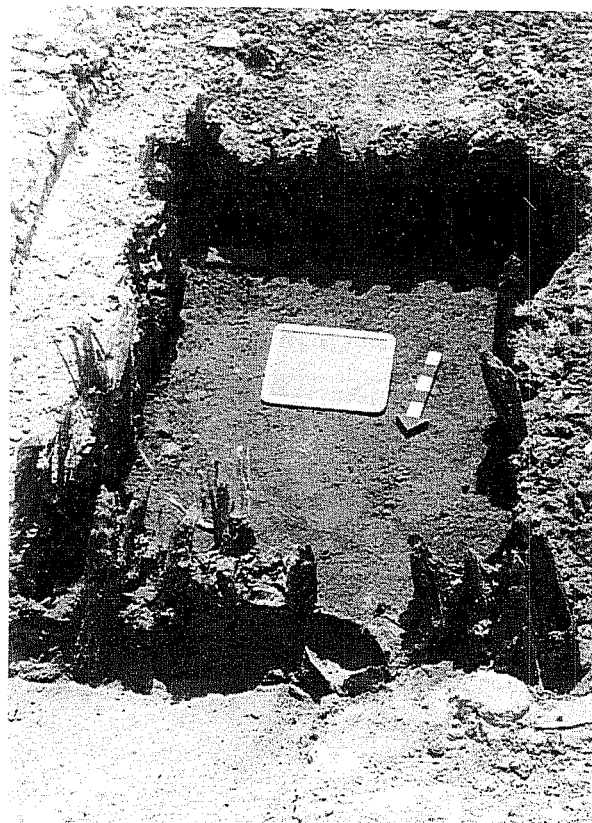
Figure 4-30. Cedar post-lined privy vault (top view).

The maximum depth of the vault was 63 inches. Varying layers of humus and clay-like soils of different colors (night soils) interspersed with layers of charcoal and ash were revealed. It was a common practice for persons to dump wood ashes into their privies to discourage the activity of insects and to reduce the smell. Lime was also used for this purpose when available (Brown and DeLaO, Volume III). Few artifacts were recovered from within the vault: several sherds of undecorated whiteware and porcelain, and one sherd of spongeware. The generally accepted date for spongeware distribution in the area is 1853–1871 (Miller 1991); this places the construction date

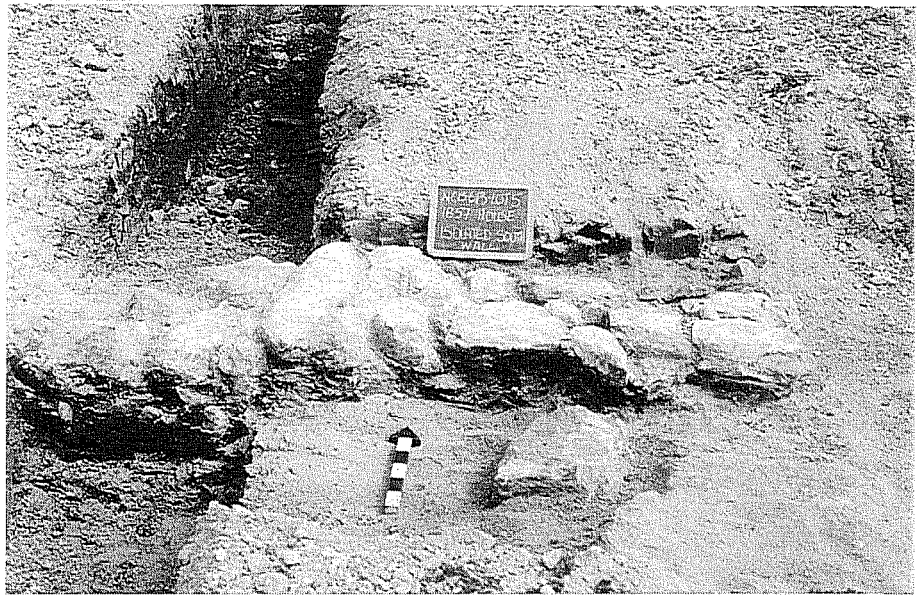
Figure 4-32. 41BX891, isolated south wall of original dwelling.

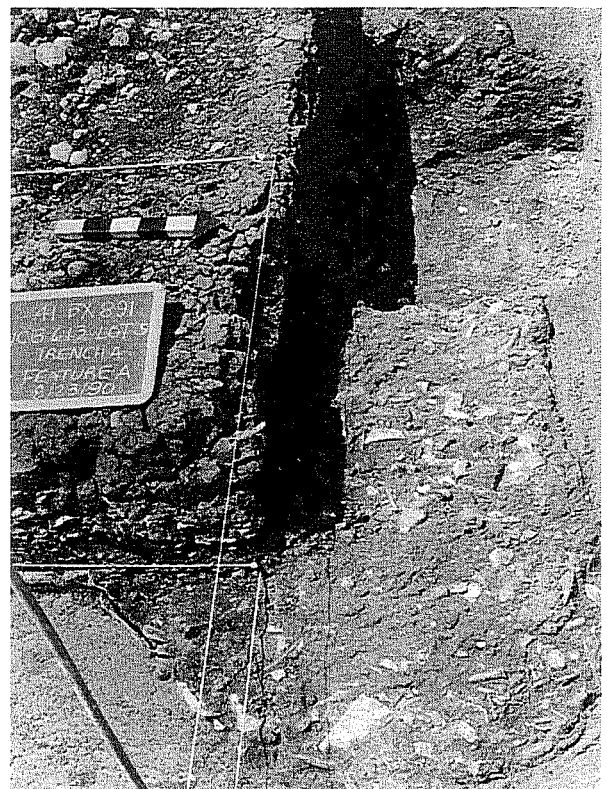
This trench measured approximately 2 x 118 ft and had one small break about 36 ft south due to a large, industrial, concrete pier. Two features were encountered within this trench. Feature A was a large midden deposit composed primarily of alcoholic beverage glass (80 percent), ceramics (10 percent), and metal (10 percent). This feature was located 86 ft south within the trench (Figure 4-33), just across the property line to the east from Feature A (cedar-post-lined privy) on 41BX890.

Five 2-x-2-ft hand excavated test units were placed to further expose this feature. Two of the units were placed within the original backhoe cut, and three units ran to the west from the west side of the backhoe cut. The feature appeared to be roughly oval in shape, approximately 6.2 ft east/west by 2.6 ft at the center north/south. The pit in which the artifacts were deposited appeared to be a simple, unlined, earthen vault. In cross section the pit was slightly lens-shaped, flat on top at a depth of 11 inches below the ground surface, and convex on the underside reaching a maximum depth of 32 inches near the center of the deposit (21 inches maximum thickness). Almost all the glass deposited within the pit was broken, only three or

Figure 4-33. 41BX891, Feature A, midden deposit.

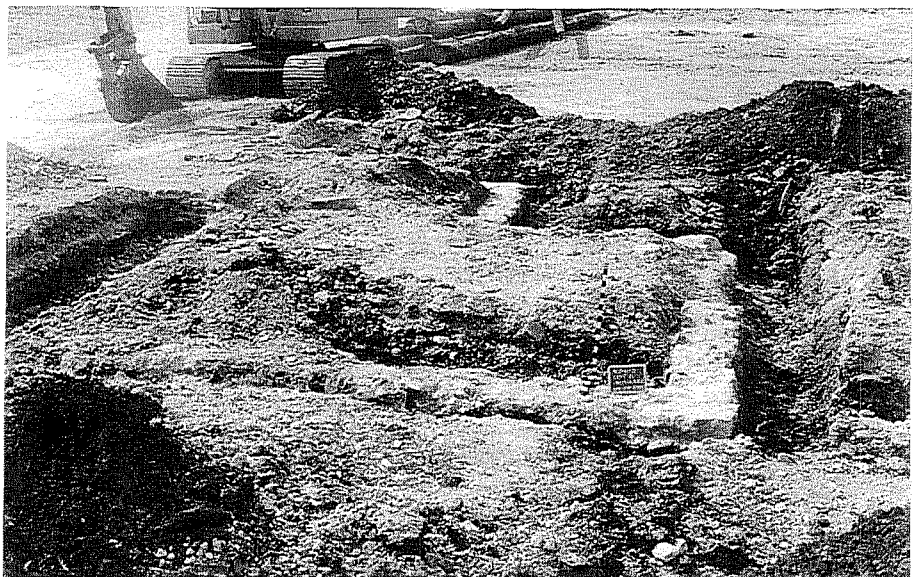
Testing for the remnants of the primary dwelling on the north side of Lot 6 (A-14) revealed a limestone foundation approximately 13 inches below the existing ground surface. The foundation, fully exposed by the backhoe, was composed of broken limestone chunks set in mortar (Figure 4-34). No living surfaces were present and the surface had apparently been cut down to a point where only about 18 inches of the foundation remained vertically. The foundation, when completely uncovered, was an accurate representation of what was pictured on the 1904 Sanborn map (Figure 4-27). Only a small section of the southeast corner was not present. The residence was a rough L-shape, with the long axis facing Hoefgen Street. Dimensions were as follows: east wall 30 ft, north wall 19 ft, south wall 11 ft, thence north 12 ft, thence west 8 ft, west wall 18 ft. No interior dividing walls were present.

Figure 4-34. 41BX891, foundation of original dwelling.

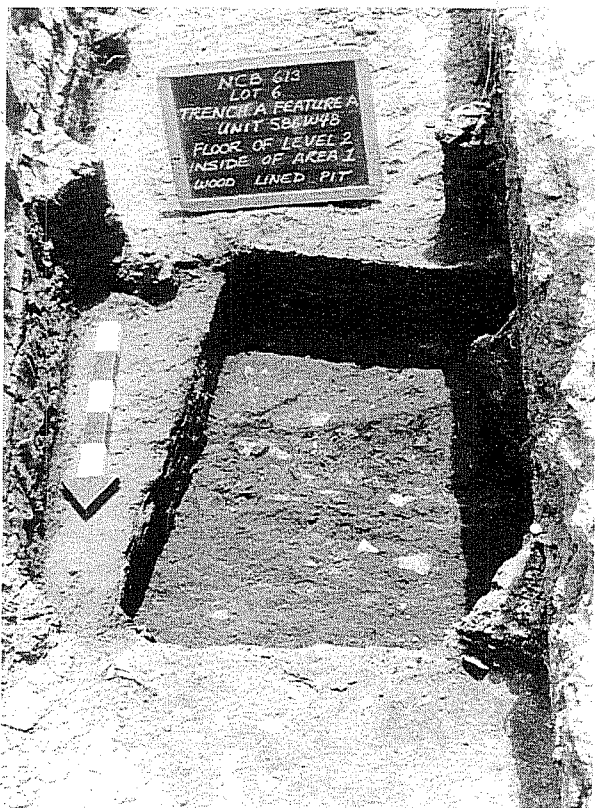
Located between 56 and 62 ft south, Feature A was almost certainly the remains of an earthen vault privy. Many different classes of artifacts and the remains of two wooden crates stacked on top of each other were found deposited under a light clay matrix (Figure 4-35). Three hand-dug 2-x-2-ft units were placed within the existing backhoe trench to further examine this feature. Within the center unit, excavations continued to a depth of 56 inches, cultural material was encountered to this depth. It appeared that the feature continued in the west profile, and a cedar post revealed near the east side of the trench was probably associated with the superstructure of this feature. Among the artifacts recovered were intact newspaper fragments written in both English and German (If the German newspaper fragments were from the German language newspaper *San Antonio Zeitung*, this would make the fragments over 130 years old). The interior stratigraphy of the deposits exhibited a “slumping” appearance that was noted in other privy pits across the site area.

Figure 4-35. 41BX891, Feature A, earthen-vault privy.

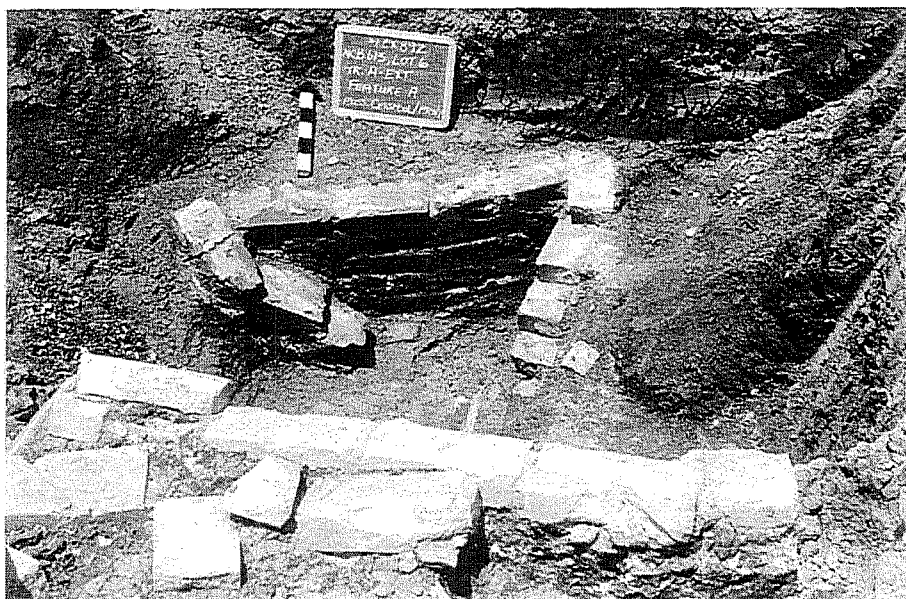
Figure 4-36. 41BX892, Trench A extension, Feature A, brick-lined privy vault.

The yellow bricks turned out to be associated with a brick-vaulted privy located 120 ft south of Wyoming Street and 62 ft west of Hoefgen Street (Figure 4-36). This location is in association with one of the two small structures pictured in the 1904 Sanborn map as having been located on Lot 6 (A-13) owned by Mr. Hogan. Although many of the privies examined during the course of this project showed signs of outside stress from the soil, this was the only privy that exhibited total structural failure due to the pressure. Both the east and west walls of the privy had collapsed inward and the north and south walls were inclined inward at

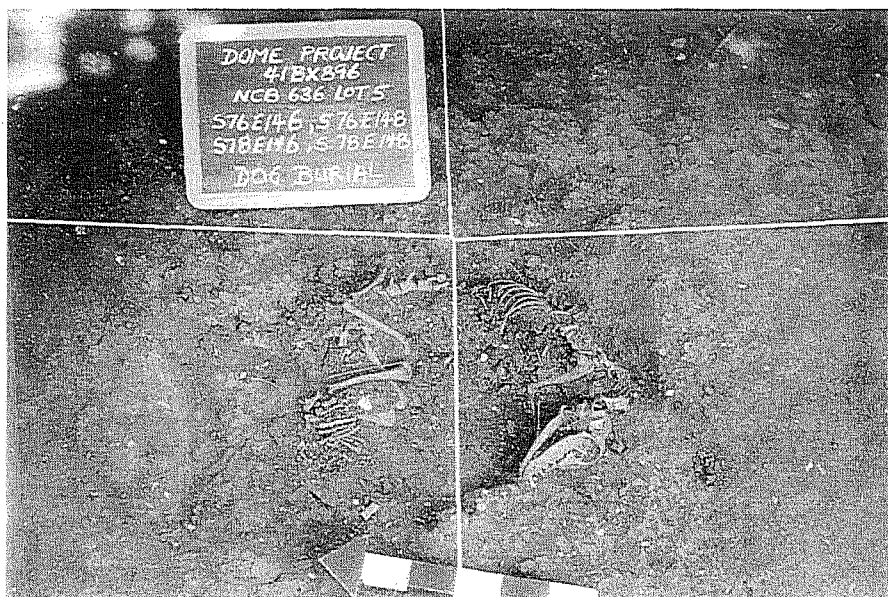
Figure 4-53. 41BX896, Phase II, dog burial.

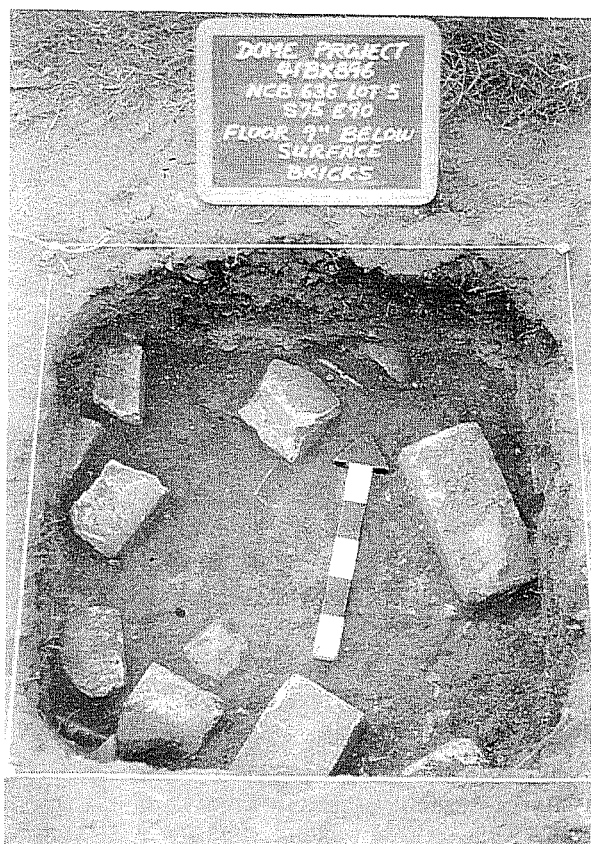
Trench B was another shallow backhoe trench, placed five feet south of the north side of Lot 4. This was an east/west trench, the west end of which was located just east of the fenceline marking the back of the yard for 706 Walnut. About 7–8 ft east into the trench, an

Figure 4-54. 41BX896, brick layer.

alignment of bricks was encountered running across the trench in a north/south direction. No other significant structural features were present in the trench. Four possibilities presented themselves as the most likely explanations for this brick alignment.

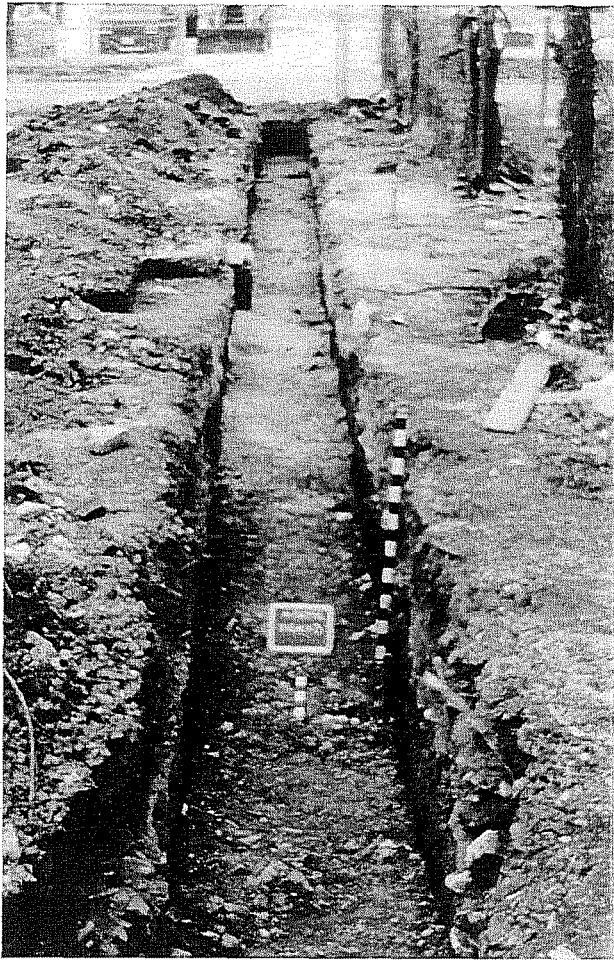
Figure 4-57. *Trench D.*

This was a 70-ft long trench designed to run north/south, perpendicular to Trench C. The south end of Trench D connected with the east end of Trench C. Several suspected activity areas were bisected by this trench: a small outbuilding complex pictured on the 1904 Sanborn map, and a larger double outbuilding shown on the 1911 and 1952 Sanborn maps.

The stratigraphy for the first 10-ft section of Trench D, running north from Trench C, was difficult to interpret. From the beginning of the trench to approximately 40 inches, was a very disturbed mixture of brick fragments, caliche, and sand with no apparent

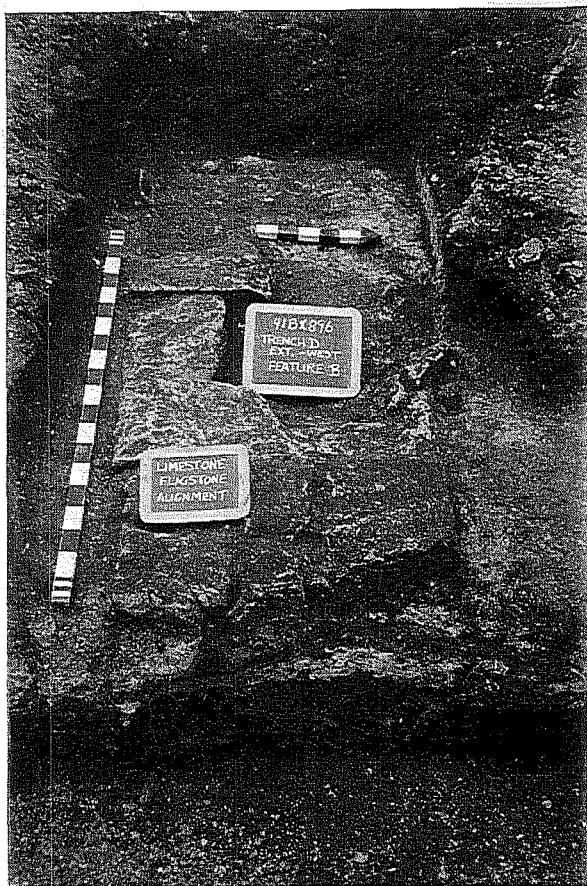
Figure 4-58. *Trench D, Feature B, limestone pavers.*

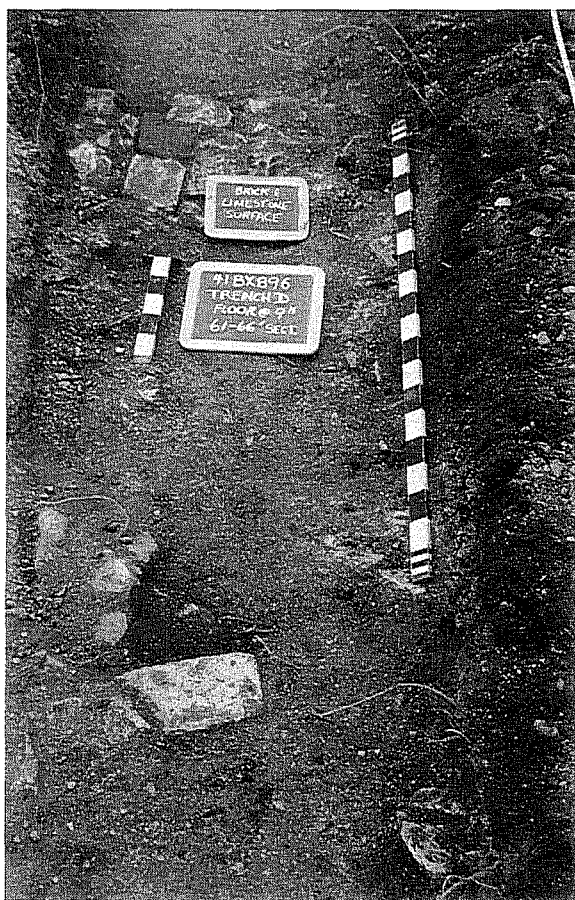
Figure 4-59. *Trench D, brick and limestone wall remnant.*

The only other notable occurrence within the trench was at 61–66 ft north in the trench. Here the remains of what was felt to be a brick and limestone construction front fence was encountered running east/west across the trench (Figure 4-59).

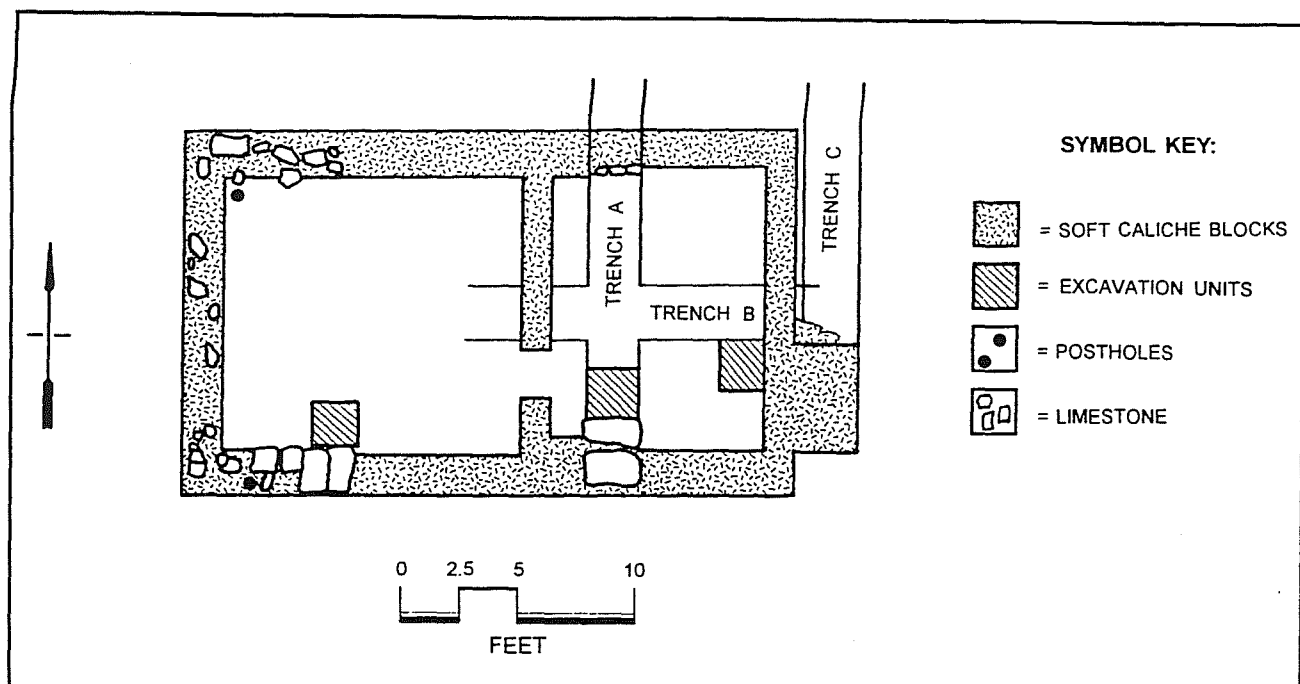
Figure 4-64. Plan map of William Webb House foundation.

The excavations revealed that the original house had been constructed completely of stone (Figures 4-64 and 4-65). Apparently the front room of the house had

The front room of the structure measured 16 x 16 ft. The average thickness of the walls was from 18–24 inches. The two rooms were separated by an interior wall with a doorway, two feet wide, located with its south edge four feet from the outside south wall. A small fireplace hearth, measuring 4.5 x 2.5 ft, was discovered along the east wall with its south edge two feet from the southeast corner of the foundation.

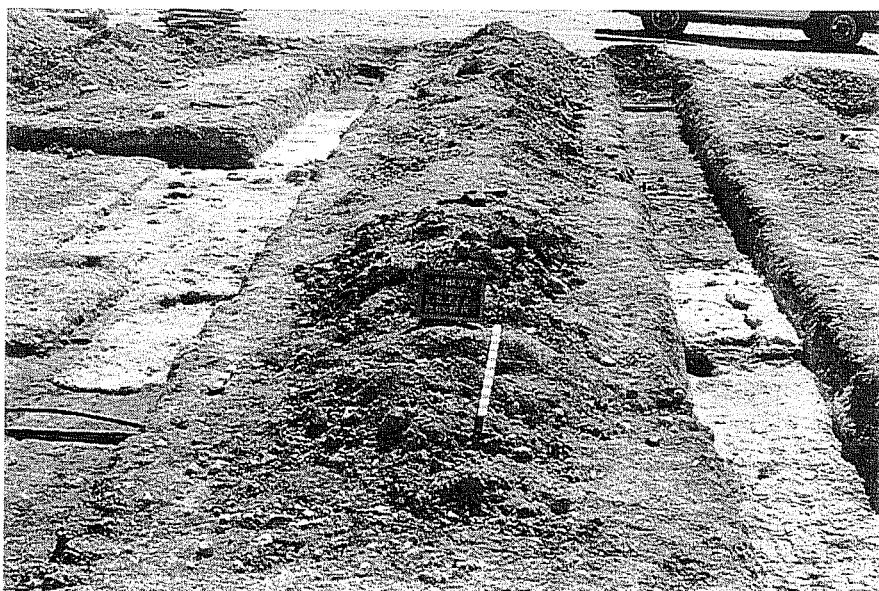
Figure 4-66. *Plaster floor of Charles Webb House.*

What now appeared in plan view of the four north/south trenches (D, E, F, and J) was a plaster surface forming a rough L-shape with the axes meeting to the northeast (Figures 4-66 and 4-67). In several locations the surface of the plaster appeared to have been laid in more than one layer, and to have been patched in several locations (Figure 4-68). Since the shape of the surface did not conform to that of the later 1889 dwelling that was in this location, and since there was

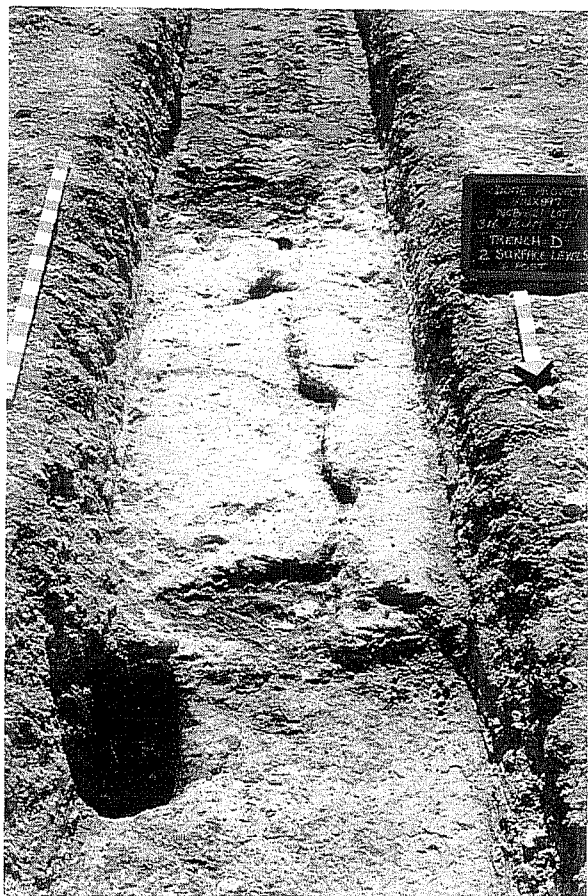
Figure 4-68. *Plaster surface of Charles Webb House, laid in several layers.*

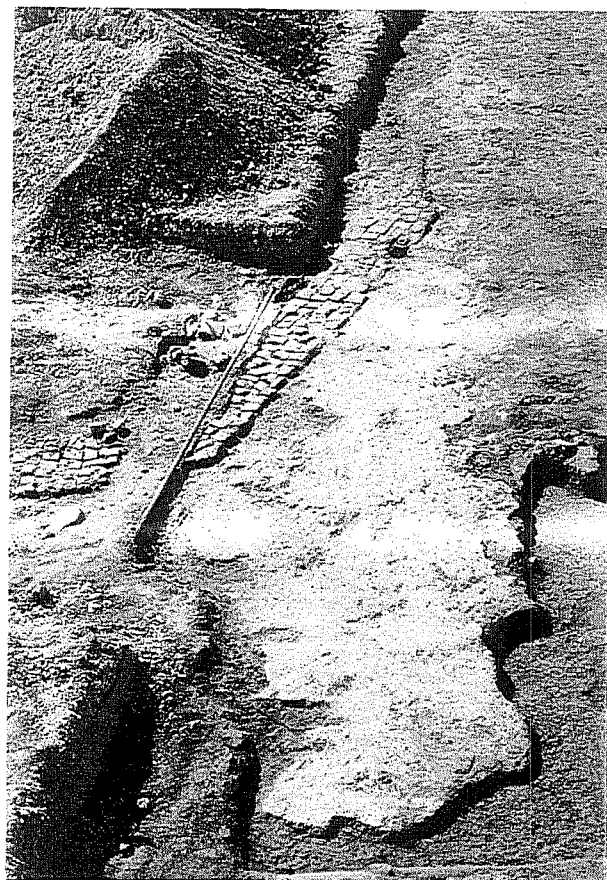
Figure 4-69. *Brick walkway and south side of plaster surface (kitchen).*

This trench ran east/west starting on the east profile of Trench E at approximately 25–27 ft south. At 8–9.5 ft east a thin plaster layer (much thinner than the previously mentioned floor surface) was encountered. At 29 ft east a brick surface was uncovered. The bricks appeared to cross the trench at an angle running northwest/ southeast. The width of the surface appeared to be two feet (relative elevation 652.6 ft amsl) (Figure 4-69).

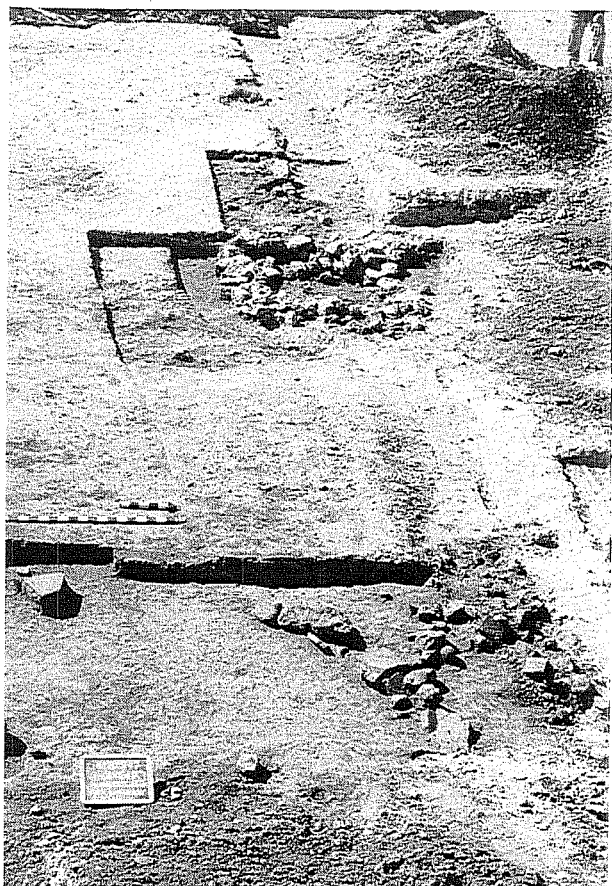
Figure 4-70. *Limestone well surface and north side of plaster surface (kitchen).*

dated the construction of the 1889 house since it was positioned under the northeast corner where the later house had stood. One of the cedar post supports for the 1889 house was actually placed in the center of the well fill surface. The well surface was cleared off and we decided that the interior of the well would be further investigated at a later date (Figure 4-70).

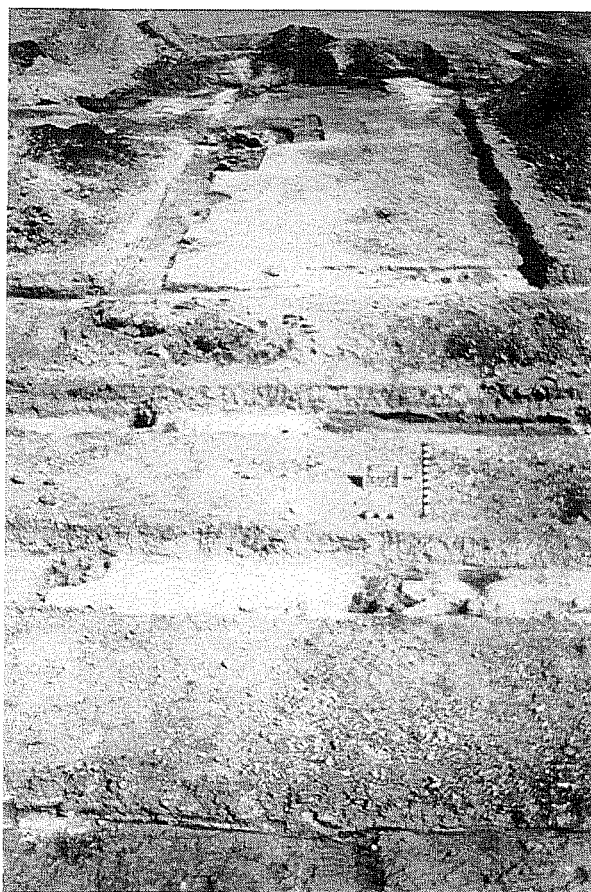
Figure 4-71. *Plaster outline of small structure (top) in southeast area of 41BX897.*

area (Figures 4-71 and 4-72); the thin plaster surface was the result of yard management and sweeping around the structure. The structure could have been an external kitchen, due to the high incidence of kitchen artifacts and bone in this area, as well as its proximity to the water well. This area was redesignated Area A. An 1857 dime was found on top of the southwest corner of the north side plaster surface, approximately four feet east of the well (Feature E).

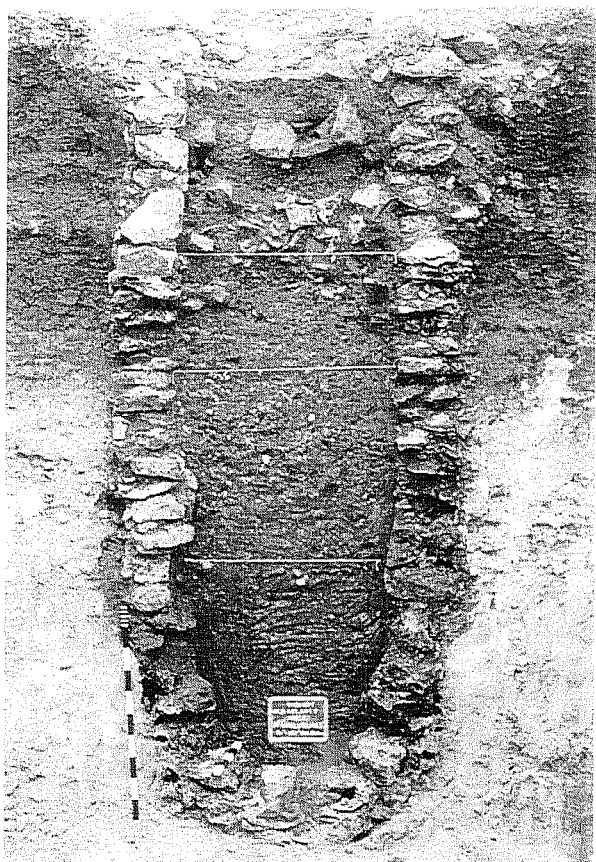
Figure 4-73. 41BX897, completed well profile.

Phase III work at 41BX897 began on December 5 and ran to December 20, 1990. We had decided to section the limestone well (Feature E), removing the south side and leaving the north side in profile (Figure 4-73). This operation was similar to work done at 41BX930 the week before and to the excavation of a well in 1985 at Mission San José (41BX3) (Taylor 1985). Several major differences were present, however. At 41BX930 much of the upper section of the well had been removed already because the well had not been filled and was located solidly within the footprint of the Alamodome construction. Demolition crews had been removing the soil within the footprint to a depth of about 10 ft below the surrounding ground surface. Therefore no cultural layers were present in the soil surrounding the well at 41BX930 when it was excavated. In the case of the well at 41BX897, we

The most interesting evidence revealed by the expansion trench excavation was the fact that the Webb/Demann family were using the adjacent lot to the south (Lot 9 - 41BX883), which they never owned. As the overall expansion trench grew in length it crossed over the boundary line between Lots 7 and 9 at a point just after the start of WET #2 (13 ft south). What was surprising was that there was no significant break in the heavy density of the sheet refuse encountered in this area. Within WET #2, seven cedar posts were discovered representing the south side of an early outbuilding complex well into Lot 9. Also surrounding this compound of outbuildings was a thin layer of swept plaster similar to that found surrounding the small kitchen outbuilding by the well itself. The well was sectioned with the north side left in profile and the south side excavated and screened through ¼-inch mesh. Eleven levels were excavated starting at 16 inches below ground surface and running to 144 inches where water was encountered (Figure 4-73).
