Archaeology at the Alamodome: Investigations of a San Antonio Neighborhood in Transition

Excavations and Artifact Distribution Analysis

Center for Archaeological Research, The University of Texas at San Antonio
Archaeological Survey Report, No. 237, 1997

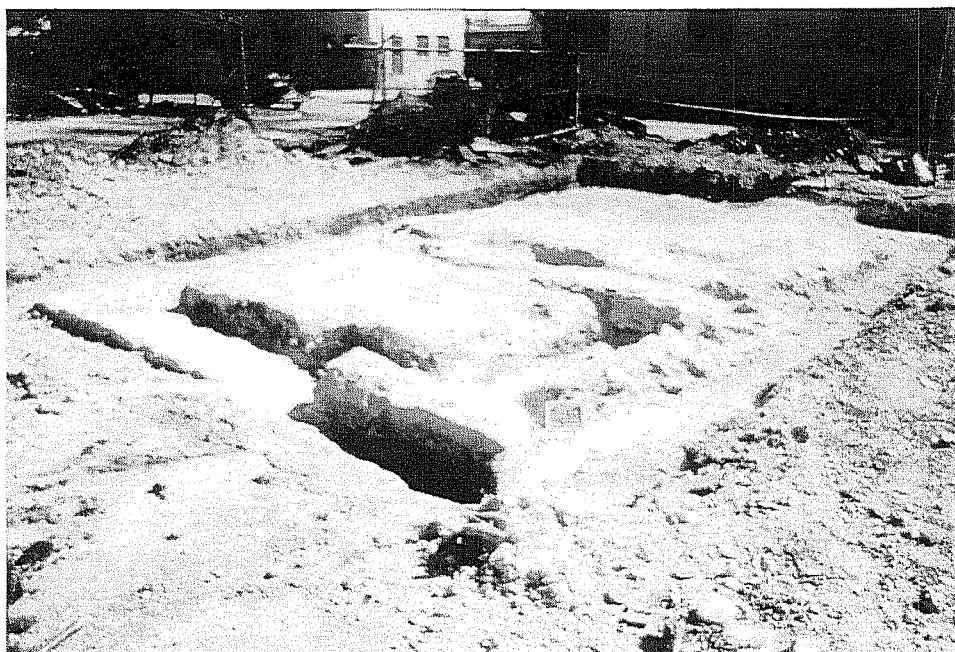
Figure 4-77. Foundation of the Gordon House.

This property was acquired in 1859 by Charles H. Gordon, for whom the site is named. It was during this period that the small settlement salt-box dwelling was probably built (Figure 4-77). In 1870 the property was sold to Gottlieb Glaeser, who owned several other lots in the neighborhood and resided on the same block just to the east (313 Nevada). Gottlieb gave this residence to his daughter Fredricka (BCDR H2:281, S1:379, V2:554, W2:118).

Once this was accomplished, the smaller backhoe was able to locate and clear off the foundation of the adobe dwelling (Figure 4-77). A site datum (elevation 653.96 ft amsl) had been established near the southwest corner of Lot 6. This datum point was approximately 240 ft SSE of Monument Number 2, one of the primary datums used during the project (elevation 654.56 ft amsl).

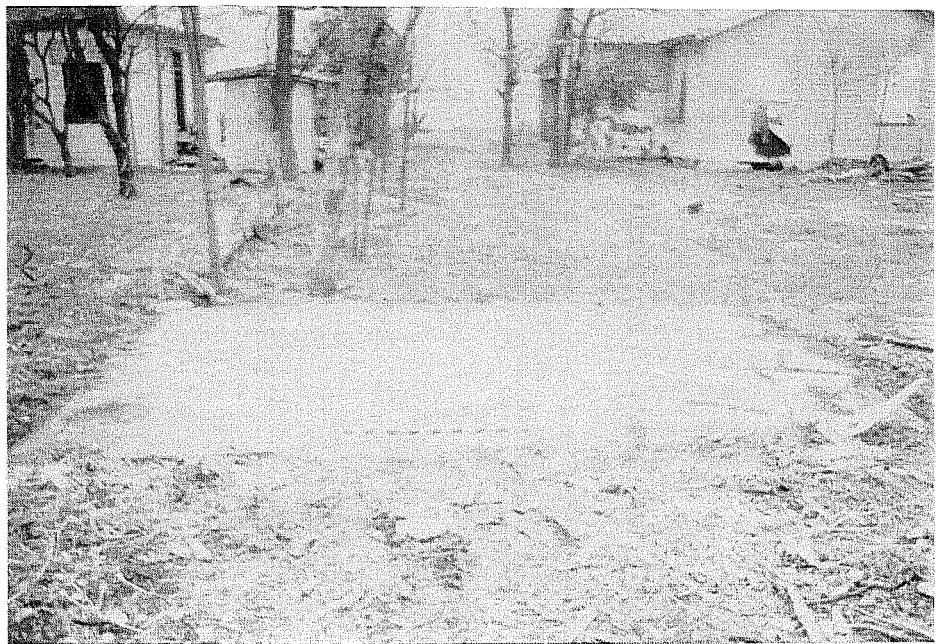
Figure 4-83. *Excavation area for Trench D.*

From 0–46 ft west, the remains of eight cedar post supports for the residential structure were found. The posts were set in concrete anchors measuring 14–15 inches in diameter. The stratigraphy was fairly uniform, being composed of varying layers of brown clay and tan caliche fill material.

Between 62 and 72 ft west, the stratigraphy became much more complex. The remains of four small cedar posts were revealed at 62.5 ft, one at 65.5 ft, and two at 66 ft west. A distinct stratigraphic break took place at 65.5 ft west about six inches below ground surface. The soil changed from a reddish sandy caliche to a dark sandy charcoal mixed with the very soft remains of bricks. The bricks were so poorly preserved that they were no longer solid, however their contrast with the surrounding matrix still showed their distinctive shapes very well. Also at 65.5 west, dividing these two areas of soil, was a vertical fragment of wood, apparently the bottom portion of a wall. These were the remains of a previous structure placed in this location and running further west under where the current driveway and storage building stood. The large

amount of charcoal present suggested that the structure may have burned.

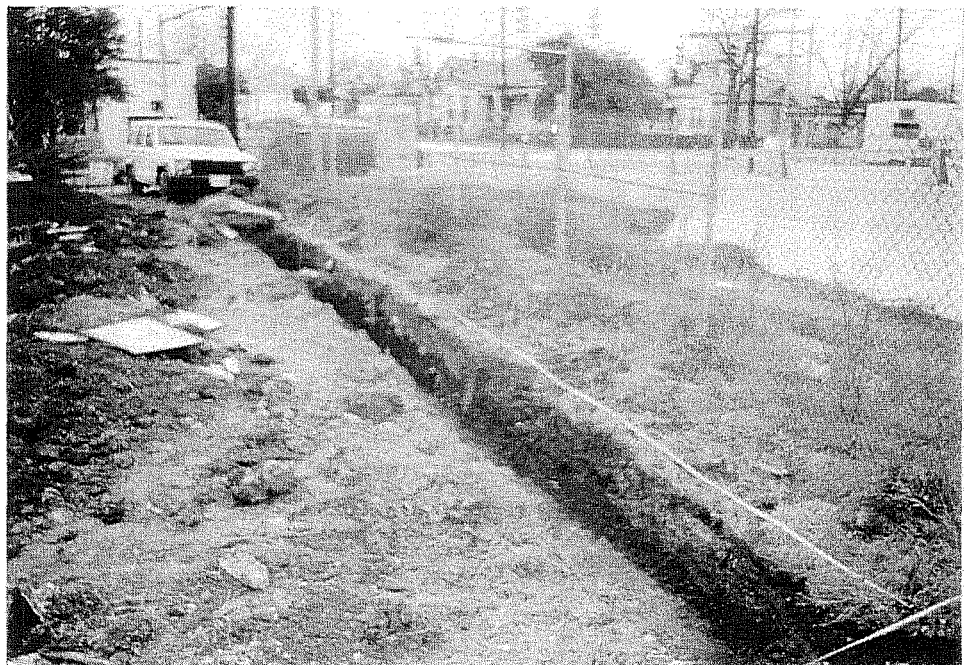
Figure 4-84. Trench E (Durango Street in background).

This trench measured 2 x 40 x 2 ft. It was placed with an east/west orientation running east from the south end of Trench D. Starting in Lot P, the trench crossed over into Lot Q (41BX943). This trench was placed to search for possible remnants of the Valley Ditch, which archival sources indicated should be in the area (Wayne Cox, personal communication 1991). The Valley Ditch was not found in this trench; we later determined the ditch ran north/south down the west side of Cherry Street. If this trench had been carried another 30 ft to the east, the ditch would likely have been revealed (Gross and Mendez, Volume III).

Three cedar post supports associated with the structure located on this lot before the addition of the Durango Street overpass were found at 13, 21, and 27 ft east in the trench. This lined up well with the placement of the still-existing homes just to the north on the other lots.

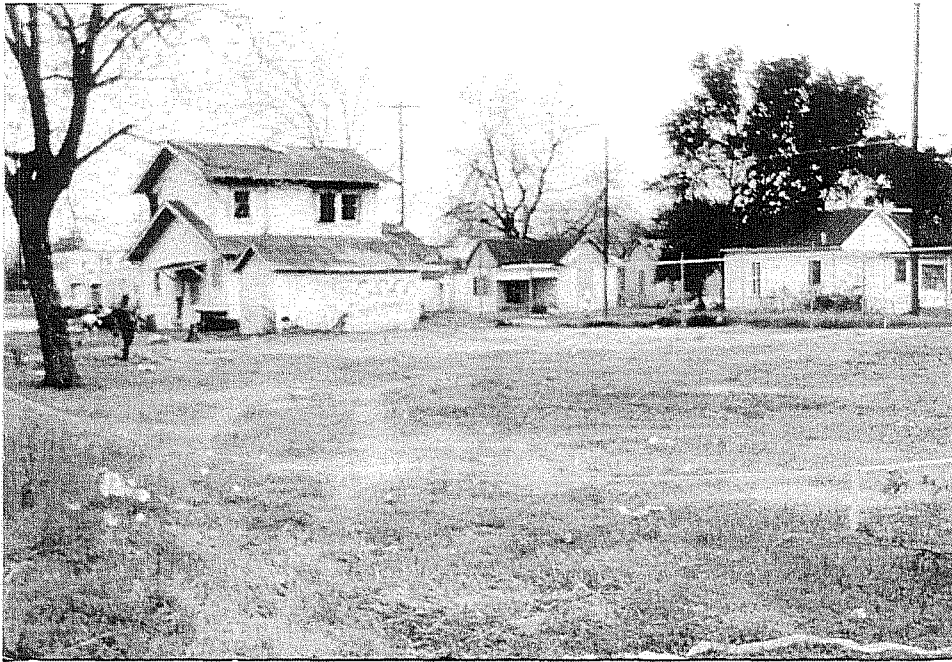
Figure 4-86. View of 41BX945 before excavation. Facing northeast.

When excavations began in 1991, all traces of structures on Lot 15 were gone with the exception of minor surface evidence of the limestone primary dwelling. The 1921 bungalow and its attendant outbuilding were still present on Lot 16. The outbuilding appeared to have been used as a garage (Figure 4-86).

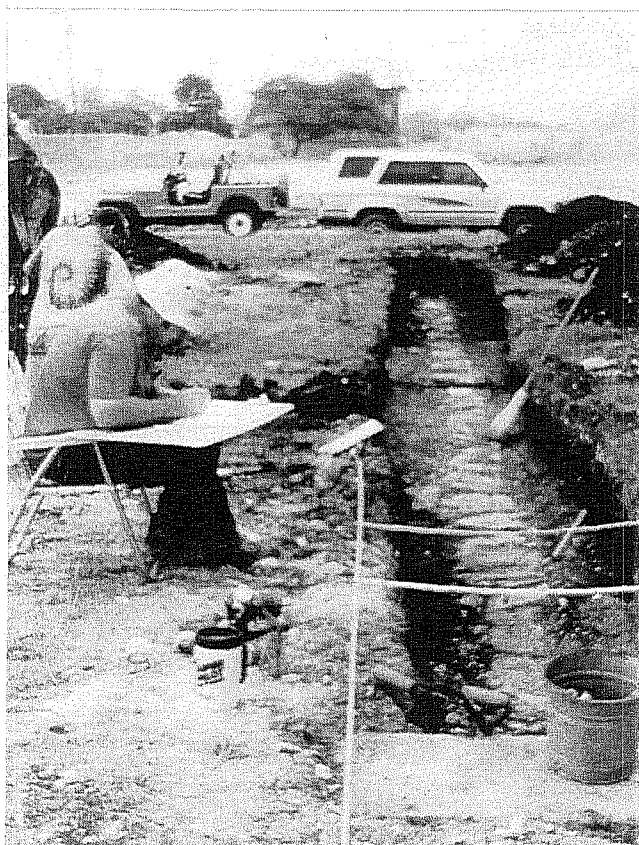
Figure 4-90. Feature C, drain, north/south extension.

drain crossed the trench running north/south and was designated Feature C. We followed the drain to see if it connected to a second drain that had been discovered running down the east side of the remnants of the primary dwelling (325 Dakota). The first extension to trace the drain was called Feature C - North Extension. The North Extension followed the drain 40 ft north of where it was first encountered to a point just south of a large limestone block presumed to have been the front entrance step for the primary dwelling (Figure 4-90). There the drain suddenly stopped with no evidence of any connector to the surface.

Two important features were revealed in the course of excavating this stretch: 1) about 24 ft north, a secondary branch of the drain was revealed running east off of this main branch; and 2) just to the south of the limestone doorstep, sitting on top of the drain stones at a depth of approximately 19 inches, was an iron dinner plate with cow rib bones on it. Several other rib bones were found in association with this plate laying on top of the drain surface. It is possible that this could represent a meal consumed when the drain was being installed.

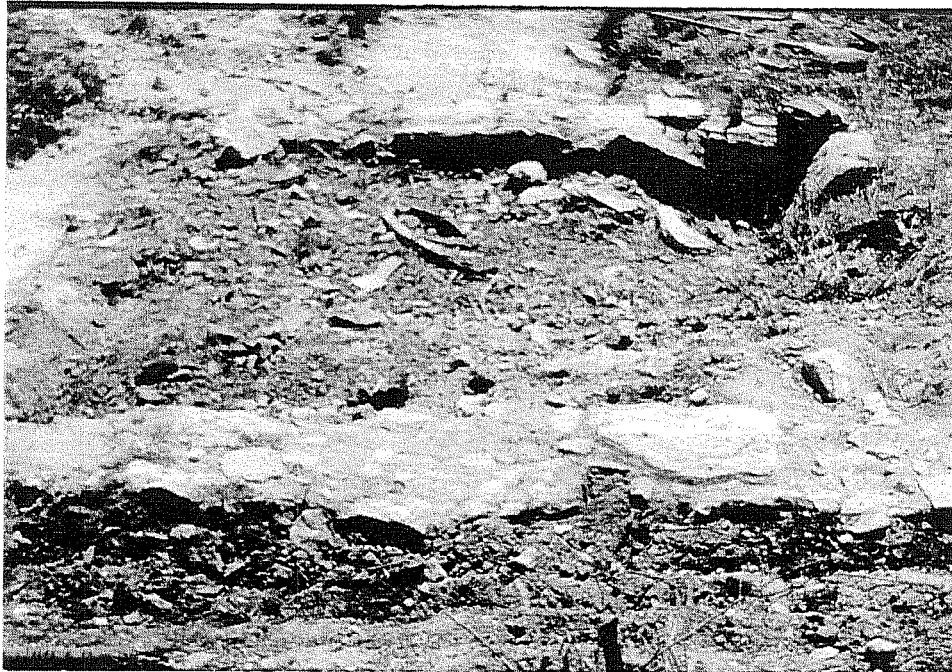
Figure 4-91. *Top view of Feature E, limestone cistern*

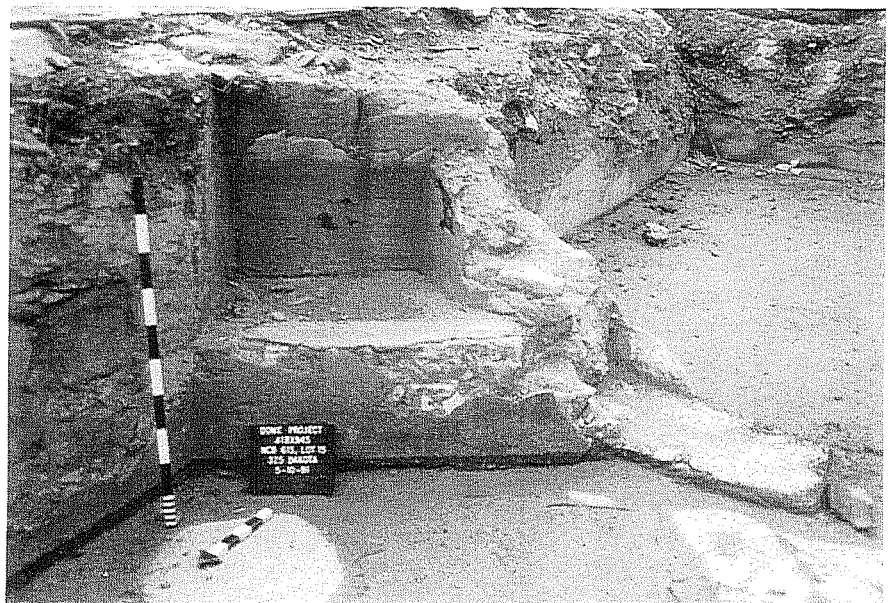
Figure 4-92. *Feature I, fireplace hearth located in dwelling basement.*

Excavation of the northeast room showed two major differences from the first room examined: this room had a solid floor constructed of limestone pavers and the remnants of a small fireplace hearth (Feature I, Figure 4-92) in the southeast corner of the room. While the other rooms of the basement had not been built to function as primary living space, this quarter of the basement had been designed for comfort. The

limestone floor was still in a good state of preservation. The fireplace showed no direct evidence of having been used (no charcoal or smudge marks were present). No foundations remained above where there would have been a damper or flue. This room also measured 15 x 15 ft and doors exited to the west and south. Recent material was found all the way to floor level, with potato chip bag closures resting on the limestone floor. The Dentler Potato Chip Company had been located approximately one mile south of this location, the thousands of bag closures encountered were probably the result of dumping.

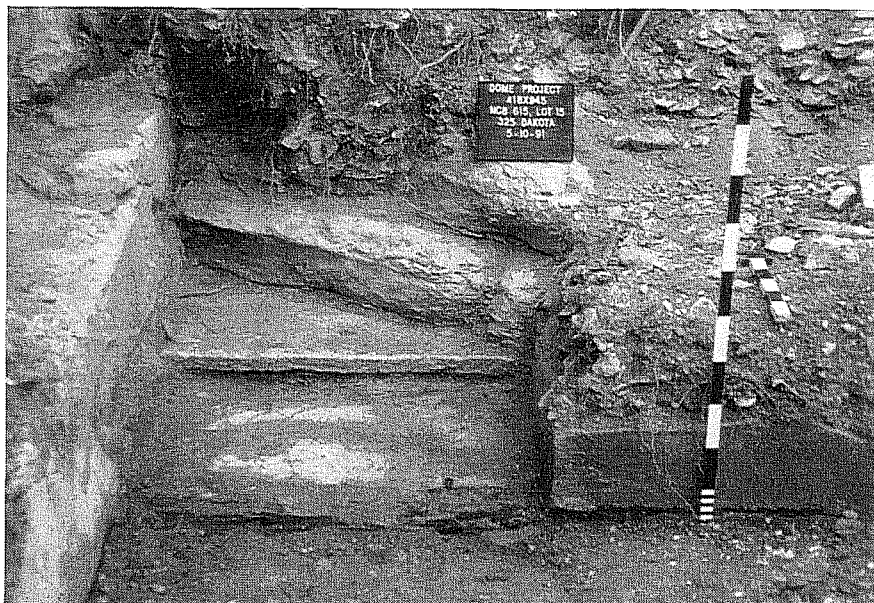
Figure 4-94. *Feature G, staircase entering the basement.*

Once the interiors of all four rooms were cleared of debris and exposed to floor level (Figure 4-93), we returned to the northwest room to clear the debris from what appeared to be an exit in the northwest corner. A staircase (Feature G)—running six feet to the north, where a wall was encountered, then turning east and continuing to the surface 10 ft to the east (Figure 4-94)—was revealed. The west wall of the primary dwelling had been lengthened to include the staircase. A small section of wall, 10 ft long, functioning as a balustrade to protect the north side of the staircase, was placed running east/west. Only the first four risers of the stair were present. A small horizontal wood slat was recessed into the floor running across the exit doorway just before the first riser.

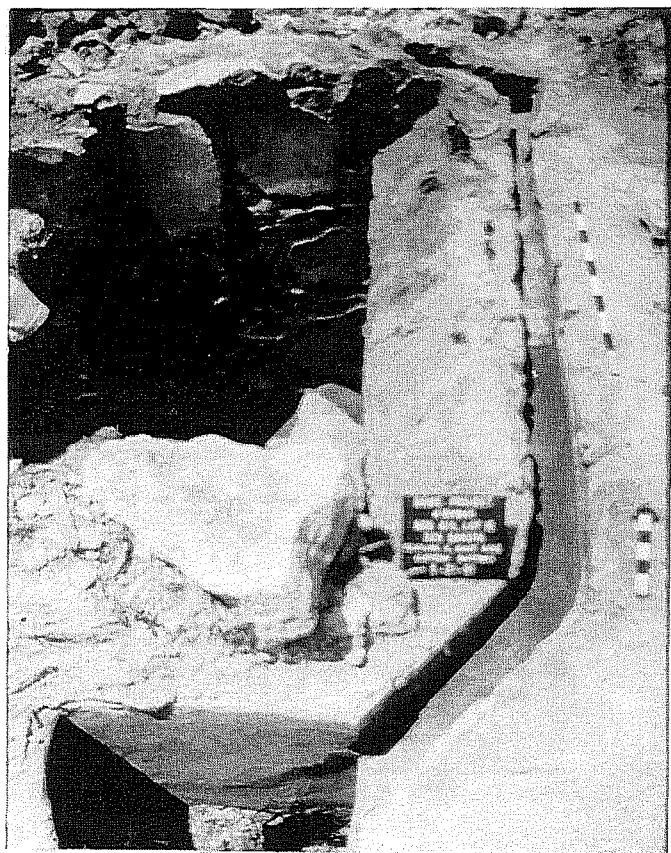
Figure 4-95. *Cistern, overflow mechanism, and filtration trap.*

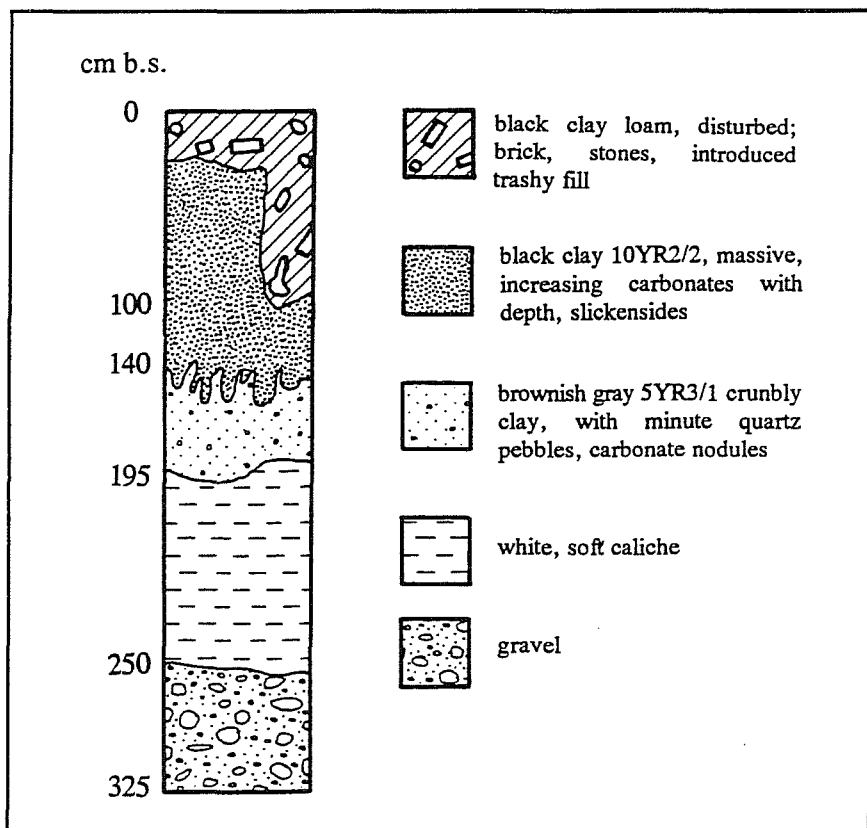
Figure C-2. *Schematic profile, GMBHT 1.* Note the Historic-period pit or posthole.
