Archaeological Monitoring of the IKE Smart City Digital Kiosk Installations in Downtown San Antonio, Bexar County, Texas

Texas Antiquities Permit No. 8539

Prepared by:
Center for Archaeological Research
The University of Texas at San Antonio
One UTSA Circle
San Antonio, Texas 78249
Technical Report, No. 89

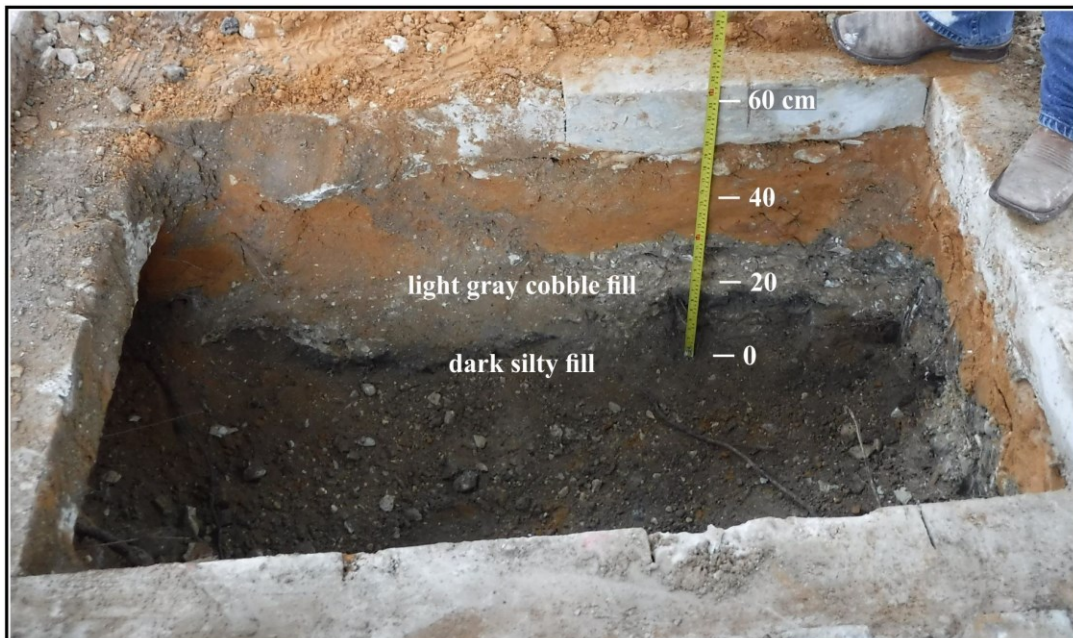
Figure 4-2. Area excavated for Kiosk 1 foundation (view west).

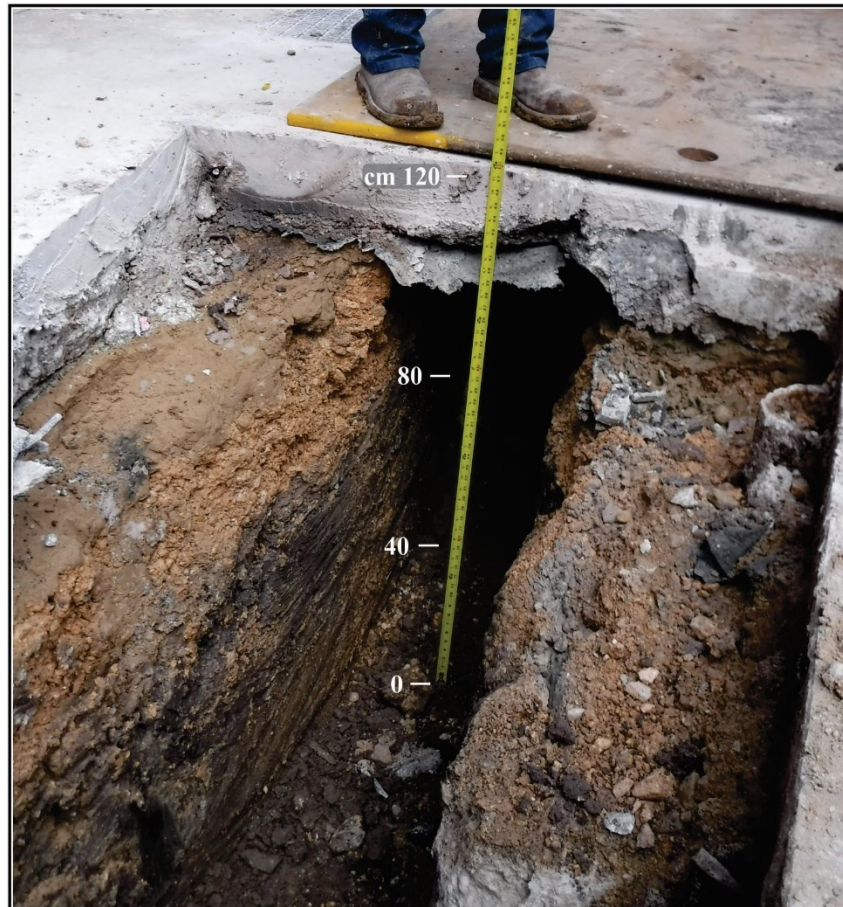
Trenching along the South St. Mary's Street sidewalk exposed more clay and cobble fill with pockets of areas disturbed by earlier utility installation. Excavation in this area was to a depth of 121.9 cm (48 in.) and extended through caliche and clay/cobble fill (Figure 4-4). The excavated area was heavily disturbed by earlier installations of electrical, gas, and water lines. No cultural features were encountered in this area. The only material observed were of post-1950 origin, and none of this material was collected.

Figure 4-4. Area excavated for electrical tie-in (view north).

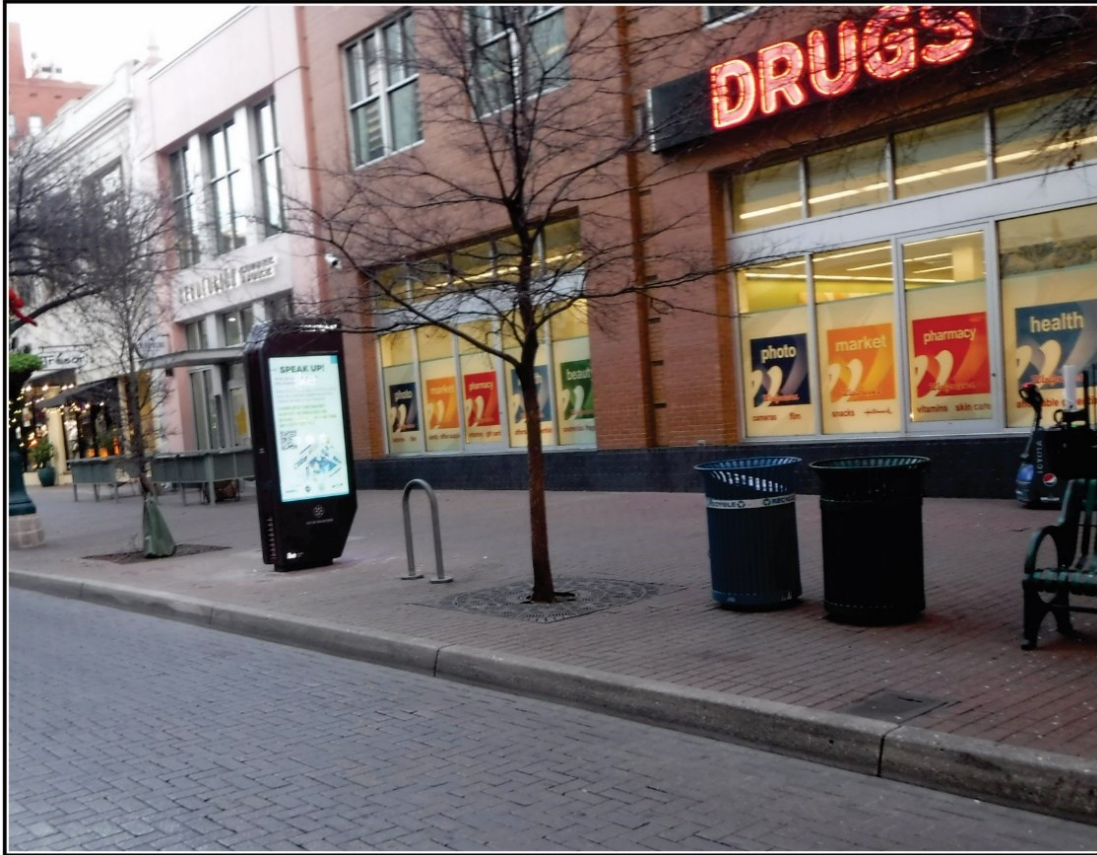
This kiosk location was at the southeast corner of East Houston Street and Navarro Street (Figure 4-7). CAR staff did not monitor any of the work related to the installation of this kiosk. According to the contractor, there was no additional excavation at this location other than removing the sidewalk pavers to expose an existing foundation. This concrete foundation was then used to mount the kiosk (correspondence on file at CAR).

Figure 4-7. Kiosk 4, left of center, at 304 East Houston Street; photograph taken January 6, 2020 (view southeast).

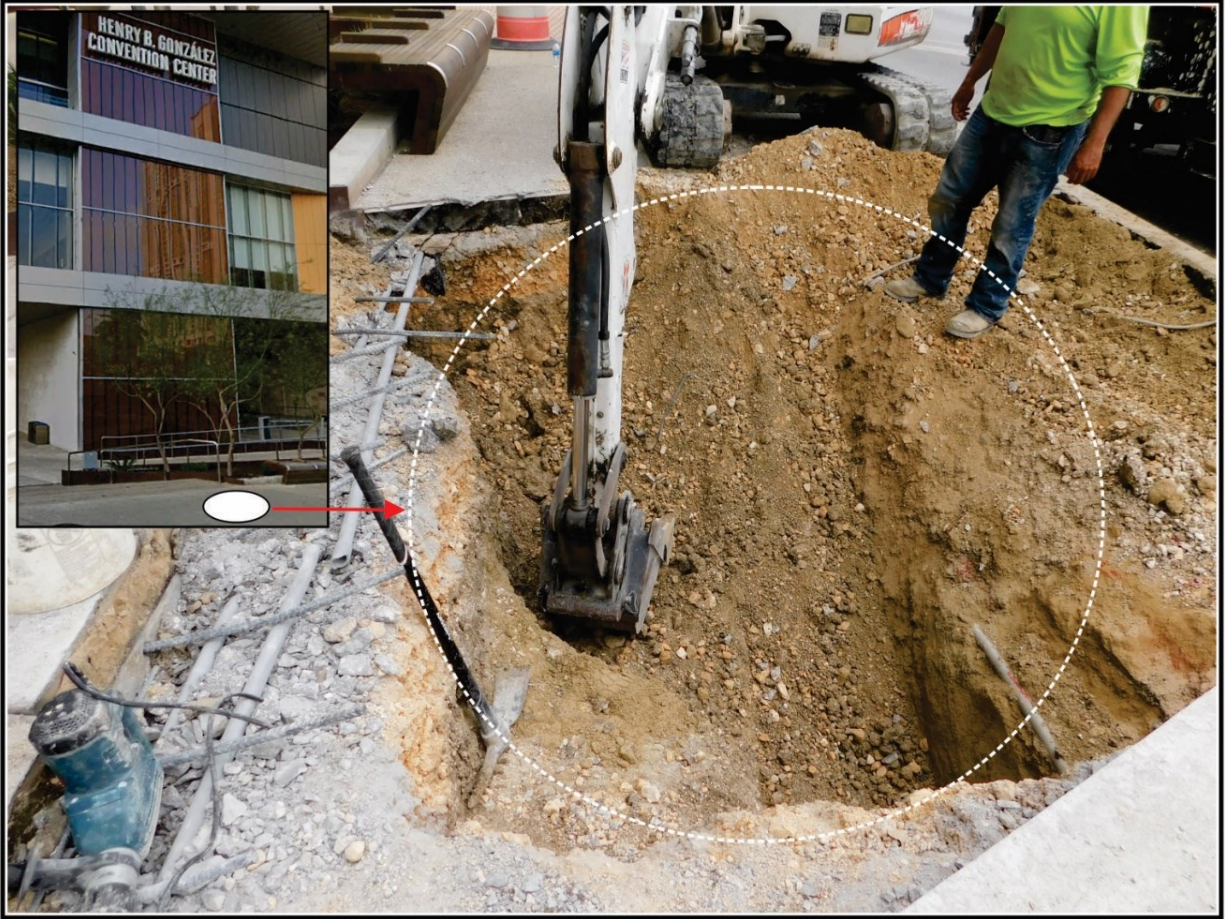
Monitoring for the installation of Kiosk 5 took place on August 26-27, 2019. The kiosk location was along the south side of East Market Street in front of the Henry B. Gonzalez Convention Center (Figure 4-8). Excavation in this area impacted a 1.8 m (6 ft.) by 2.4 m (8 ft.) area to a depth of 1.8 m (6 ft.). A 40 cm (15.7 in.) thick layer of concrete sidewalk was cut and removed. The exposed subgrade consisted entirely of caliche fill.

Figure 4-8. Excavation in-progress; inset shows location of Kiosk 5 in front of the convention center.
