Archaeological Monitoring of a Parking Lot at Hemisfair Park in San Antonio, Bexar County, Texas

Texas Antiquities Permit No. 7612

Prepared by:
Center for Archaeological Research
The University of Texas at San Antonio
One UTSA Circle
San Antonio, Texas 78249
Technical Report, No. 64

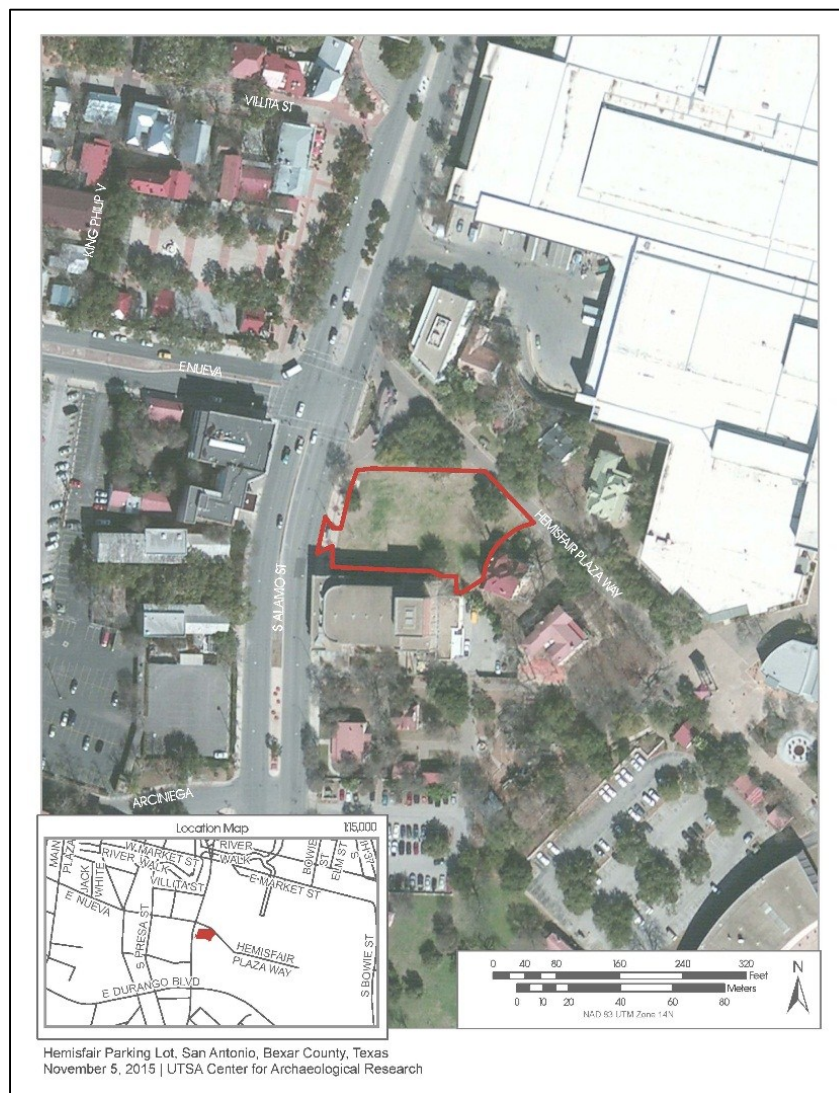
Figure 1-2. APE location (outlined in red) shown on satellite imagery.

Located in downtown San Antonio, Hemisfair Park is bounded by South Alamo, Nueva, Water, and César Chávez streets. The Area of Potential Effect (APE) includes 0.63 acres (0.25 hectares), approximately 120 ft. (36.5 m) north/south by 180 ft. (54.8 m) east/west (Figure 1-2). Ten recorded archaeological sites lie in the area, including eight extant structures and the *Acequia Madre* (41BX8). Beethoven Hall (41BX584) and the Longini-Hermann House (41BX585), formerly the Acosta House, adjoin the planned parking to the south and east, respectively (Figure 1-3). Beethoven Hall and Longini-Hermann House are designated State Antiquities Landmarks (SAL) and are listed on the National Register of Historic Places (NRHP). The planned improvements required grading of the top 6-14 in. (15.2-35.5 cm) of sod and fill, as well as boring and trenching to accommodate light pole piers and conduit. Two areas were bored (1.5-x-8 ft. deep; 0.5-x-2.4 m) at either end of the parking lot and a 1-x-1.5 ft. deep (0.3-x-0.5 m) and 90-ft. (27.4-m) long trench was excavated between the two holes (Figures 1-4 and 1-5).

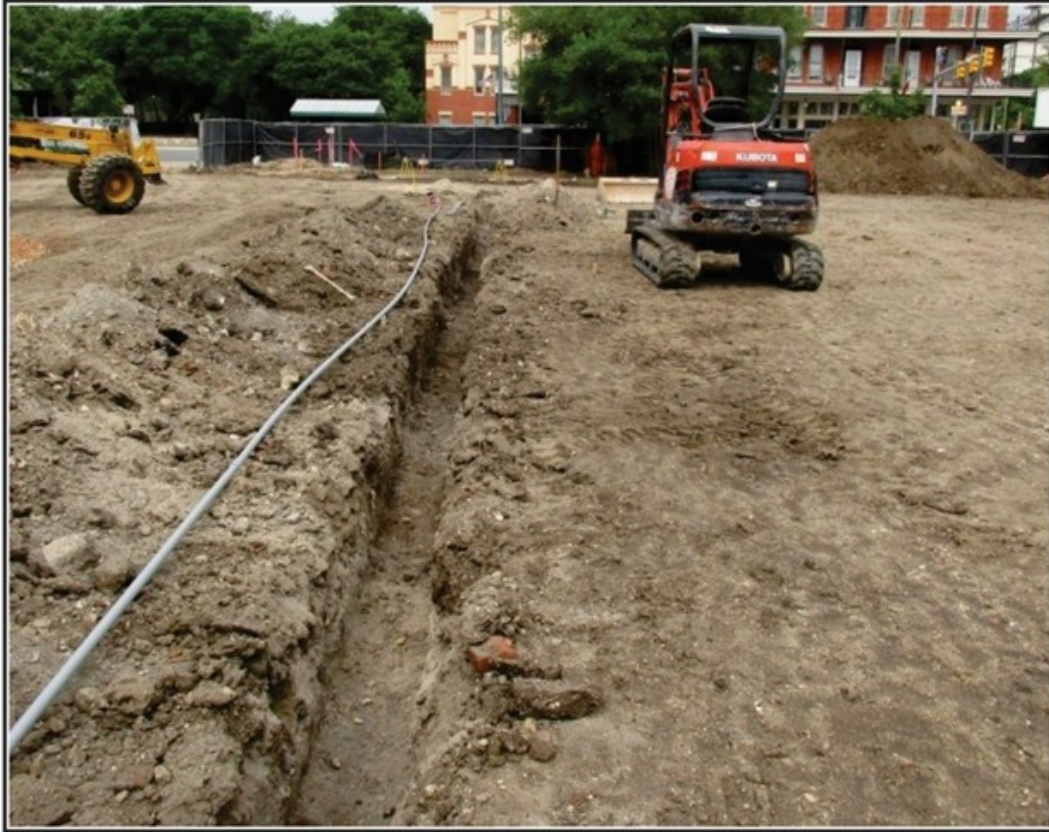
Figure 1-5. Trenching between pier holes. Note red and buff colored brick fragments on either side of the trench in foreground, April 12, 2016. View to the west.

During the second week of construction and as the construction crew was adding base material, the electrical crew bored, trenched, and installed piers and conduit for lighting see Figures 1-4 and 1-5. The holes for the pier supports were 1.5 ft. (0.5 m) in diameter and 8-ft. (2.4-m) deep. A light concentration of construction rubble was noticed in the backdirt, consisting of a dark grey clay matrix. The auger broke into the native layer of culturally sterile, caliche clay and gravel at about 5.5 ft. (1.7 m) below the surface. A 90-ft. (27.4-m) long trench was cut between the two pier holes; this trench was 1-ft. (0.3-m) wide by 1.5-ft. (0.5-m) deep. The trench was meant to accommodate electrical conduits that will service the new light fixtures. In the process of trenching, the crew exposed the main electrical conduit and were then able to tie the new electrical wiring to the existing electrical lines. Several sections of abandoned irrigation and electrical lines were excavated in the trench. Some construction rubble, in the form of fragmented brick and sandstone, was evident in the backdirt and was imbedded in the trench wall. The amount of construction rubble was negligible. A very thin, ashy lens was observed about 40 ft. (12 m) west of the pier hole at the east end. Closer examination of the lens and backdirt nearby failed to locate anything of significance.

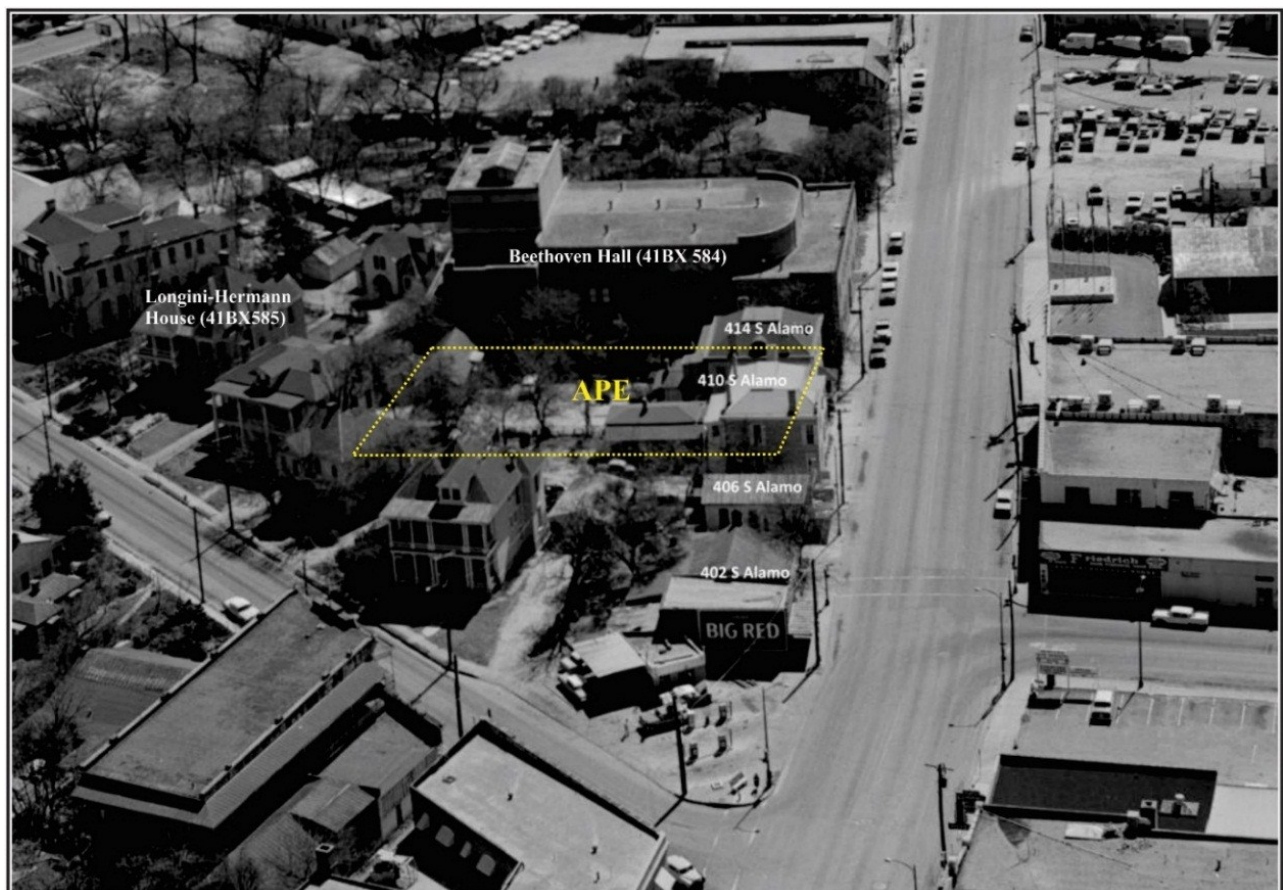
Figure 4-1. Approximate location of APE on ca. 1960 aerial photograph of the northwest corner of Goliad Road and South Alamo Street (UTSA-ITC Collection, H-0746-0199).

As seen in the referenced figures, a portion of two brick buildings and eight wood-framed structures were present within the APE as late as 1960. These structures were razed in ca. 1964 to make way for HemisFair '68. Evidence of these may exist in the form of stone-constructed wall foundations or construction material, but not within the top 24 in. (61 cm) below the surface. Figure 4-1 also shows several wood-framed

structures strewn about the entire APE. Evidence of these would be slightly less, given that these may have been constructed on more ephemeral pier-and-beam foundations.
