Archaeological Testing Associated with the Stabilization of Room 4 at Mission San Juan Capistrano, San Antonio, Bexar County, Texas

©2006
Archaeological Report, No. 368
Center for Archaeological Research
The University of Texas at San Antonio

Texas Antiquities Permit No. 4126

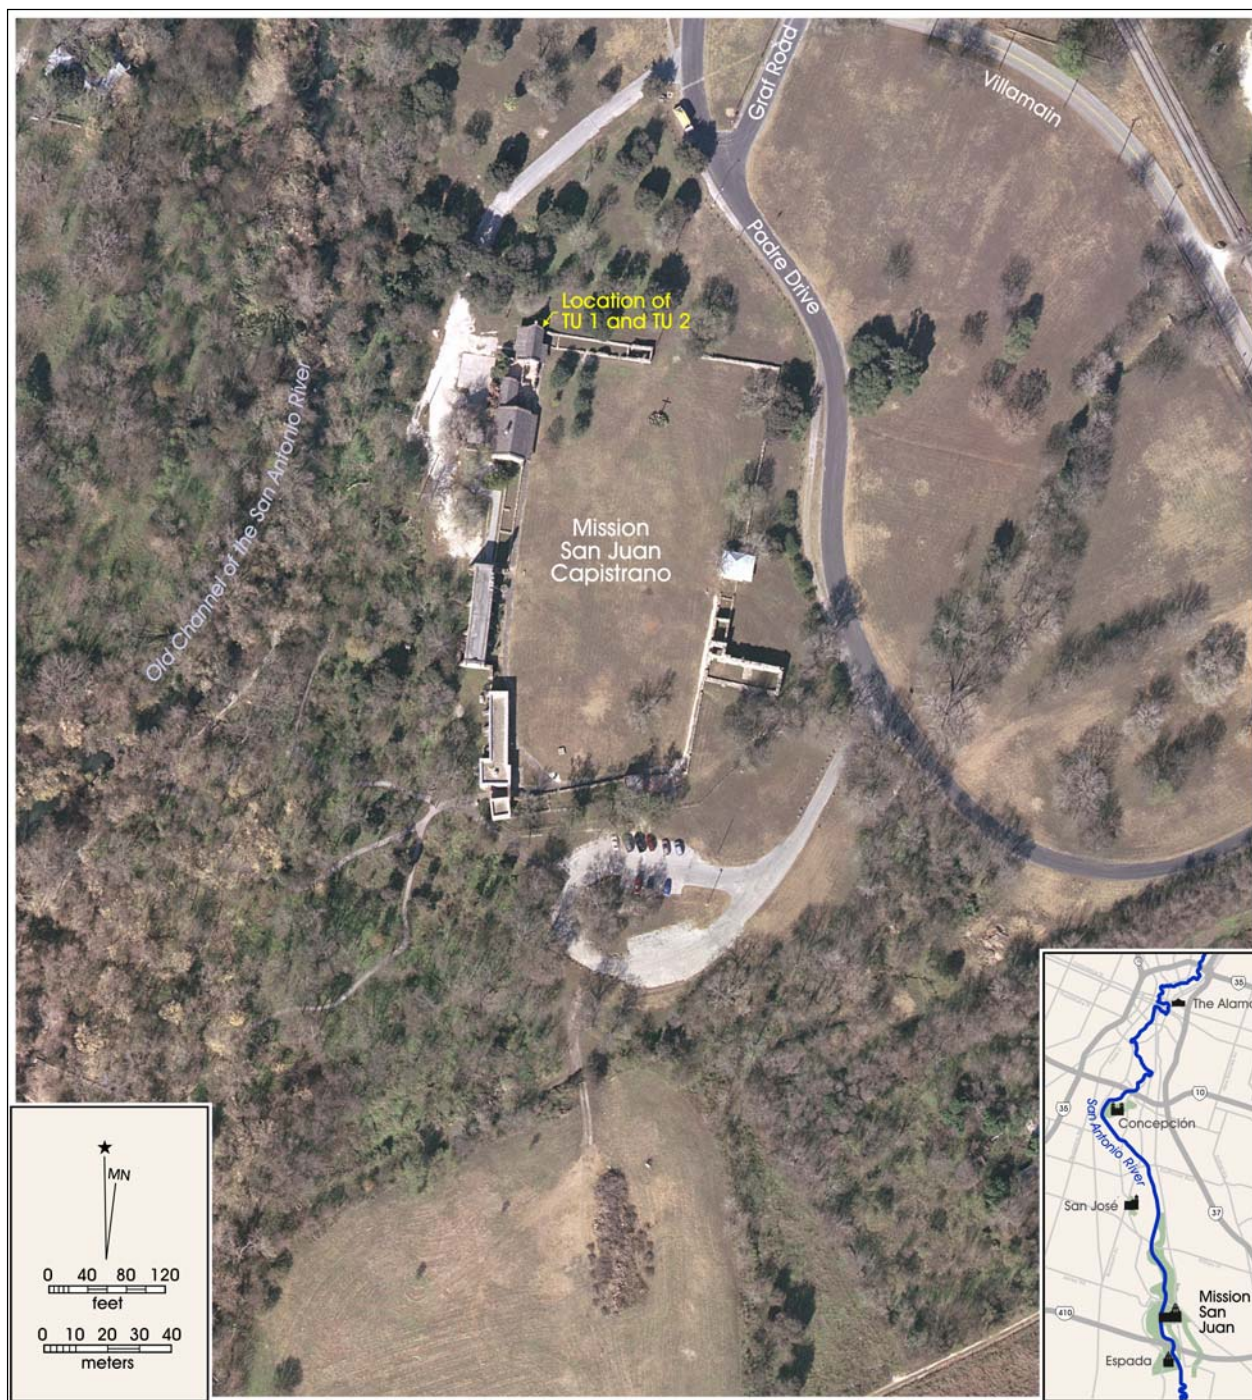
Figure 1. *The location of Test Units 1 and 2 within Mission San Juan Capistrano.*

CAR exposed the chimney footing and part of the exterior north wall of Room 4 in Test Unit 1, a 1-x-1-m (3.28-x-3.28-ft) test unit, 30 cm (11.81 in) east of the chimney (Figure 8). The unit datum was placed north of the unit. All elevations were taken from the ground surface at this point. Ground surface rises toward the building so elevations below surface were approximately 5 cm deeper near the north wall. Most of the 1-x-1-m unit was excavated to 70 cmbd (2.3 ft). In order to find the bottom of the concrete footing supporting the chimney, the northwest corner (40-x-60 cm; 1.31-x-1.97 in) was excavated deeper to 100 cmbs (3.28 ft). We also expanded 40 cm of the northwest corner 40 cm to the north in Test Unit 2 to locate the corner of the concrete footing. The units exposed 117 cm (3.84 ft) of the chimney footing (north to south) and 100 cm (3.28 ft) (east to west) of the north wall foundation (Figure 9).

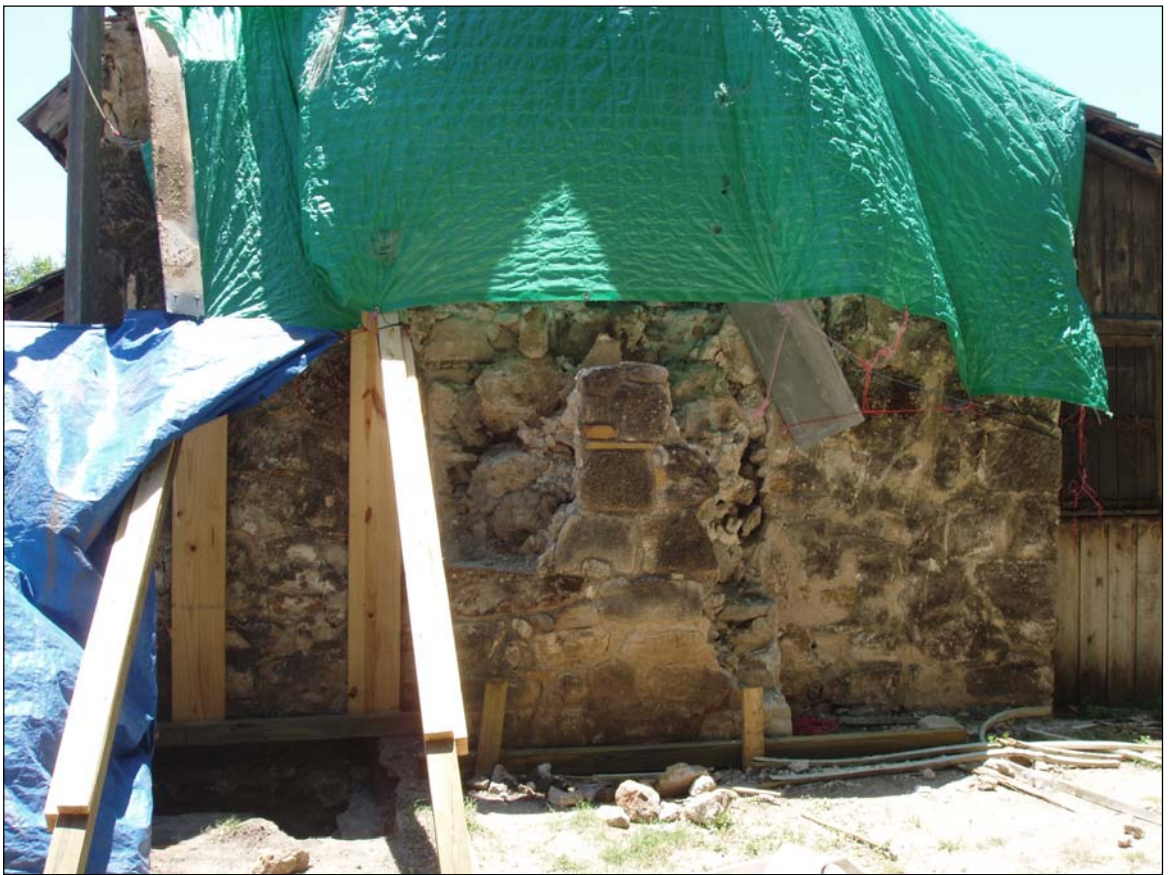
Figure 2. *The collapsed chimney and north wall of Room 4.*

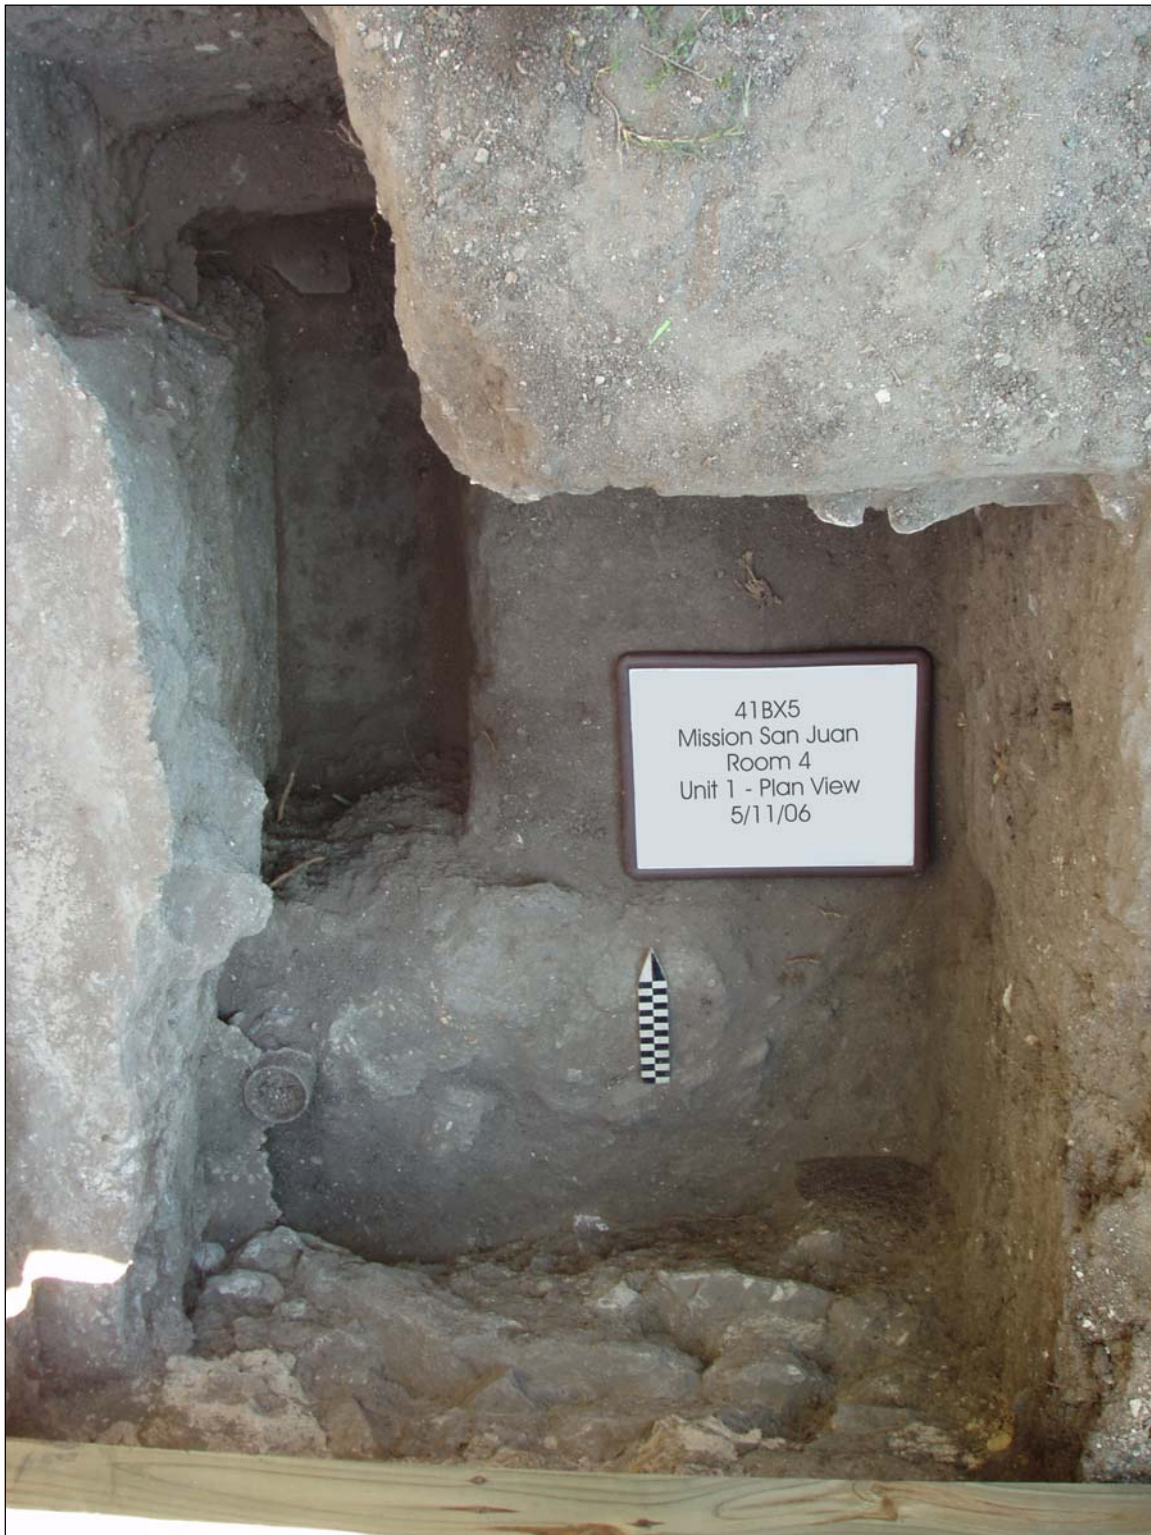
Figure 9. Photograph of final excavation of Test Unit 1.

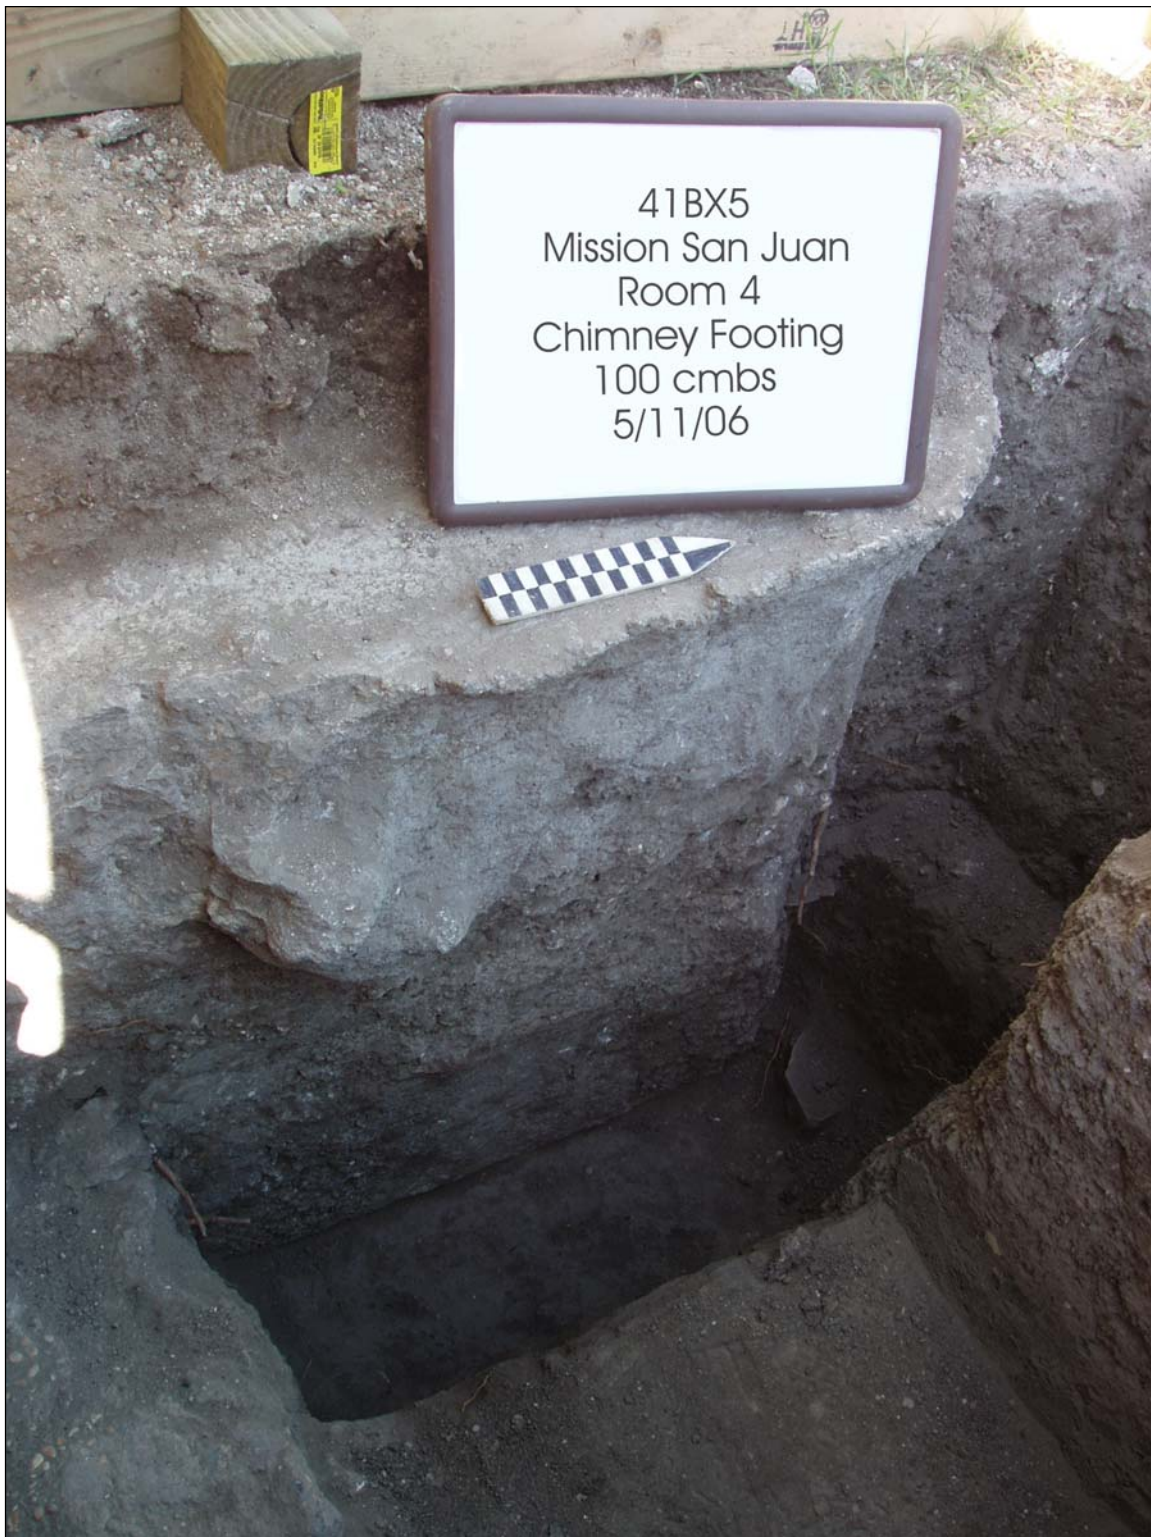
Figure 10. *Photograph of the chimney footing exposed in Test Unit 1.*

Ford, Powell, and Carson, Inc. was interested in determining the parameters of the foundation and the chimney footing of Room 4. The excavation revealed the surface of the chimney footing at 12 cmbs (4.72 in) and the edge 45 cm east of the chimney. The base of the chimney footing is at 100 cmbs. The height of the footing (top to bottom) is 88 cm (34.5 in) (Figure 10). At 48 cm (1.57 in), we uncovered a pylon set in concrete supporting the chimney footing. The center of this pylon is approximately 20 cm north of the foundation and 5 cm from the edge of the footing (Figures 8 and 9). At 69 cmbs, excavations uncovered overflow concrete across the northern portion of the unit from the pylon installation (Figure 8). Excavations revealed the base of the foundation at 60 cmbs (Figure 11). Mortar and rock crumbled from the foundation despite careful excavation. There is no recent footing supporting the foundation (Figure 12).
