# Archaeological Monitoring for Ashley Road Project, San Antonio, Bexar County, Texas

Texas Antiquities Permit No. 7589

*Prepared by:*  
Center for Archaeological Research  
The University of Texas at San Antonio  
One UTSA Circle  
San Antonio, Texas 78249  
Archaeological Report, No. 451

**Archaeological Monitoring for  
Ashley Road Project,  
San Antonio, Bexar County, Texas**

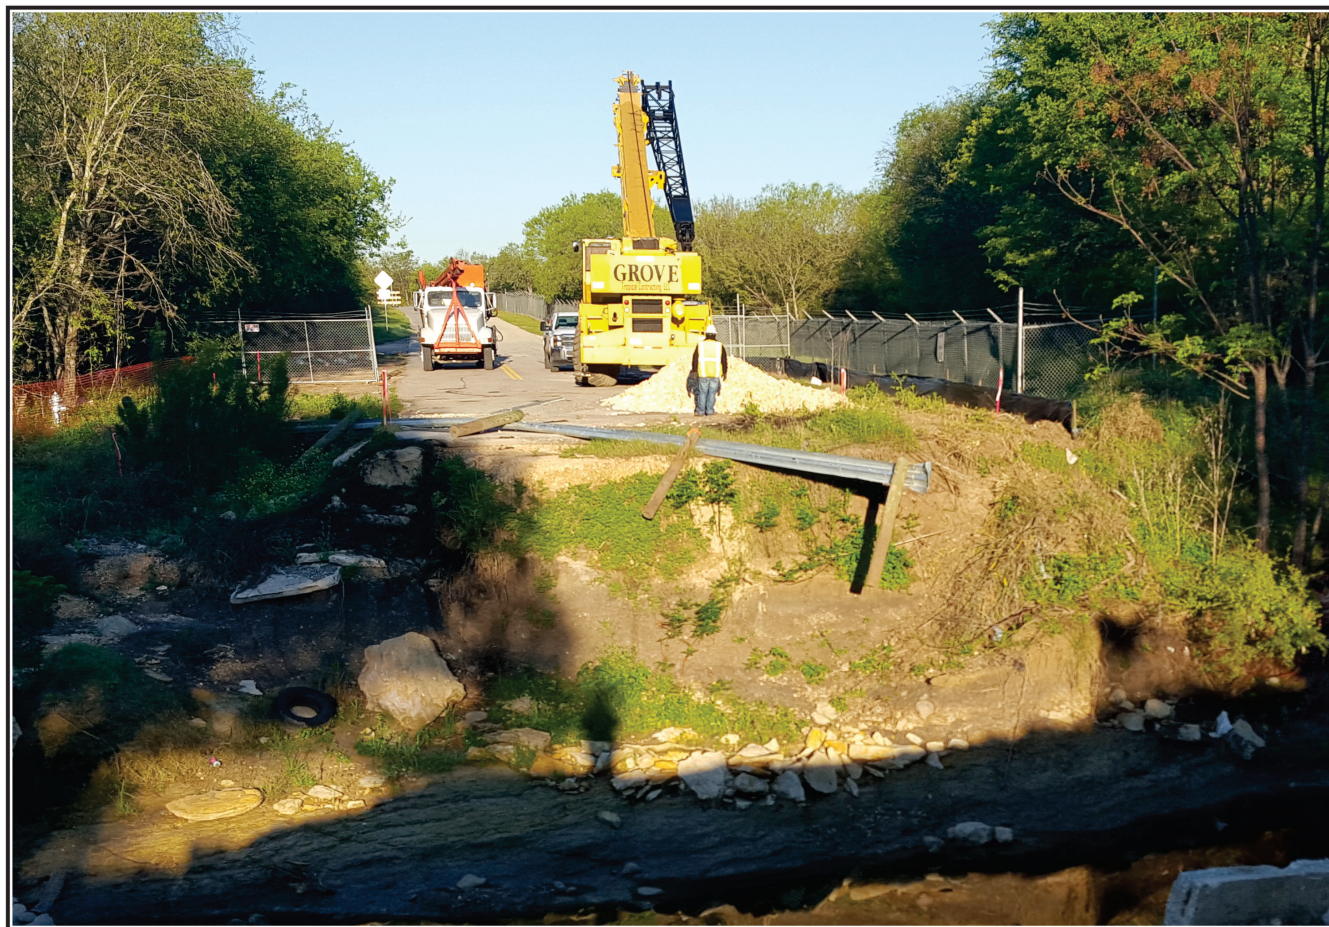
*Figure 4-1. The banks of Sixmile Creek within the APE, taken from the east bank along Ashley Road.*

Construction efforts associated with the project began on the east bank of Sixmile Creek (Figure 4-1) where the

culvert and bridge had been washed out in flooding events. The washed out concrete culvert was removed on March 17, 2016. On March 31, 2016, two holes were drilled reaching a depth of 11.3 m (37 ft.) for piers that would support the newly constructed bridge. The auger bit measured 60 cm (24 in.) in diameter. No cultural material was observed during the drilling of the pier holes on the east bank. As seen in Figures 4-2 and 4-3, the slope of bank was graded for the placement of a concrete riprap to create a six percent slope. Modern material in the form of a cassette tape was noted; however, no historic material was observed during these excavations.

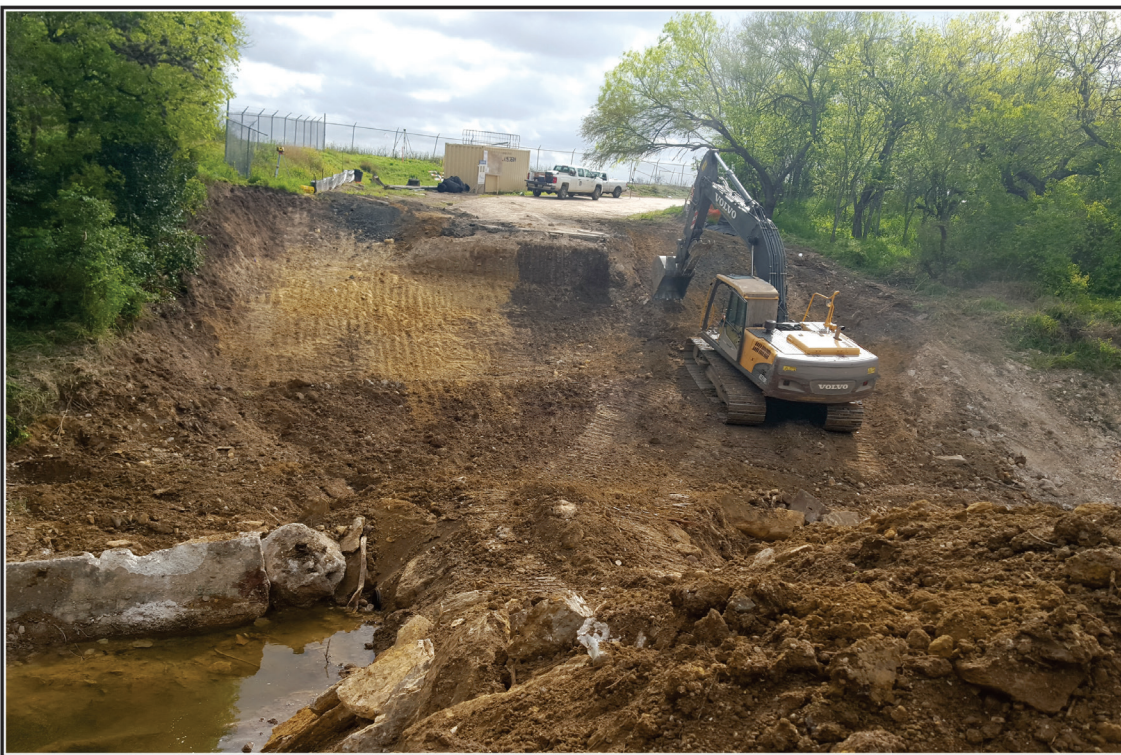
Figure 4-2. Grading of east bank of the creek for riprap.

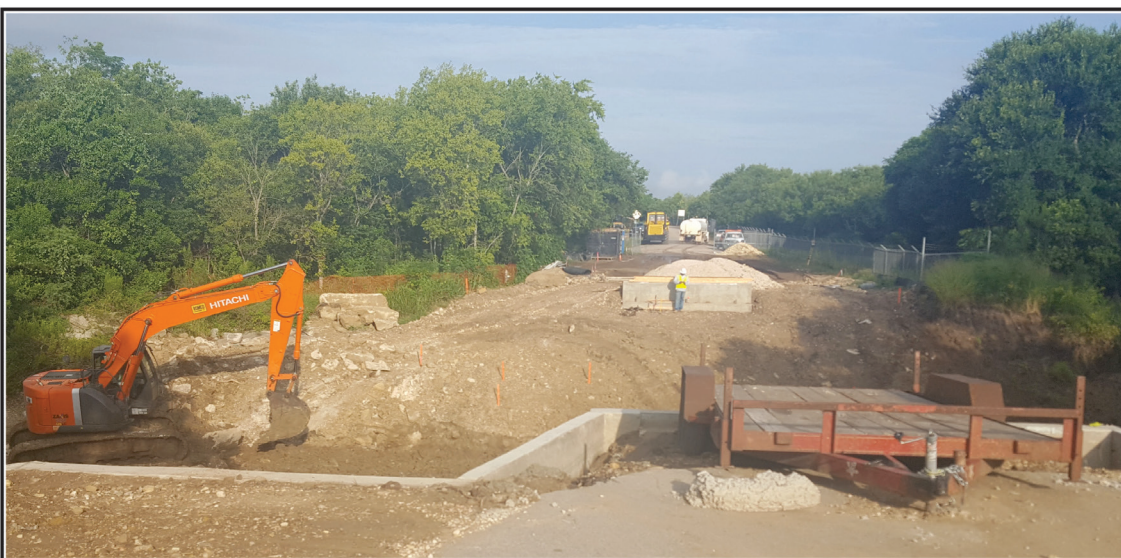
Figure 4-3. Concrete riprap on the east side of the creek.

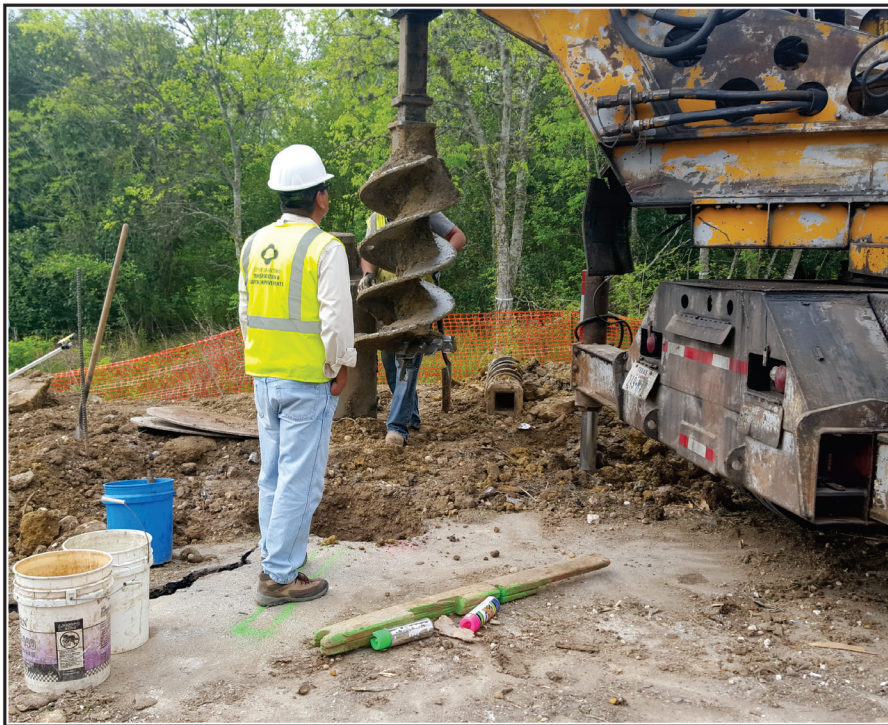
*Figure 4-4. Drilling of holes for pier installation on the west bank.*

Work on the west bank of Sixmile Creek along Ashley Road started on March 23, 2016, with drilling for piers (Figure 4-4). Two holes were drilled to a depth of 12 m (42 ft.) with the same 60 cm (24 in.) auger bit used on the east side of the project area. No cultural material was observed during this time.

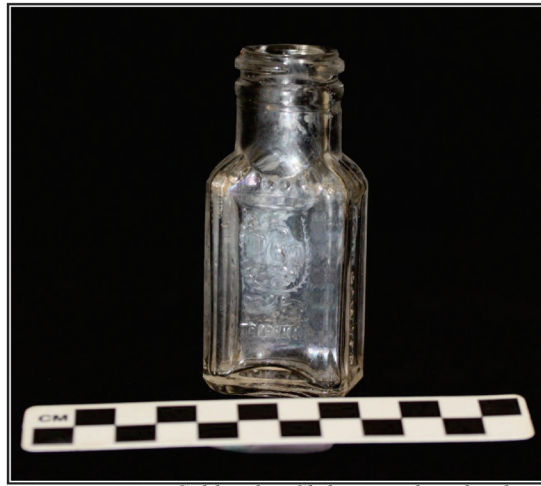
Material collected (Table 4-1) from the feature dates to the early twentieth century. Makers' marks were used to conclusively date the material. A Gebhardt Chili Powder glass bottle that dates to the 1920s (Digger Odell Publications 2016) is shown in Figure 4-7. The Phillips'® Milk of Magnesia bottle (Figure 4-8) dates as early as 1906. The material in Feature 1 more than likely represents domestic refuse from the nearby residents.

Figure 4-7. Gebhardt Chili Powder bottle recovered from Feature 1.

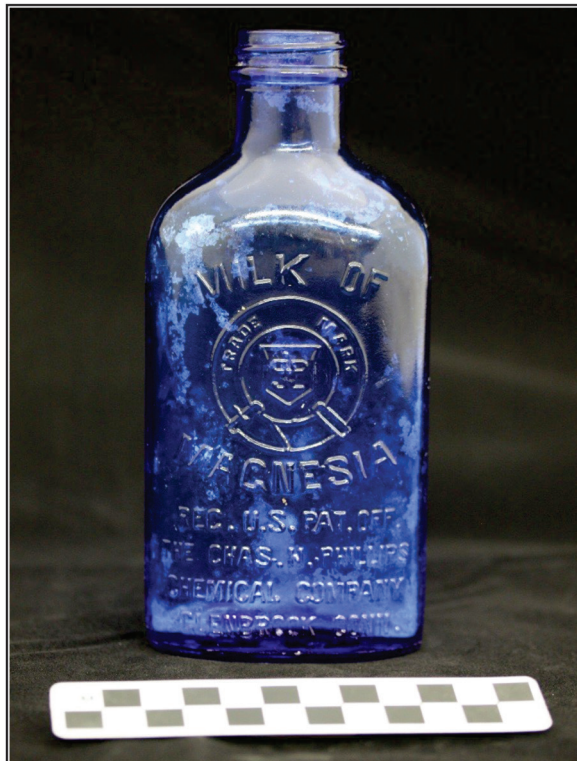
Figure 4-8. Phillips'® Milk of Magnesia bottle, collected from Feature 1.

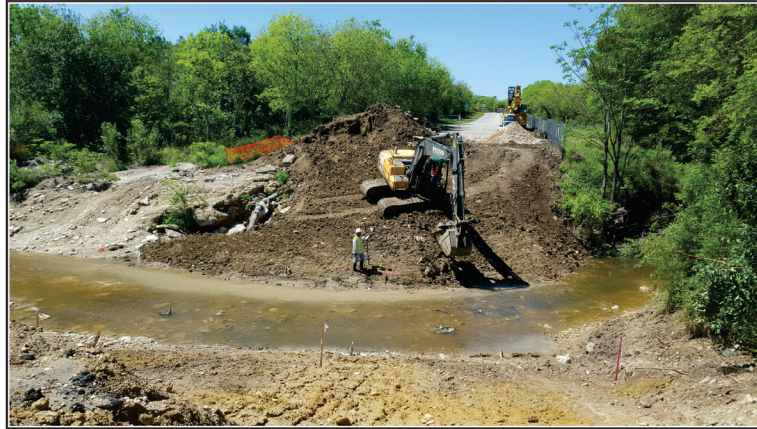
After CAR staff documented the feature, it was removed, and grading of the east bank continued. The southern portion of the bank had been previously impacted by sewer lines (Figure 4-9). On June 27, the final day of fieldwork, CAR monitored the removal of road base along with fill on the east side of

*Figure 4-9. Grading of slope on east bank of Sixmile Creek.*

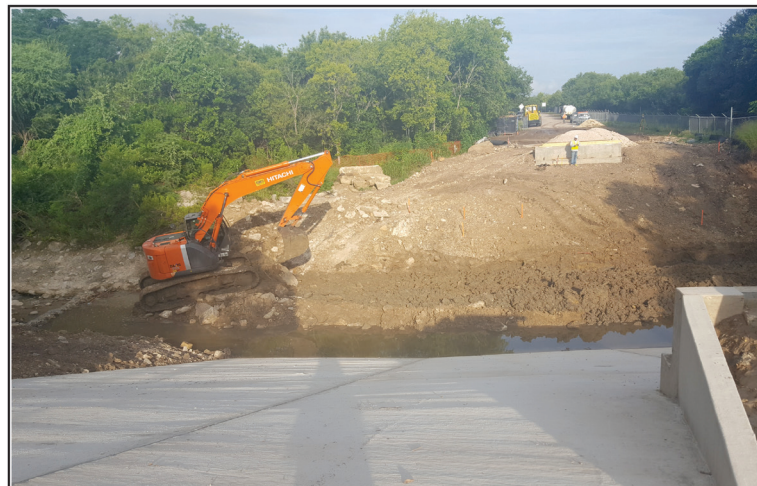
Sixmile Creek. On the same day, CAR archaeologists noted the removal of the road asphalt and fill at the corner of Ashley Road and Acequia Road (Figure 4-10). These activities did not require monitoring. Concrete ripraps had also been poured prior to the last day of fieldwork (Figure 4-11).

*Figure 4-11. Picture of APE taken on June 27, 2016 (facing west).*
