Prepared by:
Center for Archaeological Research
The University of Texas at San Antonio
One UTSA Circle
San Antonio, Texas 78249
Technical Report, No. 40

**Background Research and Historic Standing Structure
Survey for the New Alamo Colleges Office Complex
and Veterans Outreach and Transition Center,
San Antonio, Bexar County, Texas**

Management Summary:

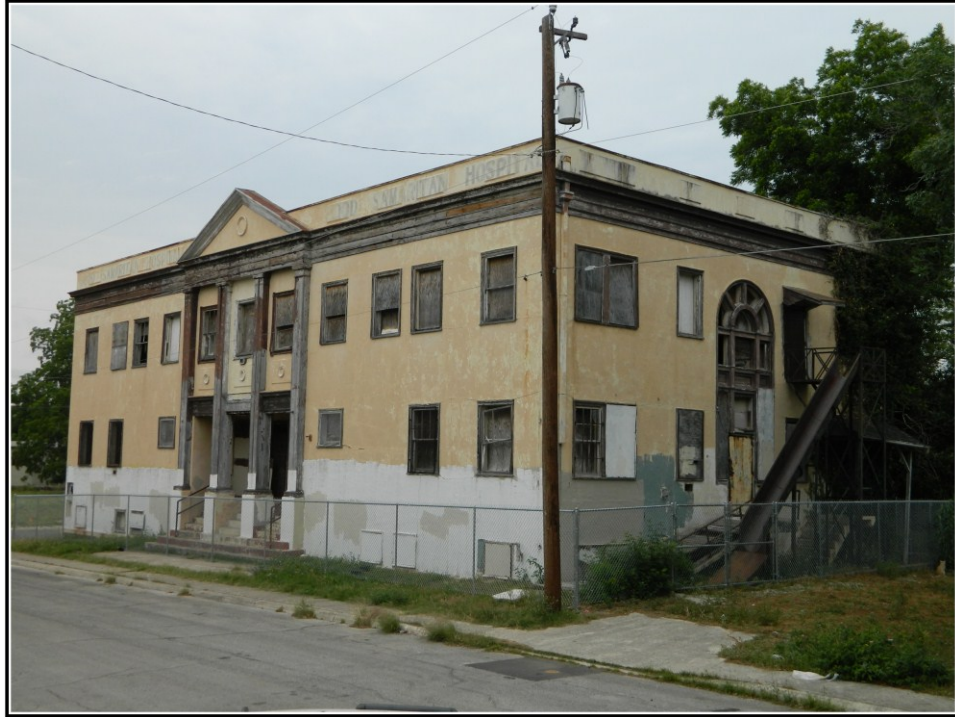
Figure 6-3. *Historic Resource 1, the Good Samaritan Hospital.*

Historic Resource 1, the Good Samaritan Hospital, is located at the corner of Dakota and Connelly Streets (Figure 6-3) on Lot 1, Block 8, NCB 1508. At the time of documentation, the hospital was boarded up and a chain-link fence surrounded the building along the north, west, and south elevations. The Good Samaritan Hospital is a designated City of San Antonio local historic landmark. The structure is a two-story, flat-roofed, rectangular building on a raised basement with a few architectural styles exhibited, including Classical Revival and Greek Revival elements. The west and east elevations of the building are symmetrical to each other and so are the north and south elevations. There is a main floor, a second floor, and a basement. The entire structure has a stucco façade. At the top of the building, on the parapet, the words “GOOD SAMARITAN HOSPITAL” are stenciled on either side of the pediment (Figure 6-4).

Saving the structure will require much work, but the architectural assessment indicates that barring any unforeseen impacts it is possible. Excavation around the perimeter of the structure would be necessary to install a foundation drain and add waterproofing. Removal of the concrete slab of the basement floor is proposed to investigate the foundation construction. It would be replaced with a slab that meets current standards. Bringing everything up to code will be a major undertaking. Due to the designation as a local historic landmark, coordination with the City's Office of Historic Preservation will be required prior to any exterior modifications or alterations.

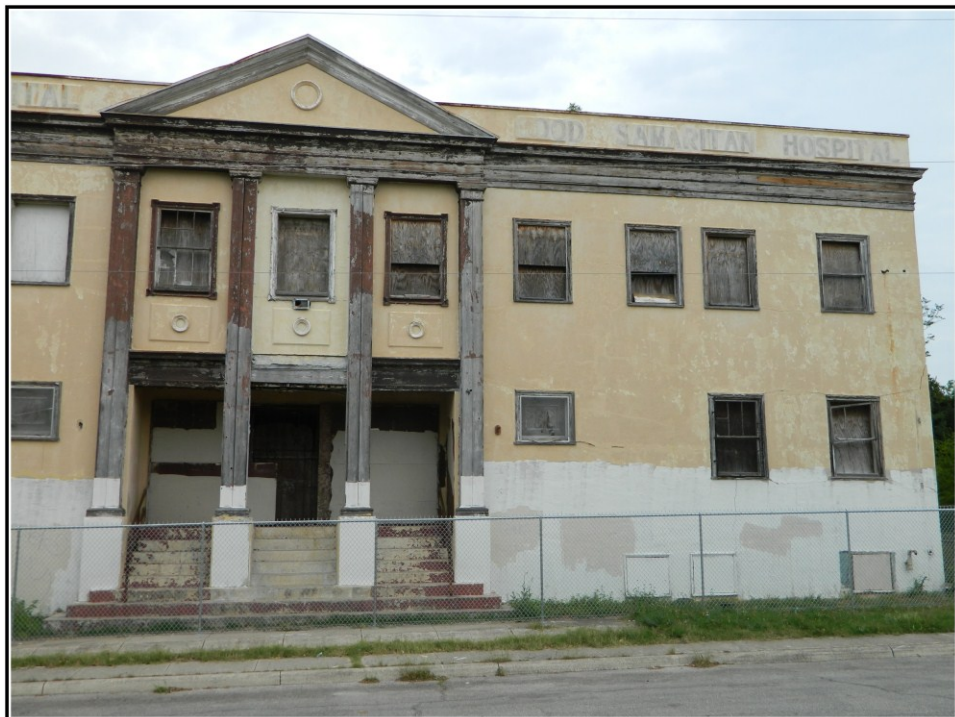
Figure 6-4. *"GOOD SAMARITAN HOSPITAL" is still seen on the front façade.*

The square columns at the front of the building exhibit wood capitals and shafts, but the columns are sitting on concrete bases (Figure 6-4). The square column is loosely based on Greek and Roman style, but square prototypes do not exist. These types of columns are considered to be vernacular Doric simplifications that are commonly used in the Greek Revival architectural style. The wood appears to be fairly weathered. In addition to the wood columns, a wooden architrave is present near the top of the building. A very thin cornice, also made of wood, is at the top of the building.

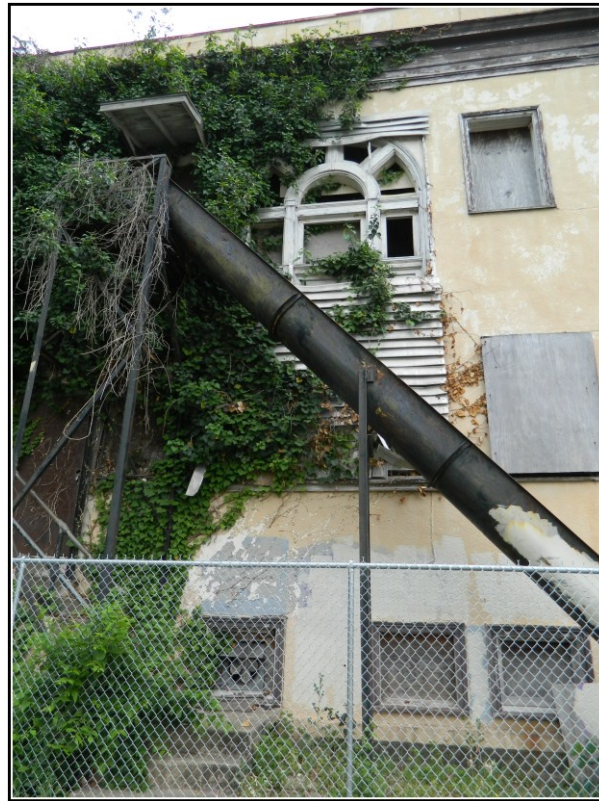
basement. An ornate arched window is located on this side of the building as well. The window exhibits a Classical Revival architectural feel with a Palladian style to the feature. This window appears to have been boarded up with clapboard covering. Approximately half of the boards are now missing, and it is unknown if the covering was added after the building was vacated to protect the window (Figure 6-5).

Figure 6-5. *Window located on the north side of Historic Resource 1.*

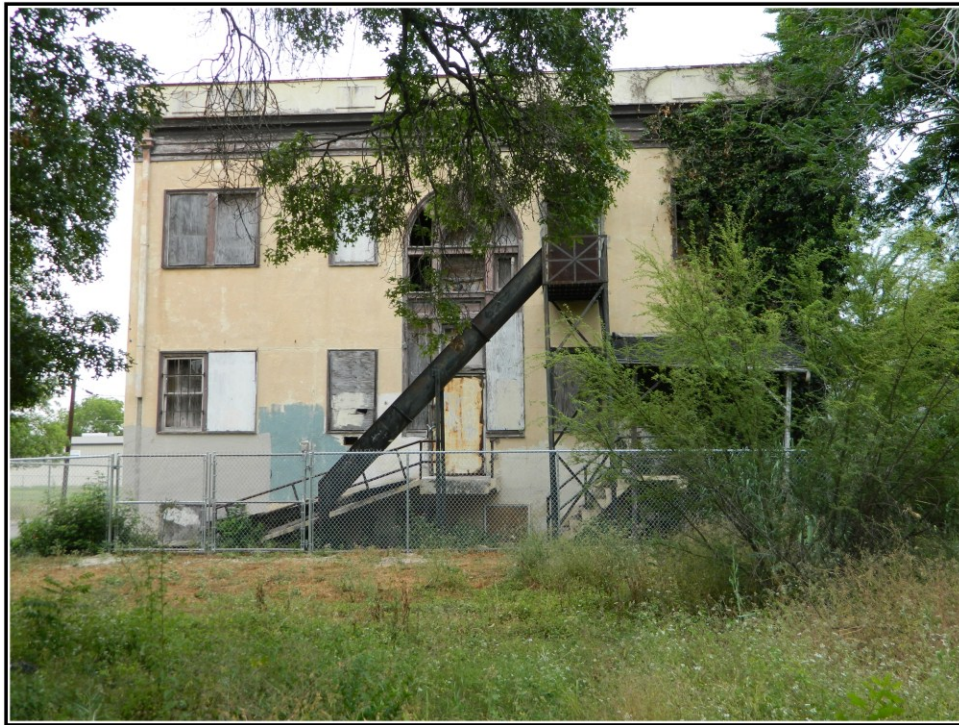
Figure 6-6. *Metal fire escape slide located on the south side of Historic Resource 1.*

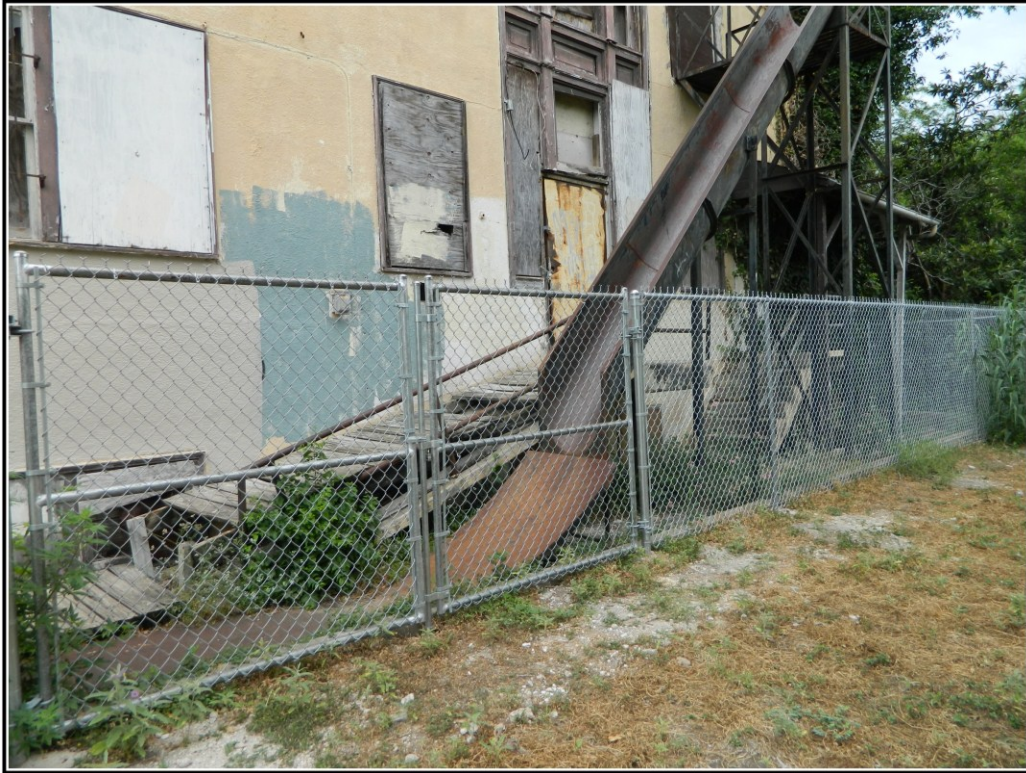
Figure 6-7. *Stairways leading to the entrances on the south side of Historic Resource 1.*

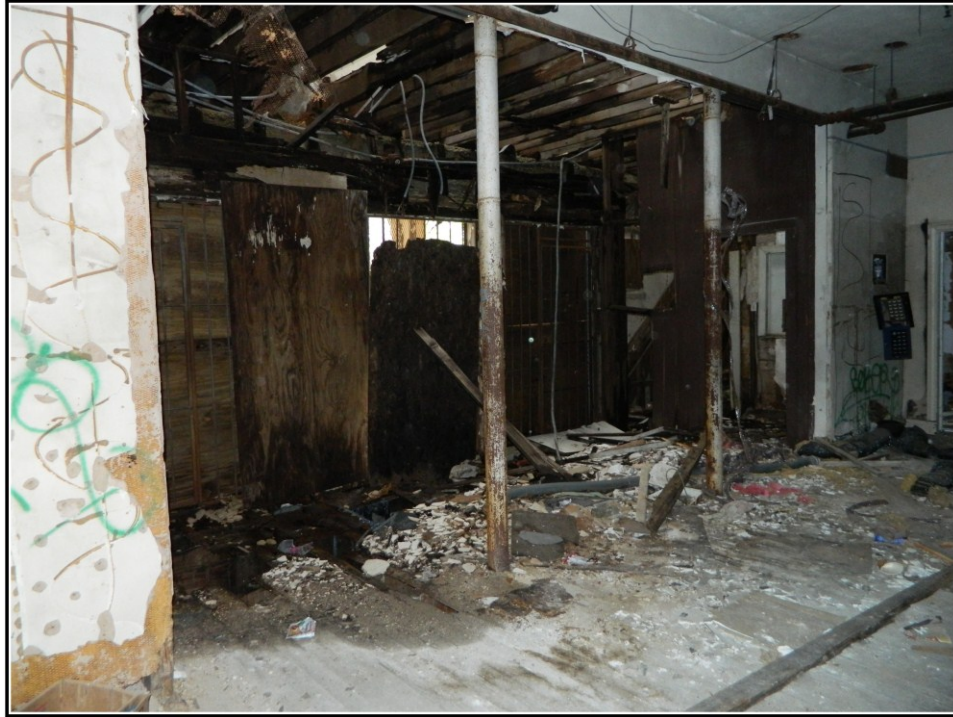
The floors of the first floor were wood with wooden joists and a few steel beams. Both the joists and steel beams were visible in areas that the wood flooring was missing. The wood is decaying due to water damage, and there were areas where the floor was no longer intact (Figure 6-8). A portion of the second floor had fallen into the first and exposed the basement of the structure. The main hallway was still intact, but the northwestern room floors were not present. The flooring along a portion of the east wall was also missing on the first floor.

Figure 6-8. *The interior of the Good Samaritan Hospital at the main entryway to the first floor.*

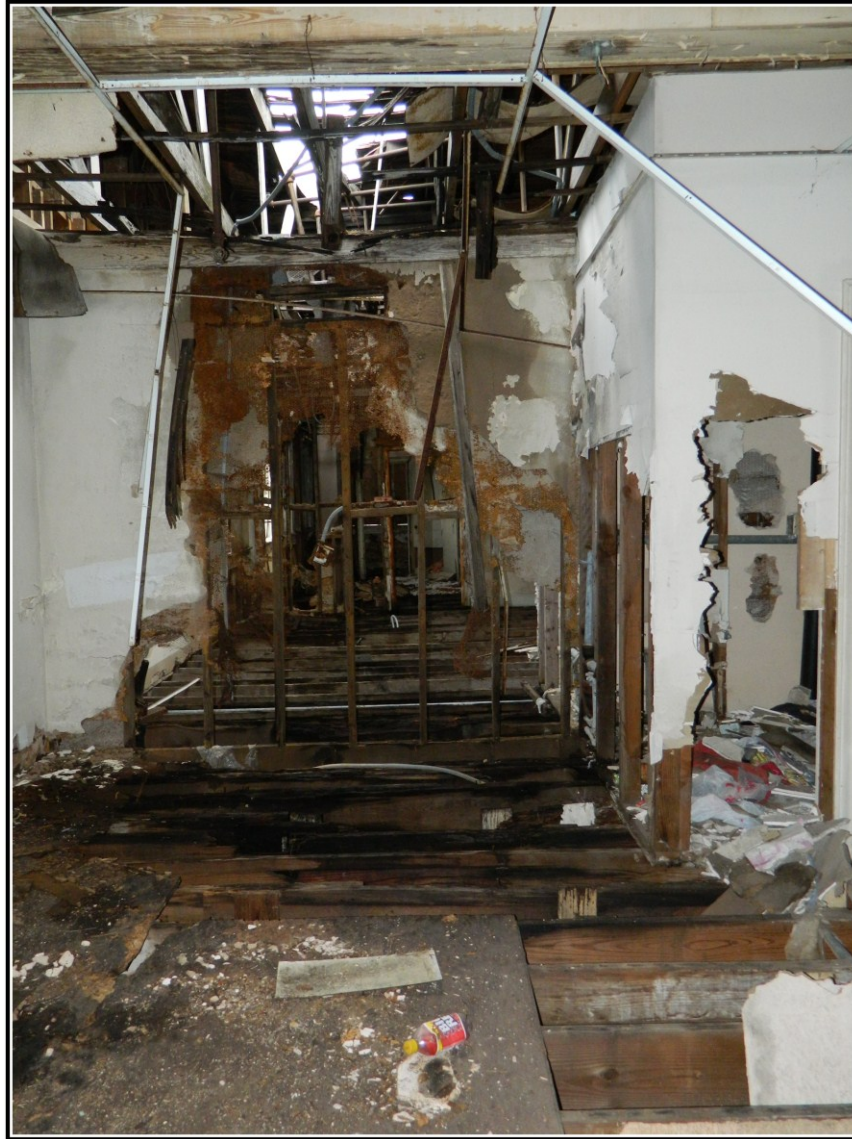
The second floor was missing a good portion of its wood flooring (Figure 6-9). Stairs leading to the second floor from the main foyer were missing, but remnants of the frame were still visible. Access to the second floor was obtained through a smaller stairwell southeast of the main entrance. These stairwells would have mirrored each other. The missing stairwell was removed at one time due to the damage resulting from the fallen roof and ensuing exposure to the elements. Two stair treads were missing in the remaining stairwell. The flooring at the head of the stairs on the second floor was extremely waterlogged and weakened. What appears to be a door was laid across missing flooring to allow for access to a portion of the second floor. The main hallway of the second floor was intact. The area above the foyer was missing floor boards as well as portions of the floor in each corner of the second floor.

Figure 6-9. *The interior of the Good Samaritan Hospital on the second floor above the main entryway.*

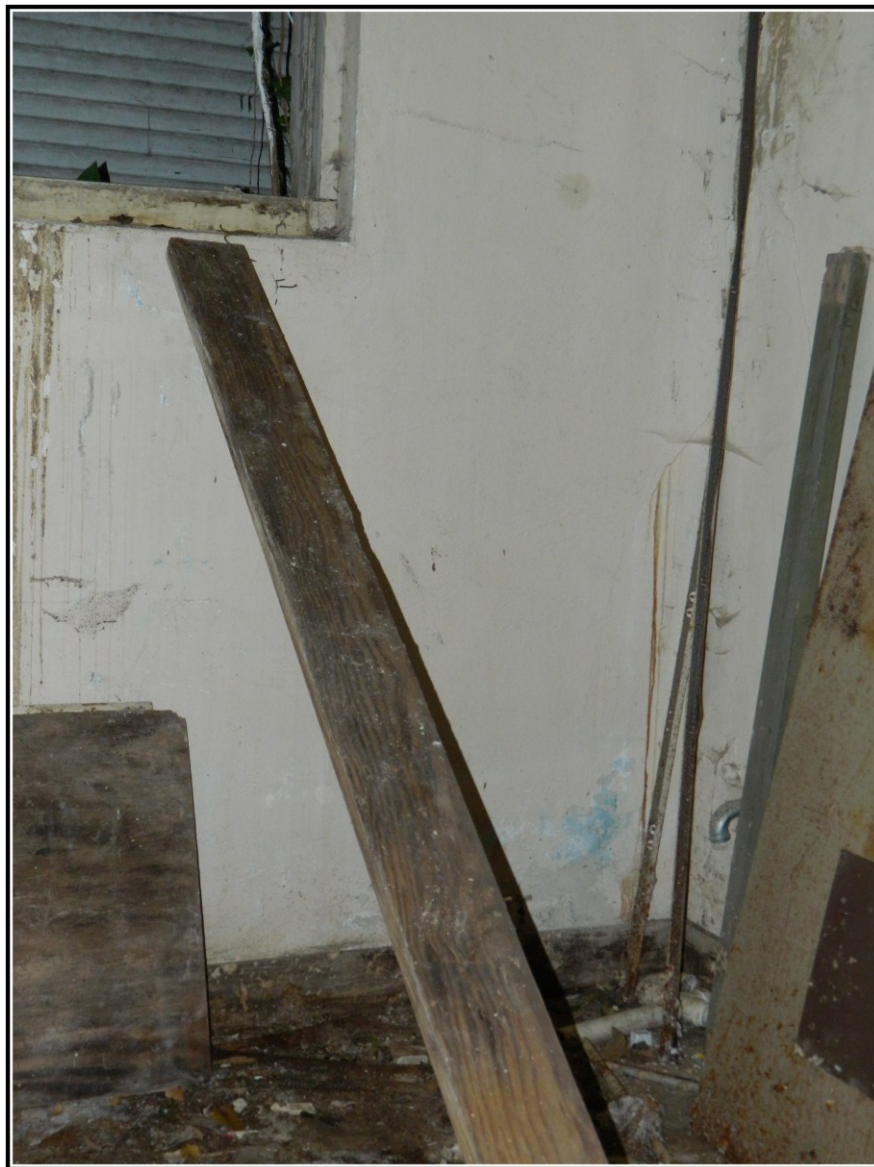
One stairwell gave access to the basement. The stairs were in much better condition than those leading to the second floor. The basement had concrete flooring and concrete walls. Steel beams were visible on the ceiling of the basement but showed signs of rust. There were several smaller side rooms in the basement off a larger main room. Small windows were located in these rooms but were currently boarded up. The west central portion of the basement under the main entrance to the hospital had remnants of the first floor collapse. Rotted wood flooring and floor joists mixed with other debris filled the western rooms. Evidence of water seepage and flooding was noted in the waterlogged wall and warped doors. In the main room of the basement the plaster has either fallen or been knocked off the walls exposing the wood frames.

Figure 6-10. Room at the Good Samaritan Hospital in the basement that had an open window and plank.

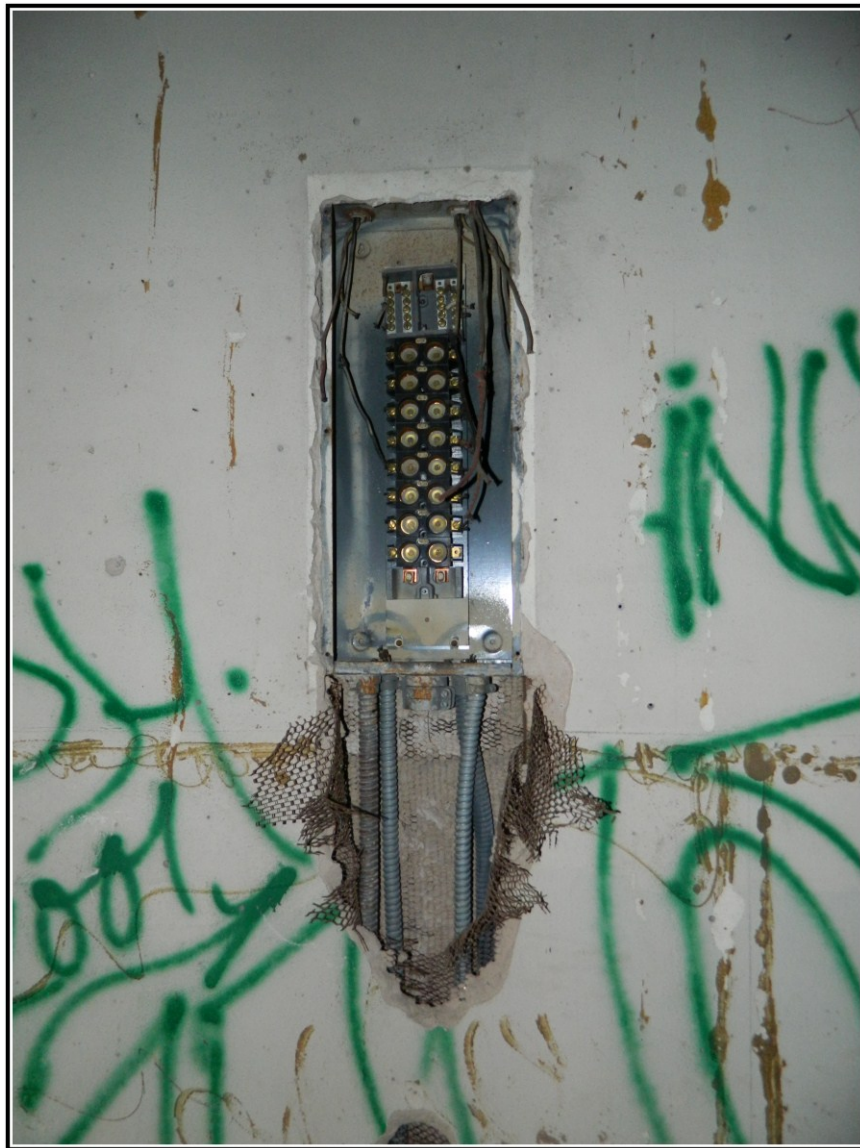
All fixtures have been removed from the structure. Each of the fuse boxes has been opened, and the fuses and wiring have been torn out (Figure 6-11). In many of the bathrooms the toilets and showers have been smashed. There are no switches, doors, door knobs, glass window panes, or any decorative pieces. The air ducts have been ripped open. Only three things with ties to the original construction were noted in the building. One is the sprinkler system. The lines are still present and can be seen throughout the building (Figure 6-12). The second is a water valve located in the northwestern room on the first floor (Figure 6-13). The date on the piece is 1948. The third is located in the basement and is likely connected to the water system (Figure 6-14). It is a control valve that appears to have been part of the original construction.

Figure 6-11. Fuse box noted on the main floor of the hospital.

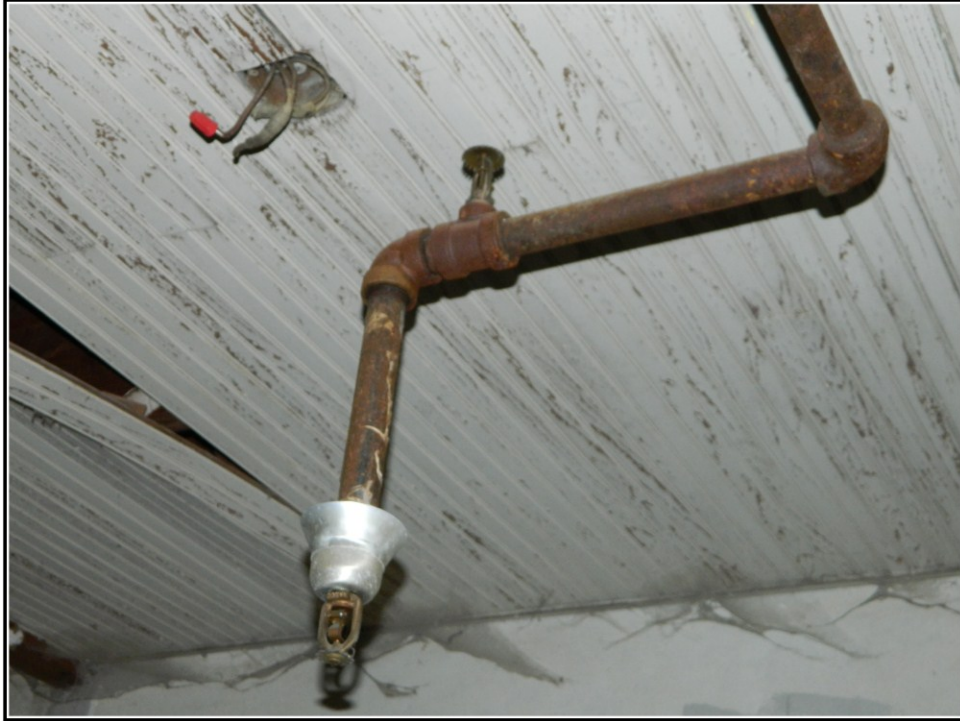
Figure 6-12. Example of the sprinkler system present throughout the hospital.

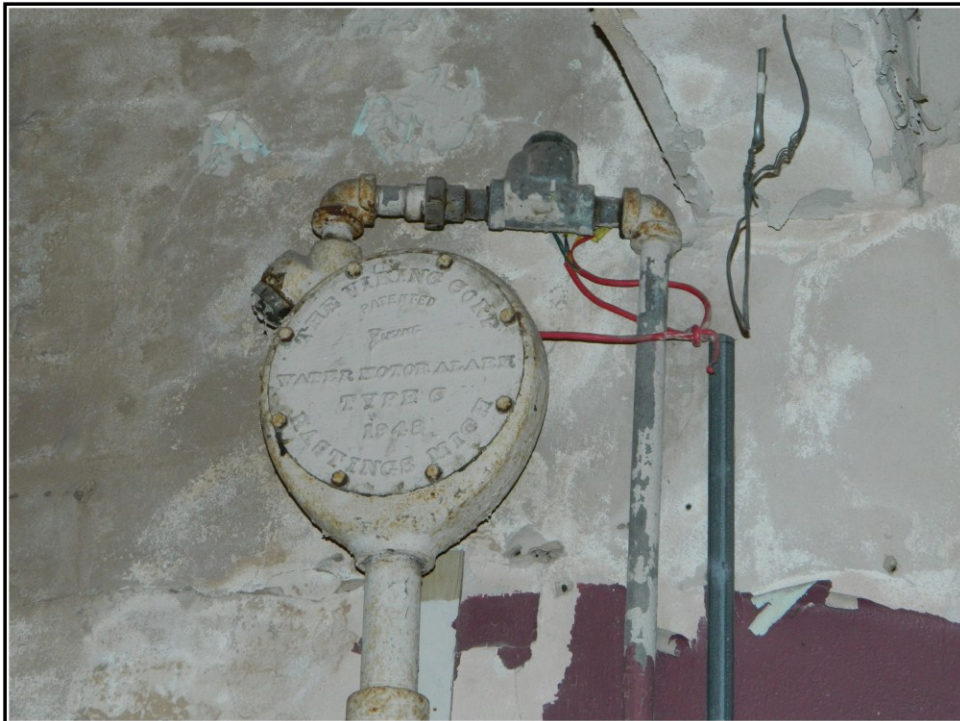
Figure 6-13. Water valve noted on the main floor of the northwestern room in the hospital.

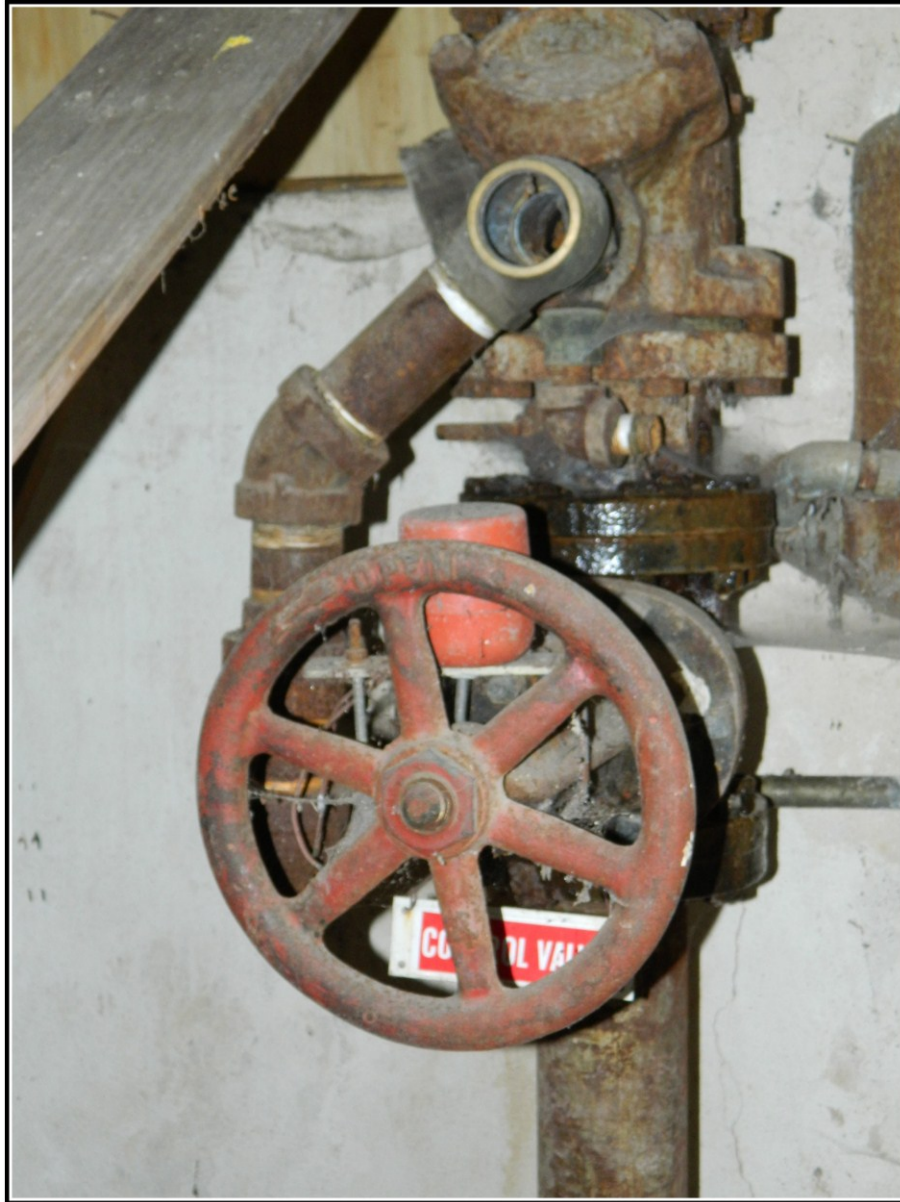
Figure 6-14. *Water line and valve located in the northern room in the basement.*

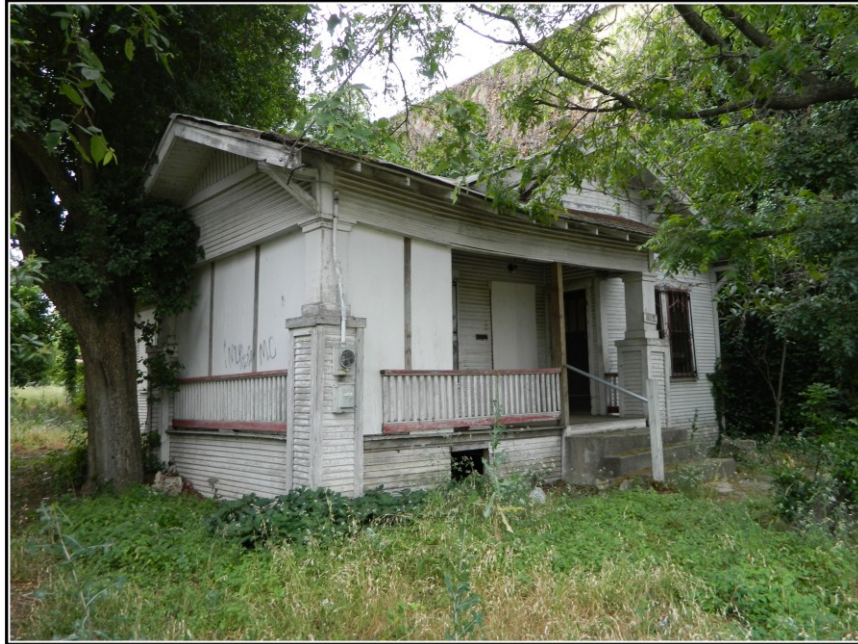
Historic Resource 2 is a one-story Craftsman bungalow located at 1604 Connelly Street on Lot 2A, Block 8, NCB 1508 (Figure 6-15). It is a wood frame, wood siding, clapboard dwelling that rests on a pier-and-beam foundation. The low roof line, wide overhanging eaves, and exposed rafter ends add visual interest as do the decorative brackets supporting the overhanging eaves. The roof is covered with fiberglass shingles. Craftsman-influenced square boxed piers topped with square box columns support an attached front- and side-gabled porch.

Figure 6-15. *Historic Resource 2, facing southwest.*

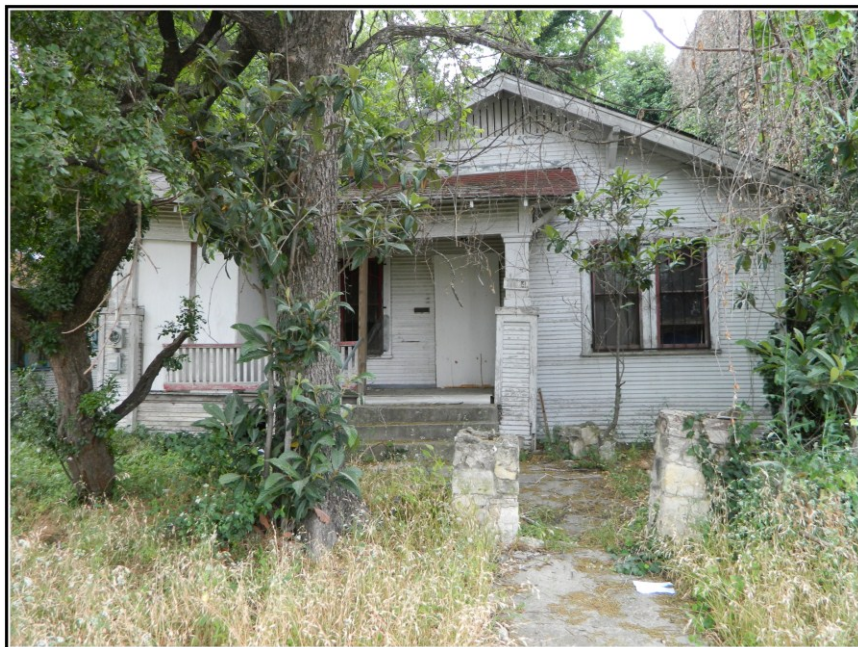
The porch has rails and a clapboard skirt below the railing. Concrete steps provide access to the porch level of the dwelling off the concrete sidewalk that is framed by two stone columns offset from the curb (Figure 6-16). The north elevation, the front of the dwelling, has one 1/1 wood sash window centered under the space defined by the covered porch, and two doorways provided entry into the dwelling, one facing the stairway and the other to right of it. A double set of 1/1 wood sash windows are centered in the façade.

Figure 6-16. *Historic Resource 2, north elevation.*

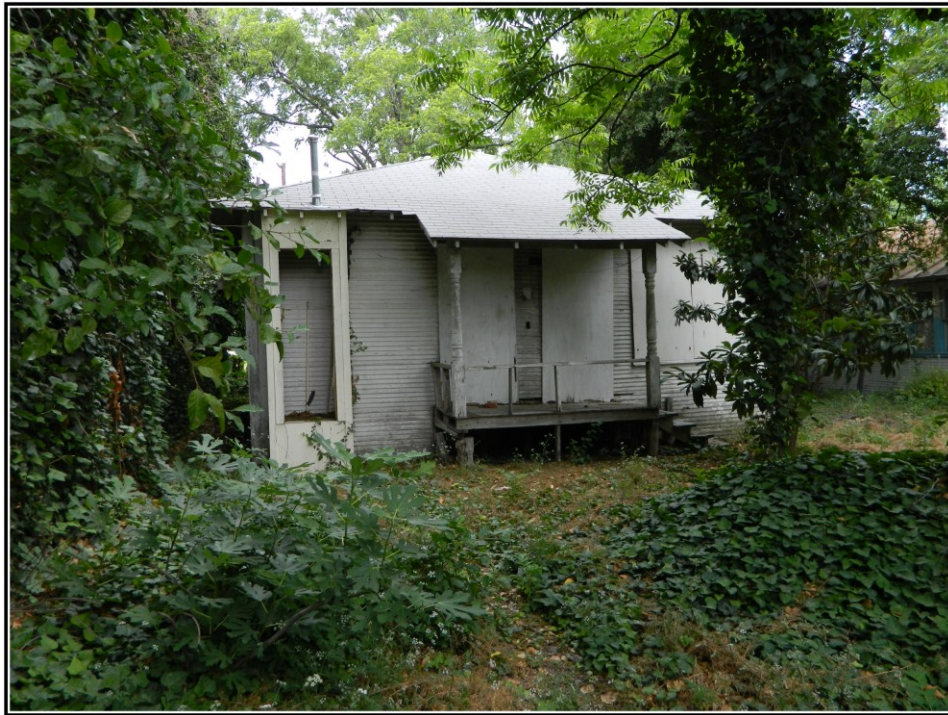
The south elevation, or back façade of the dwelling, has two boarded doors that open onto a covered porch (Figure 6-17). Turned spindle columns support a shingled roof, and the floor of the porch is supported by a combination of milled dimensional lumber and logs. The railing frames the porch on two sides, and the entire porch is a later construction possibly having replaced a previous porch given the doorways that opened to the back of the house. A double-hung wood sash window overlooked the backyard prior to having been boarded up. A narrow sheet-rock-framed addition at the southwestern corner of the back of the dwelling, and given the chimney pipe extending from it through the roof of the house, the addition may have housed the water heater.

Figure 6-17. *Rear of Historic Resource 2, facing northeast.*

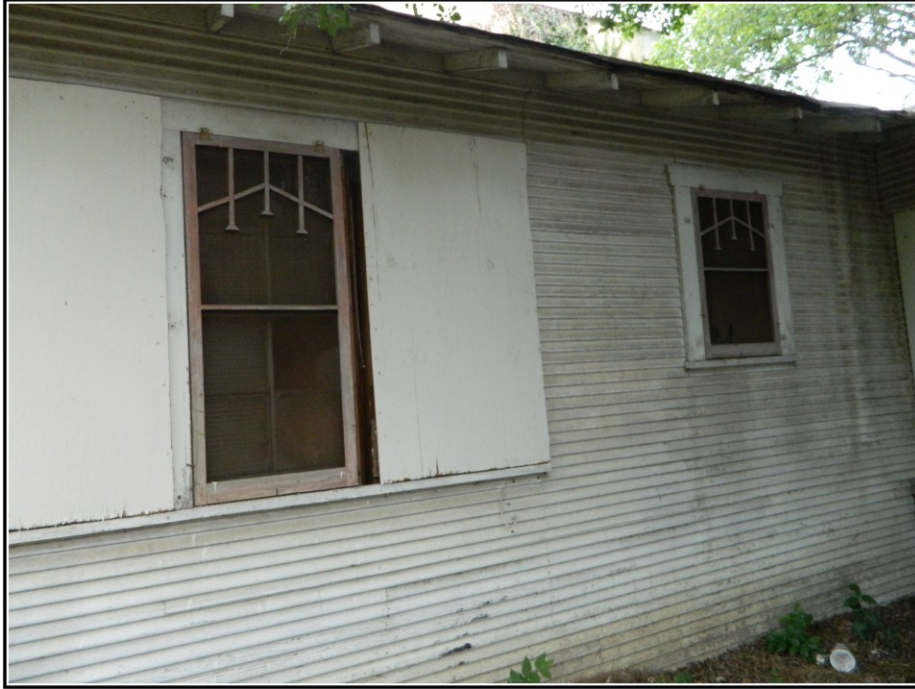
The windows that are not boarded up on the house exhibit decorative screens (Figure 6-18). The screens were hinged to the top of the window frame. The front windows of the house also have decorative wrought iron bars. One window on the side had shutters on the interior of the house that could be seen through the screen.

Figure 6-18. *Decorative screens covering the windows of the eastern side of the house.*

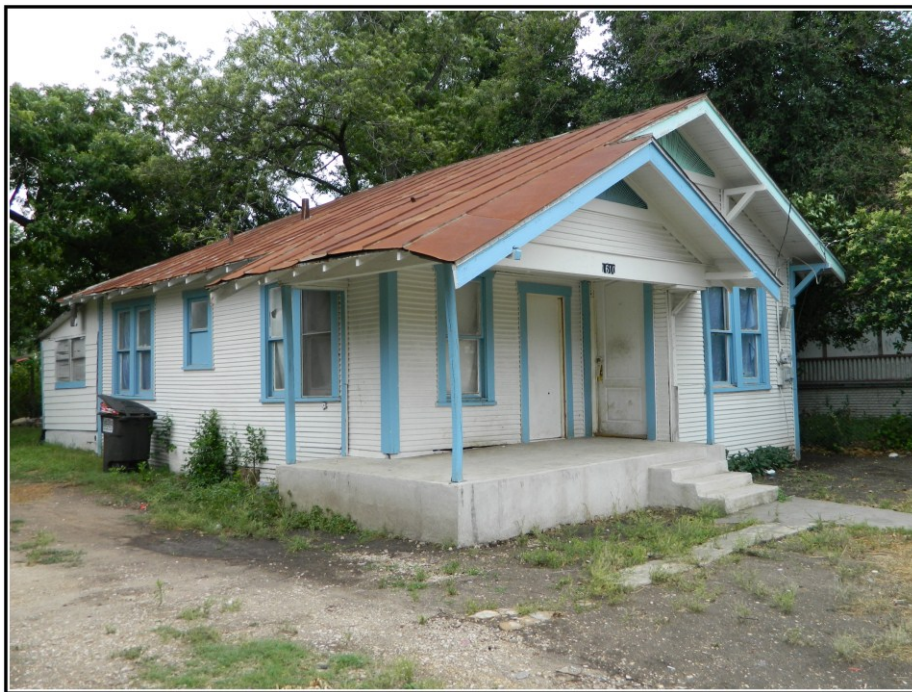
Historic Resource 3 is located to the east of Historic Resource 2 at 1610 Connelly Street on Lot 3, Block 8, NCB 1508. It is a one-story wood frame, wood siding, clapboard dwelling that rests on a pier-and-beam foundation (Figure 6-19). The dwelling has double front-facing gables. The moderate roof line, wide overhanging eaves, and exposed rafters are Craftsman style elements. Decorative brackets support the overhanging eaves. The pinnacles under the eaves exhibit decorative lattice details. The porch is supported by metal posts rather than wooden columns. The floor plan appears to be a variation on that employed in Historic Resource 2 with entry to the dwelling provided through two doors that open on the front porch. The structure exhibits a standing-seam metal roof.

Figure 6-19. *Historic Resource 3, facing southwest.*

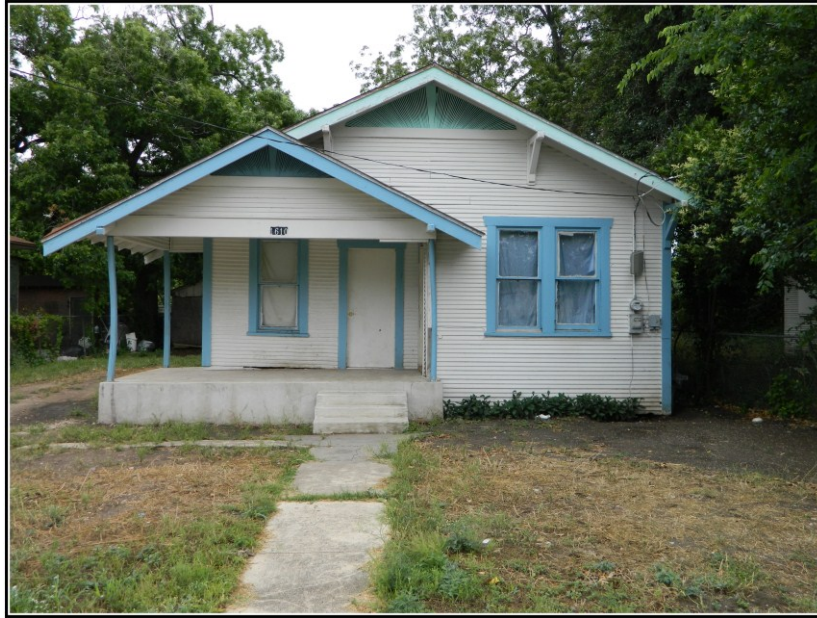
doorways provided entry into the dwelling, one facing the stairway and the other to right of it. A double set of 1/1 wood sash windows are centered in the façade. Flat board moldings frame each of the windows.

Figure 6-20. *Historic Resource 3, north elevation.*

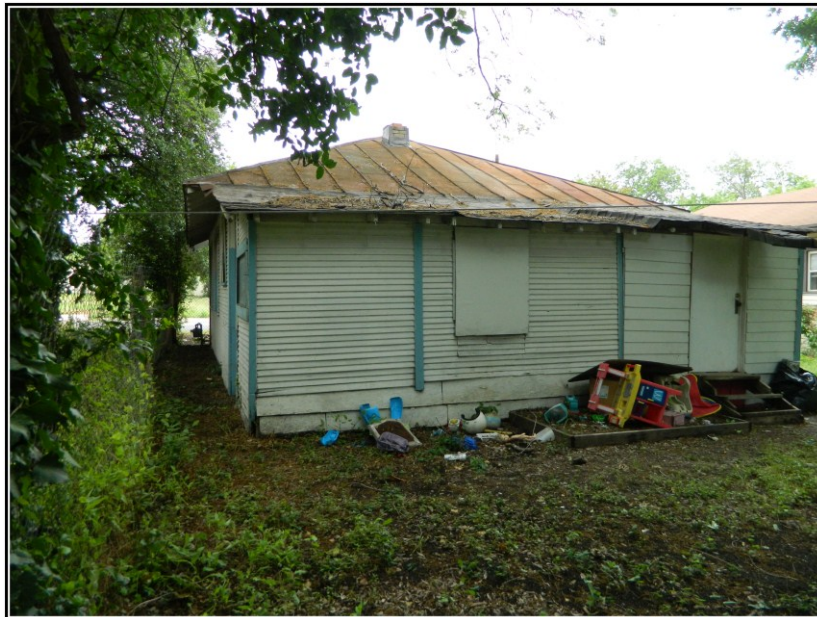
The south elevation of the dwelling has a wood framed door that opens onto wooden steps providing access to the backyard (Figure 6-21). A window, which is now boarded up, overlooked the backyard.

Figure 6-21. *Historic Resource 3, south elevation.*

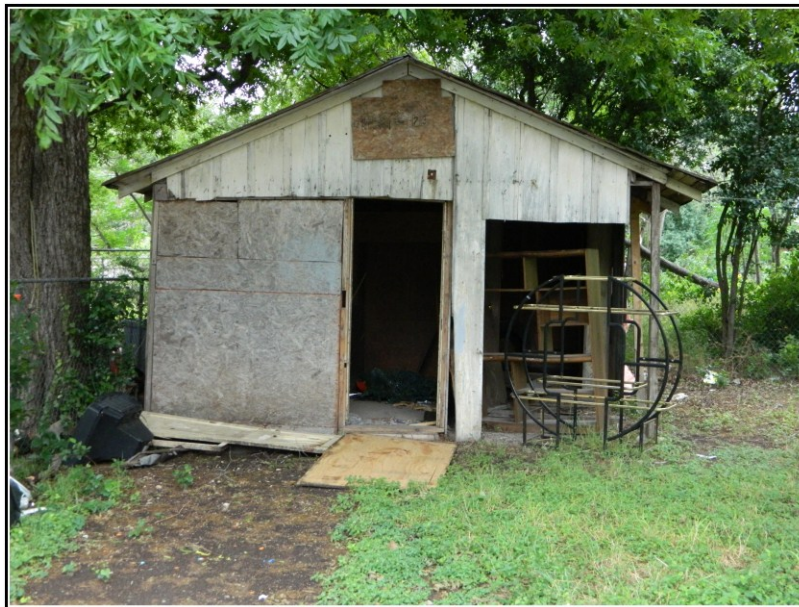
At the back of the property is a small outbuilding that appears to have more recently been used as a workshop or shed (Figure 6-22). The outbuilding may be contemporaneous with the main house, likely built between 1912 and 1952 as evident on the Sanborn maps. The roof is of the same material (tin sheets) as that used on the main portion of the house. The structure exhibits a house number on the front, suggesting that it was used as a residence at one point. If this is the case, the structure has not been used in many years as the siding and door has been removed.

Figure 6-22. *Associated structure located at the rear of the lot, Historic Resource 3.*
