# Archaeological Monitoring for the San Pedro Avenue, Main Avenue, and Navarro Street Roundabout Project, San Antonio, Bexar County, Texas

*Prepared by:*  
Center for Archaeological Research  
The University of Texas at San Antonio  
One UTSA Circle  
San Antonio, Texas 78249  
Technical Report, No. 74

From March 2017 to February 2018, the Center for Archaeological Research (CAR) at The University of Texas at San Antonio (UTSA) conducted archaeological monitoring for the San Pedro Avenue, Main Avenue, and Navarro Street Roundabout Project in downtown San Antonio, Bexar County, Texas. Adams Environmental, Inc., on behalf of the City of San Antonio (COSA), contracted CAR to conduct the archaeological monitoring in association with road and utilities improvements. The project fell under COSA's Unified Development Code (UDC) (Article 6 35-630 to 35-634) and required review by the Texas Historical Commission (THC) under the Antiquities Code of Texas. The archaeological work was performed under Texas Antiquities Permit No. 7906. Dr. Paul Shawn Marceaux served as Principal Investigator, and Antonia L. Figueroa served as the Project Archaeologist.

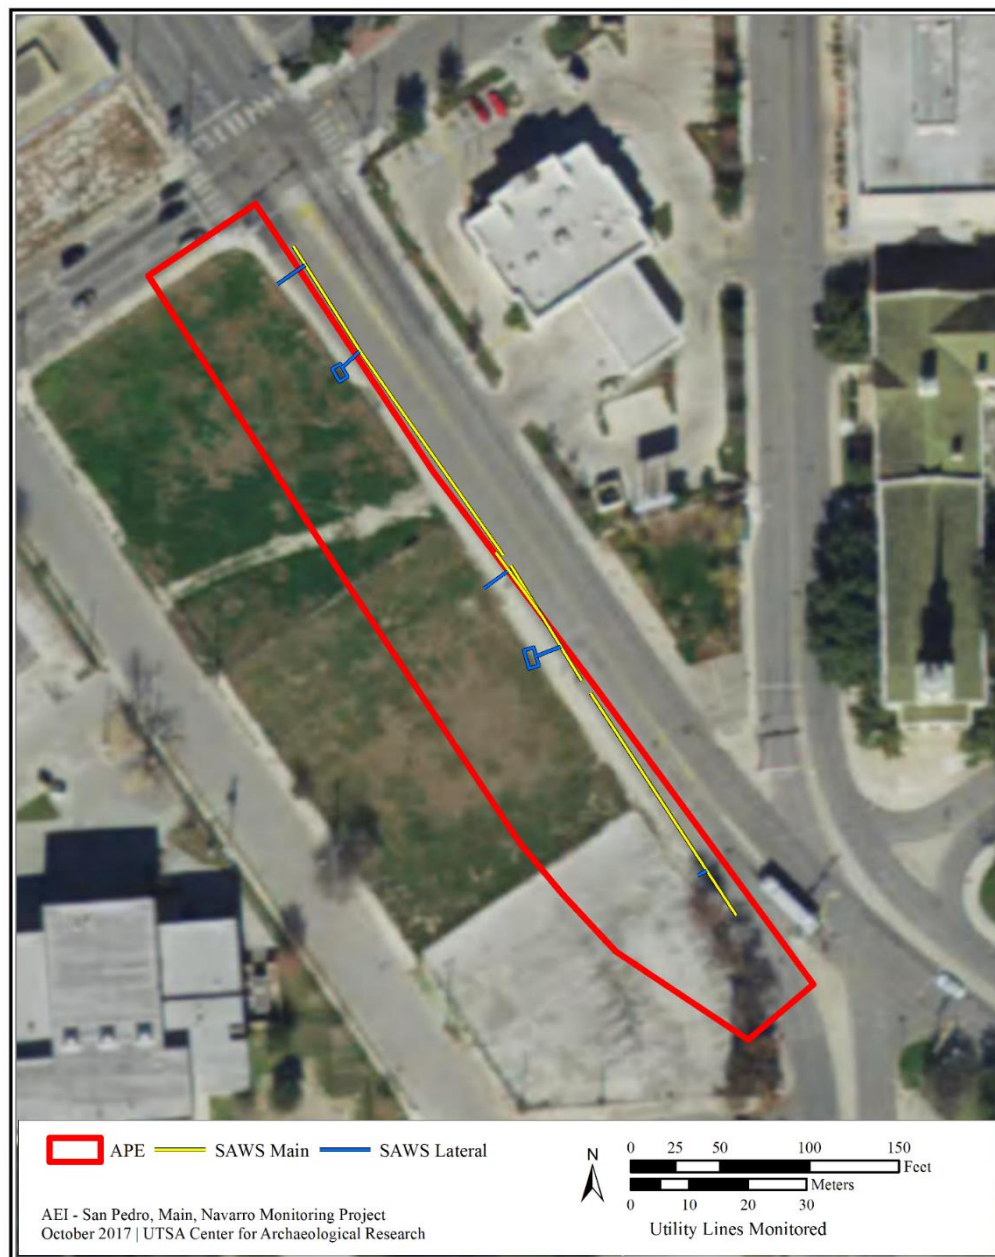
Below-ground excavations associated with SAWS utilities installations and COSA roadwork were conducted from March 2017 through February 2018. This chapter summarizes the archaeological monitoring, beginning with the SAWS utilities and concluding with the COSA roadwork. Figure 4-1 displays the SAWS utilities monitored by the CAR. All trenches contained old utilities and showed evidence of some disturbance. After excavations, utilities pipes and equipment were installed, trenches were filled, and asphalt was replaced.

*Figure 4-1. SAWS utility installations monitored by the CAR during the project.*

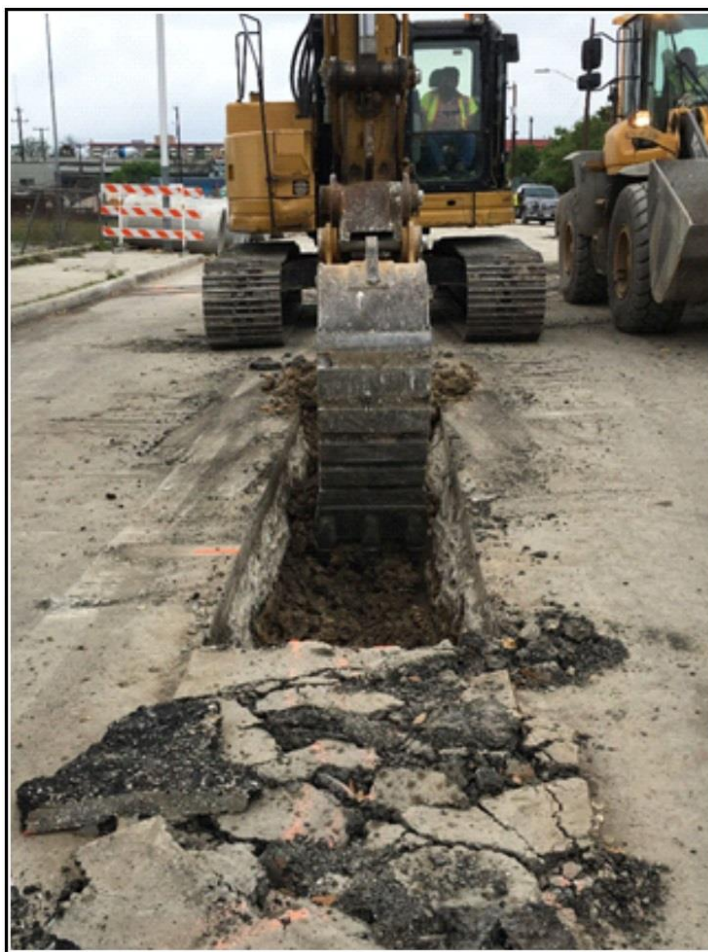
SAWS work consisted of a main water line and associated lateral lines. Archaeological monitoring for this portion of the project began on March 21, 2017. SAWS utility work continued intermittently until February 2018. CAR monitored the SAWS main line for which the excavations reached a depth of 1.5 m (5 ft.) below the surface (Figure 4-2). Fill material was represented by sand used to cover the previously installed utility lines. Sections of undisturbed soils were observed in some areas not impacted by utility work. These soils consisted of a dark brown (10YR 3/3) clay with few inclusions. No cultural material was observed during these excavations, and further work is not recommended. As seen in Figure 4-3, the water main excavations spanned the entirety of the APE.

*Figure 4-2. Excavation of main SAWS utility prior to blacktop removal (facing south).*

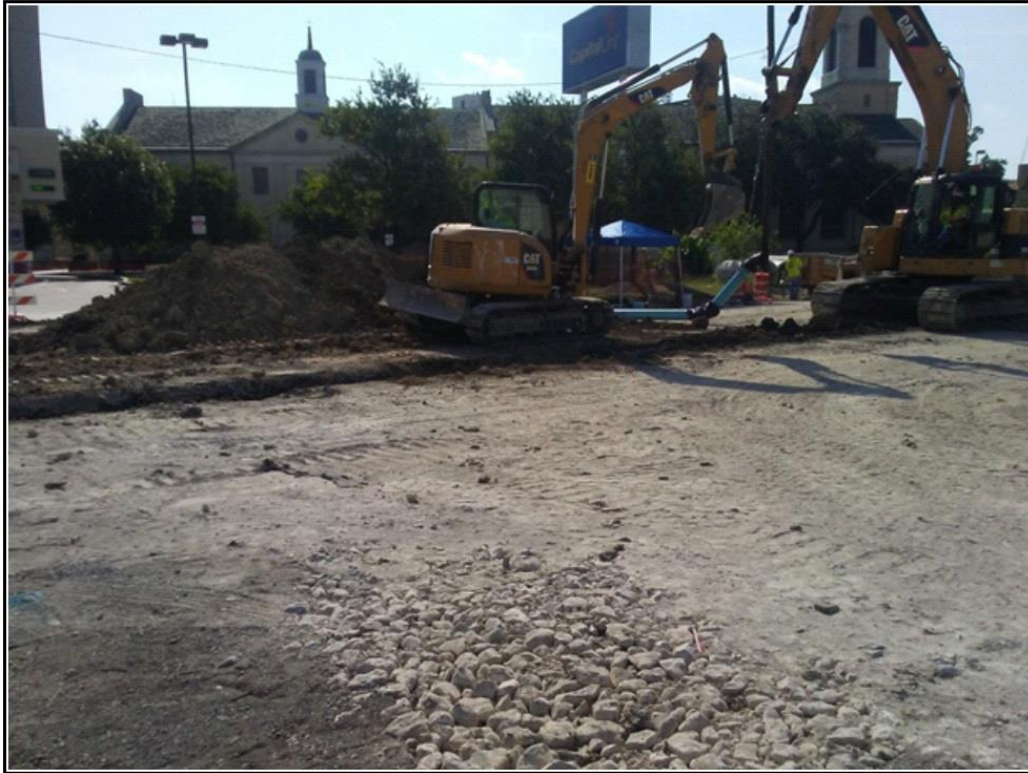
*Figure 4-3. Photograph of main SAWS water utility trench and installation of pipe.*

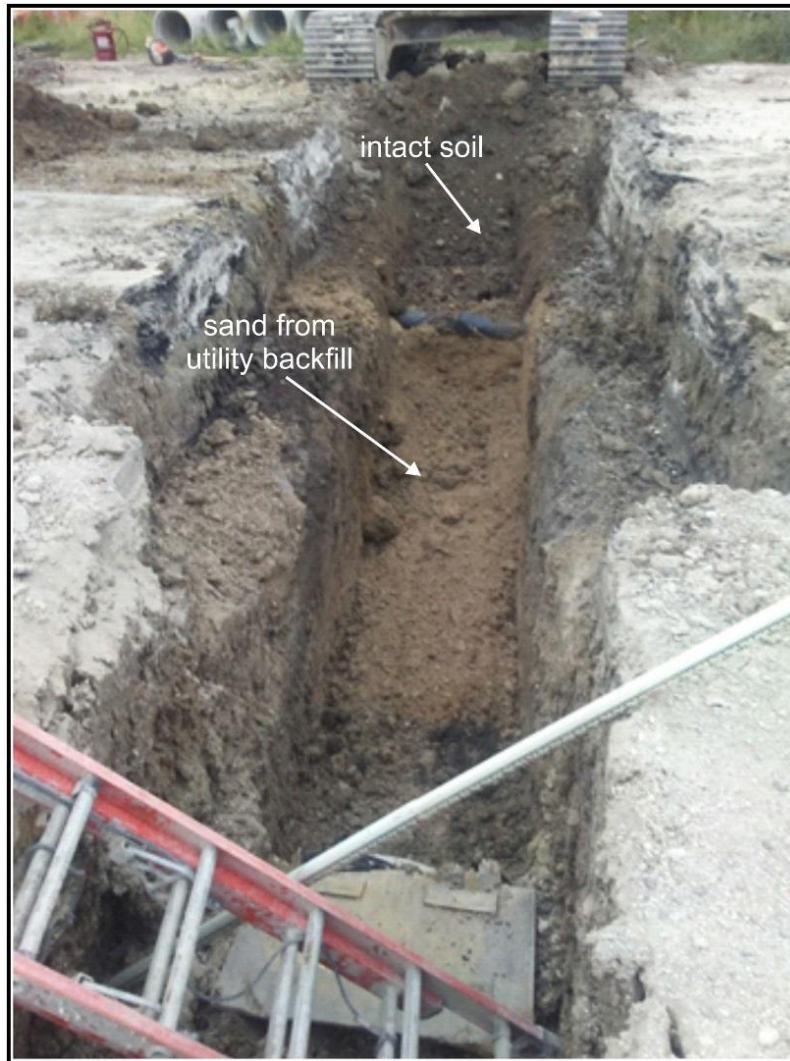
As noted, contractors excavated lateral lines that connected to the SAWS water main trench. These excavations were conducted and monitored intermittently by CAR staff from April 5 through May 8, 2017. The excavations ranged in depth from 1.5 m below the surface (mbs; 5 ft.) to 1.8 mbs (6 ft.). The maximum width of one lateral line excavation was 2.4-m (8-ft), while the remaining lateral trenches were a standard bucket width of 0.6 m (2 ft.). Figure 4-4 shows one of the lateral line excavations. As seen in the photo, much of the area had been disturbed by previously installed SAWS utilities. Undisturbed portions of the excavations revealed a dark brown (10YR 3/3) clay. During the lateral line excavations, no cultural material was observed or collected. Further archaeological work for these areas was not recommended.

*Figure 4-4. SAWS lateral excavations, note differences in soils.*

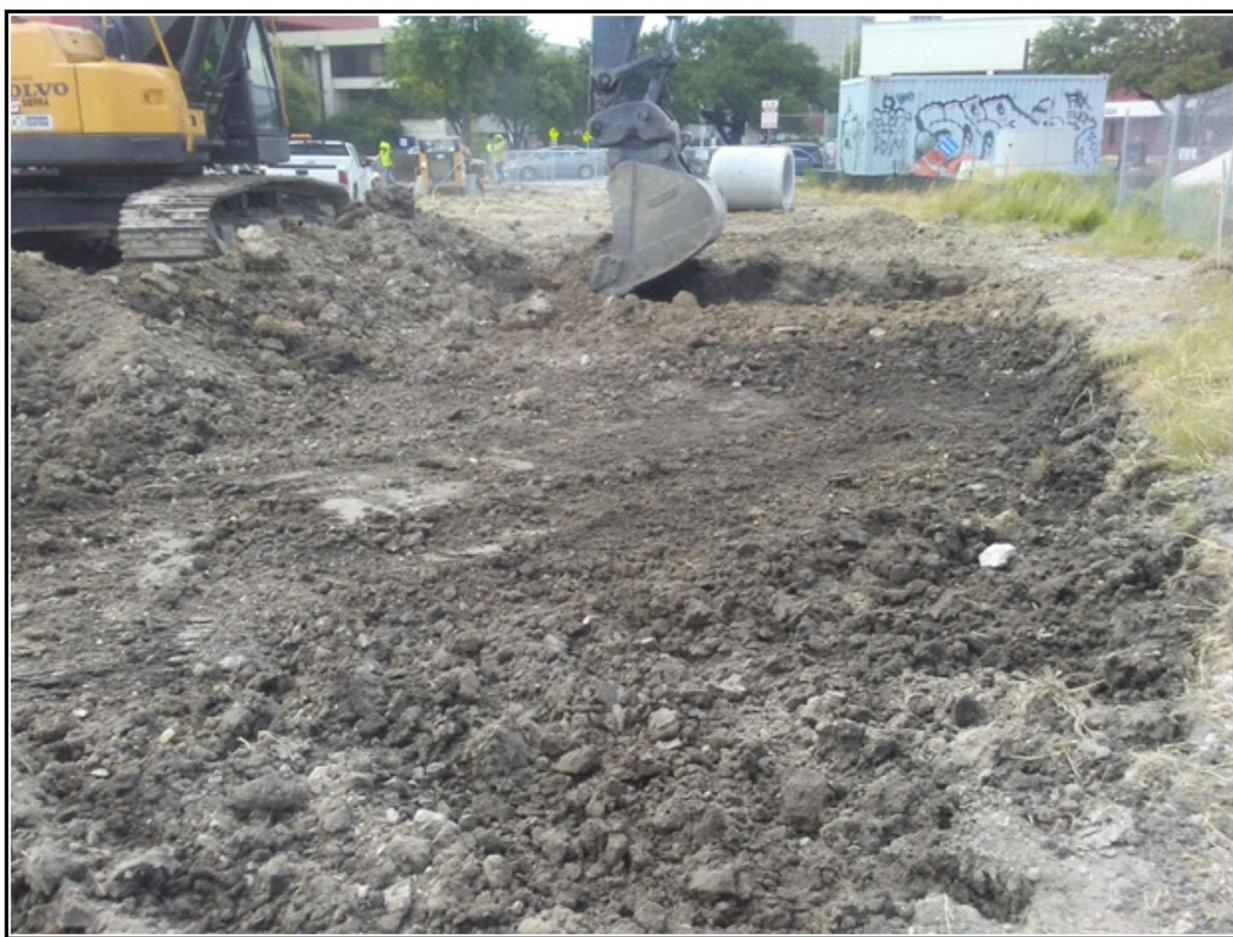
COSA excavations were associated with the installation of storm sewers and road grading. Contractors conducted the road grading over the entire APE. During the grading activities, removal of the blacktop and base was conducted with only spot monitoring. Grading included the removal of about 0.16 mbs (0.5 ft.) of asphalt and gravel base. The remainder of the grading was conducted intermittently between July 31 and August 3, 2017. These excavations (Figure 4-5) were done with a larger excavator and to a depth of 0.5 mbs (1.6 ft.). Much of the area had been disturbed by previous utilities, and excavations in the northern portion of the APE revealed concrete and rebar. No cultural material was observed or collected during these excavations, and further work was not recommended.

*Figure 4-5. COSA road grading with large excavator (facing south).*

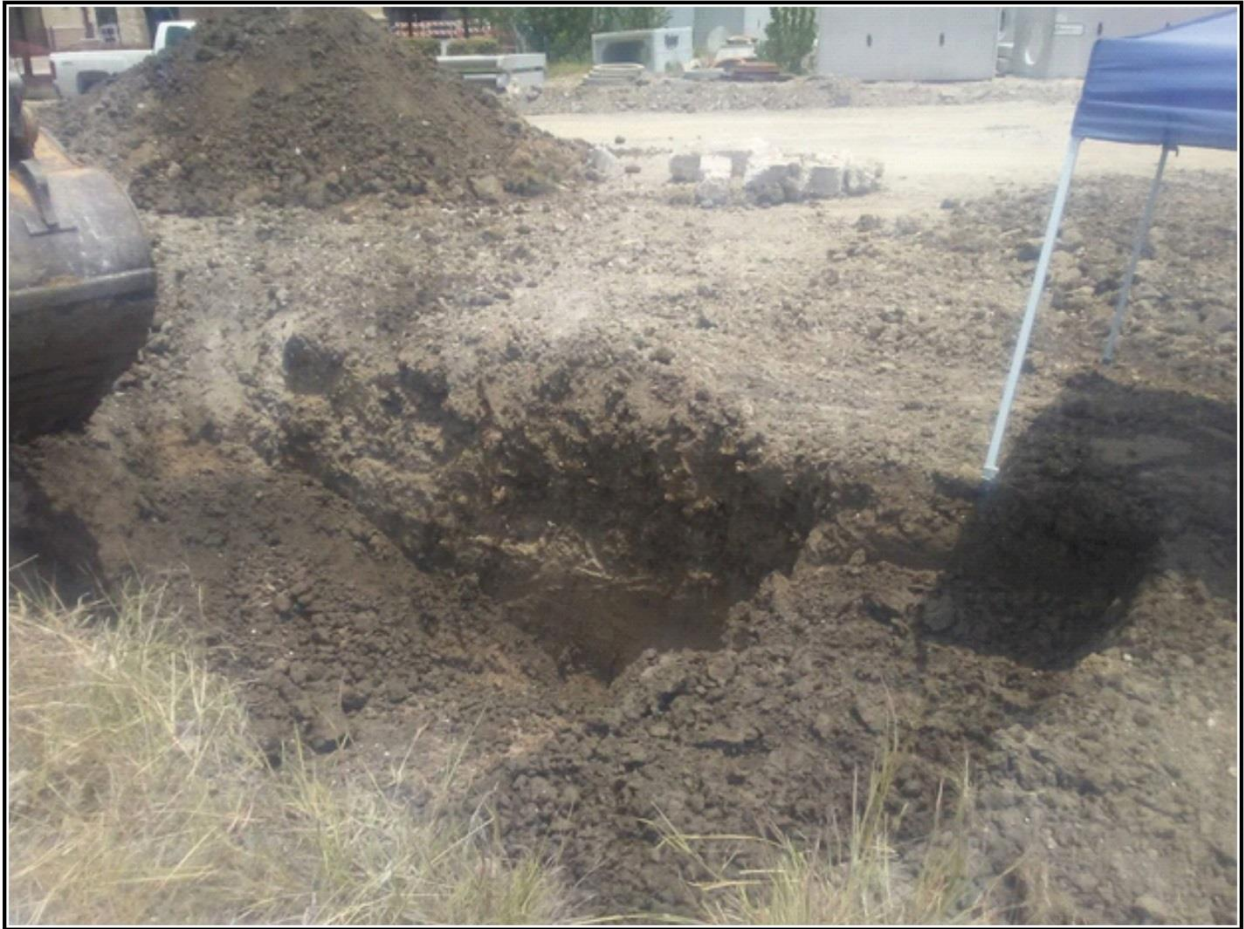
Excavations for storm sewer drains were also conducted on behalf of COSA. As seen in Figure 4-6, the excavations measured to a depth of 1.8 mbs (6 ft.) and were up to 4 m (14 ft.) in width. Much of the areas excavated were disturbed by previous utility work. Undisturbed soils were dark brown (10YR 3/3) in color. No cultural material was observed or collected during these excavations, and further archaeological work was not recommended.

*Figure 4-6. Storm sewer excavations for COSA.*
