# Archaeological Investigations in the Courtyard of Mission Nuestra Señora de la Purisima Concepción Acuña (41BX12)

by  
Antonia L. Figueroa and Steve A. Tomka

*Prepared by:*  
Center for Archaeological Research  
The University of Texas at San Antonio  
Archaeological Report, No. 403

Archaeological investigations took place in the courtyard of Mission Concepción between 2002 and 2005 in order to identify remnant architectural remains of Spanish Colonial structures prior to the installation of a drainage system. Archaeological investigations were performed under the auspices of two field schools held by the Department of Anthropology's Center for Archaeological Research of The University of Texas at San Antonio (UTSA). The Center's Legacy Public Outreach Program also held a field school as part of these investigations. Archival documents indicate that the granary and another structure, possibly the community storeroom or corridor, occupied the courtyard. Investigations in the courtyard uncovered several foundations or architectural alignments that may represent remnants of these structures. Excavations within the said granary area revealed disturbances derived from utilities ins

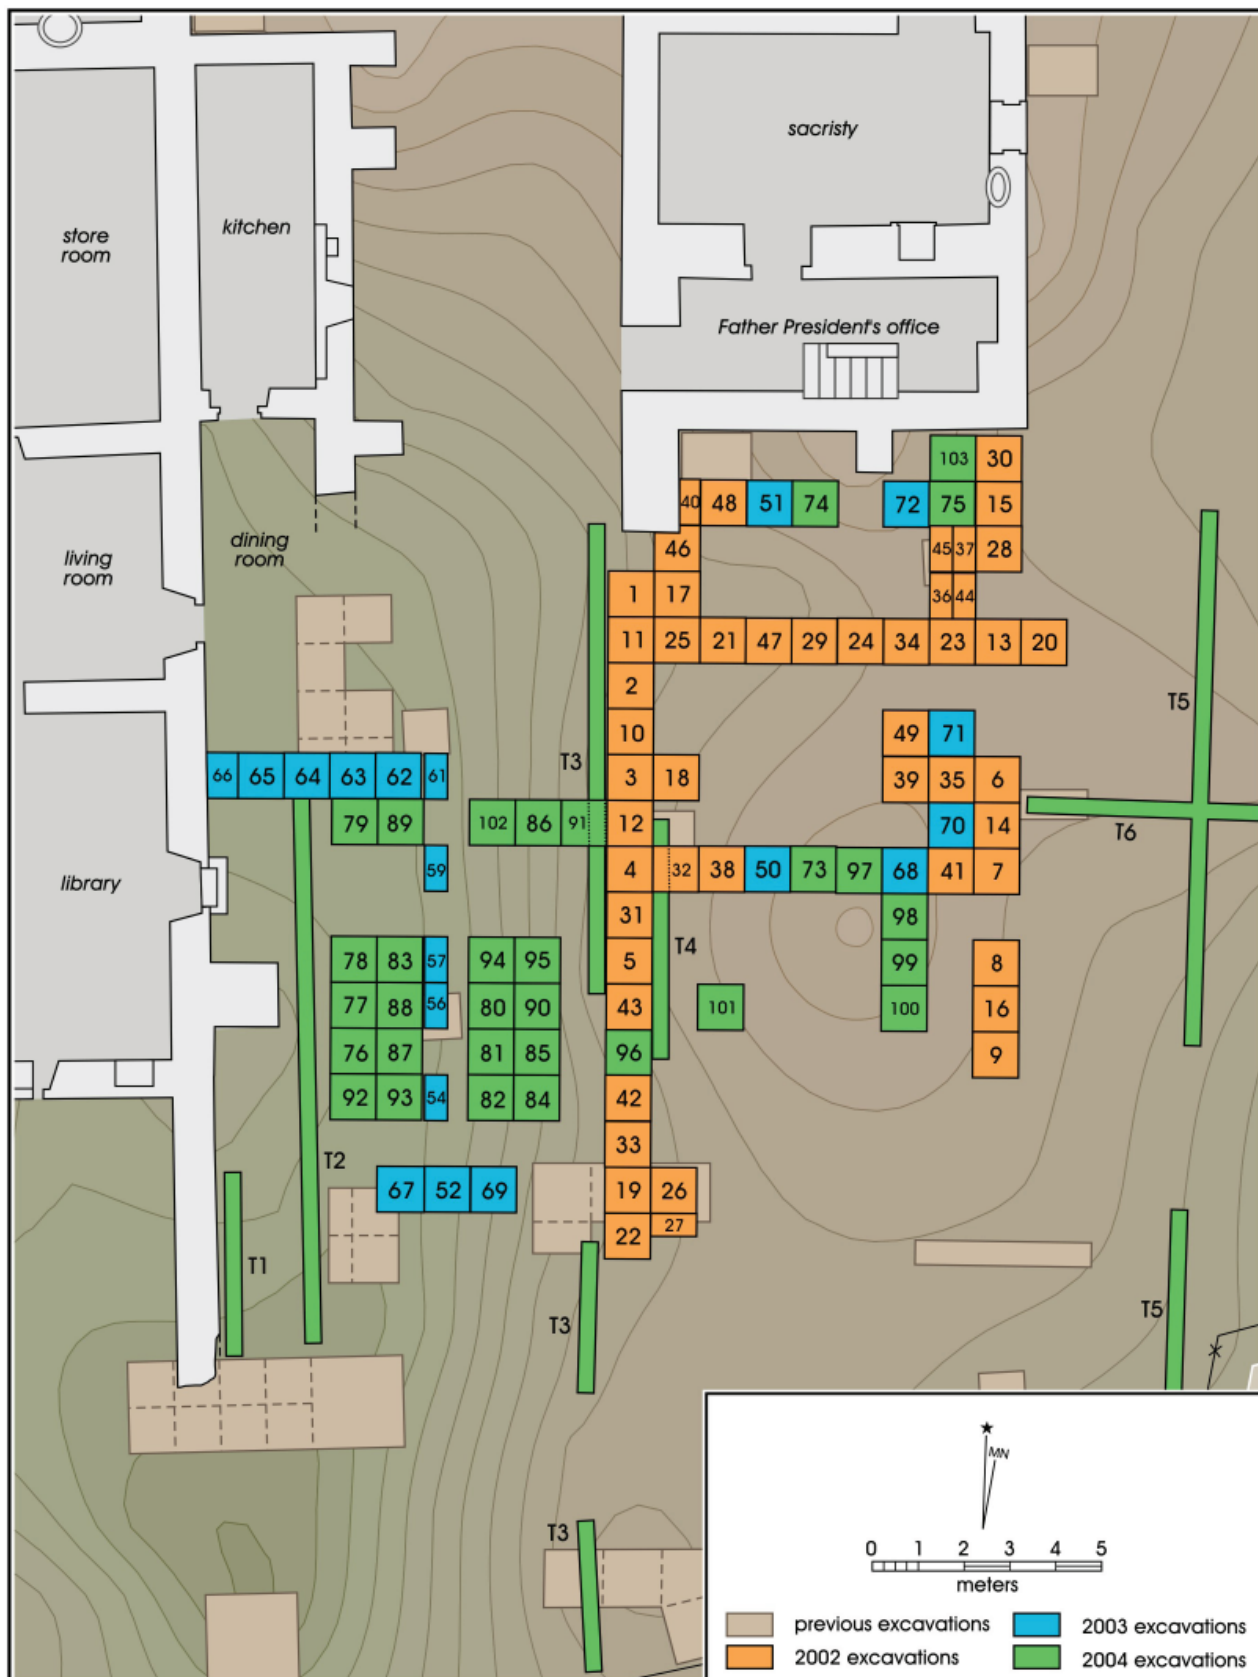
Figure 4-2. Map of test units and trench excavations conducted from 2002 to 2004.

The 2002 excavation units were positioned immediately south of the Father President's Office (FPO, Figure 4-2). Two N-S running lines were placed in line with the east and west corners for the office hoping to expose presumed foundations located in the area. Only after consulting the WPA map produced by H.P. Smith, was it realized that the eastern

A majority of test units excavated during 2003 were located along the western portion of the courtyard (Figure 4-2). Six adjoining test units were placed perpendicular to the east wall of the *convento* to expose the foundation of the wall and also more fully expose the N-S running alignment in line with the east wall of the kitchen. Five 1x.5 meter test units (TU's 54, 56, 57, 59 and 61) were positioned parallel the east wall of the *convento* approximately 6 meters from the wall. The goals of these units were to cross-cut and/or expose any potential E-W running intersecting walls in this area. Unfortunately, these units were placed directly within an existing trench used for the installation of electric conduits within the area (Figure 3-3). Only two levels were excavated in each unit prior to the discovery of the disturbed context. Nonetheless, no architectural alignments were noted in the walls of these units suggesting that no E-W running walls were present in the area. In addition, six 1x1 meter units excavated during volunteer Saturdays were dispersed south of the sacristy to explore architectural features partially exposed during previous excavations. The volume of matrix excavated from the 2003 test units is approximately 6.2 m<sup>3</sup>.

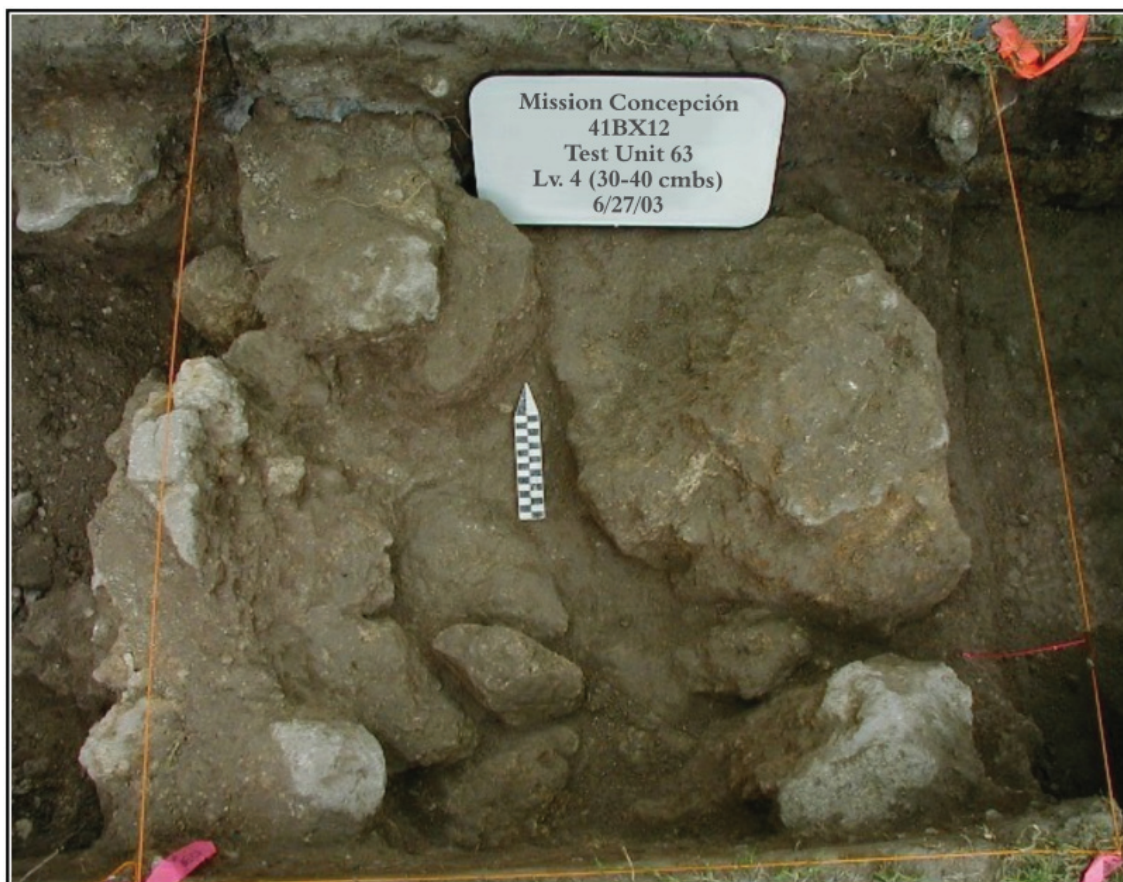
Figure 5-2. Alignment 1 uncovered in Test Unit 63.

The northern portion of this tufaceous limestone alignment was recorded in the 1990 excavations (Krueger and Meskill 1992) and documented by Harvey Smith during WPA investigations. The Krueger and Meskill investigations encountered one segment of the alignment just north of the CAR TUs 63 and

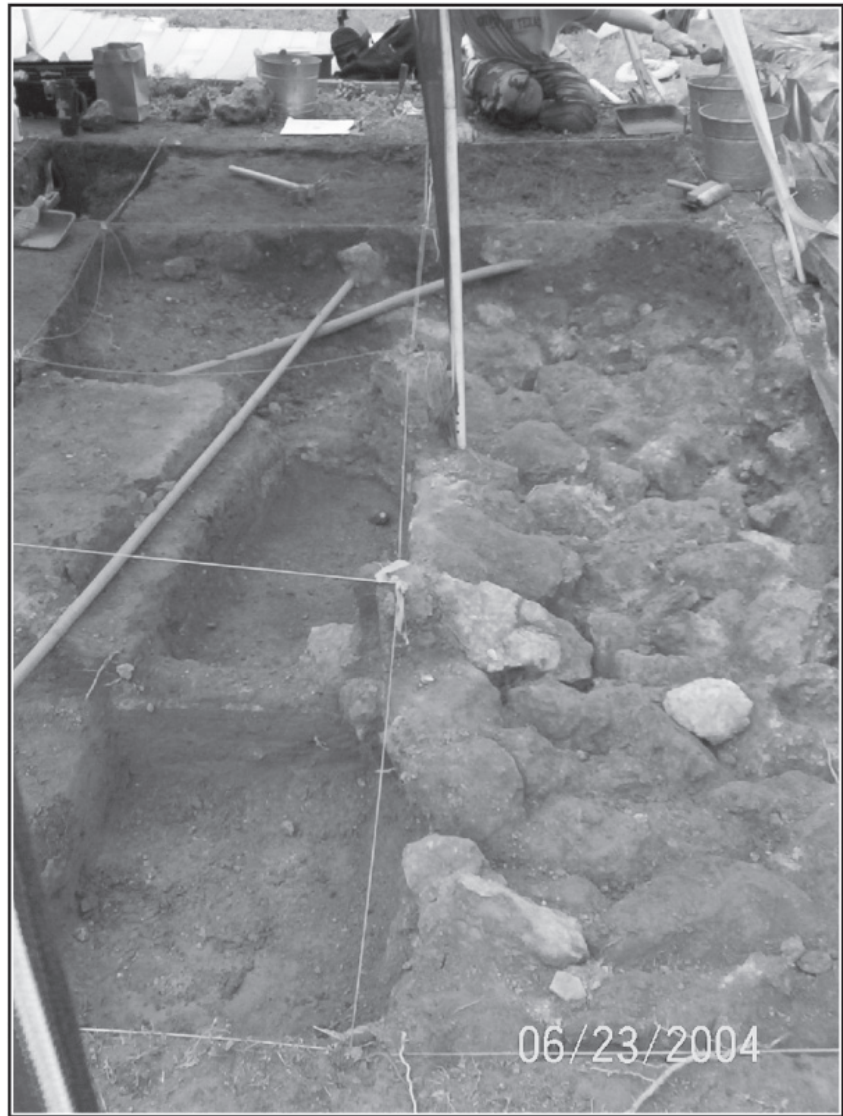
Figure 5-3. *Alignment 1 in Test Units 78 through 92.*

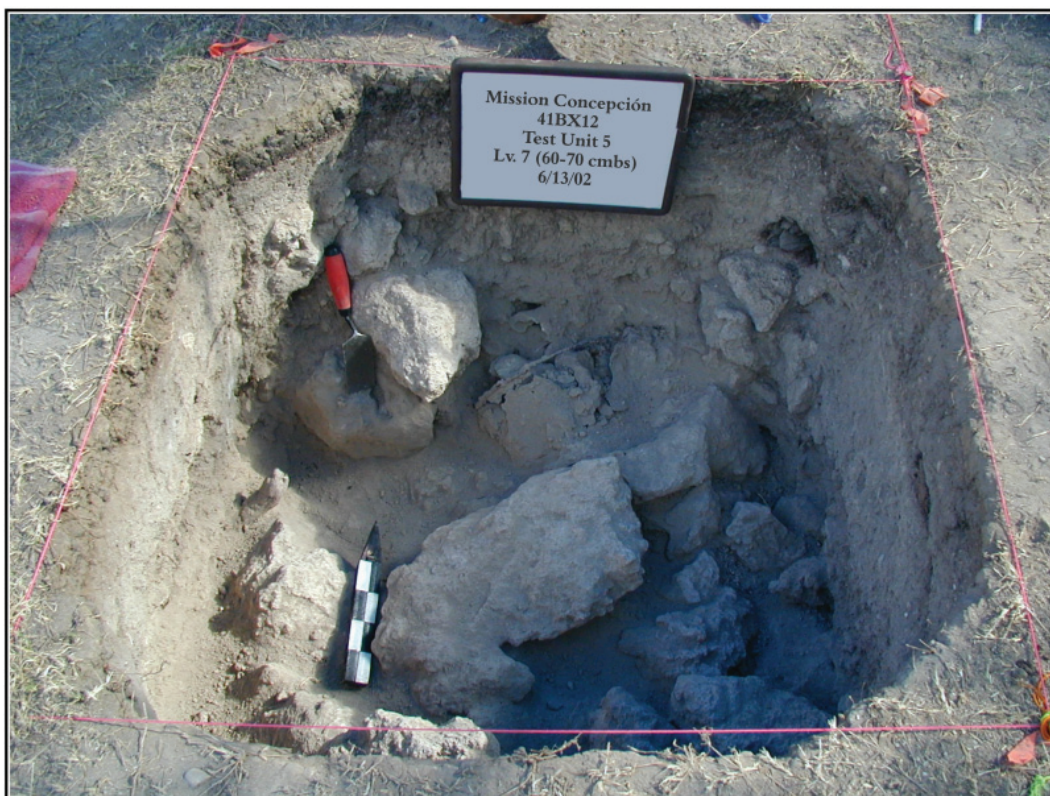
Figure 5-6. Disturbed portion of Alignment 2 uncovered in Test Unit 5.

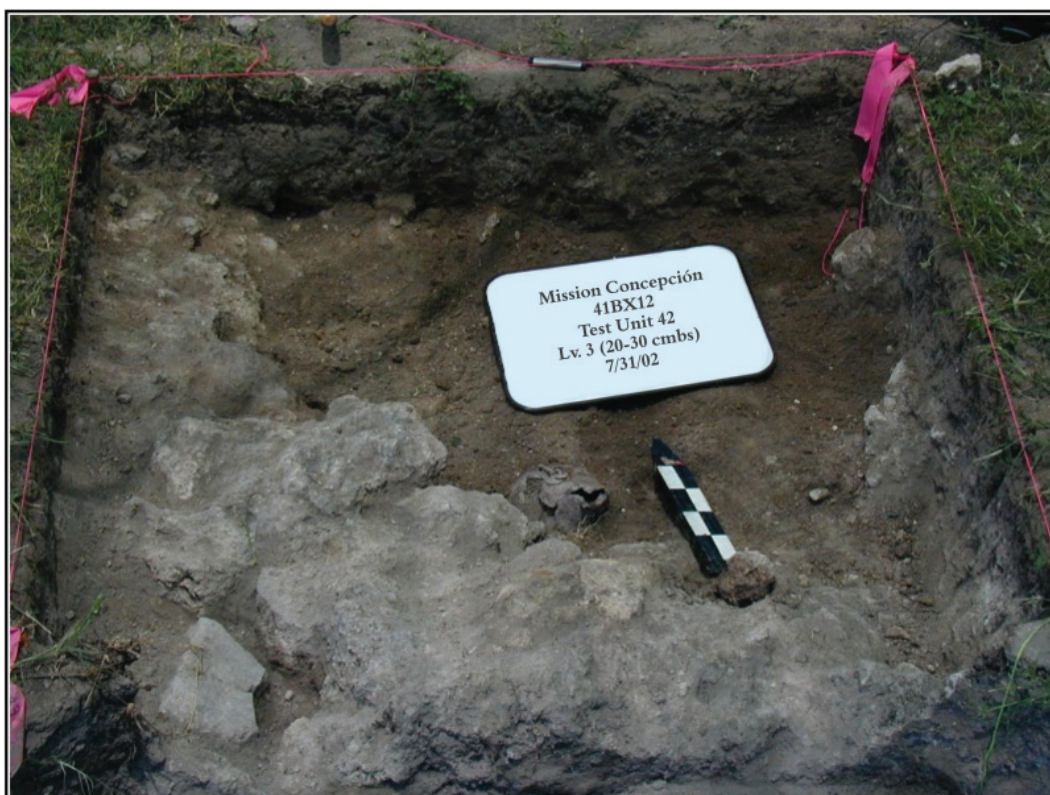
Figure 5-7. Portion of Alignment 2 uncovered in Test Unit 42.

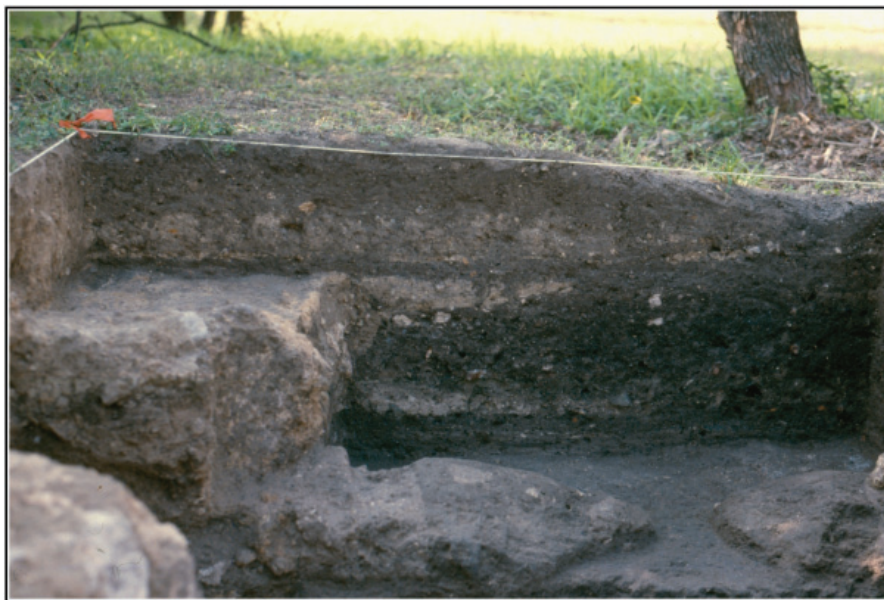
Figure 5-8. Ivey and Fox (1999) excavations, Block I, probable southwest corner of structure represented by Alignment 2.

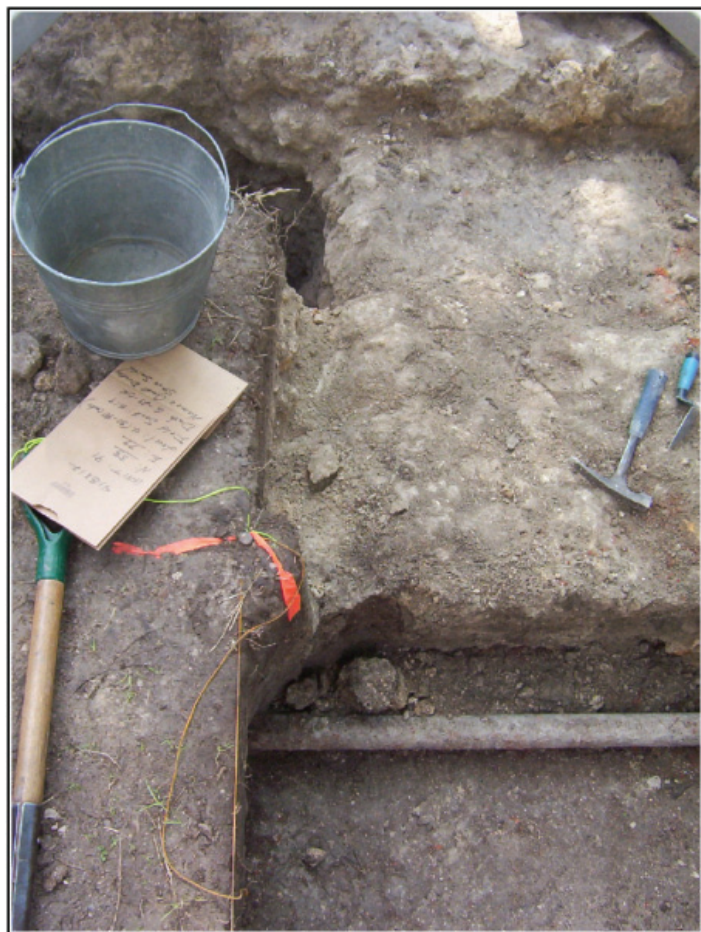
Figure 5-9. Alignment 2 (at top of photo) and Buttress 1 (center of photo) in Test Unit 91.

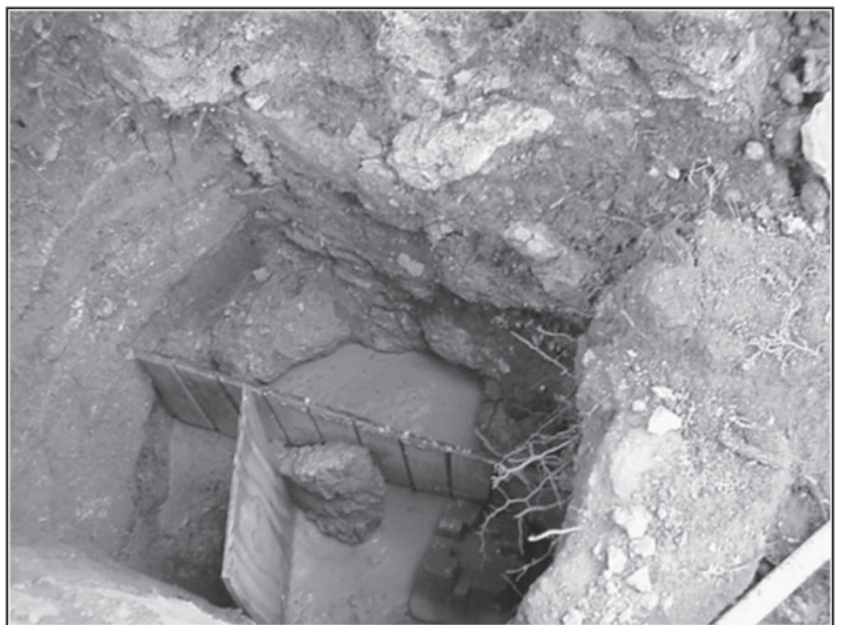
Figure 5-12. *Cement slurry at bottom of Test Unit 30.*

the foundation was intact and structurally sound exhibiting no cracks or deterioration, a large void was encountered immediately under the corner. This void also was filled with a slurry of cement to provide a solid footing for the foundation (Figure 5-12).

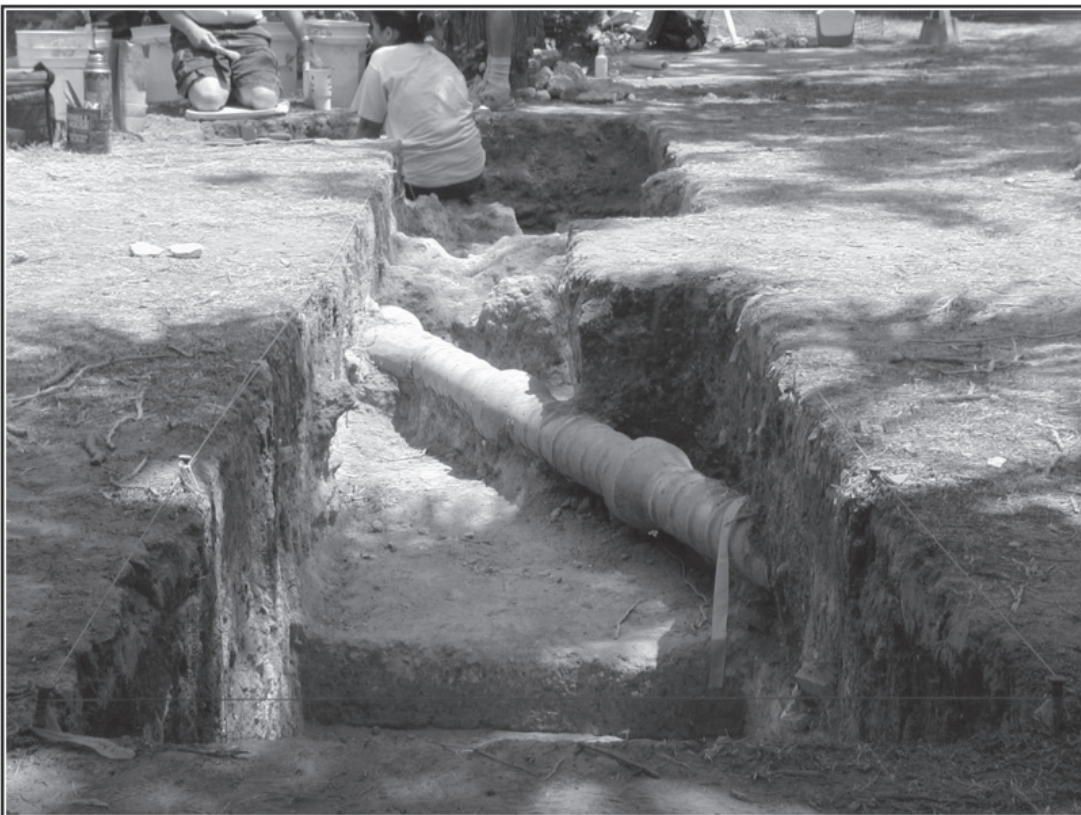
Figure 5-14. Concrete sewer pipe south of remnants of possible buttress in Test Units 8, 16 and 9.

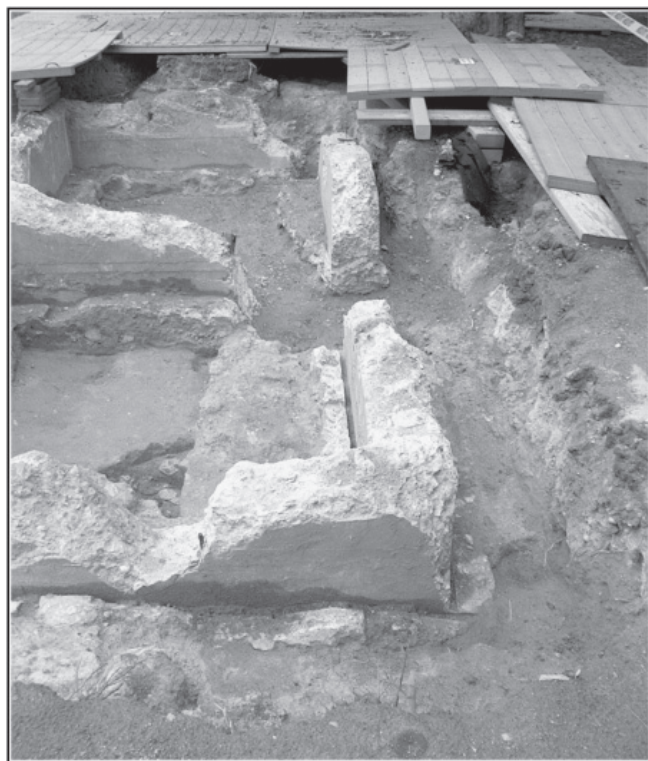
Figure 5-15. Foundation remnants of restroom facility.

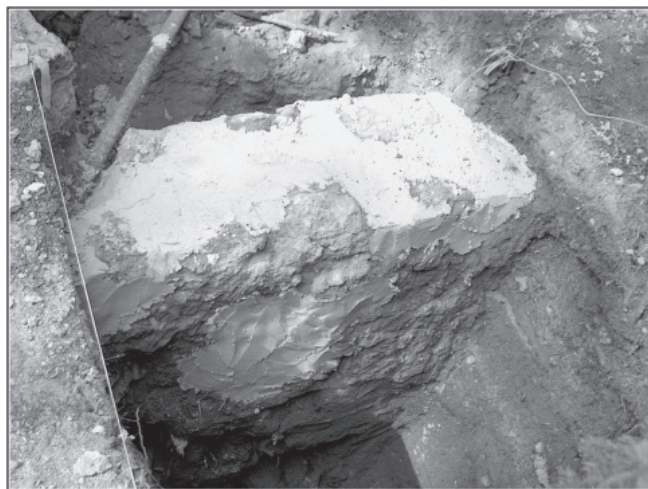
Figure 5-16. Cement-reinforced stone wall identified in Test Unit 15.

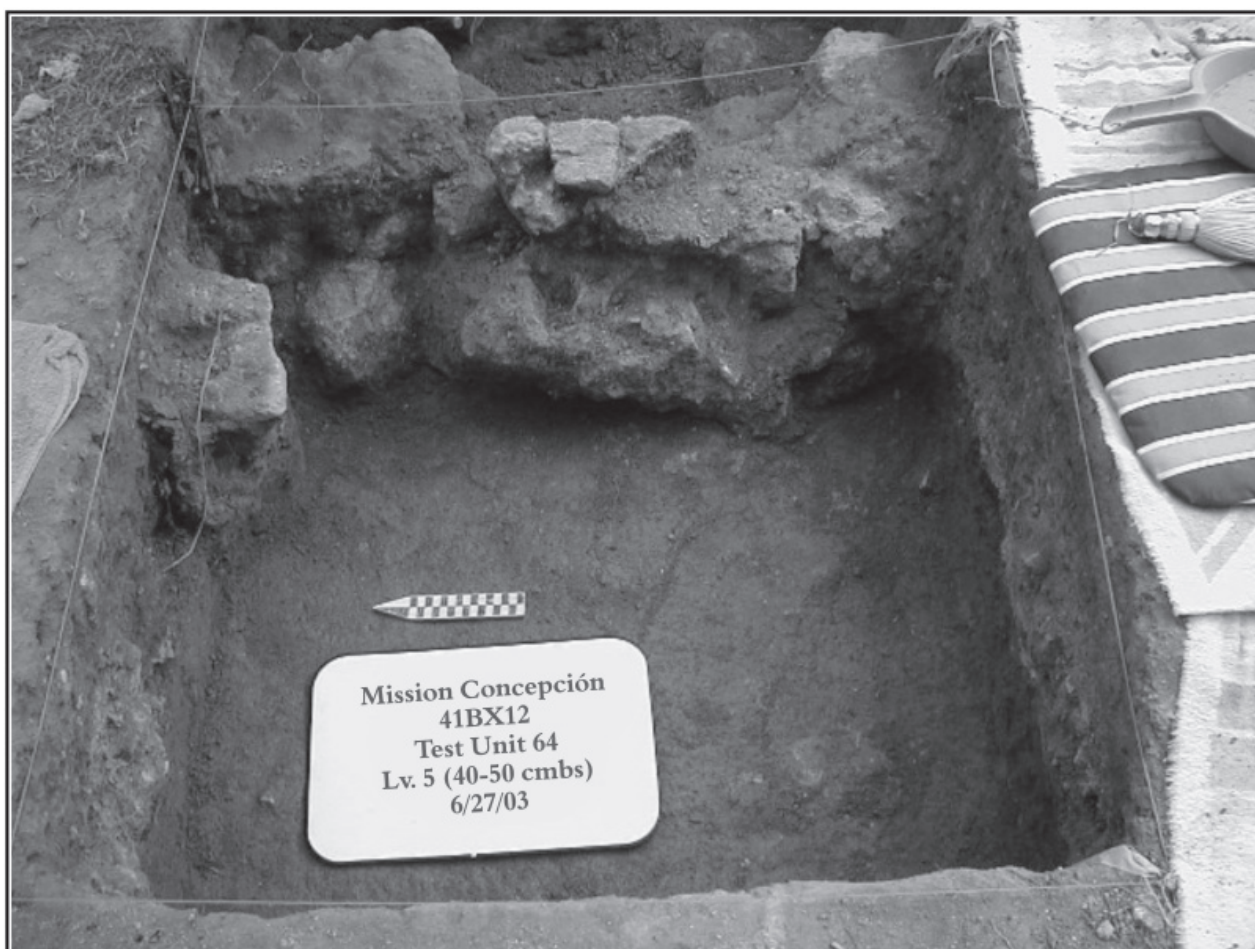
Figure 5-18. Eastern face of Alignment 1 as seen in Test Unit 64.

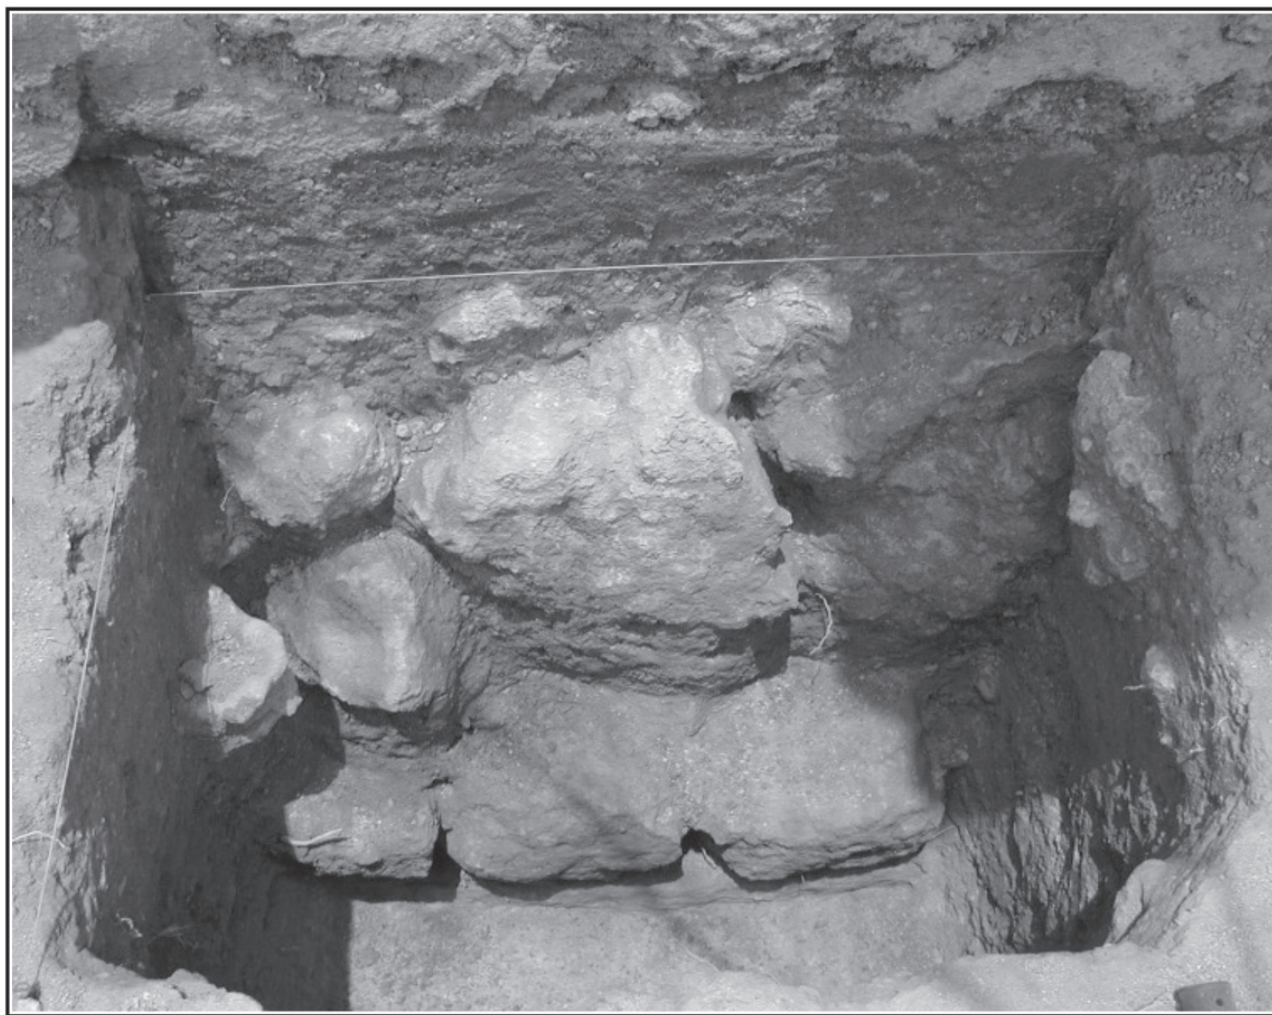
Figure 5-19. Foundation of Convento wall exposed in Test Unit 66.

The principal goal of these units was to determine the depth of the foundation of the east wall of the *convento* and examine the foundation itself. The top of the foundation began roughly 20 cmbs. The foundation consisted of large boulders of limestone that expanded toward the base creating a trapezoidal appearance. The rocks are held in place by what appears to be mortar. The outline of a trench that would have been dug for the foundation rocks could not be discerned in the north or south walls of TU 66. The large rocks that form the foundation and its trapezoidal shape are different from architectural Alignments 2 and 3. The difference may reflect

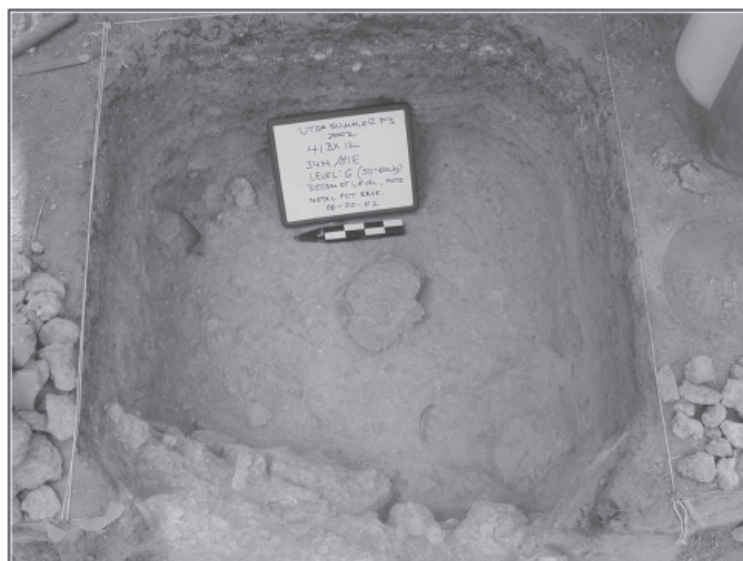
Figure 5-20. Layer of red sand that formed surface of foot path within courtyard.

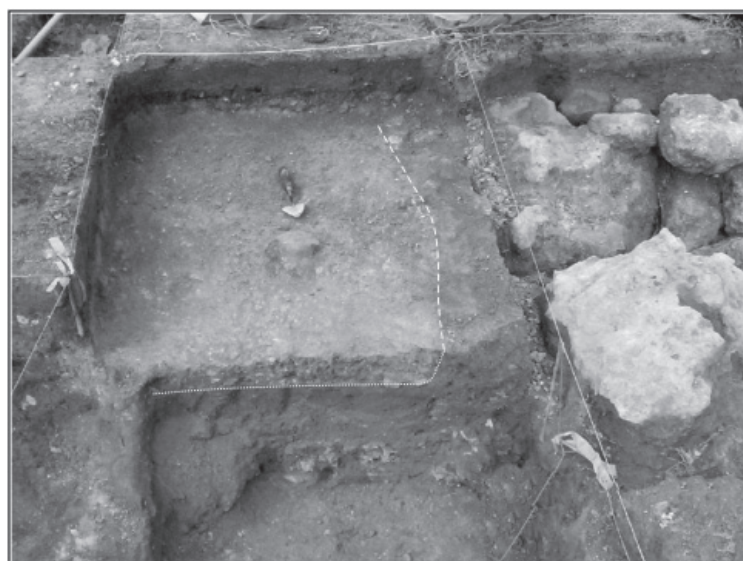
Figure 5-21. Test Unit 89 (Area 2, Block I) excavation with hard-packed gravel surface (Feature 3) exposed.

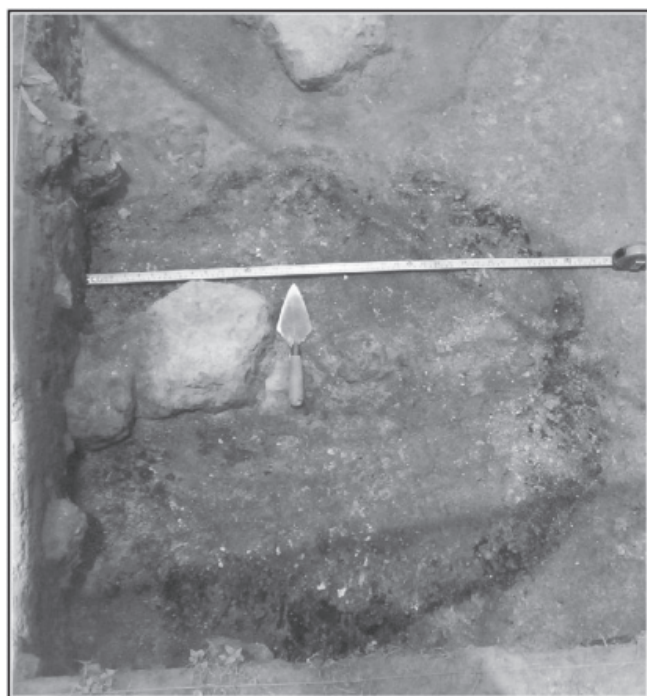
Figure 5-22. Feature 1, Test Unit 82.

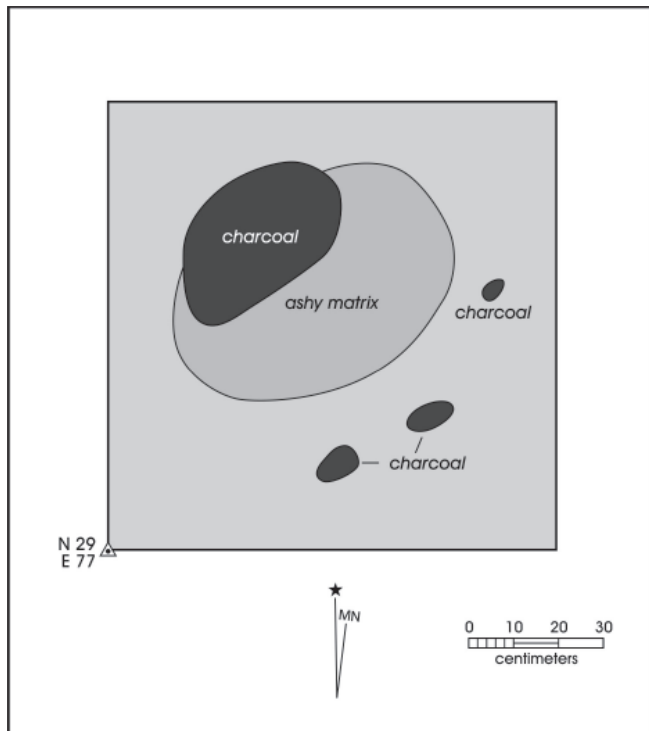
Figure 5-23. Planview of Feature 2, Test Unit 80, at 40 cmbd.

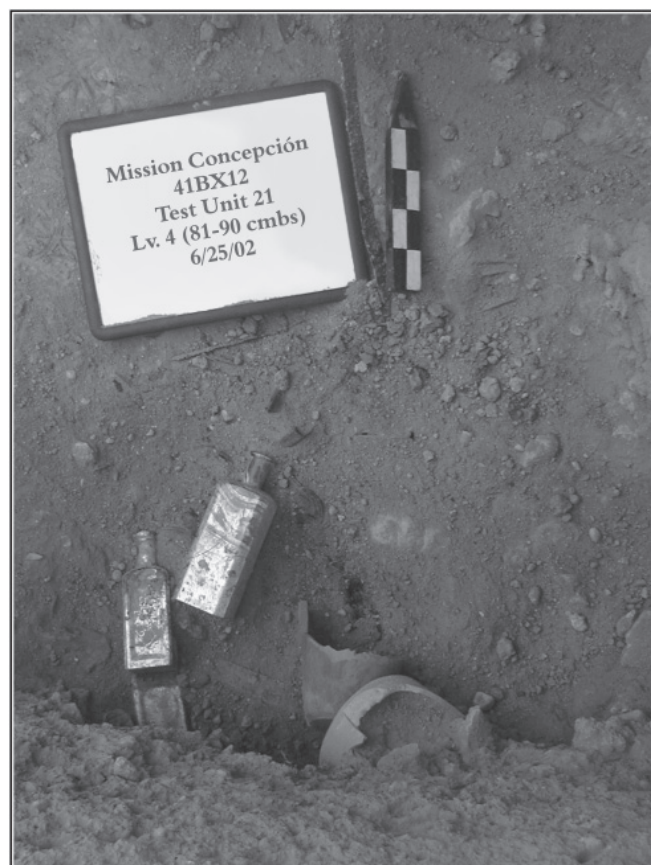
Figure 5-26. Garbage in Feature 5, Test Unit 21.

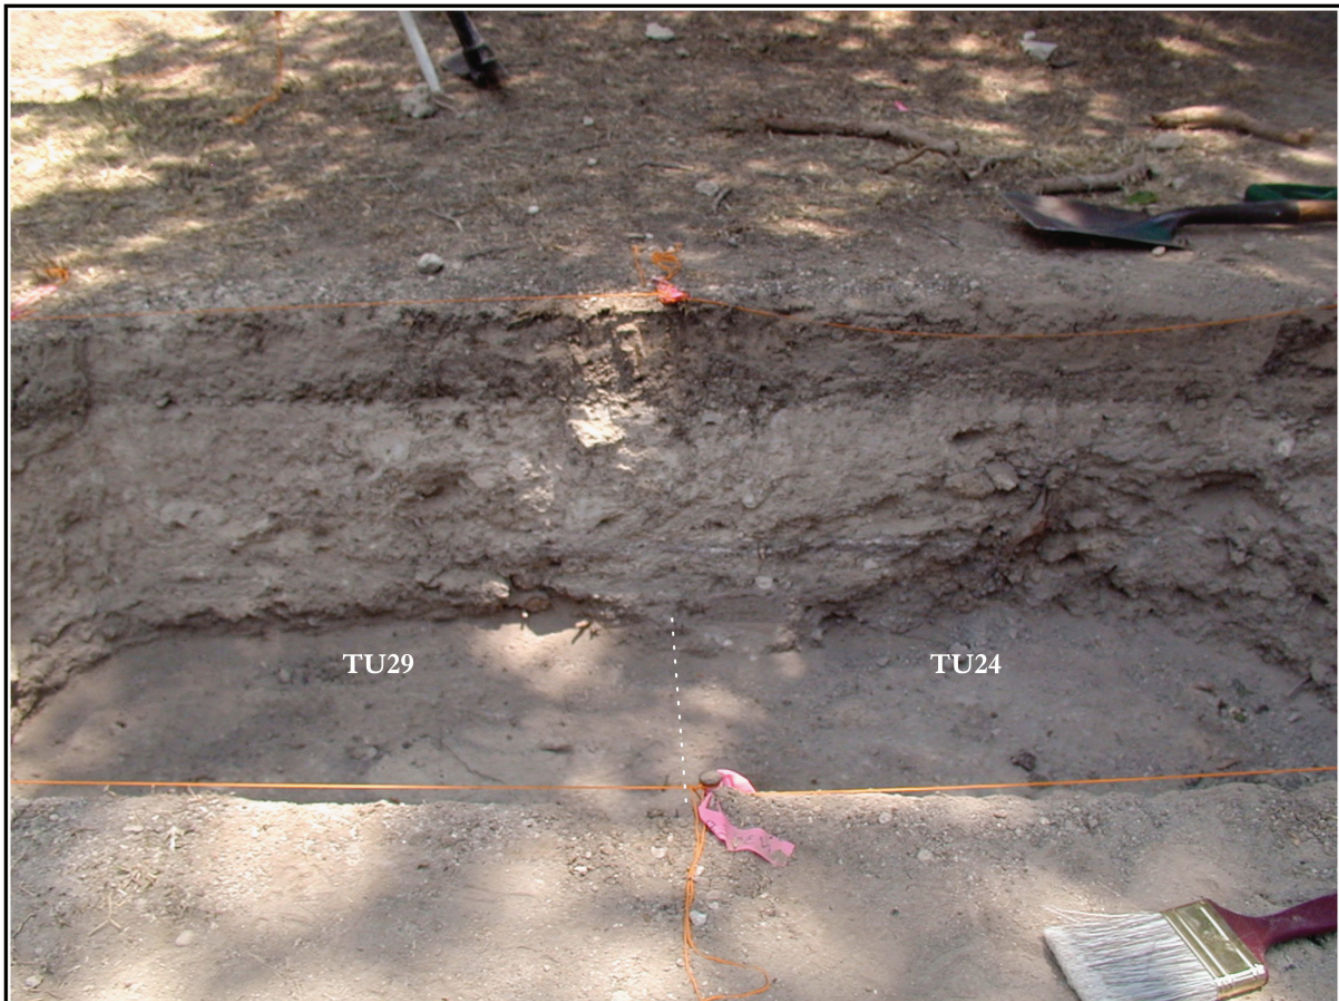
Figure 5-27. Hard-packed level surface below top soil in Test Units 24 and 29.

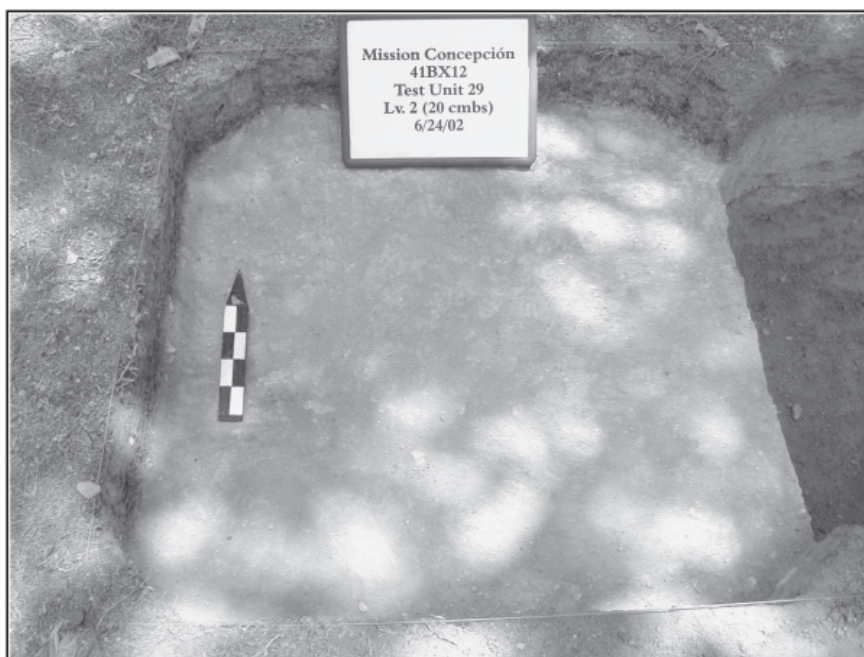
Figure 5-28. Top of hard-packed surface in Test Unit 29.

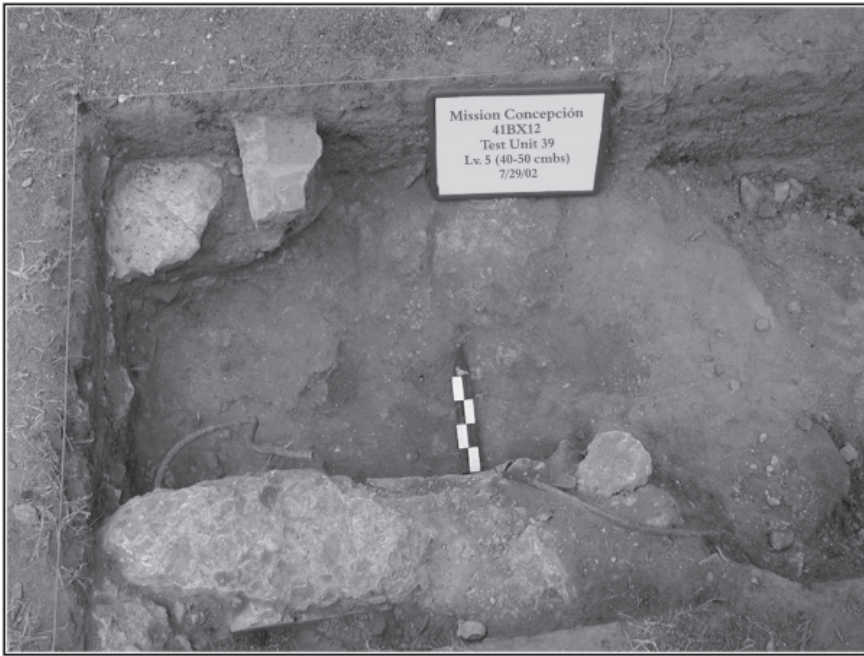
Figure 5-29. Remnant of concrete foundation of restroom facility in Test Unit 39.

previous restroom facilities that once occupied a portion of this area was present in Test Units 39, 73, 68, 98 and 99 (Figure 29). Segments of the concrete foundation

associated with this facility were exposed at the bottom of Level 2 (10-20 cmbs) in each of the test units (39, 73, 68, 98, and 99). Spanish colonial foundation remains were identified beneath the 1940s bathroom when the bathroom was removed.

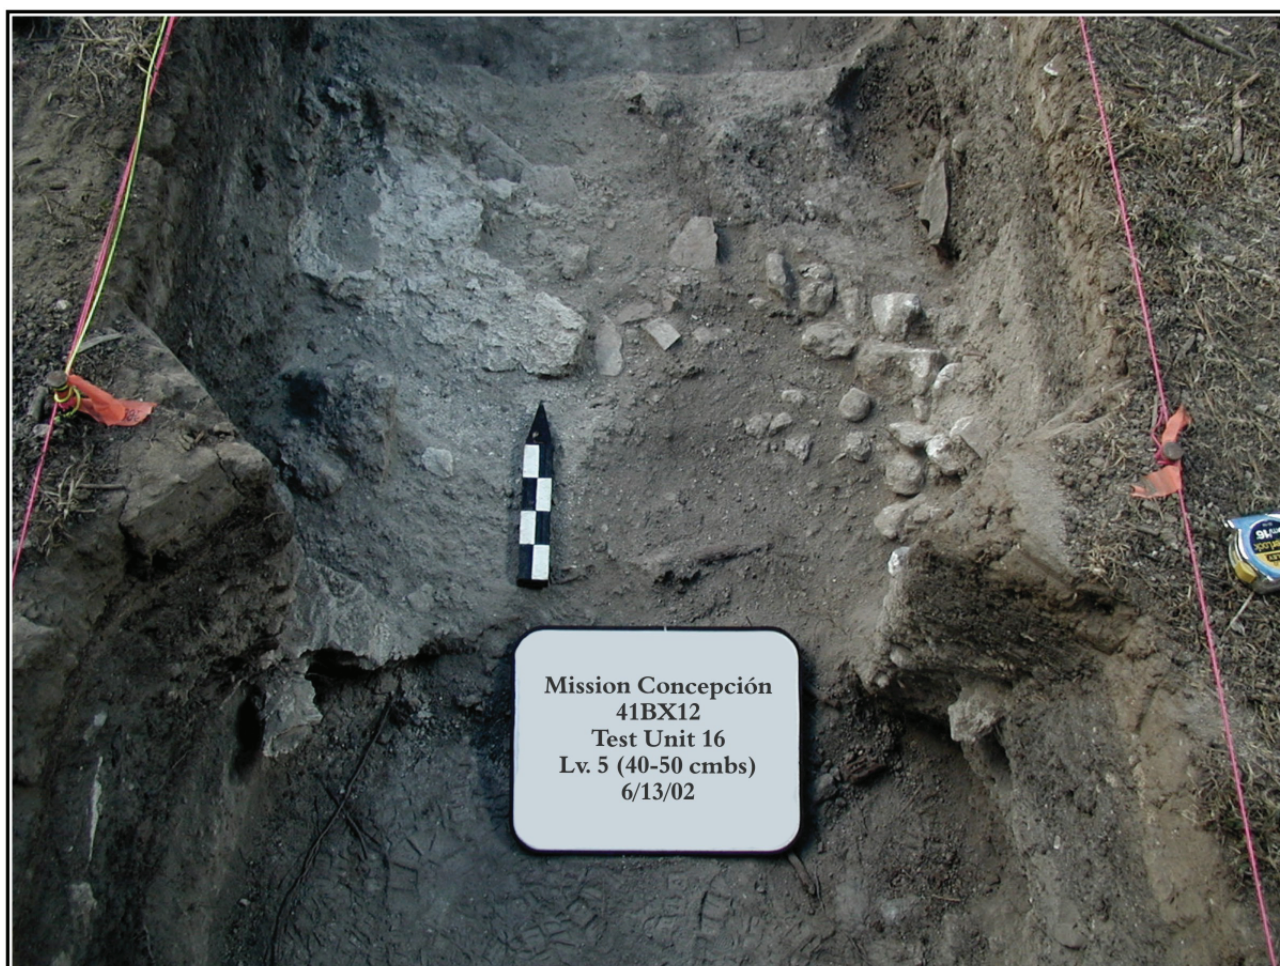
Figure 5-30. Plaster surface exposed in Test Unit 16, Area 5.

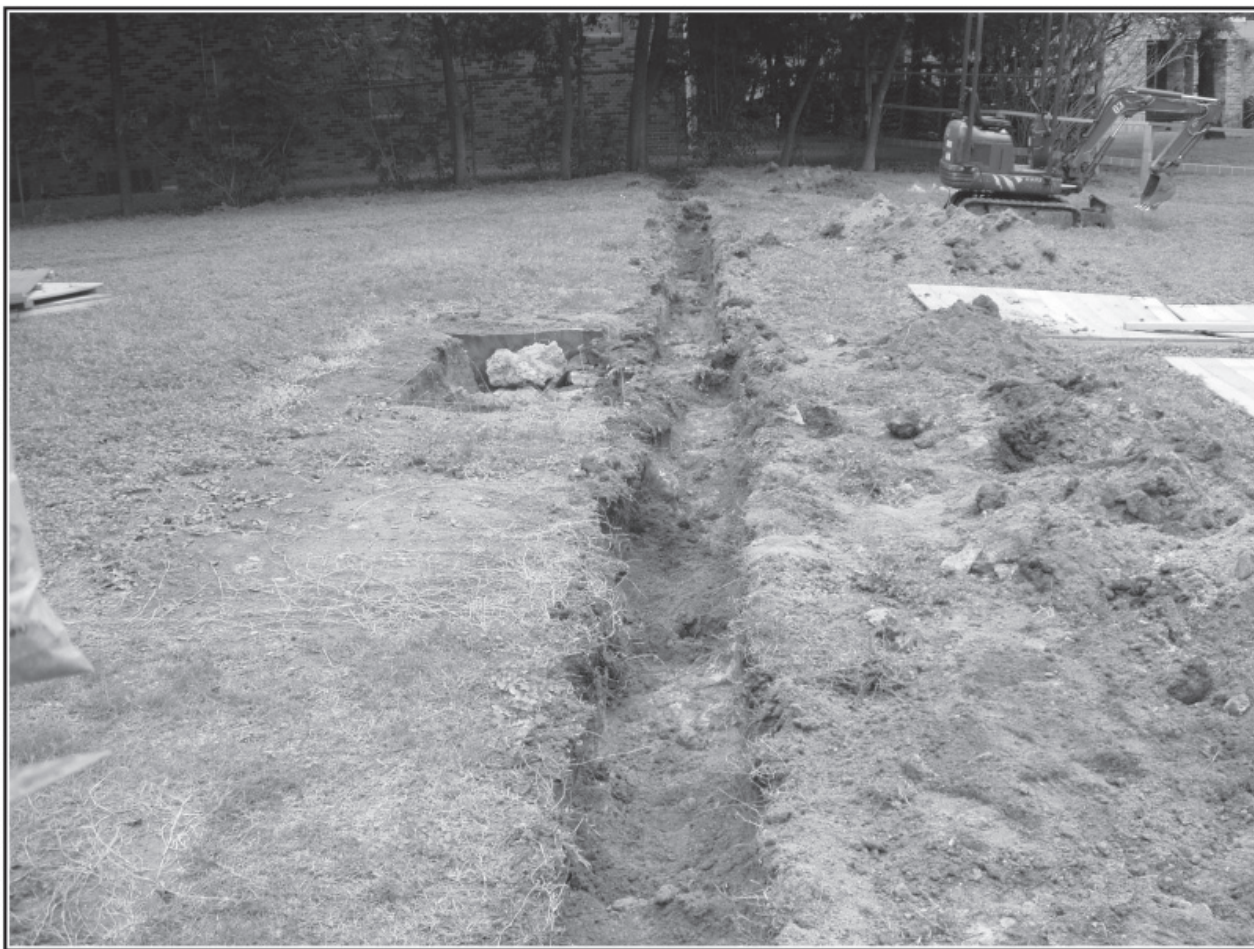
Figure 5-32. Southern portion of Trench 3 excavated by small trackhoe.
