# Archaeological Investigations of the Monterrey Park Improvements, San Antonio, Bexar County, Texas

Texas Antiquities Permit No. 8798

Prepared by:
Center for Archaeological Research
The University of Texas at San Antonio
One UTSA Circle
San Antonio, Texas 78249
Technical Report, No. 81

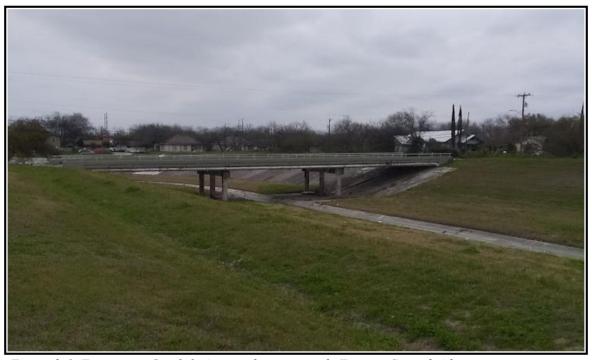
Figure 2-1. Zarzamora Creek facing northeast towards Fortuna Street bridge.

The soil series present in the APE are represented by the Tinn and Frio soil complex (Tf). This soil type is a clayey loam that occurs along flood plains (Natural Resources Conservation Services 2019). Zarzamora Creek runs along the eastern portion of the APE. The creek originates in northern Bexar County and stretches 12.7 km (8 miles) through the western part of San Antonio, where it terminates at San Pedro Creek (Texas State Historical Association 2010). The portion of the creek along the APE has been channelized (Figures 2-1 and 2-2).

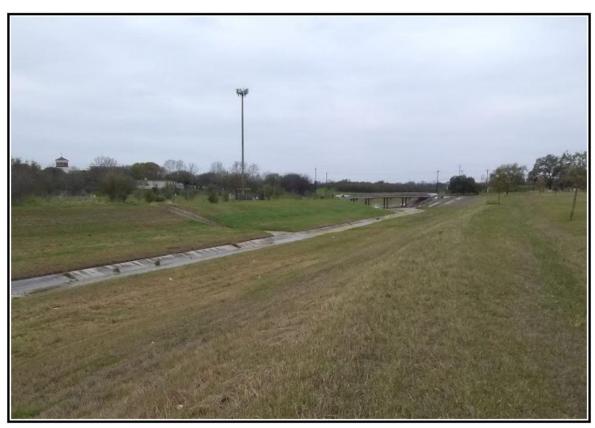
Figure 2-2. Zarzamora Creek facing southeast towards the Commerce Street bridge.
