Archaeological Monitoring of the Dignowity and Lockwood Parks Improvements Project, San Antonio, Bexar County, Texas

by
Lynn Kim and José E. Zapata

Prepared by:
Center for Archaeological Research
The University of Texas at San Antonio
One UTSA Circle
San Antonio, Texas 78249-1644
Archaeological Report, No. 506

The Center for Archaeological Research (CAR) conducted archaeological monitoring for the City of San Antonio (COSA) Dignowity and Lockwood Parks Improvement Project, an area comprised of 3.4 hectares (ha; 8.5 acres). The work, completed intermittently between February 2021 and June 2023, involved extensive grading and utility trenching. Because the project area is on COSA-owned land, the project falls under the Unified Development Code (UDC; Article 6 35-630 through 35-634) and requires review from the COSA's Office of Historic Preservation (OHP). In addition, the work required review by the Texas Historical Commission (THC) under the Antiquities Code of Texas and was conducted under Permit No 9747. The Principal Investigator of this project was Cynthia Munoz, Interim Director of the CAR, with Lynn Kim serving as the Project Archaeologist.

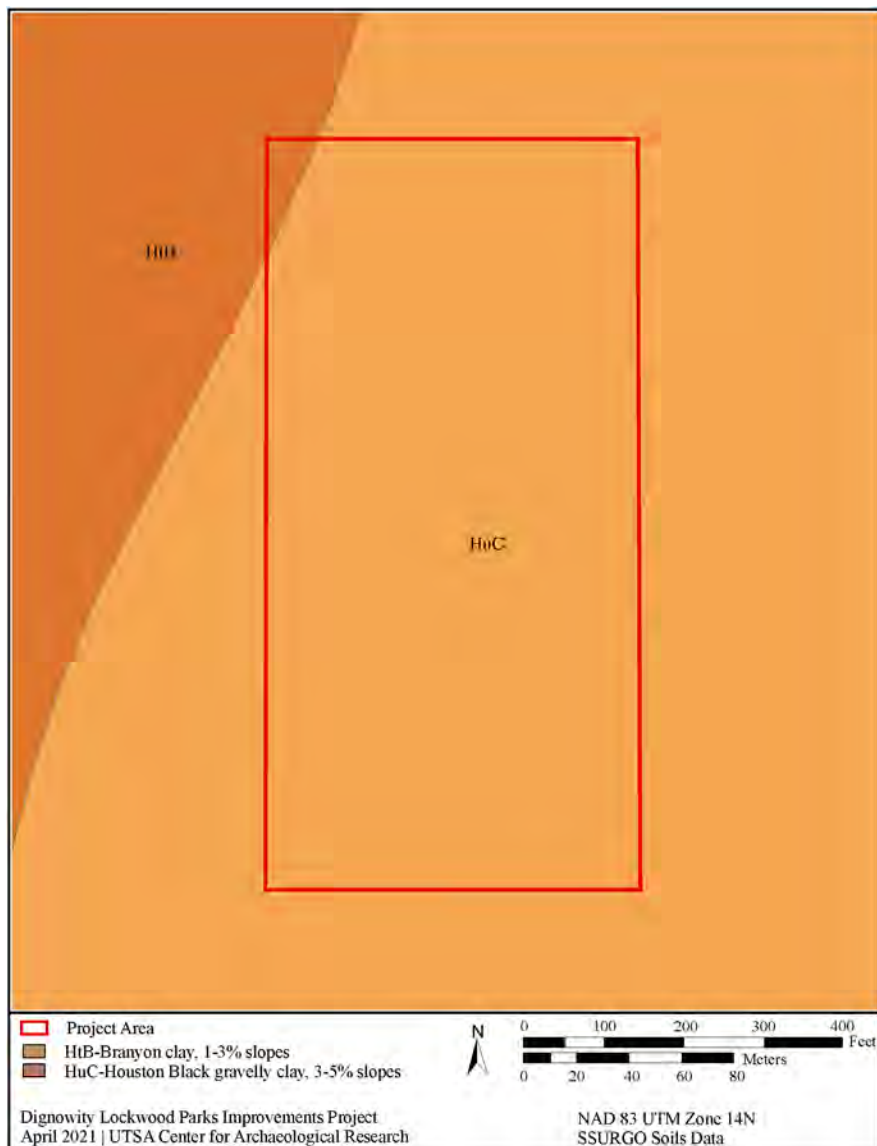
The predominate soil within the project area is Houston Black gravelly clay (HuC; Figure 2-1). The HuC soil in the project

Figure 2-1. Soils within the project area.

area is a dark grayish brown clay with 50-80 percent gravels (Zapata 2023). Houston Black soils can extend past depths of 250 cm below surface (NRCS 2021). A small area at the far northwest corner of the project area is composed of Branyon clay (HtB). Both soil series are moderately well-drained.

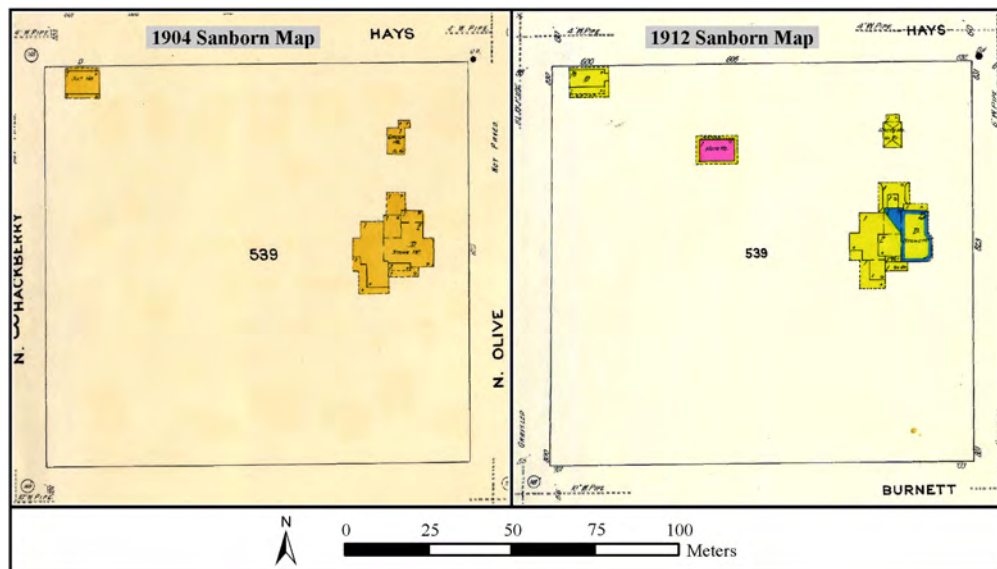
Figure 3-1. The Lockwood property, NCB 539 close-up from the 1904 and 1912 Sanborn Fire Insurance Maps. Structures in yellow are of wood frame construction; pink represents brick construction; and blue represents stone construction (Zapata 2023:Figure 3-1).

Situated in the northeast section of the project area, the Lockwood home fronting N. Olive Street was probably built soon after NCB 539 was purchased in 1872. The home appears on the 1904 and 1912 Sanborn Fire Insurance maps as a multi-level, wood, and stone structure (Figure 3-1). The 1904 and 1912 Sanborn maps illustrate the main house and ancillary buildings, including an additional dwelling, a garage, and a greenhouse. Joseph S. Lockwood and his wife, Elizabeth C. Lockwood, were listed as living at 817 N. Olive Street, along with their four children and four employees (U. S. Census 1920; Figure A-3).

The 1904 and 1912 Sanborn Maps show a wood constructed dwelling off the corner of Hays and N. Hackberry (Figure 3-1). This house was likely set aside for the family's staff and may have been occupied by either Oscar and Mary Milner, along with their daughter and grandchildren, or by Harvey, Ketura, and Sarah Grant. Both families, Milner and Grant, are listed as being part of the Lockwood household (U. S. Census 1920; Figure A-4). Cultural material was encountered here by the CAR in 2019 and the site was assigned trinomial 41BX2295 (Zapata 2023). Features 1 through 4, discussed in Chapter 5, are associated with this same site.

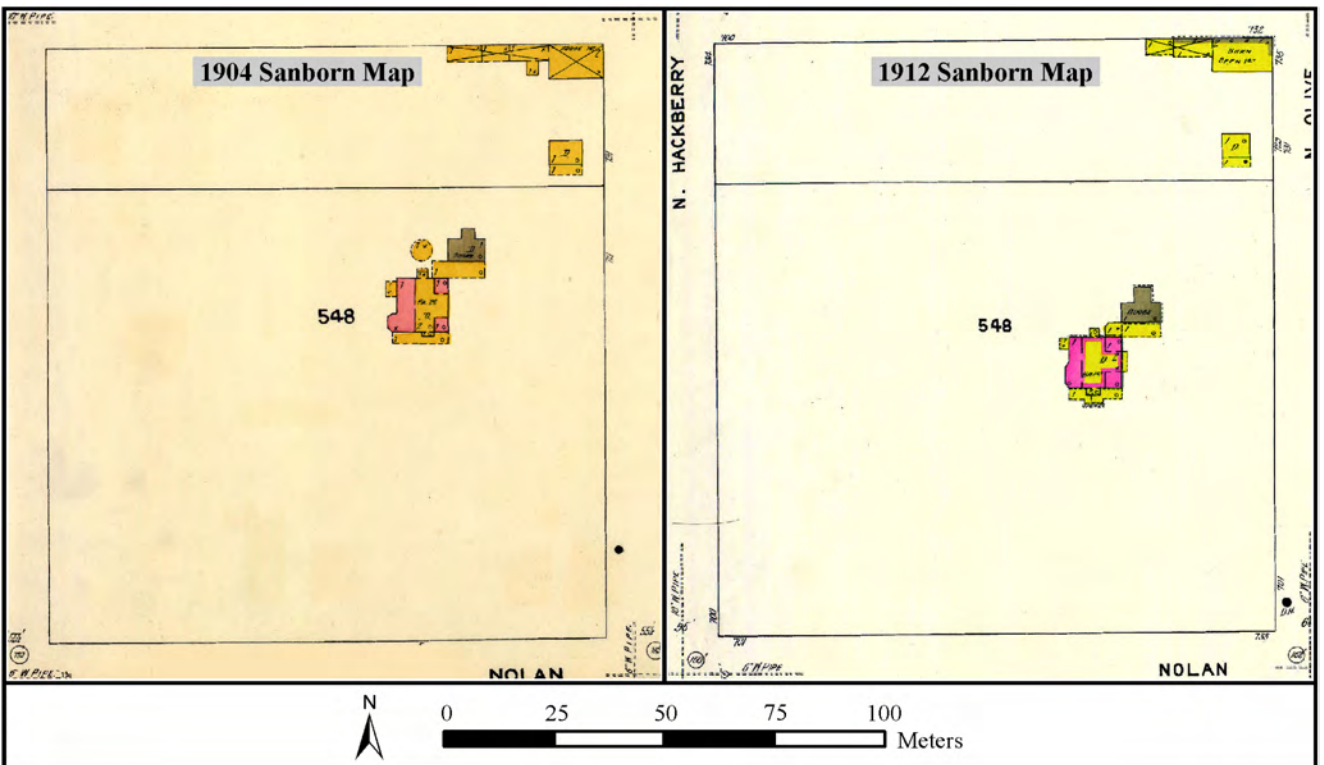
Figure 3-3. The Dignowity property, NCB 548, on the 1904 (left) and 1912 (right) Sanborn Fire Insurance Maps (1904 Sheet 164, 1912 Sheet 147, original located at Dolph Briscoe Center for American History, University of Texas at Austin). Brown represents adobe construction; yellow represents wood frame construction; and pink represents brick construction (Zapata 2023:Figure 3-2).

J. Dignowity (née McCann, 1820-1907). He built his family home, Harmony House, in 1853 on one of those tracts (Lot 10, Range 5, District 1, NCB 548, BCDR 1853:S2:151; Dignowity 1859:223; Fisher 1996:136; Lewis 1907). Harmony House, which lies within NCB 548, appears on the 1904 and 1912 Sanborn maps (Figure 3-3). As in the case of the Lockwood estate, the Dignowity estate included ancillary buildings, such as a barn and an additional dwelling.

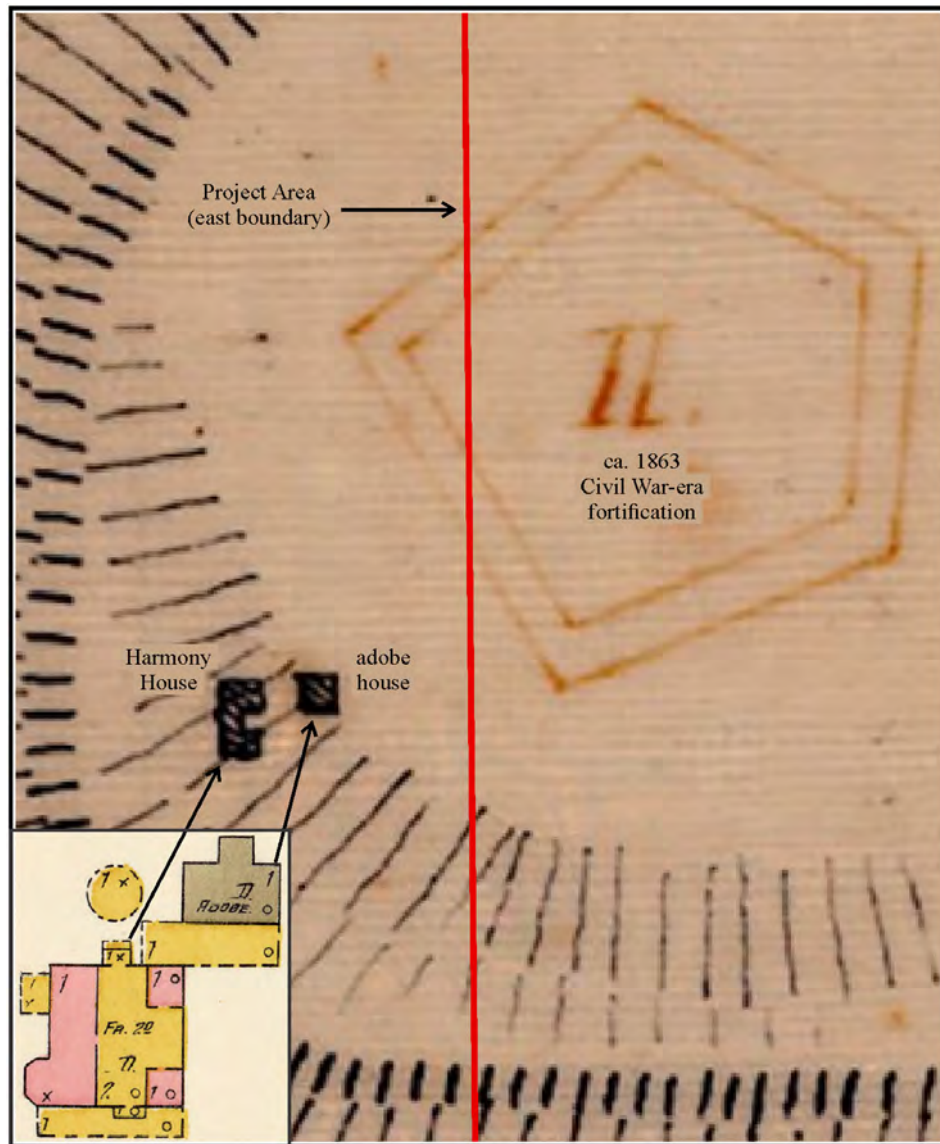
Figure 3-6. Comparison of the Dignowity family home shown on a ca. 1863 map, with an inset of the house from the 1904 Sanborn Map. Note project area's east boundary line (Zapata 2023: Figure 3-3).

There are two structures located southwest of Fortification II that are illustrated in the ca. 1863 Civil War-era map. Based on their configuration, these appear to be Harmony House and the adjoining adobe structure depicted on the 1904 Sanborn map (Figure 3-6). While not exact, the buildings on both maps are similar. The adobe structure was likely Dignowity's first home while Harmony House was being constructed (Valentine 2014:15). As depicted in the 1904 Sanborn map, Harmony House and the adobe structure were later attached by a wood frame porch. The barn and dwelling at the northeast corner of the estate must have been constructed after the Civil War and prior to 1904.

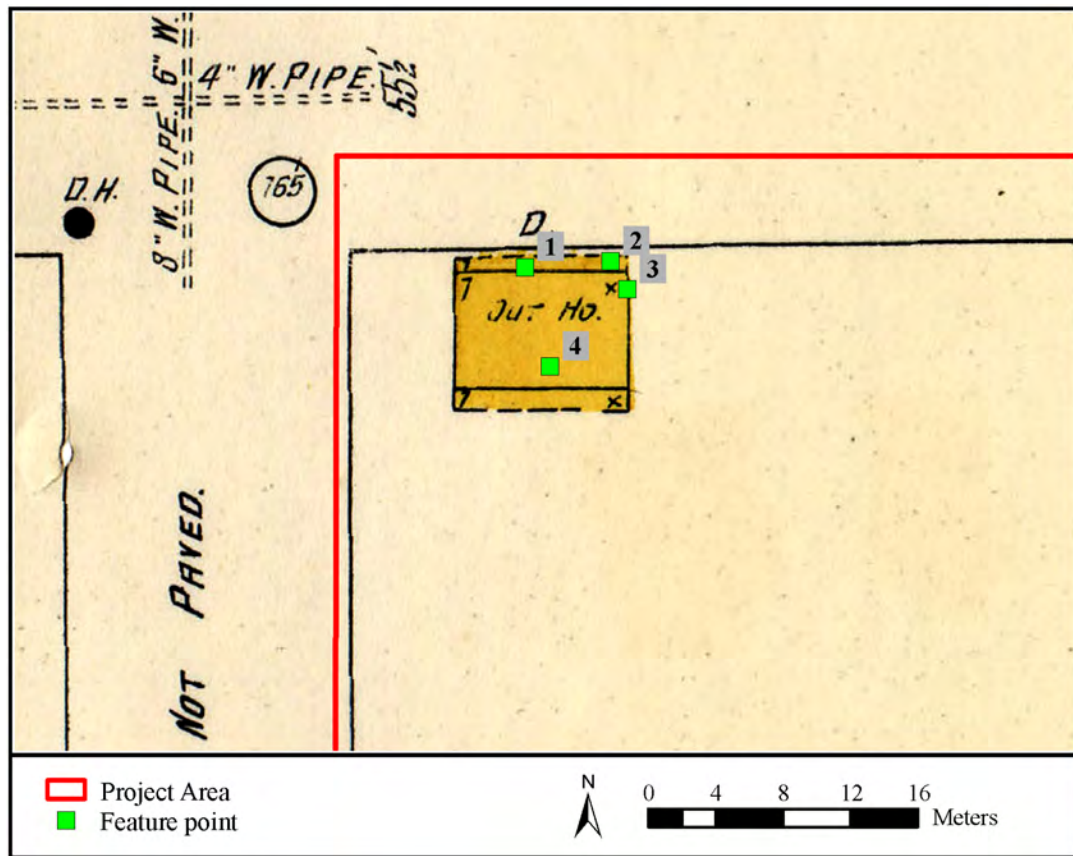
Figure 5-3. Features 1–4, close-up of a georeferenced 1904 Sanborn Map, Vol. 2, Sheet 4.

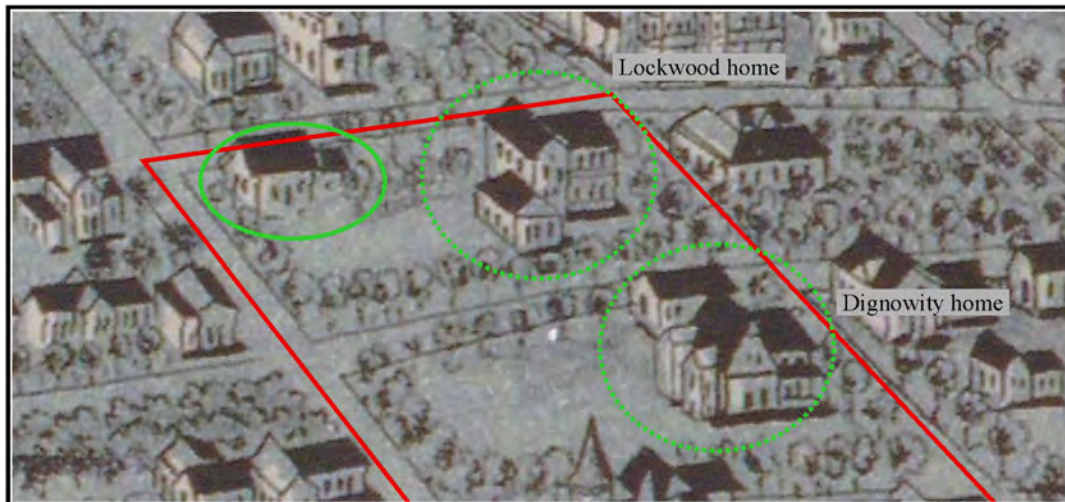
Figure 5-4. A close-up from the 1891 Birds Eye View of San Antonio shows site 41BX2295 (circled in green) on the northwest corner of the Lockwood homestead (Johnson 1891). The project area is marked in red. The Lockwood home is also pictured, as is the Dignowity home.

An address for the house is not shown on the 1904 Sanborn, but the 1912 Sanborn shows it as 600 Hays Street, at the corner of N. Hackberry and Hays Street. The georeferenced points for Features 1 through 4 are shown on the 1904 Sanborn map in Figure 5-3. The property is also depicted on the 1891 Bird's Eye View Map of San Antonio (Johnson 1891) and shown as Figure 5-4. This property may have been the home created to house the Lockwood servants: Oscar and Mary Milner, their daughter Annie and her four children along with the Grants, Harvey and Ketura, and Sarah Magnussen (U.S. Census 1920). Archival research by Zapata (2023) indicated that there was no post-1928 occupation. Therefore, all historic materials encountered date prior to 1928. After Mrs. Lockwood sold the property to COSA, records indicated she moved to Terrell Hills with the Grants and an additional servant, Frances Harman (U.S. Census 1930).

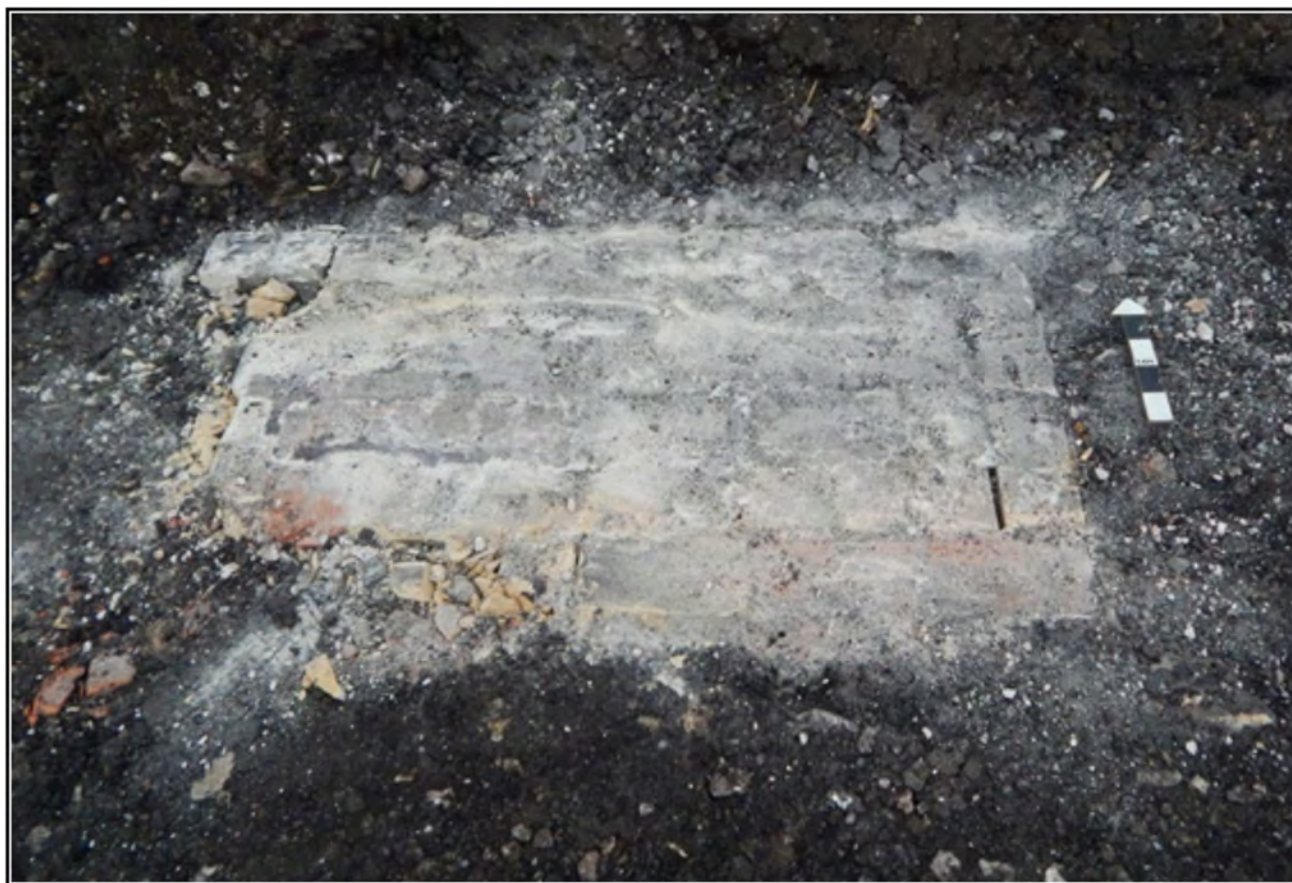
Feature 1 may have been a fireplace, as it appears to be a prepared brick floor surface. It is 130 cm north to south and 160 cm east to west (Figure 5-5). Features 2 and 3, east of Feature 1, appear to reflect a room corner. A two-inch diameter steel pipe, oriented east to west, was found 8 cm above Feature 2 (Figure 5-6). Feature 3 has two rows of three bricks each and Feature 4 is a set of loose four bricks. Two are Seco bricks

Figure 5-5. Feature 1, a possible brick hearth from a fireplace, view north.

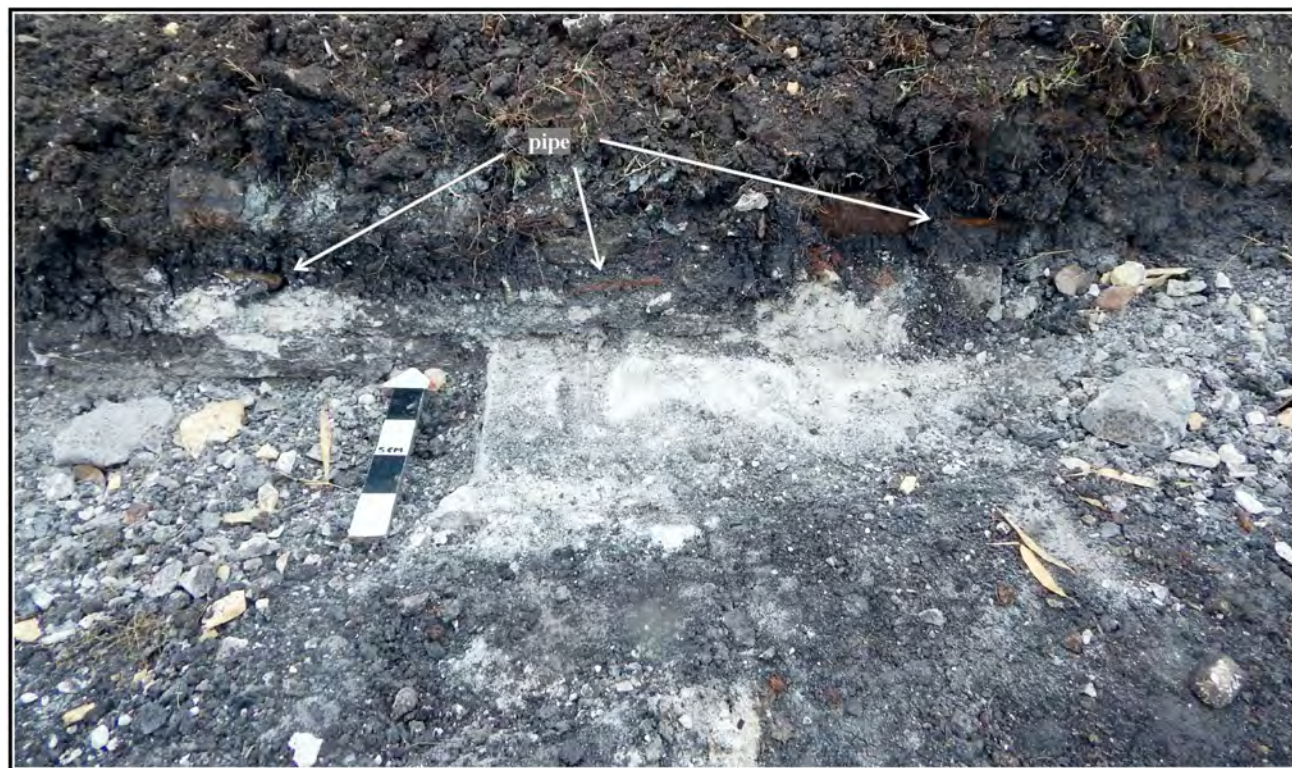
Figure 5-6. North wall profile of Feature 2 with intrusive two-inch steel pipe, view north.

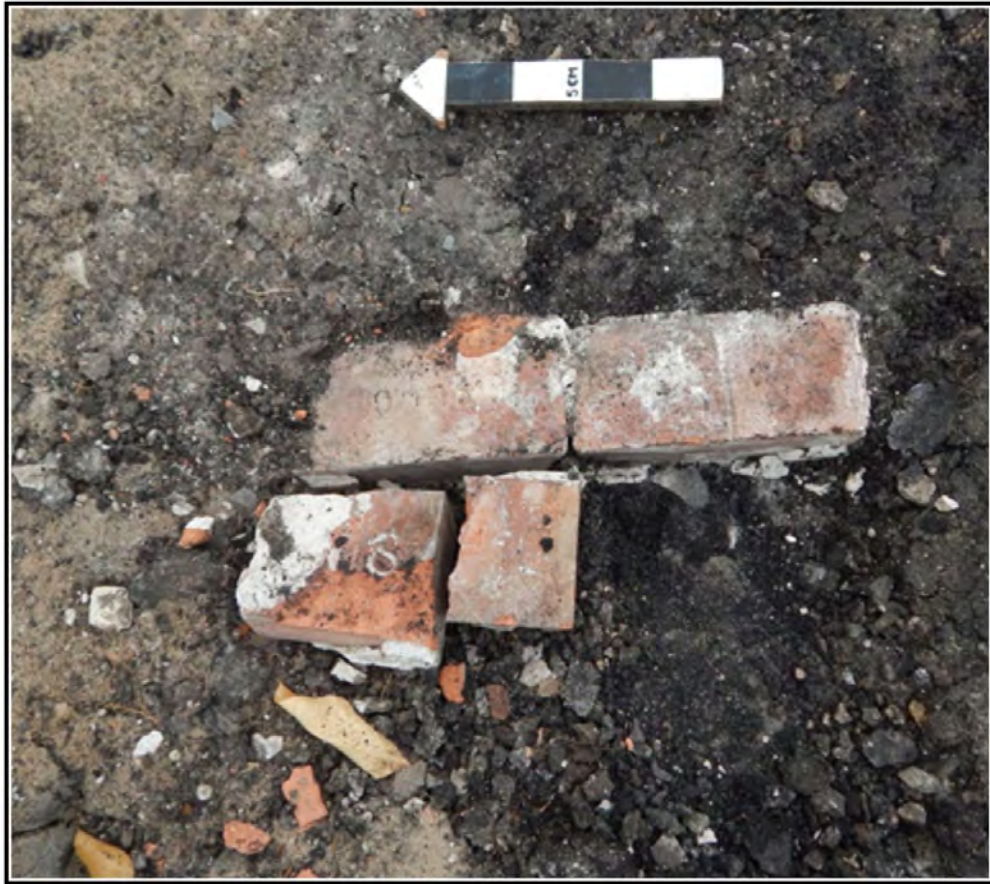
and one is a D'Hanis brick, which were popular in the early to mid-1900s (Figure 5-7). Unfortunately, no paperwork, field notes, or emails could be located that document if the features were preserved in place and, if so, how they were preserved. CAR staff who worked in the feature area at the time recall that the features were not removed, but do not remember how they were preserved.

Figure 5-7. Feature 4 – fractured bricks. Bricks marked “SECO” are to the right and the fractured D’Hanis bricks are to the left. Maker’s marks “NIS” and “D’H” are discernible on brick fragments.

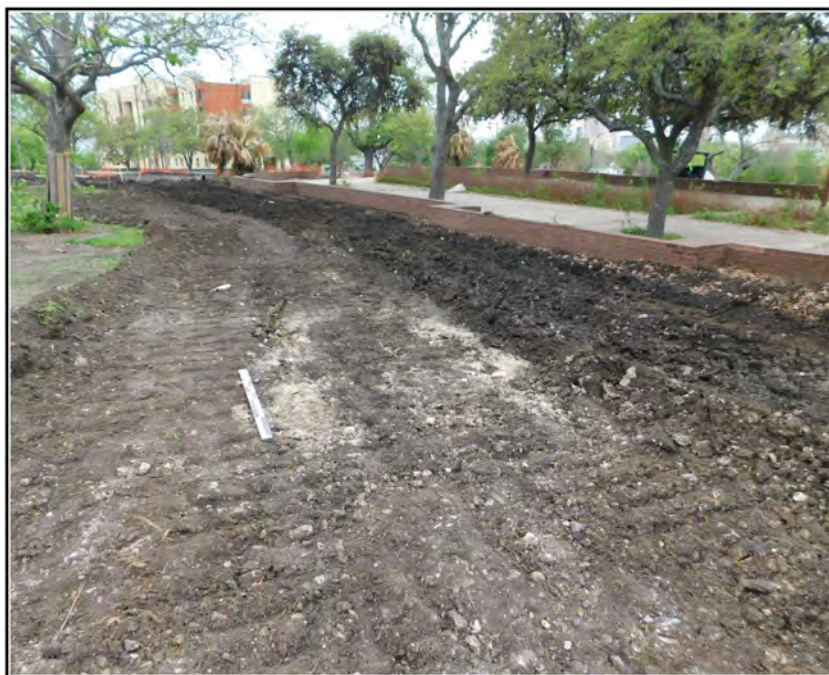
Figure 5-8. Photograph of Feature 5 in the northeast quadrant of Dignowity Park, view southwest.

War-era fortification consisted of a lime slurry with fist-sized cobbles (Zapata 2023). Features 5 and 6 were preserved in place with landscape material, covered by sand, then backdirt.

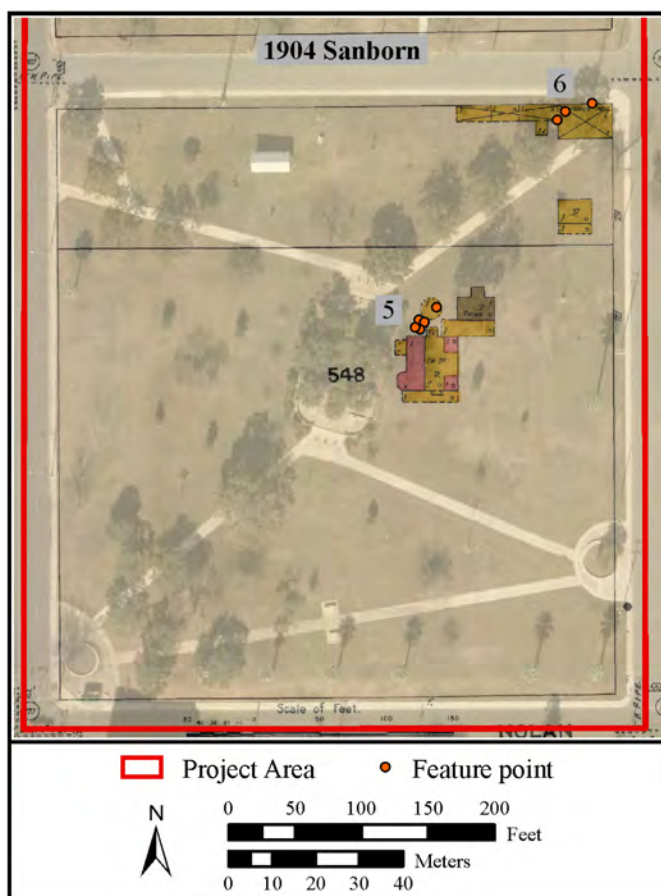
Figure 5-9. Dignowity home on the 1904 Sanborn map, overlain on park image with feature point locations for Feature 5 and Feature 6 shown in orange.

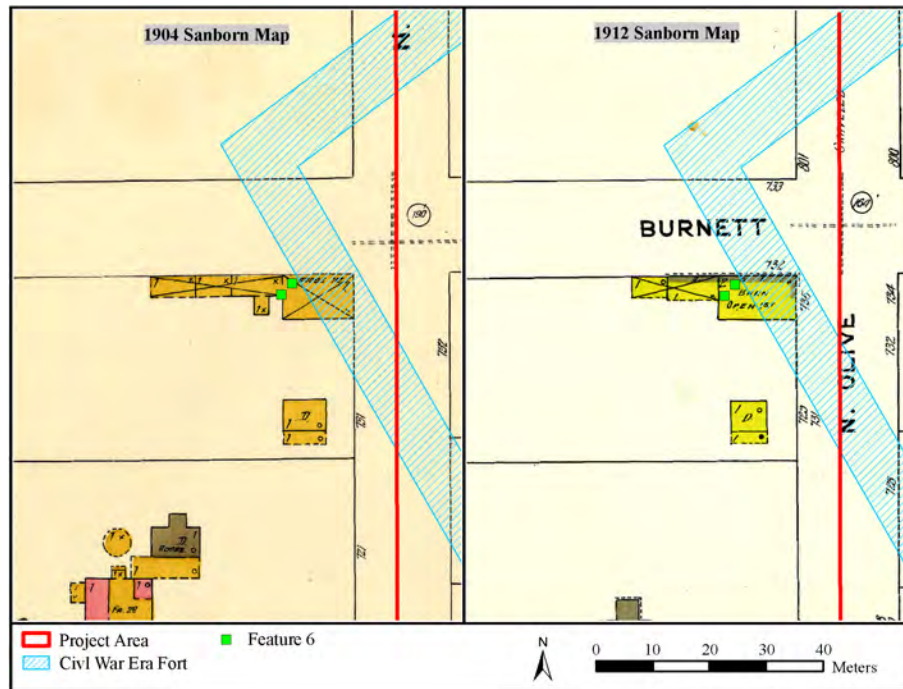
Feature 6 was encountered twice, in early 2021 and then in mid-2022. On both occasions, grading of the area by the contractor exposed sections of limestone wall footings. Owing to a slight slope of the surface in this area, Feature 6 was exposed at between 1 and 20 cm below surface. Based on the GPS location and plotting of the feature onto the 1904 and 1912 Sanborn Maps, the wall footing is likely associated with the Dignowity barn which, when constructed, would have disturbed the Civil War-era fortification (41BX2294). Feature 6 is located just west of the fortification footprint and within the 41BX2296 site boundary (Figure 5-10).

Figure 5-10. Feature 6 is located within the barn structure on the 1904 and 1912 Sanborn Maps. Note the trace of the ca. 1863 Civil War-era fortification, site 41BX2294.

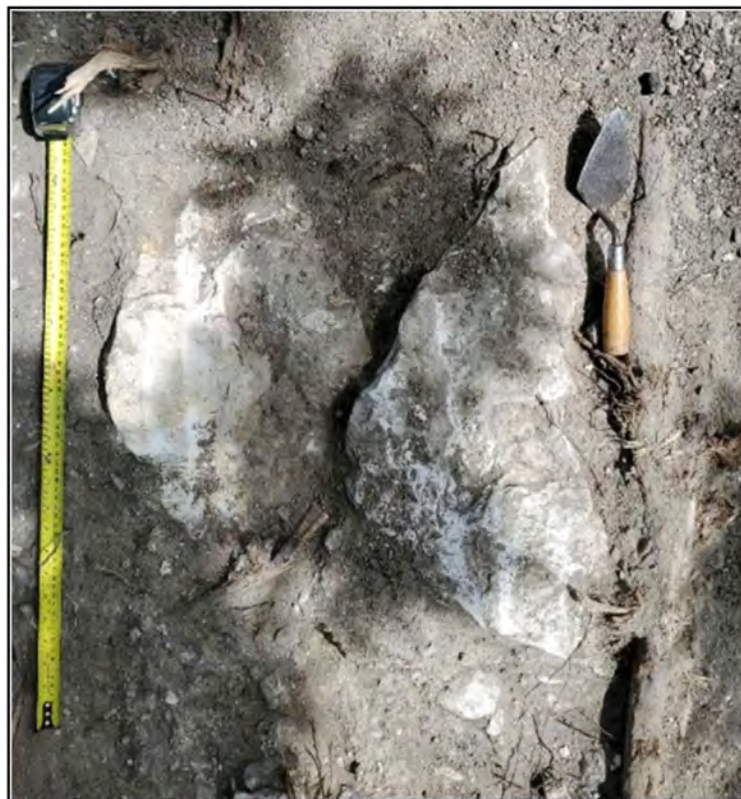
Feature 6 is composed of irregularly shaped limestones, from fist-sized cobbles to larger stones, which were weakly mortared together (see figures 5-11, 5-12, and 5-13). In contrast, the Civil

Figure 5-11. Feature 6 located in the northeast section of Dignowity Park. Three remnants of walls were encountered.

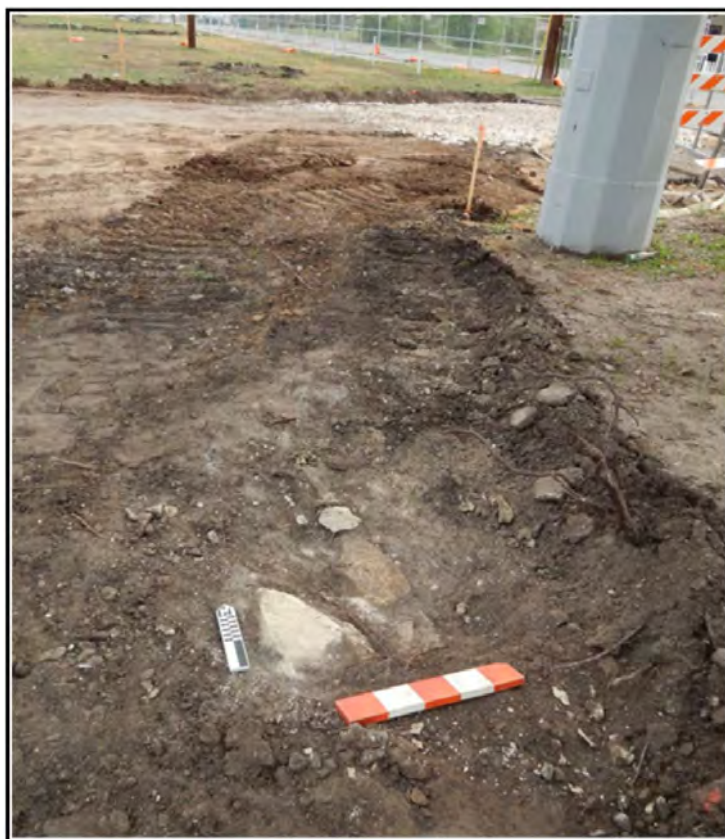
Figure 5-12. Another portion of Feature 6; notice the distinct line of limestones.

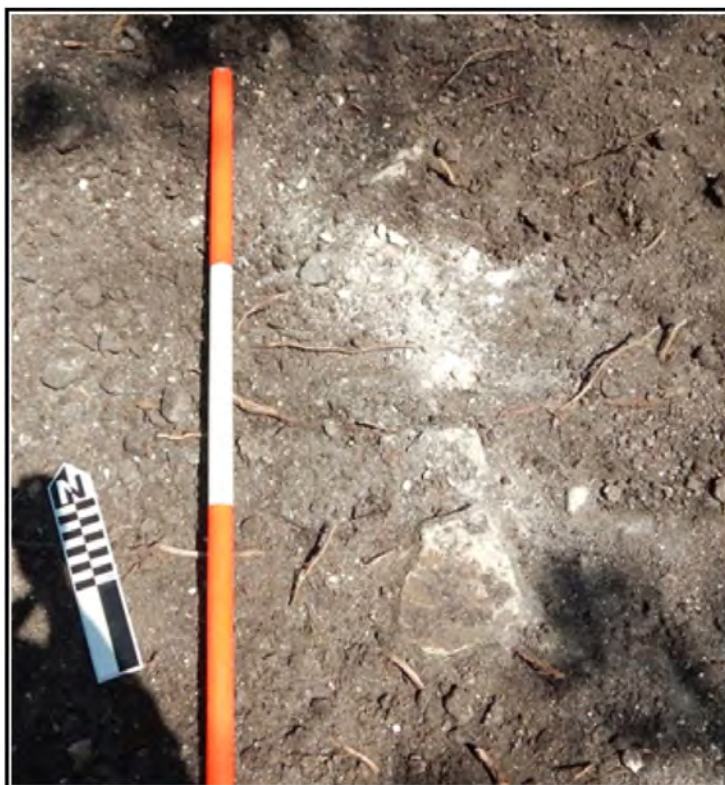
Figure 5-13. The southwest portion of Feature 6.

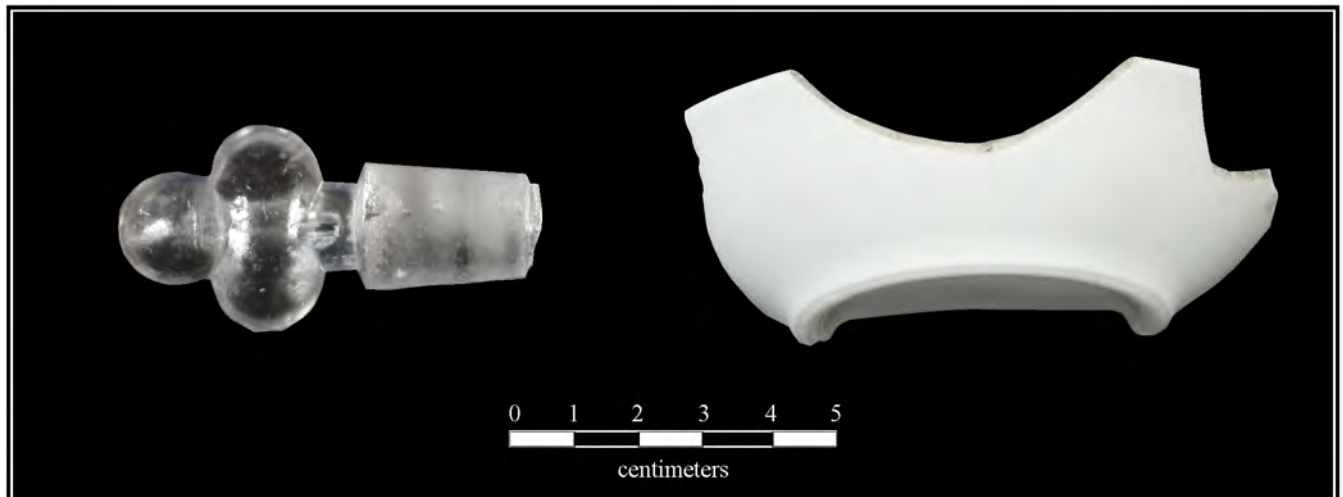
A horseshoe fragment and a glass stopper were also collected. The glass stopper is molded into a spade shape and the shank shows sign of grinding (Figure 5-14). Molds were in common use in the late eighteenth century and early nineteenth century (Lindsey 2021). The remains of a small semi-porcelain dish were also found. Semi-porcelain has been in production since the 1820s but was most popular between 1850 to 1900 (Shelton 2015).

Figure 5-14. Molded glass stopper with possible burnished end (left) and semi-porcelain dish (right).

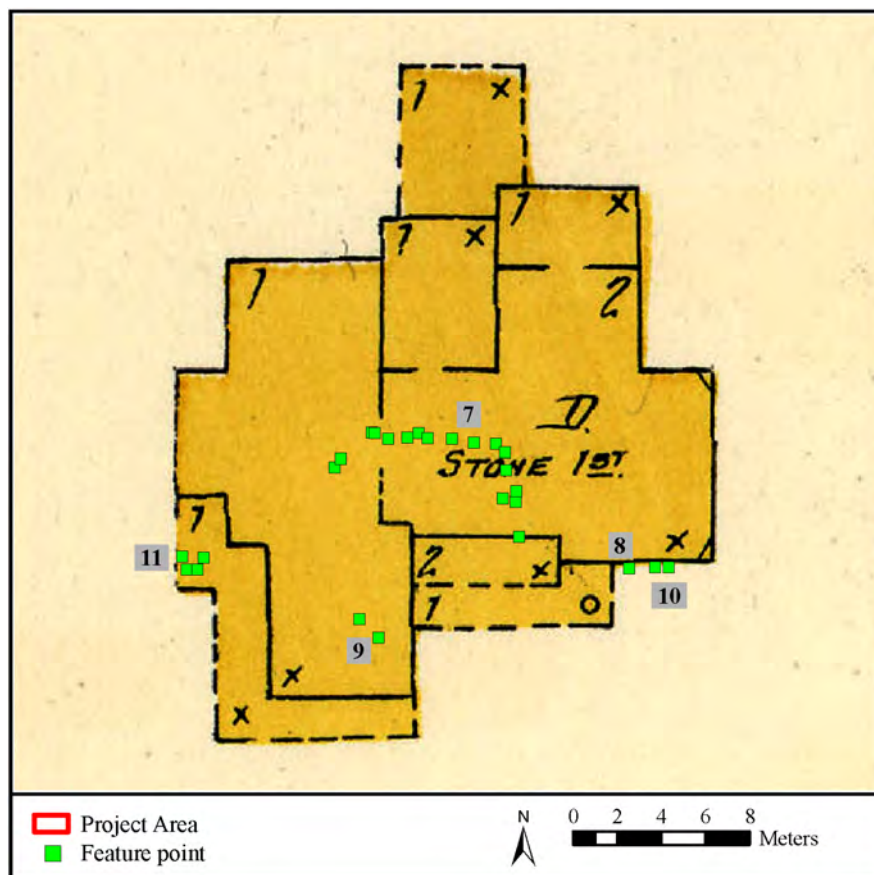
Figure 5-15. The location of Features 7, 8, 9, 10 and 11 on the 1904 Sanborn map. The relationship of the georeferenced feature points to the historic image may be skewed to the northwest (Sanborn Fire Insurance Map 1904).

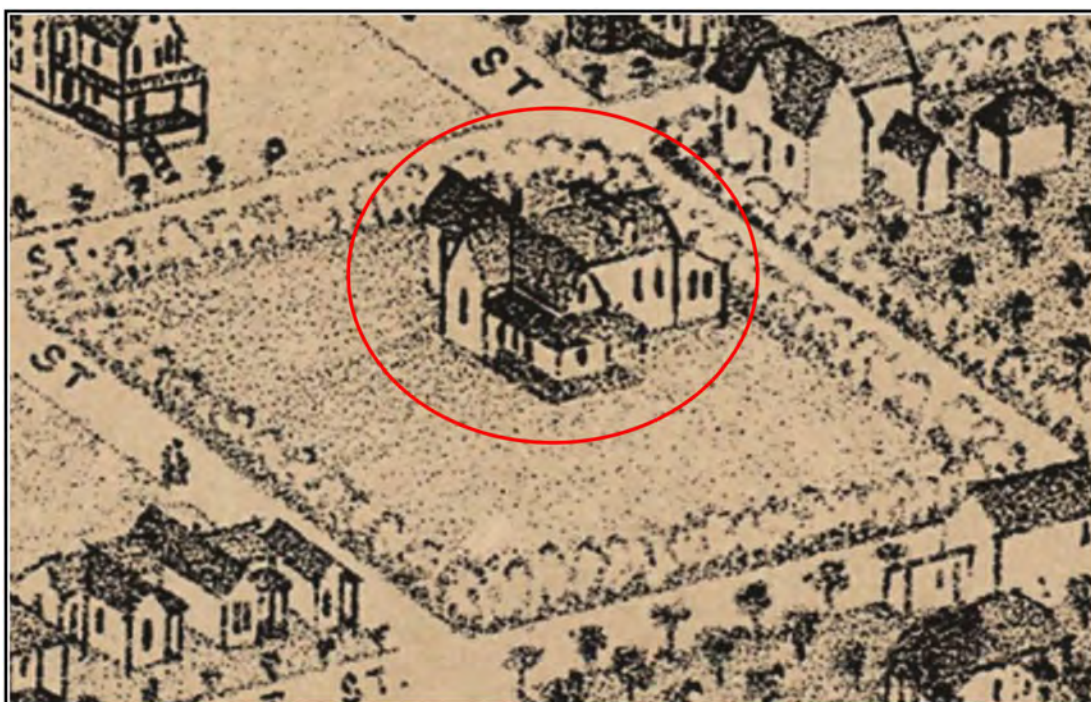
Figure 5-16. Close-up view from Birds Eye View of San Antonio, showing the two-story Lockwood home (Koch 1886).

Remnants of the Lockwood family home were uncovered beneath the Lockwood Park children's playground and immediately south of the Empower House. These remnants are represented by a series of five features depicted in Feature 5-15 overlain on the 1904 Sanborn. The Lockwood house is also illustrated in the 1886 Bird's Eye View of San Antonio (Koch 1986; Figure 5-16). The only artifacts collected from this site were associated with Features 7 and 8.

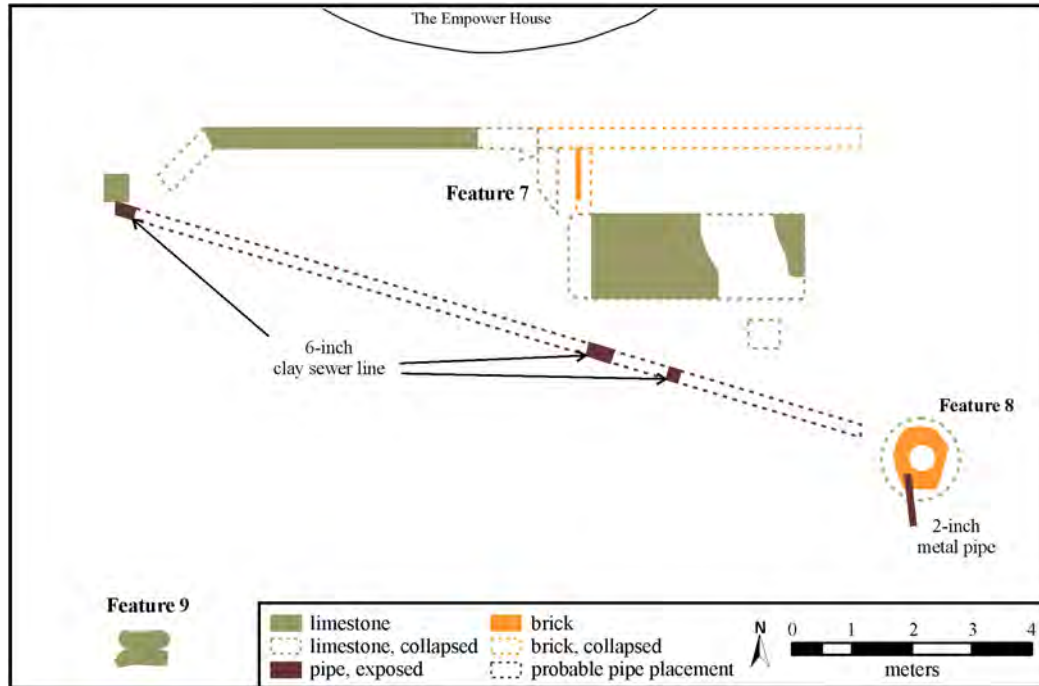
Lockwood home (Figure 5-17). The north end wall footing was intact and measured 0.49 m wide by 4.6 m long (see Figures 5-15, 5-17 and 5-18).

Figure 5-17. Sketch map of site 41BX2414 showing Features 7, 8, and 9 (Features 10 and 11 not shown).

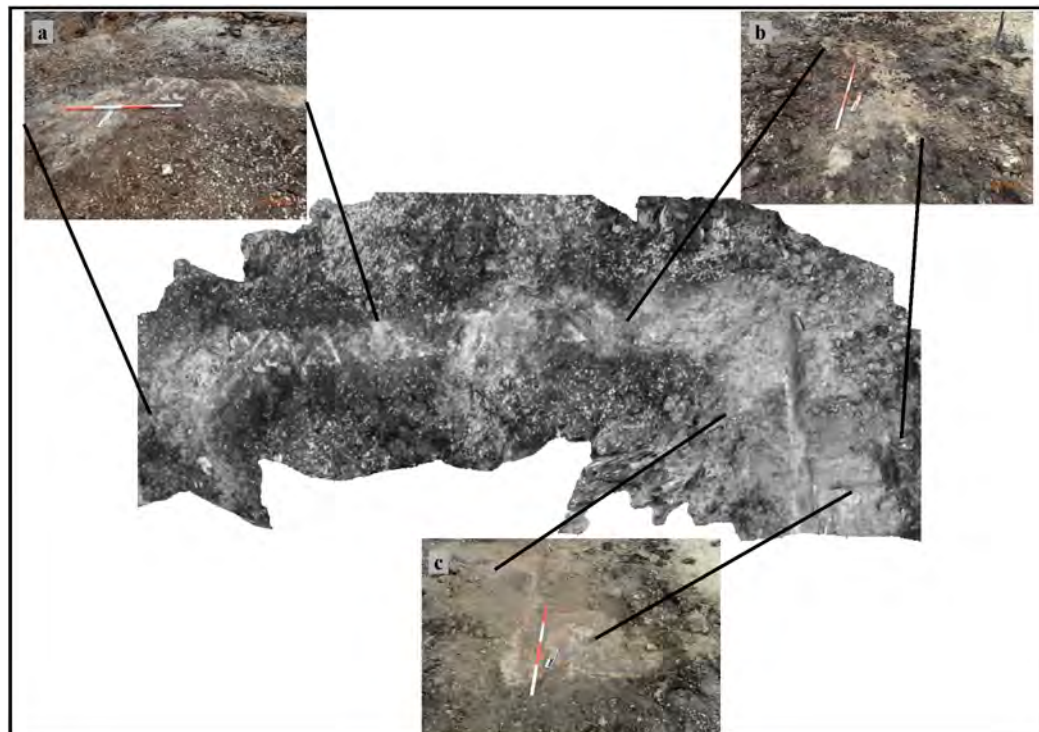
The west end of Feature 7, a possible corner, appeared to have been impacted by the removal of mulch material and grading

(Figure 5-18, insert A). The northeast section was disturbed at some point by the inclusion of red brick (Figure 5-18, insert B). A section of the east side wall footing was in place and connected to a 1.40 m by 1.41 m limestone pad that may have been for a fireplace (Figure 5-18, insert C). A hunter green colored tile was found on top of the possible fireplace.

Figure 5-18. Composite photograph of Feature 7 with inserts highlighting different sections of the wall footing. Insert C is a possible fireplace.

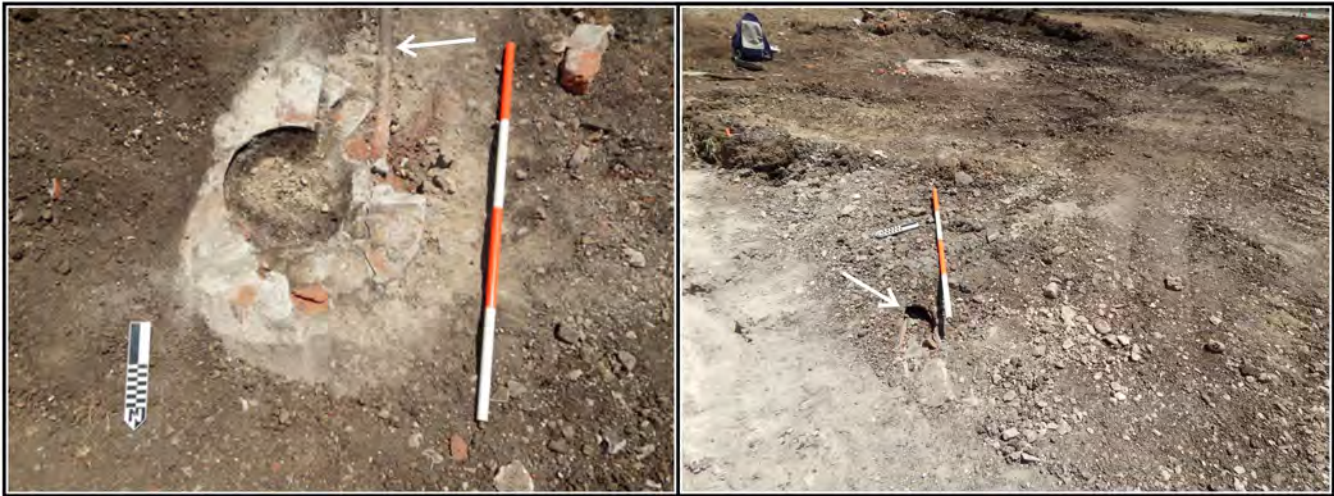
A section of a six-inch clay sewer pipe was exposed at the west end of Feature 7. Additional clearing of debris from this area revealed that the pipe was oriented southeast toward an abandoned cistern. This cistern was exposed at between 40 and 60 cm below surface and designated Feature 8. The feature was circular and brick-constructed and, given the associated sewer line, may have been repurposed as a septic tank (Figure 5-19). A two-inch steel pipe was located at the south end of the

cistern, and may have served as an overflow outlet, when it was used to harvest rainwater.

Figure 5-19. Feature 8 has the appearance of a capped cistern. Photo at left—notice the two-inch metal pipe extending south (arrow at top); photo at right—notice six-inch clay sewer pipe (arrow left of center) oriented southeast to cistern at top.

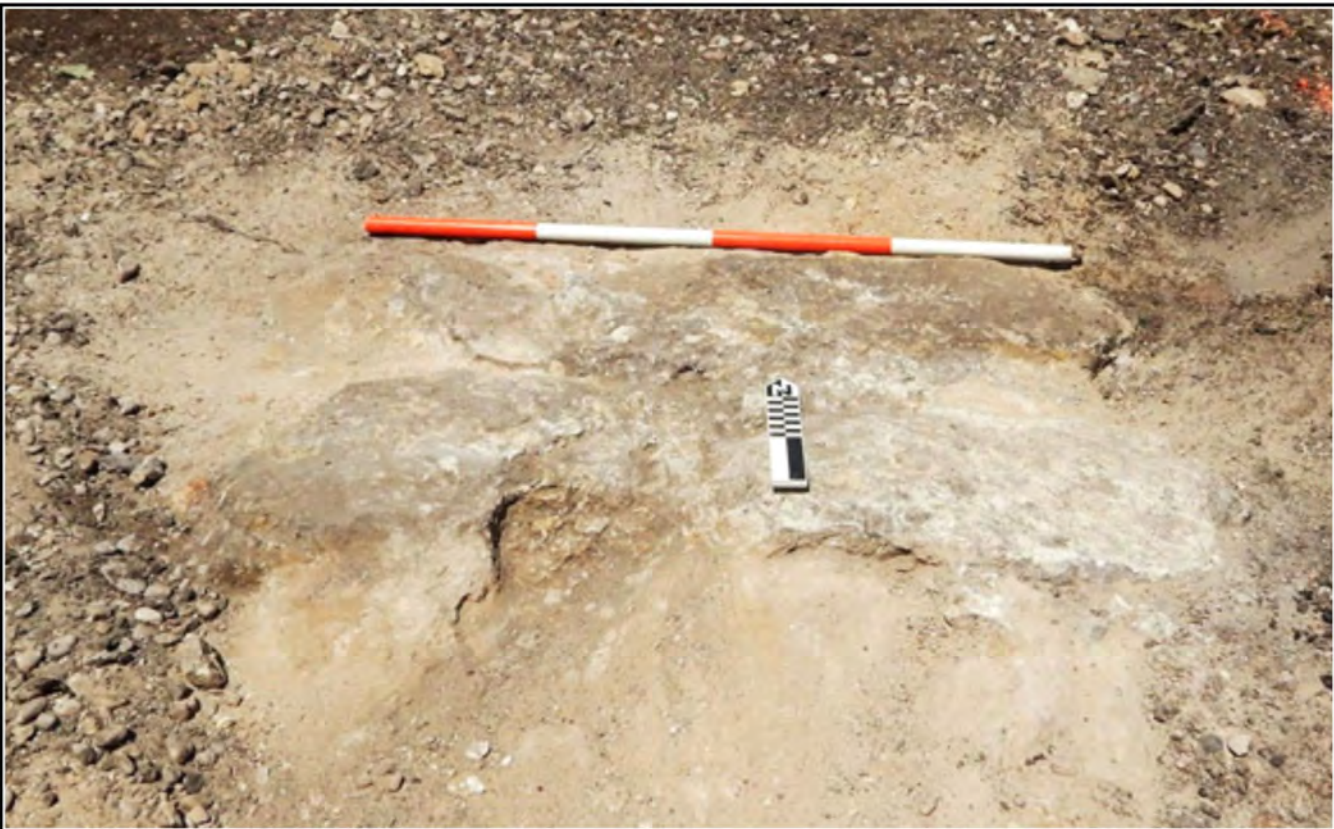
Feature 9 was comprised of two large limestone blocks, with the uppermost stone exposed at 3 cm below surface and the second at 20 cm below surface. The blocks were reminiscent of steps (Figure 5-20). The 17 cm difference in elevation suggests a typical height difference between steps.

Figure 5-20. Photograph of Feature 9, probable steps, found at the southwest end of Feature 7.

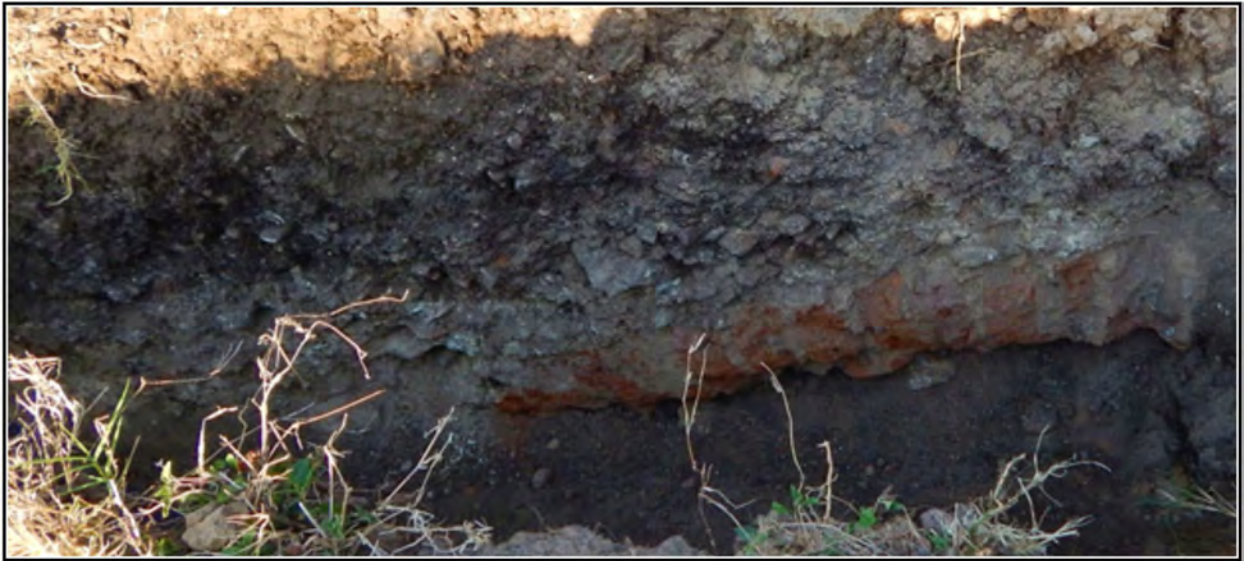
The CAR returned to monitor excavations 1.6 m west of Feature 8 for the installation of an irrigation line. A portion of what may have been a cistern was exposed at 20 cm below surface and was designated Feature 10. In retrospect, this may be an extension of Feature 8, as the feature appeared to have been brick lined and domed shaped (Figure 5-21). This feature was severely damaged by previous trenching activities.

Figure 5-21. Photograph of Feature 10.

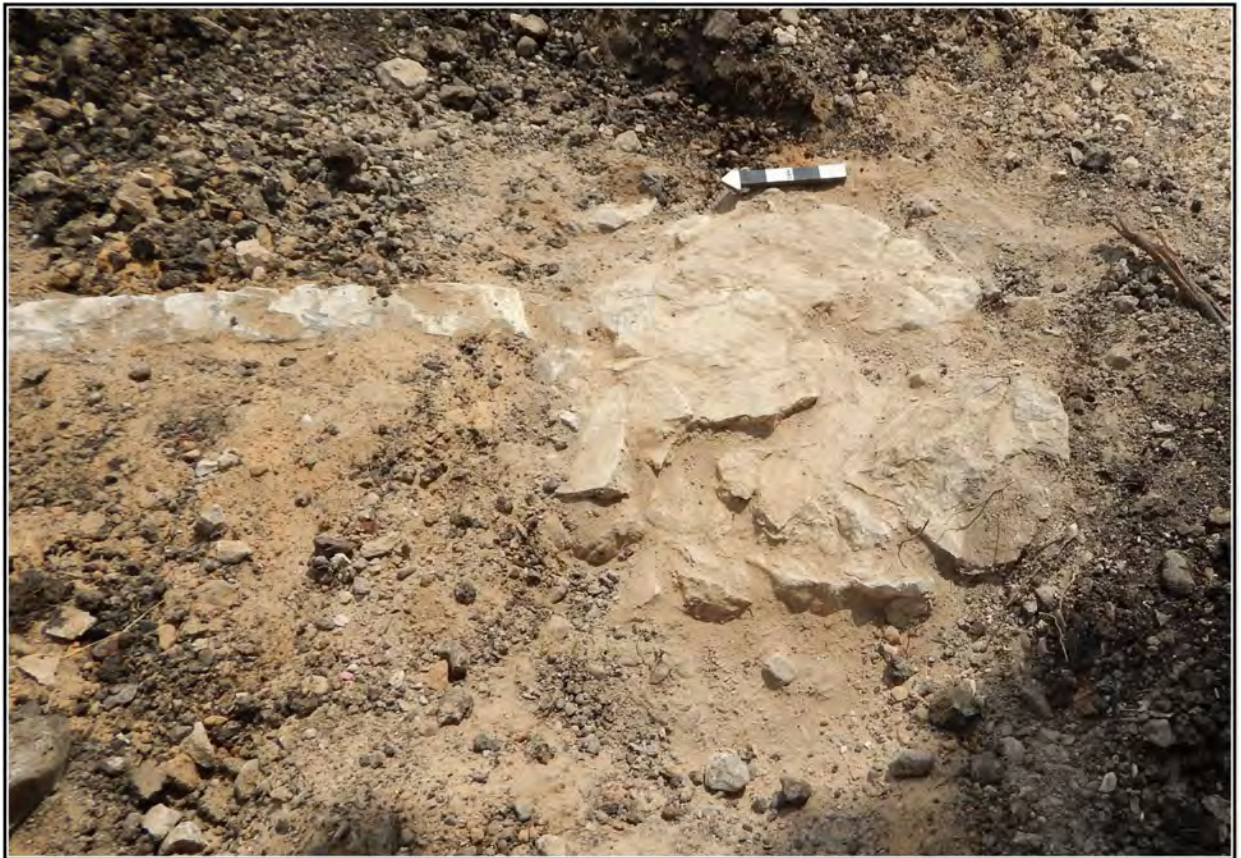
Feature 11 was exposed at 30 cm below surface and was located west of the Feature 7 and 9. It is composed of limestone cobbles that lie underneath a concrete intrusion (Figure 5-22). Feature 11 may represent a southwest corner of the Lockwood home (see Figure 5-15). Features 7 through 11 were preserved in place with landscape cloth, covered by sand, and backdirt.

Figure 5-22. Feature 11 is constructed of limestone topped by a concrete intrusion.
