Archaeological Monitoring of the Dignowity and Lockwood Parks Improvements Project, San Antonio, Bexar County, Texas

by
Lynn Kim and José E. Zapata

Prepared by:
Center for Archaeological Research
The University of Texas at San Antonio
One UTSA Circle
San Antonio, Texas 78249-1644
Archaeological Report, No. 506

The Center for Archaeological Research (CAR) conducted archaeological monitoring for the City of San Antonio (COSA) Dignowity and Lockwood Parks Improvement Project, an area comprised of 3.4 hectares (ha; 8.5 acres). The work, completed intermittently between February 2021 and June 2023, involved extensive grading and utility trenching. Because the project area is on COSA-owned land, the project falls under the Unified Development Code (UDC; Article 6 35-630 through 35-634) and requires review from the COSA's Office of Historic Preservation (OHP). In addition, the work required review by the Texas Historical Commission (THC) under the Antiquities Code of Texas and was conducted under Permit No 9747. The Principal Investigator of this project was Cynthia Munoz, Interim Director of the CAR, with Lynn Kim serving as the Project Archaeologist.

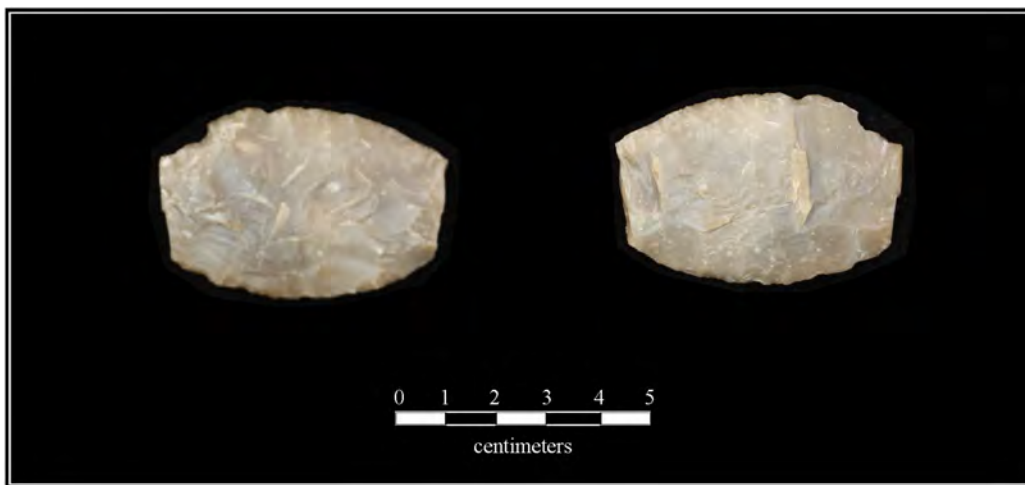
A broken projectile point was recovered from the surface, near an electrical conduit trench. The monitored area was off the southeast corner of Lockwood Park, and just west of the Civil War-era fortification (41BX2294). Based on previous work in this project area, the find was not surprising, as lithics are distributed throughout Lockwood and Dignowity Parks (Zapata 2023). The recovered point is made from a brown

(Munsell 7.5YR 5/2) waxy chert. The thickness of the fractured distal end measures 3.4 mm, the medial 8.5 mm, and the base 7.5 mm. The fractured point is 55.25 mm long and 37.0 mm wide (Figure 5-23). We are unable to assign this find to any precontact period, though the general characteristics may reflect Archaic use (8800-1200 BP, Turner and Hester 2011).

Figure 5-23. Broken projectile point, surface collection.

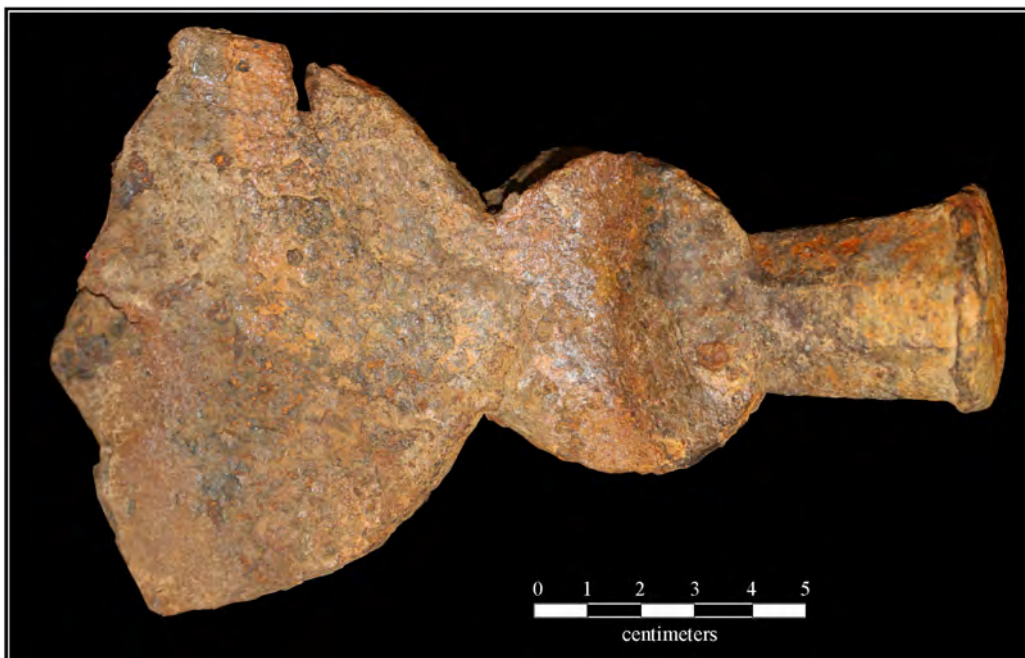
A historic plumb broad hatchet, typically used for installing roof shingles, was recovered from an electrical conduit trench at the northeast quadrant of Dignowity Park (Prentiss 1986:746; Weisgerber 1999). The hatchet dates to between the late nineteenth to early twentieth century. It was recovered near a CPS pole, off the corner of N. Olive and Burnett streets. The hatchet was damaged, resulting in a bend in the cheek and breakage between the cheek and poll. The poll was a hammer, and the notch in the blade is a nail puller (Figure 5-24).

Figure 5-24. The plumb broad hatchet. Notice the nail pull notch, upper left.
