# **Archaeological Investigations at the Lily Pond in Brackenridge Park, San Antonio, Bexar County, Texas**

**Texas Antiquities Permit No. 6021**

*Prepared by:*  
Center for Archaeological Research  
The University of Texas at San Antonio  
One UTSA Circle  
San Antonio, Texas 78249  
Technical Report, No. 35

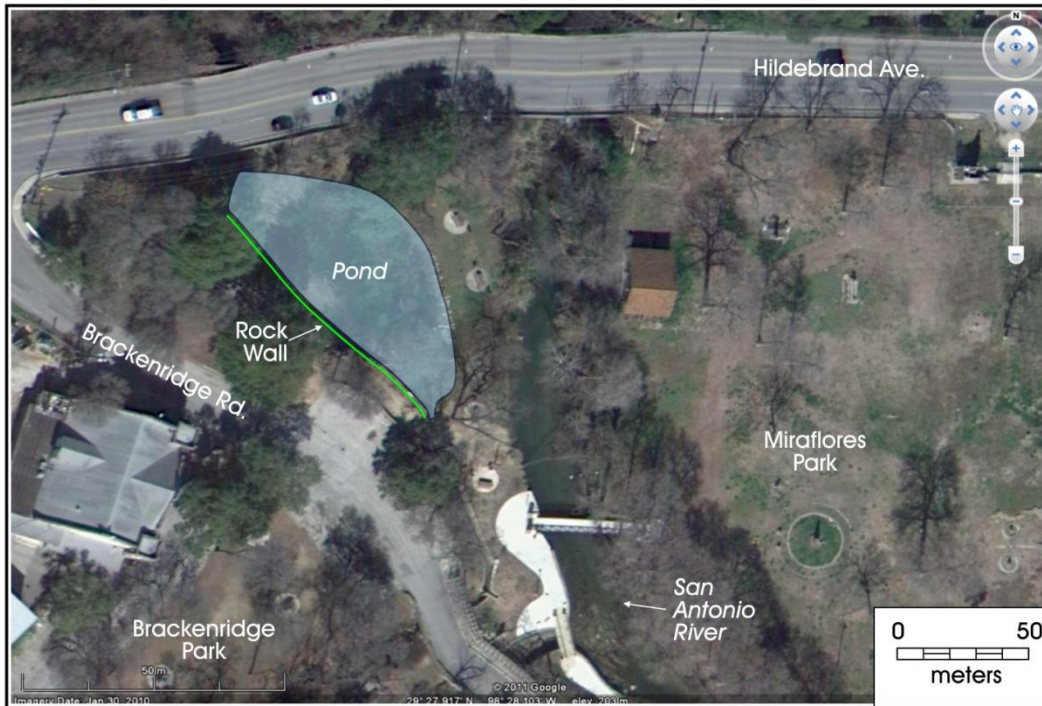
Figure 1-2. Aerial photo of the APE with the Lily Pond outlined.

Recent attempts by San Antonio Parks and Recreation Department to clean out silt that had accumulated in the Lily Pond immediately west of the Spanish Colonial Upper Labor Dam exposed an apparent rock alignment in the western portion of the pond paralleling the existing rock wall (Figure 1-2). This apparent alignment is located approximately 0.9-1.1 m (3-3.5 ft.) inside of the reconstructed rock wall that borders the Lily Pond along the western edge. The rock alignment appeared to consist of large cut limestone blocks. Prior to the beginning of the project, only the upper few inches of these blocks had been exposed. At the time, it appeared as if these blocks were held in place by cement-containing mortar. The wall segment appeared to be approximately 5.5-6.1 m (18-20 ft.) in length starting near the mouth of the reconstructed channel of the Upper Labor *Acequia* and running northward. Given the small amount that was exposed, it was not possible to establish the construction technique of the wall or its possible relationship to the Upper Labor Dam that is located on the east bank of the Lily Pond.

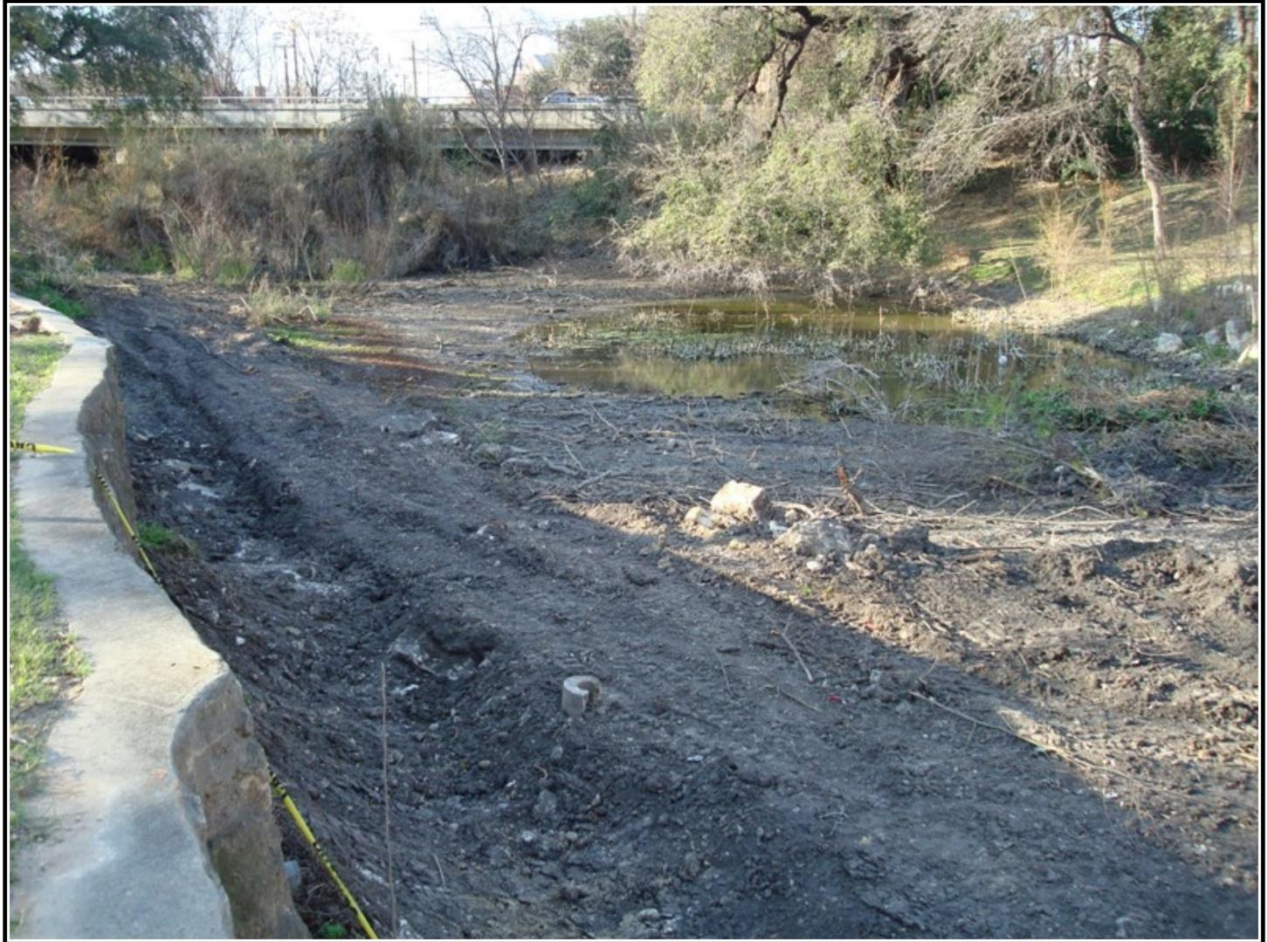
Figure 1-3. *Possible rock alignment as it appeared shortly after being exposed.*

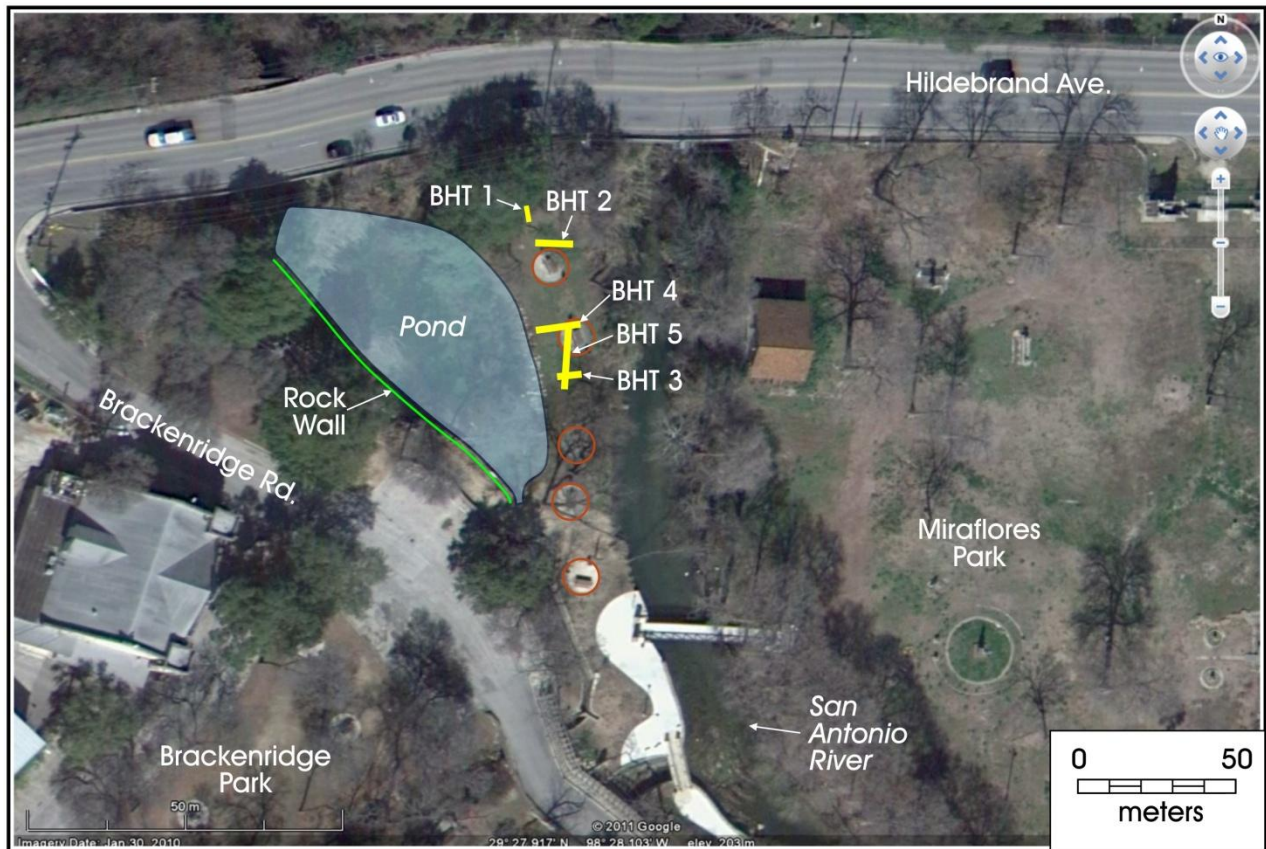
Figure 2-1. Aerial photo showing the Upper Labor Acequia and the locations of the BHTs excavated during the 1996 investigations.

In 1996, a portion of the Upper Labor *Acequia* was exposed in the northern portion of Brackenridge Park. The City of San Antonio Parks and Recreation Department contracted the CAR to investigate the feature. During the course of the project, Site 41BX1273 was recorded. The site was identified as the Upper Labor Dam, first constructed in 1776 with limestone blocks to divert water from the river into the Upper Labor *Acequia*. The dam was modified during the nineteenth century with dressed stone and set at a slightly different angle. A prehistoric component to the site was also recorded during this project. The prehistoric deposits were noted at 120 cm (47.2 in.) below the surface and consisted of lithic debitage (Figure 2-1) (Cox et al. 1999).

Finally, in 2009, the CAR staff excavated the remnants of a dam on the west bank of the San Antonio River within the footprint of the bridge that was to connect Miraflores Park with Brackenridge Park (Tomka and Dowling 2009). The bridge is shown in the lower center of Figure 2-1. The archaeological materials that were recovered included Early Archaic temporal diagnostics, but they were determined to be out of context and re-deposited from a site located immediately adjacent to Hildebrand Avenue. The dam appeared to have been associated with the San Antonio Waterworks Raceway although a 1926 map of the area shows at least three smaller dams across branches of the stream near this location (see Chapter 3).

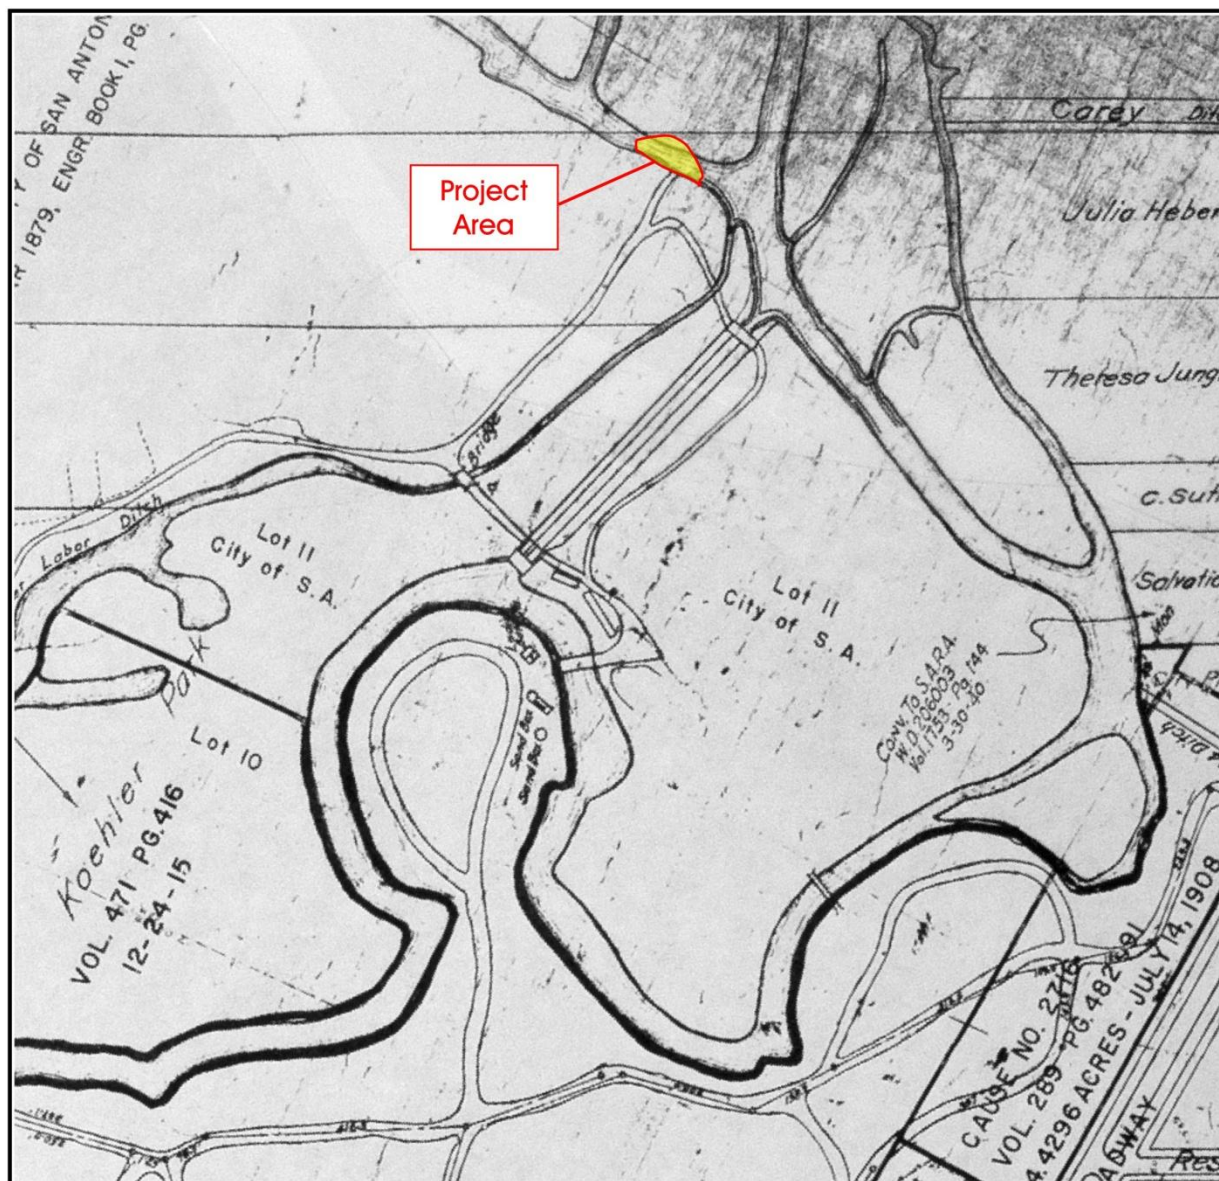
Figure 3-5. The current APE on a map of Brackenridge Park, circa 1908, that depicts the acquired parcels of land that make up the park (Electronic copy on file, CAR).

An undated map, likely drawn in 1908 or later, of the Brackenridge Park area depicted all the additions that had occurred since the first designation of the property as a park (Figure 3-5). Inspection of the area of the Lily Pond does not reveal a feature that could be related to the stone alignment. As evident on the map, a path or road leads to the area of the Lily Pond and also splits off to cross over the Upper Labor Acequia and the millrace that lead to the Water Works pump house.

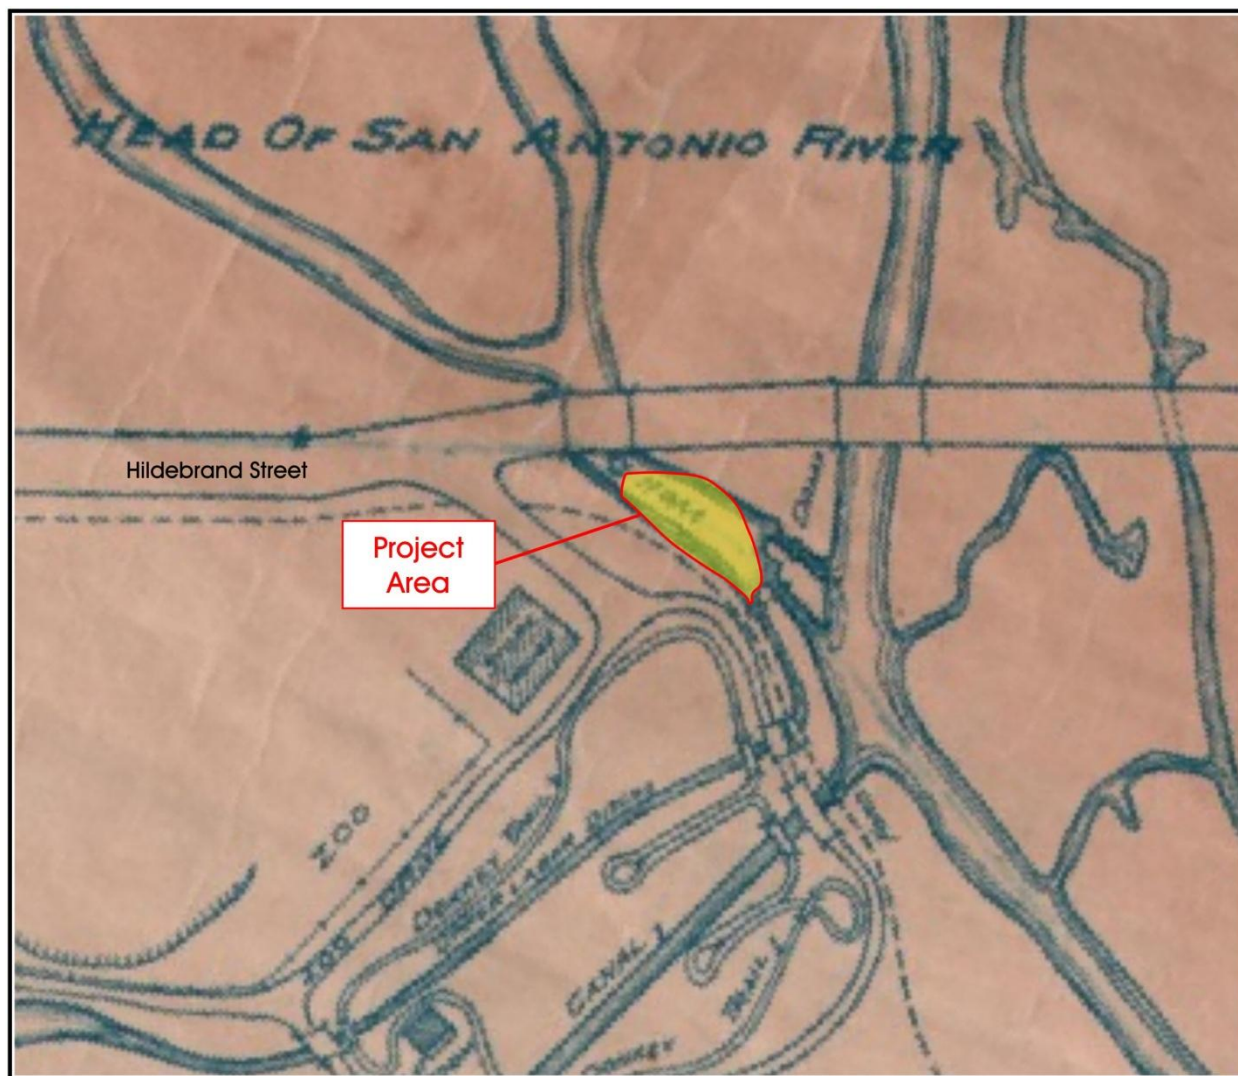
The 1926 map of Brackenridge and Koehler Parks shows a more detailed illustration of the headwaters of the River at Hildebrand Road (Figure 3-6). Three dams are depicted on this map just south of the current APE. The Lily Pond area seems to be the same as what is labeled as “Well” on this map. It is difficult to see if there is a feature that could be related, but there is a line on the 1926 map that potentially can be interpreted as something other than the riverbank. This map is more accurate with its depiction of the road leading into the park from Hildebrand. The road passed by the Lily Pond and a foot path, which had been created at this time, located between the road and the river.

Figure 3-6. Detail of 1926 map, "Brackenridge and Koehler Park" (Electronic copy on file, CAR).

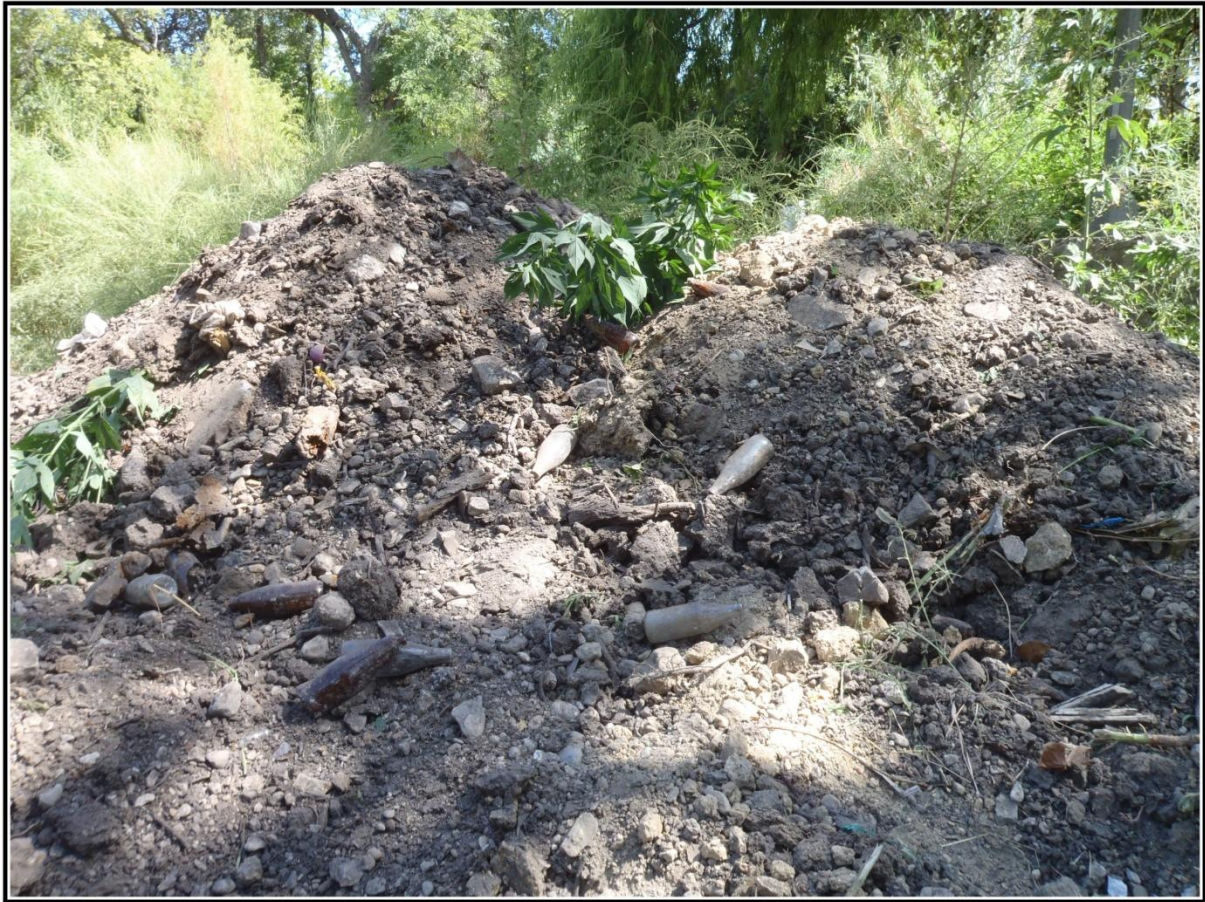
The project archaeologist asked the backhoe operator to stop work in the northern portion of the trench and open what would be the southern end of the trench. Large limestone blocks were noted on the surface in the southern portion adjacent to the southern wall of the pond, and the trench was opened up approximately 30 cm (12 in.) east of the stones. No evidence was noted in the profile of the trench that would indicate a dam or rock alignment. The soil in the southern portion of the trench consisted of fill material that had many glass bottles (Figure 5-1). The bottles dated to the 1970s and 1980s and consisted of soda (Pepsi, RC Cola, Sprite, Mountain Dew, and other varieties) and beer bottles (Michelob). Several pull tab cans were noted as well (Pepsi and Budweiser). The project archaeologist then had the trench expanded to the west to see if stones were present, but none were noted that were adjoined to one another.

Figure 5-1. *Bottles and modern material encountered in the southern portion of the trench.*

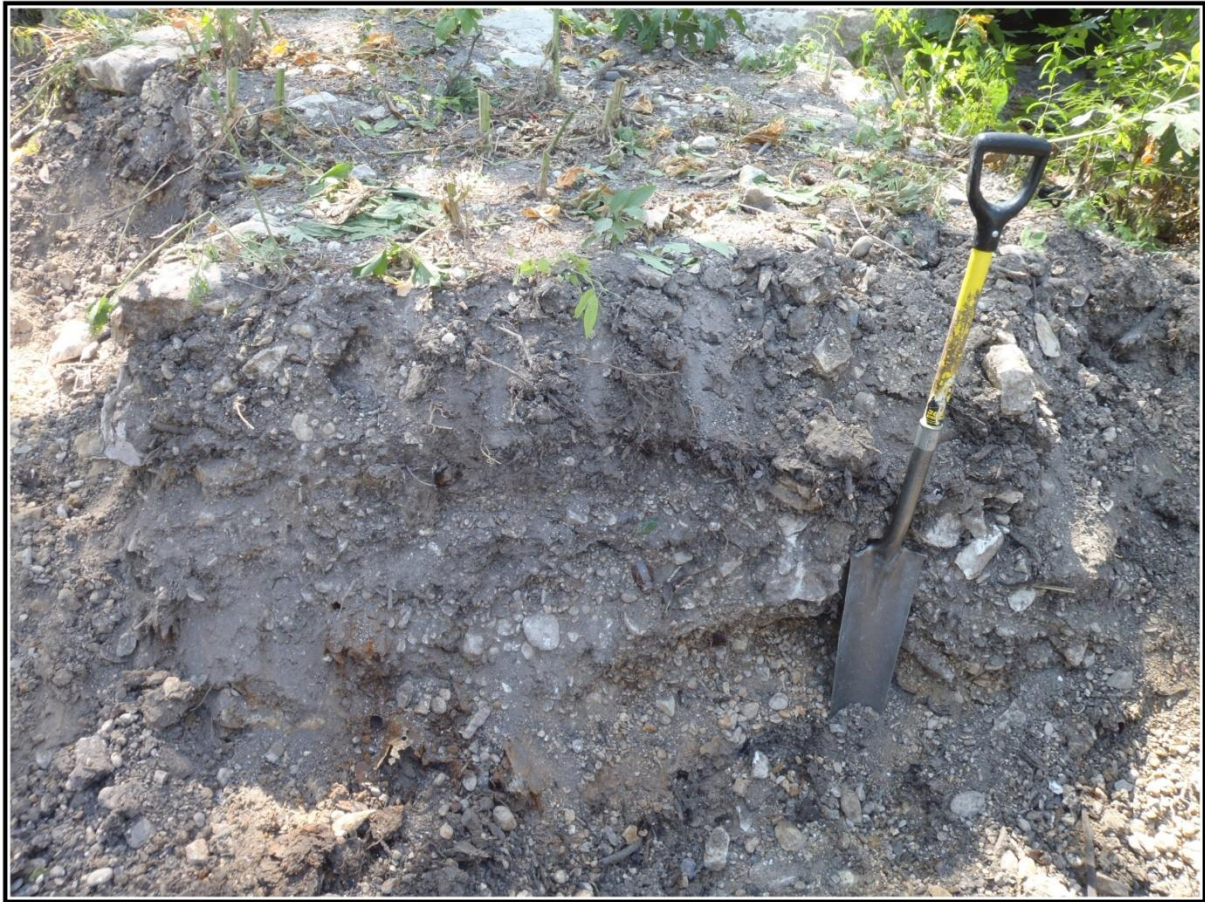
Since both the northern and southern portion of the trench appeared to have no evidence of a systemic alignment, the project archaeologist opted to cross-section the area that was believed to contain an alignment. This east-west running trench was located approximately 5 m (16 ft.) north of the south wall of the pond. The trench did not reveal any rock alignment (Figure 5-2). The fill noted in the southern portion of the initial north-south trench extended well into this area.

Figure 5-2. *Southern profile of the cross-section of the backhoe trench.*

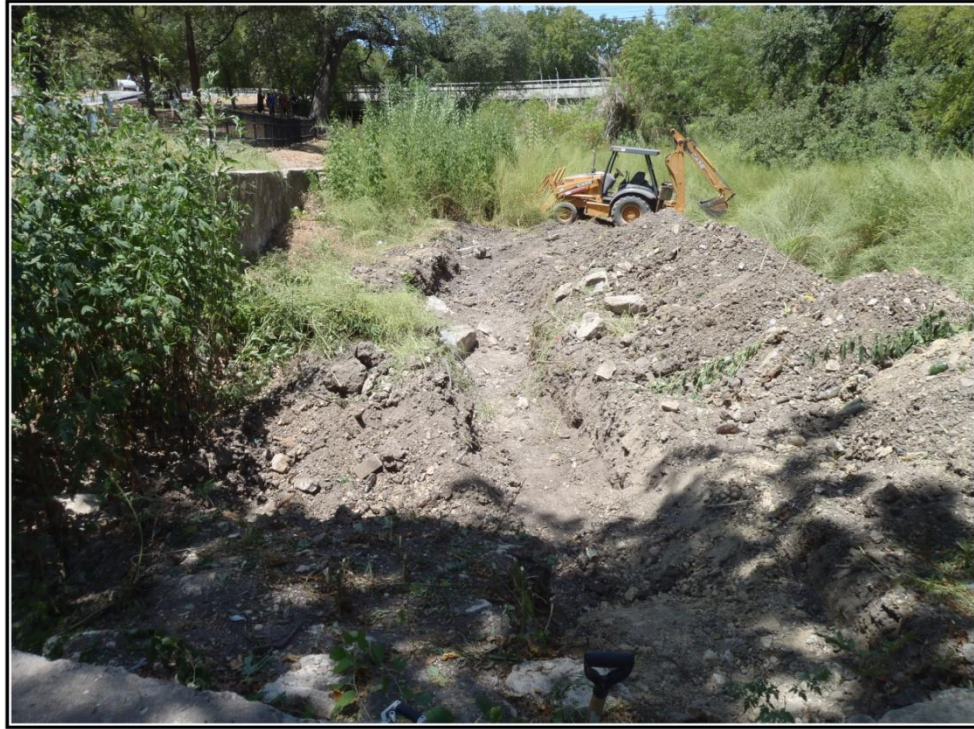
In a final attempt to search for any buried rock alignment, it was decided to connect the two ends of the trench (Figure 5-3). In the process, two remnants of the original Lily Pond wall were encountered in the mid-portion of the trench. The larger fragment was approximately 2.05 m (6.7 ft.) in length (Figure 5-4). Approximately 1.75 m (5.7 ft.) of the second fragment was uncovered in the trench (Figure 5-5). Both fragments appear to have fallen into the pond (Figure 5-6). The wall is 30 cm (11.8 in.) in thickness, which is the same as the currently standing reconstructed portion running around the pond today. The location of the wall fragments within the pond coincides with areas of the wall that show cracks and repairs. These wall fragments are related to the original rock wall that, in all likelihood, was constructed during the WPA era.

Figure 5-3. Entirety of the backhoe trench excavated within the Lily Pond. Rock wall fragments were encountered in the mid-portion of the trench.

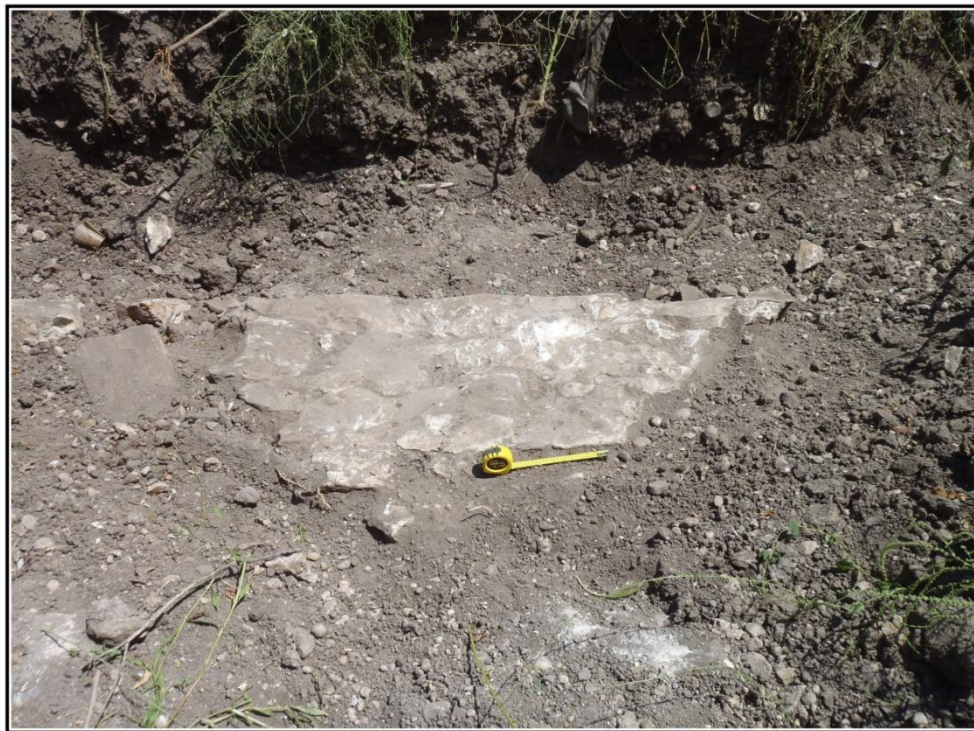
Figure 5-4. Fragment of the 1930s reconstructed Lily Pond rock wall encountered during backhoe trenching.

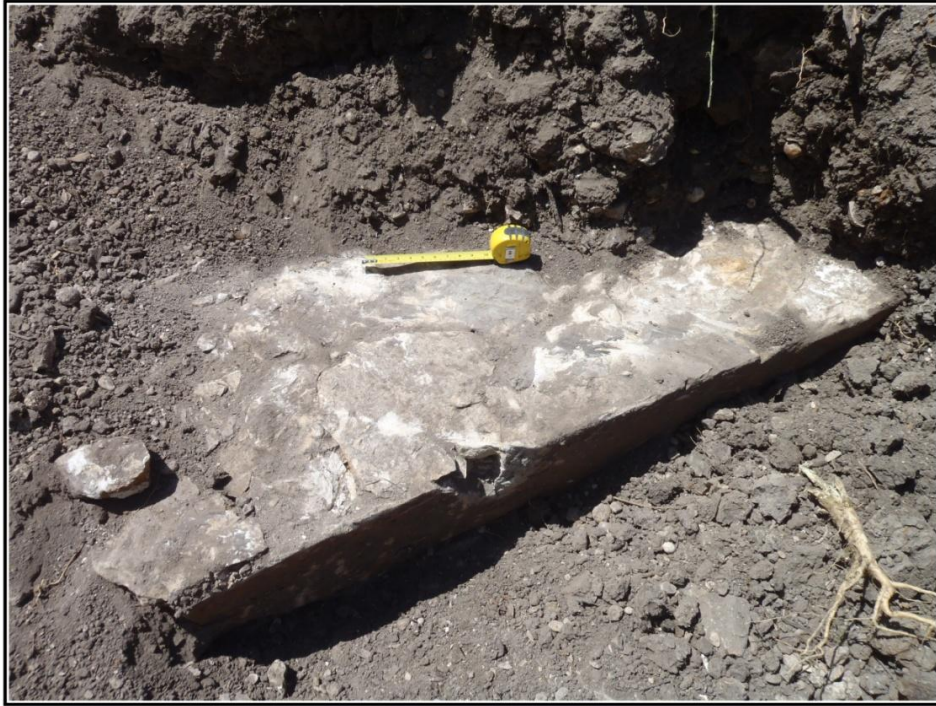
Figure 5-5. *Second fragment of the rock wall encountered while backhoe trenching in the Lily Pond.*

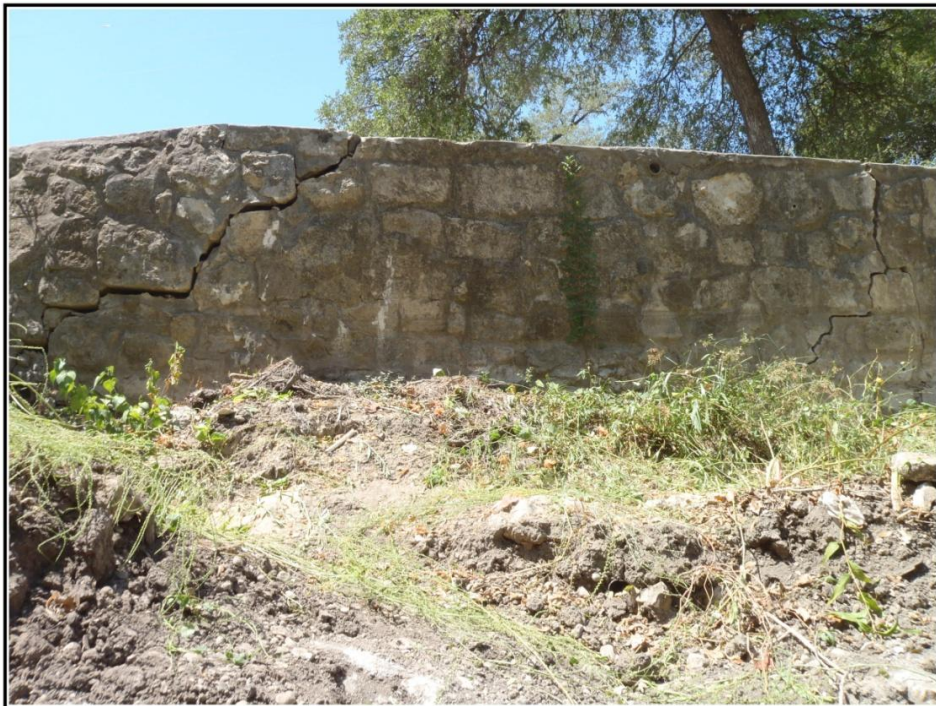
Figure 5-6. *Portion of the currently standing Lily Pond wall near the fragments that were encountered in the backhoe trench. Note the cracks that indicate the unstable nature of the current wall.*
