AN ARCHAEOLOGICAL ASSESSMENT OF

*The
Dolores Aldrete
House Property*

SAN ANTONIO, TEXAS

Center for Archaeological Research
The University of Texas at San Antonio
Archaeological Survey Report, No. 58

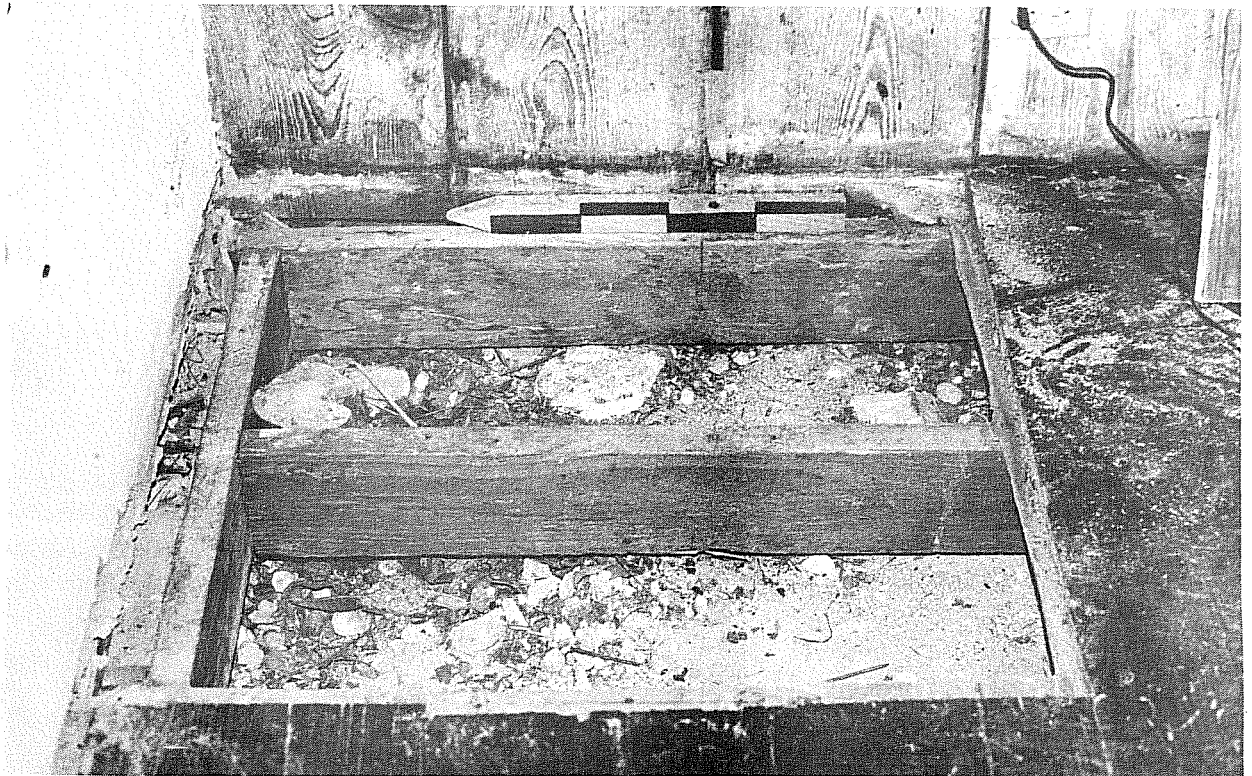
Figure 6. *Test Pits 4 and 5.* a, west profile of Test Pit 4 in Caile House (note water line, roots, layers of fill); b, surface below wood floor in southeast corner of Dolores Aldrete (Palisado) House.

Test pit 4 (1 m²) was located on the north side of the palisado house (lot 9), adjacent to its concrete front porch (Fig. 6,a). Test pit 5 (33 x 88 cm) was excavated through a hole in the 1 x 12 inch wood flooring inside and against the north jacal wall of the palisado house (Fig. 6,b). Test pit 6 (40 x 70 cm) was placed outside, near the corner, against the east board-and-strip wall of the palisado house.

Test Pit 4 (Fig. 6,a; 7,d)

Test Pit 5 (Fig. 6,b; 8)
