**Test Excavations at the  
Old Rock Store (41MC827),  
Tilden, McMullen County, Texas**

Texas Antiquities Permit No. 8155

*Prepared by:*  
Center for Archaeological Research  
The University of Texas at San Antonio  
One UTSA Circle  
San Antonio, Texas 78249  
Archaeological Report, No. 461

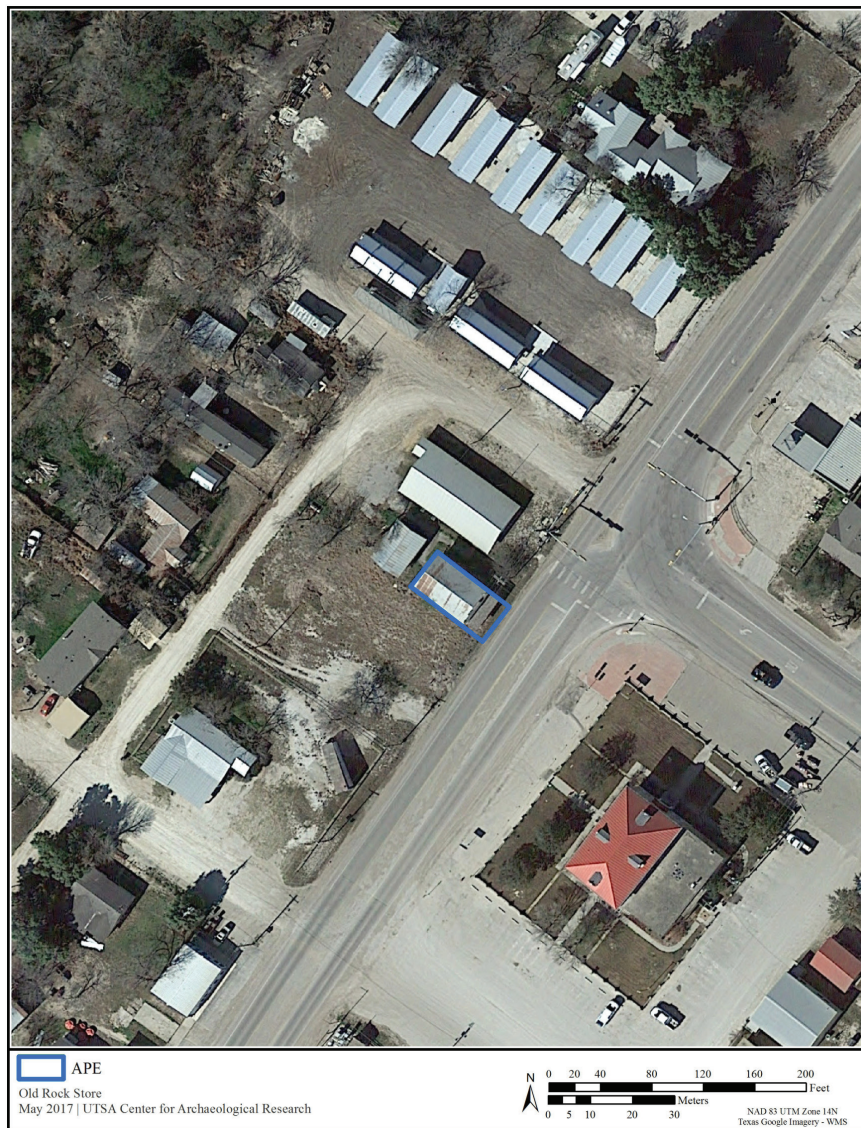
*Figure 1-2. Aerial image of the Old Rock Store APE.*

The Area of Potential Effect (APE) is a 10.6-x-16.2 m (35-x-53 ft.) is located on Lot 2 (15.2-x-42.7 m; 50-x-140 ft.), Block 4, of the town site. The CAR defines the APE as a 1.5-m (5-ft.) buffer around the perimeter of the 7.6-x-13.1 m (25-x-43 ft.) structure (Figures 1-2 and 1-3). The Old Rock Store is said to have been built in 1865 by Patrick Cavanaugh, an Irish stonemason.

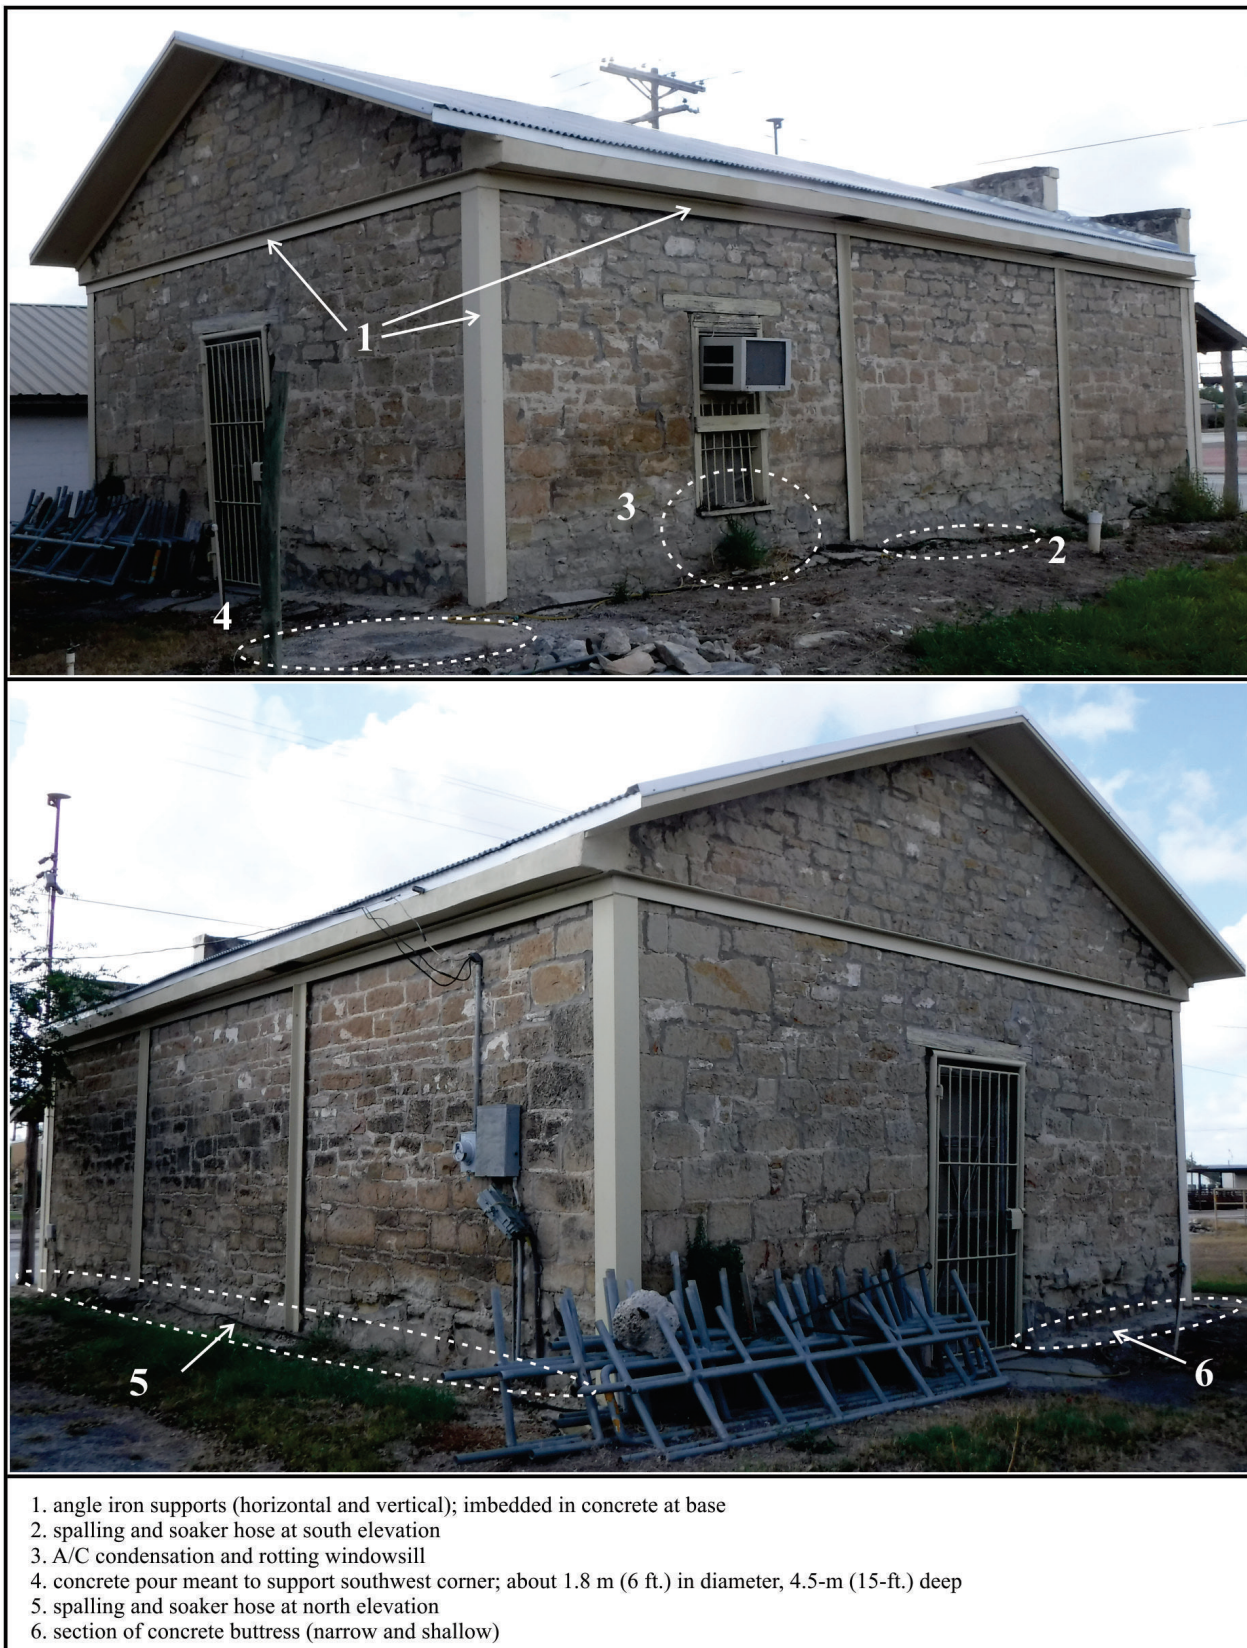
The east elevation of the store, facing State Highway 16, has a coat of stucco and a concrete porch, so the condition of the sandstone blocks, is unknown. There is extensive spalling along the surface course of sandstone blocks, and the problem is acute at the southwest corner. According to Jason Cooper, McMullen County Fire Chief (personal communication 2017), the stones at the southwest corner appeared to be failing about 15 years ago, and at that time, he and some other county employees excavated a pit, undercut the corner of the building and then filled it in with ready-mix concrete. He said the pit was about 4.5-m (15-ft.) deep and 1.8 m (6 ft.) in diameter with a 1.8 m (6 ft.) in diameter concrete pour off the southwest corner. CAR staff observed a backfilled cistern (cavity is evident) located opposite the concrete pour and on the adjoining lot. The south elevation, adjoining Lot 3, appears to be heavily impacted and littered with rock rubble. A narrow and shallow concrete buttress is poured up against the wall, and it continues around and along the west elevation. The roof trusses are held up by a series of vertical and horizontal heavy gauge angle irons. Soaker hoses were noted along the south, west, and north elevations. CAR staff was advised that several attempts to stabilize and otherwise arrest the deterioration of the walls have been made over the years. At one point, the MCHC was advised to keep the perimeter of the structure wet to prevent settling (Cecile Stanley, personal communication 2017). These series of exterior interventions are identified in Figure 4-1.

Figure 4-1. Old Rock Store showing areas of concern. Top: oblique view of west and south walls, facing northeast. Bottom: oblique view of north and west walls, facing southeast.

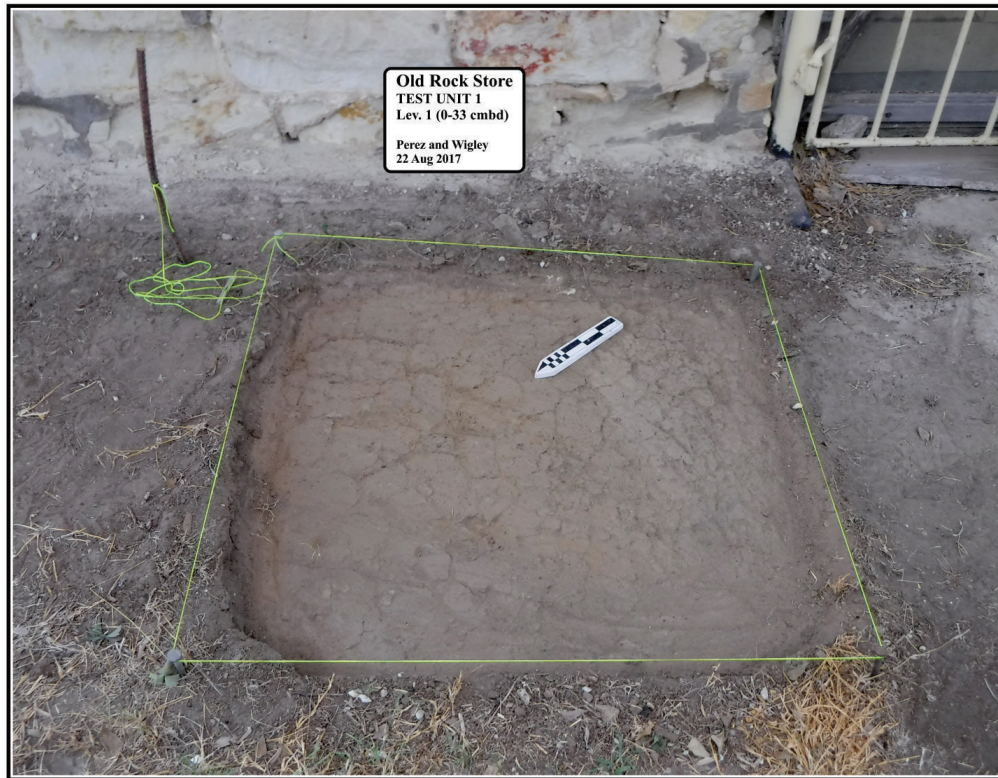
Level 1 (0-33 cmbd; 0-13 in.) was composed of a very loose silty sand (23-27 cmbd; 9.1-10.6 in.), followed by a hard and dry sand with one percent gravel (27-33 cmbd; 10.6-13 in.; Figure 4-2 and Table 4-1). Screening of soils produced an assortment of surface trash, such as glass shards, nails, pieces of plastic, and mortar fragments. This material was not collected.

Figure 4-2. Test Unit 1, Level 1 (0-33 cmbd; 0-13 in.).

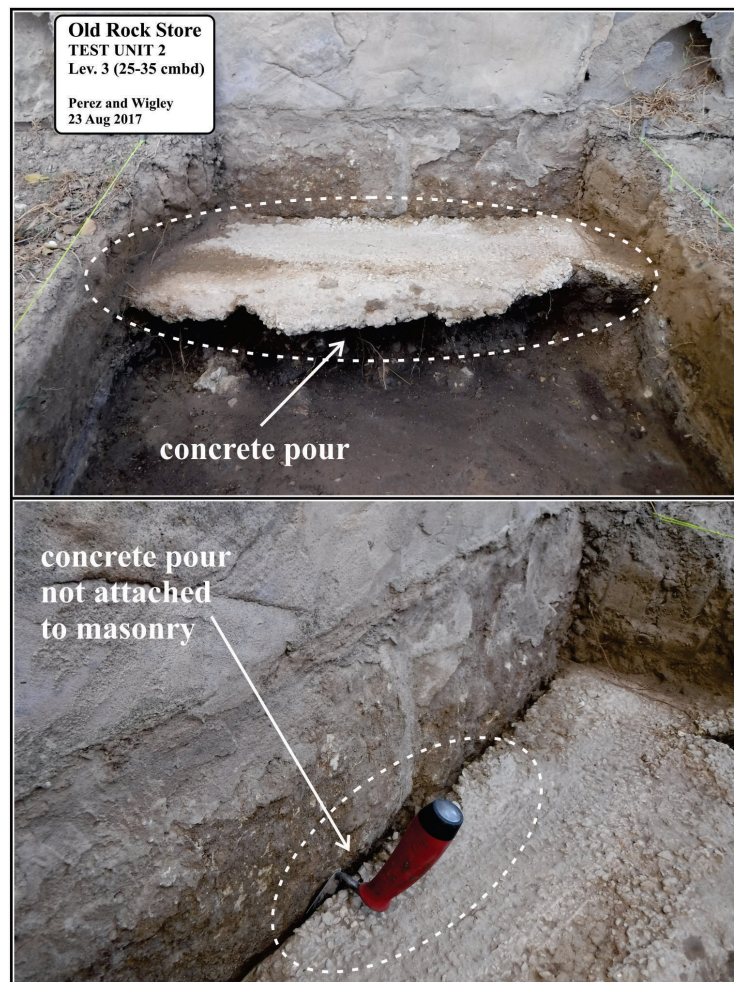
Excavation of Level 3 (25-35 cmbd; 9.8-13.7 in.) further exposed the concrete pour (buttress). A trowel was used to probe and ascertain that the buttress was not attached to the building. There was a 0.6-cm (0.25-in.) gap between the

Figure 4-3. Close-up photos of TU 2; note concrete pour meant as a water barrier.

pour and the sandstone wall (Figure 4-3). After consulting with Cecile Stanley (personal communication 2017), it was decided to break off a 1-m (3.3-ft.) section of the buttress in order to continue excavating. The procedure was photo documented. The excavation then continued and exposed a 35 cm (13.7 in.) strip of light colored, silty textured sediment that abutted the sandstone wall. The screened soils produced a small number of artifacts (n=32), which included cut nails, bottle glass, and ceramic sherds.

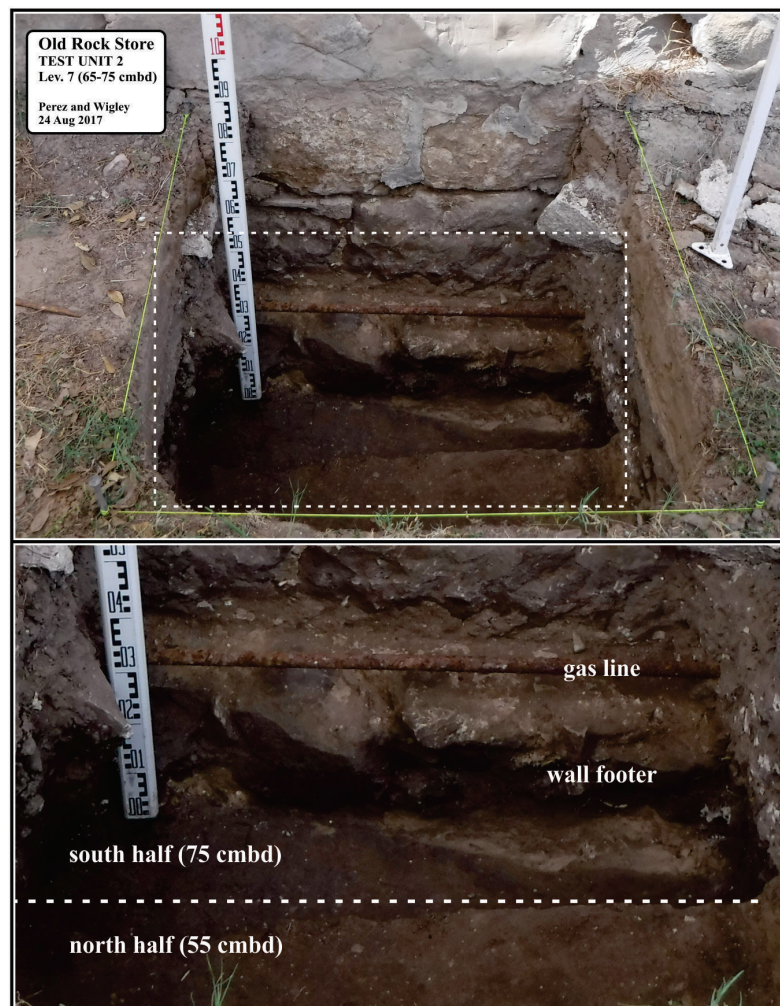
*Figure 4-5. Test Unit 2 (view south) with close-up (bottom) of wall footer and wall setting trench.*

Excavation of TU 2 ceased at 75 cmbd (29.5 in.), and the unit and wall footer were photo documented (Figures 4-5 and 4-6). Note that the abandoned gas line was not removed. A 20.3-cm (8-in.) long section of a 1/4-inch metal rod was used to probe beneath the exposed wall footer. The probe indicated the wall footer continued to an unknown depth. With the exception of Levels 8 and 9, the other levels are a mix of sandy loam, clay, and cobbles (Figure 4-7). These upper seven levels most likely represent fill episodes or disturbances caused by repeated attempts to remedy the rising damp problem.
