Archaeological Monitoring for the World Heritage Sidewalk Improvements Project, San Antonio, Bexar County, Texas

Texas Antiquities Permit No. 8240

Prepared by:
Center for Archaeological Research
The University of Texas at San Antonio
One UTSA Circle
San Antonio, Texas 78249
Archaeological Report, No. 490

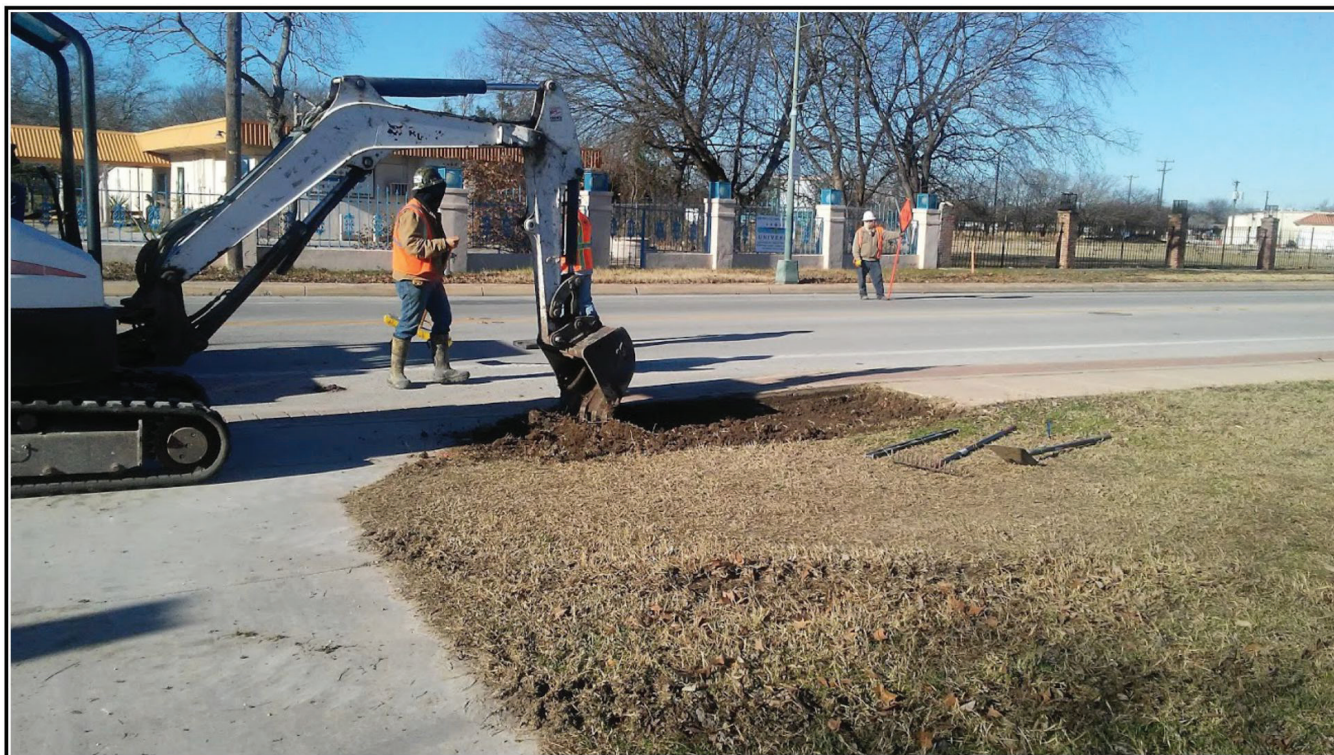
Figure 4-1. Beginning of excavations on Padre Drive (facing west).

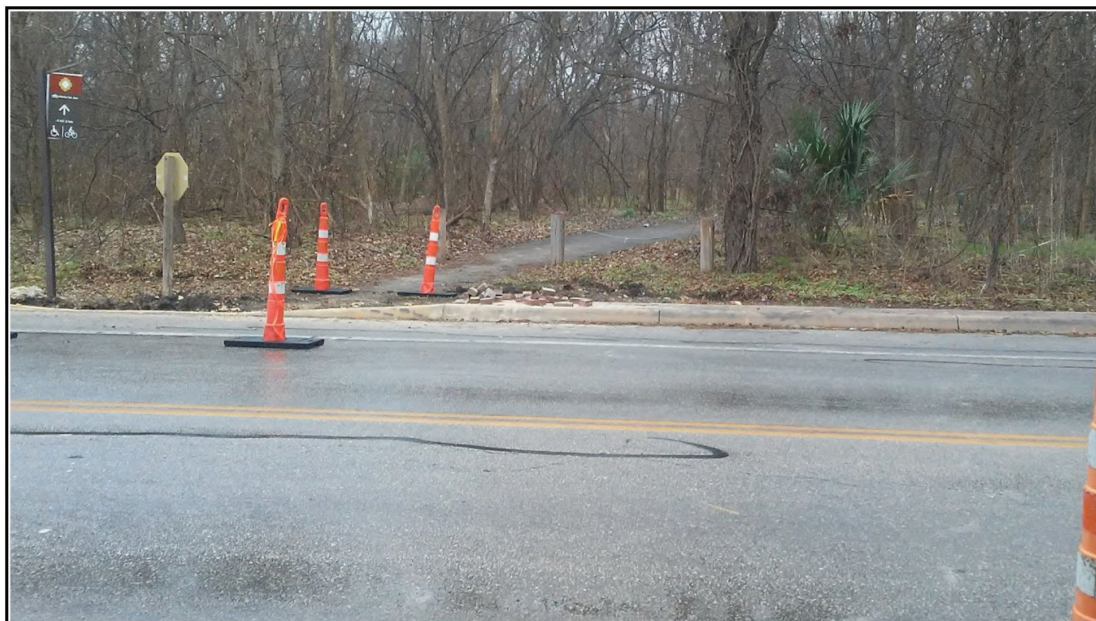
Figure 4-2. Excavation on west side of Padre Drive.

monitoring for excavations located on the southwest ROW of Padre Drive began (Figure 4-2). On February 6, 2018, excavations were completed for this project area. Excavations terminated at the existing trails and portal to Mission San José (Figure 4-3). No cultural material was observed or collected during monitoring of this section.

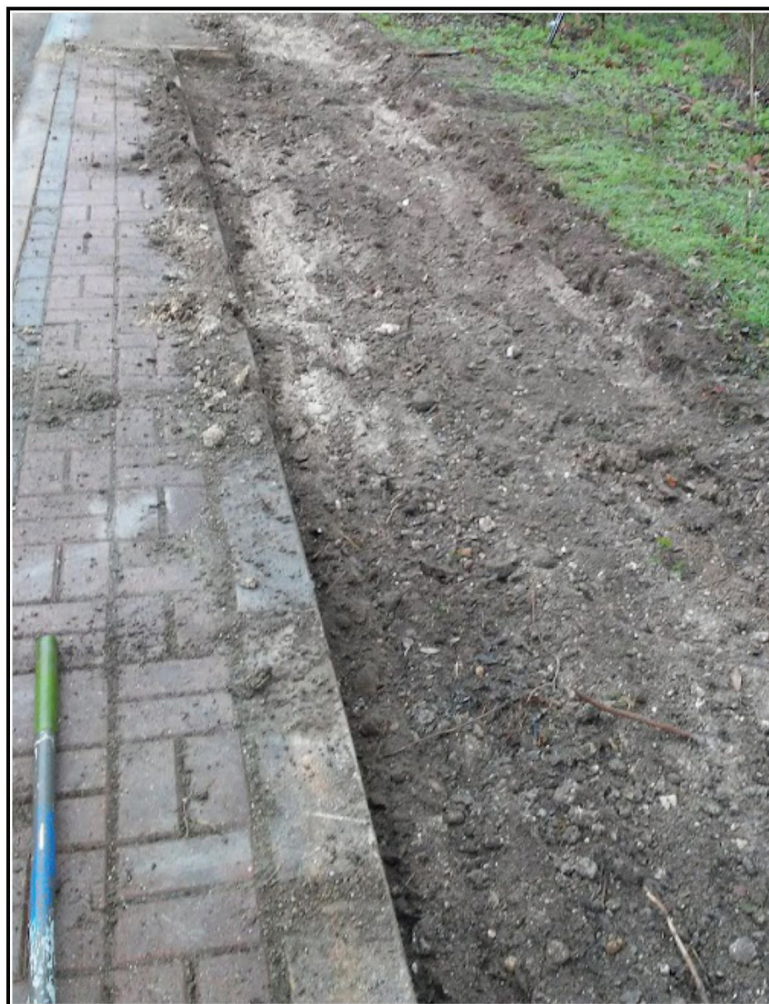
Figure 4-3. Existing trails and portal to Mission San José (facing west).

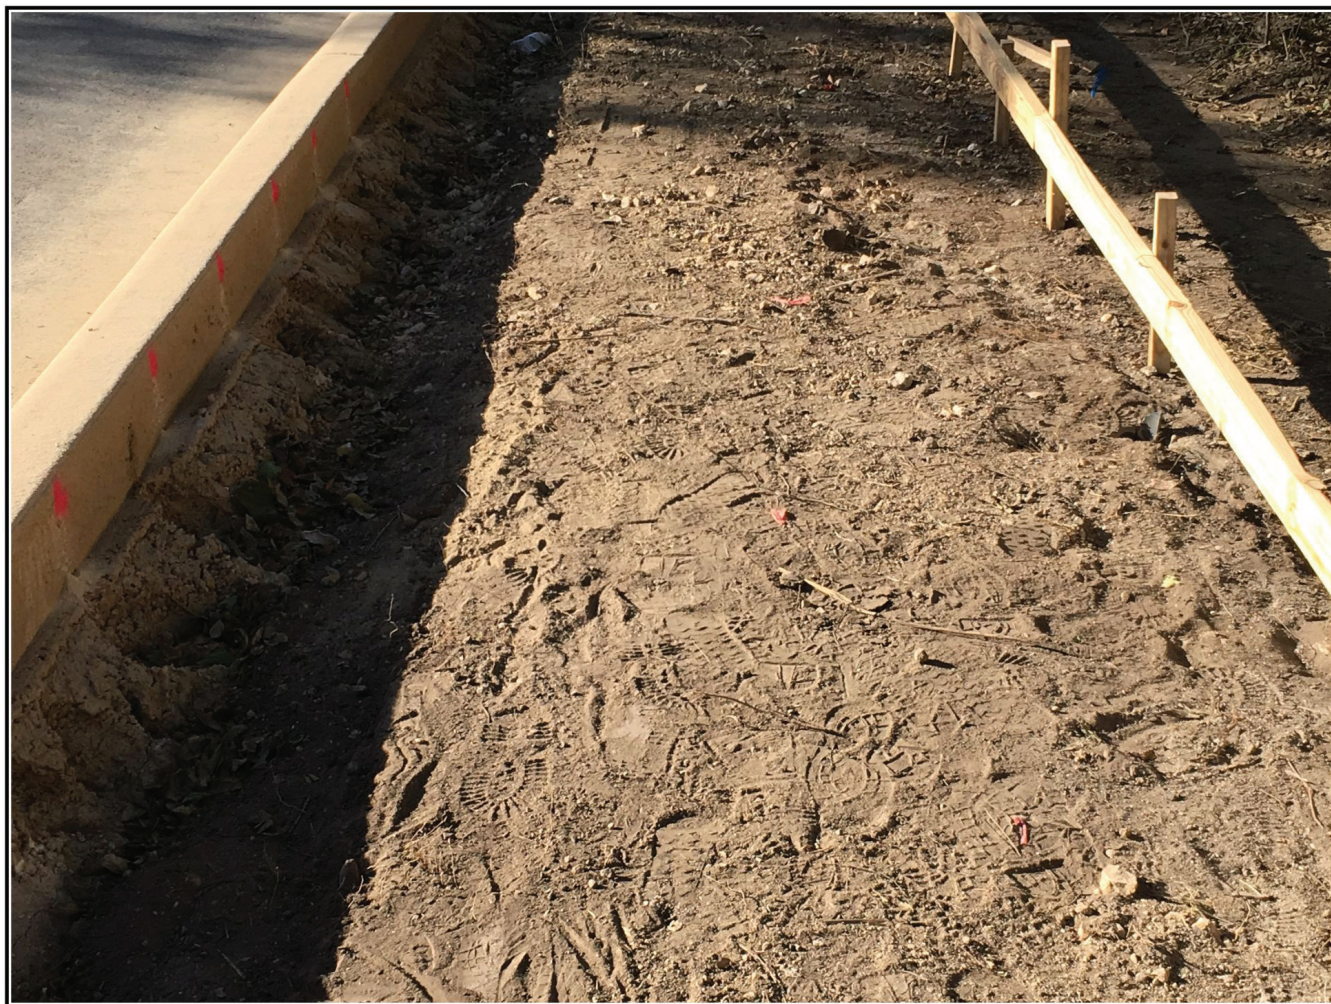
Figure 4-4. Graf Road sidewalk section as observed by CAR archaeologist.

CAR was not notified when excavation of the sidewalks at Graf Road began in November 2020, and the excavations were not monitored. A CAR archaeologist visited the site when CAR became aware that work was ongoing. However, all areas had already been graded and prepped for sidewalk, and in some areas, sidewalk had already been installed, severely limiting visibility (Figure 4-4). No cultural material or cultural features were observed at the time of the visit. Discussions with the contractor indicated that the excavations did not reach depths of more than 15 cmbs (6 in.). The CAR reported the incident to COSA and the THC.

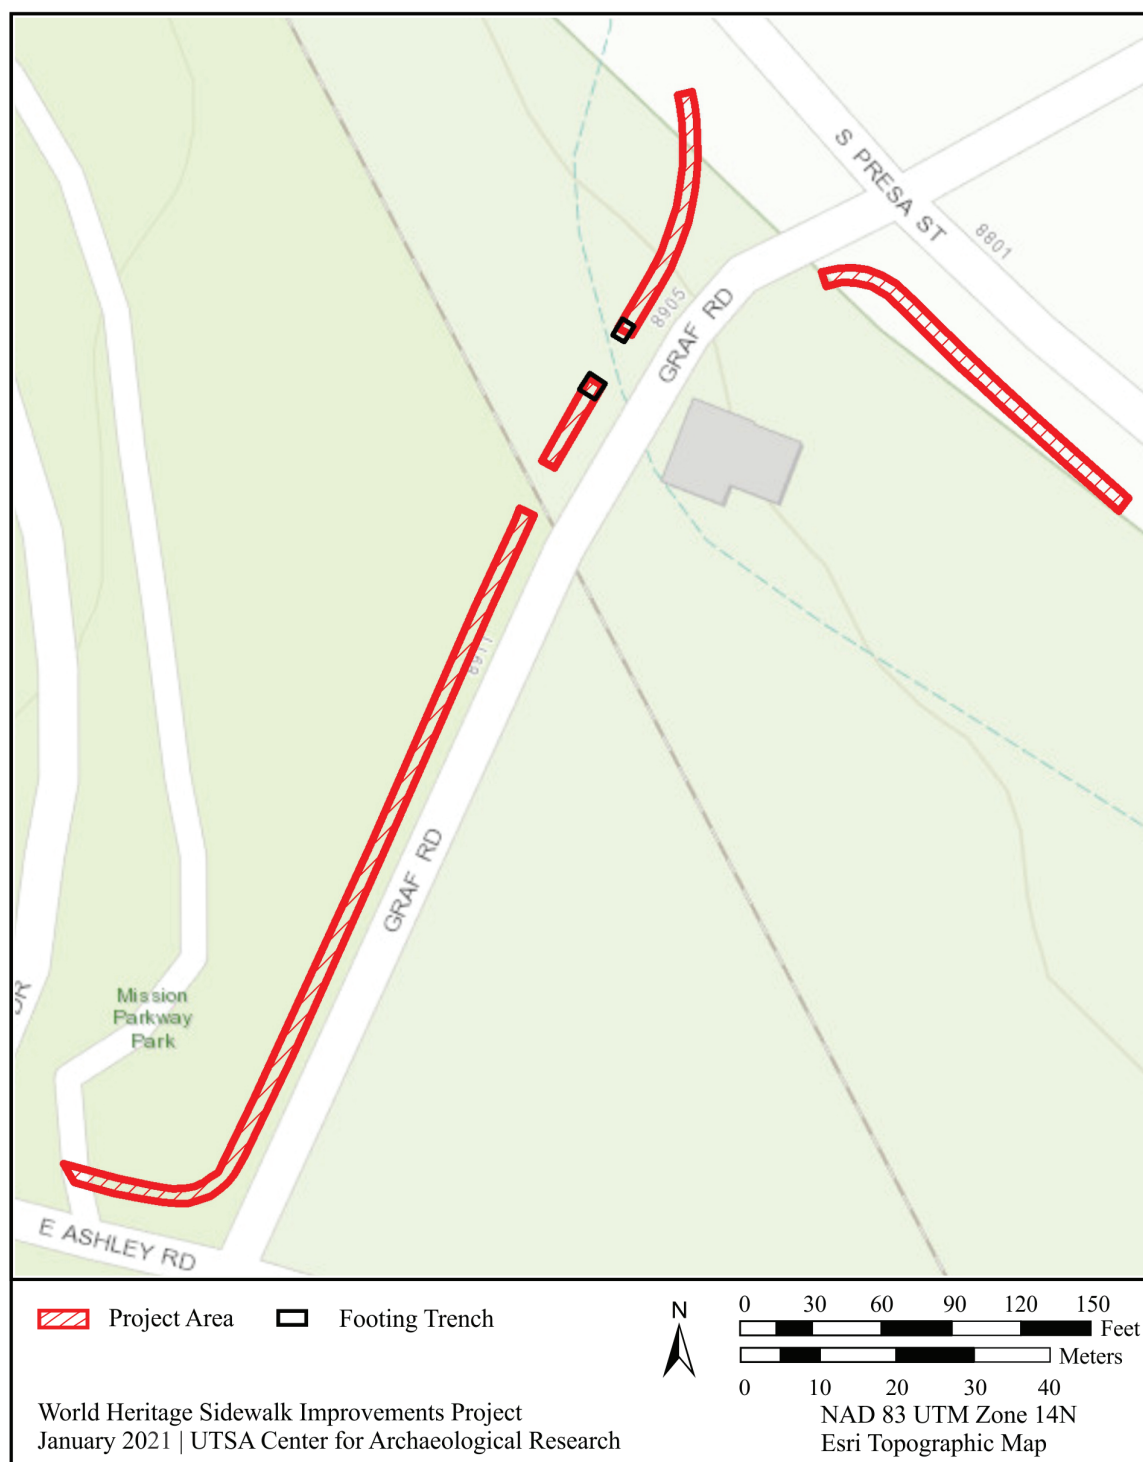
trenches were located north and south of the *acequia* (Figure 4-5), and they measured 1.8 m by 2.4 m (6 ft. by 8 ft.) and reached depths of 1.5 m (5 ft.). In the northern footing trench, modern trash, such as crown caps, plastic, pavement, and brown glass, was observed in the backdirt. A number of large, displaced limestone blocks were also present, suggesting that the installation of the culvert carrying the *acequia* below the road may have impacted the original *acequia* structure (Figure 4-6). Visibility was impacted due to water seeping in from the *acequia* at the southwest corner, slowly flooding the trench.

Figure 4-5. Location of excavations for pedestrian bridge crossing the San Juan Acequia.

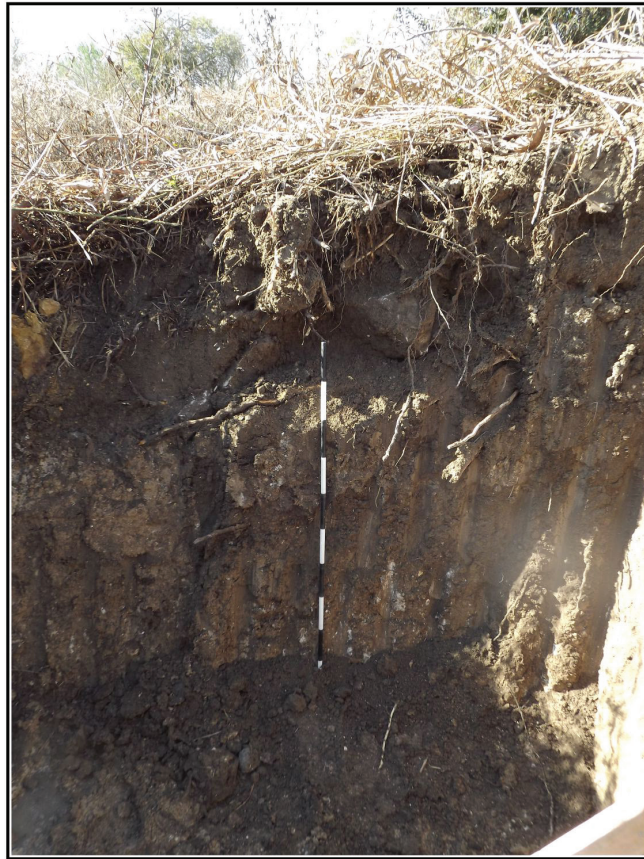
previous installation of culverts in the immediate area. Loose limestone blocks in the vicinity of the San Juan Acequia suggested that the *acequia* structure was damaged when the culvert was installed.

Loose limestone blocks were also encountered in the southern trench. The body of the *acequia* culvert was encountered at about 45 cm (18 in.) in this trench. The position of this trench over the culvert suggests that most of the soils encountered are disturbed by culvert construction. The culvert had numerous holes, allowing the trench to become quickly flooded (Figure 4-7). The culvert construction resembles the cobble and cement seen at the missions, suggesting that it may have

Figure 4-6. Northern footing trench profile; note loose limestone blocks near the surface.

Loose limestone at the pedestrian bridge excavations at the San Juan Acequia suggests the stone lining of the ditch was disturbed by installation of the culvert. Similar stone was not observed during excavation for a pedestrian bridge crossing the Espada Acequia, which was likewise disturbed by a cement culvert near the bridge location.

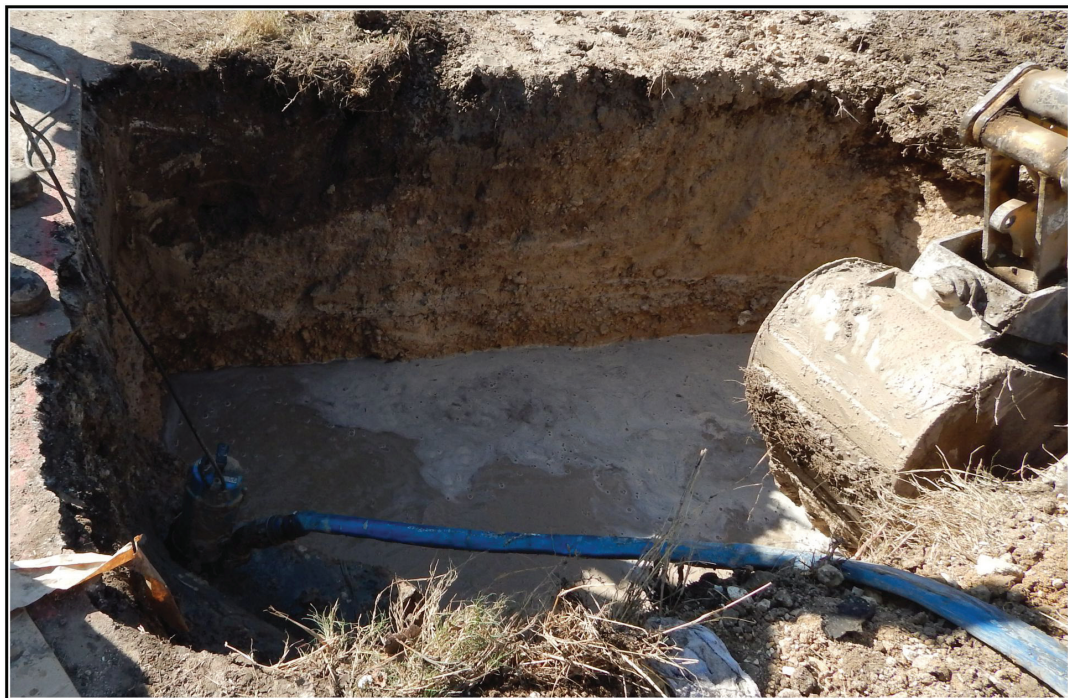
Figure 4-7. Flooded footing trench for pedestrian bridge crossing the San Juan Acequia. The layered appearance in the lighter portion of the soil profile is an artifact of the trench being repeatedly flooded and pumped during excavation. The profile did not exhibit this layering during the initial excavation.

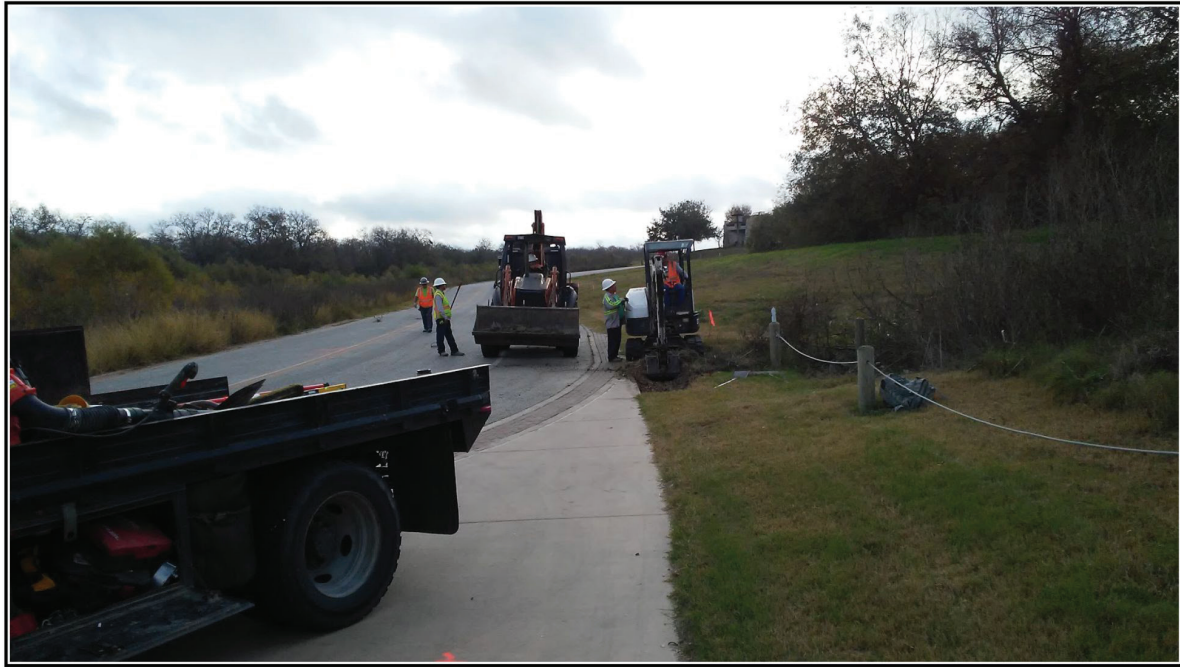
Figure 4-8. Beginning of excavations on Camino Coahuilteca (facing south).

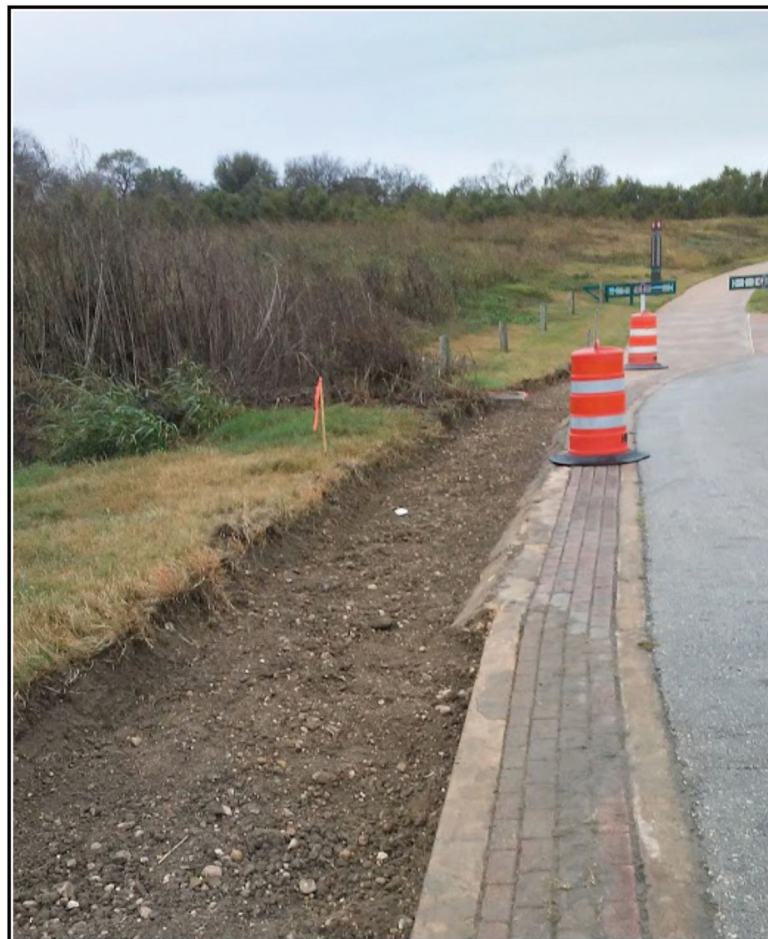
Figure 4-9. Excavations on Camino Coahuilteca for sidewalk installment, with existing sidewalks to the north.

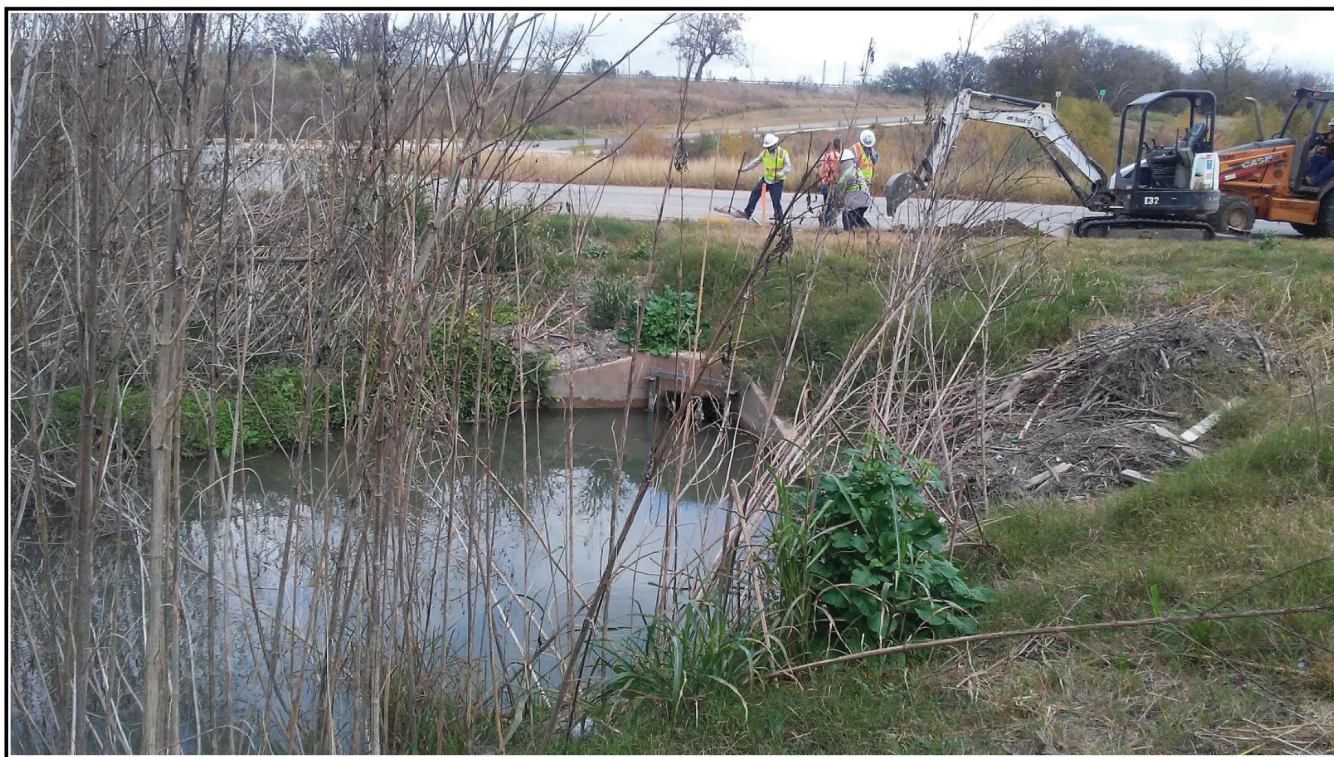
CAR began monitoring excavations along the ROW along Camino Coahuilteca and Espada Road. December 4, 2017, for this area, and monitoring ended on December 16, 2020. The contractors began excavations where an existing sidewalk associated with a trail system extends west to the San Antonio River (Figures 4-8 and 4-9). The depth of excavations was 15 cm below the surface (cmbs) (6 in.) on average, and excavations were 1.2 m (4 ft.) wide. Disturbances in the area consisted of a dead irrigation line and a concrete embankment associated with an *acequia* lateral that runs southeast of the mission (Figure 4-10).

Figure 4-10. Acequia lateral culvert that runs under Camino Coahuilteca to the San Antonio River.

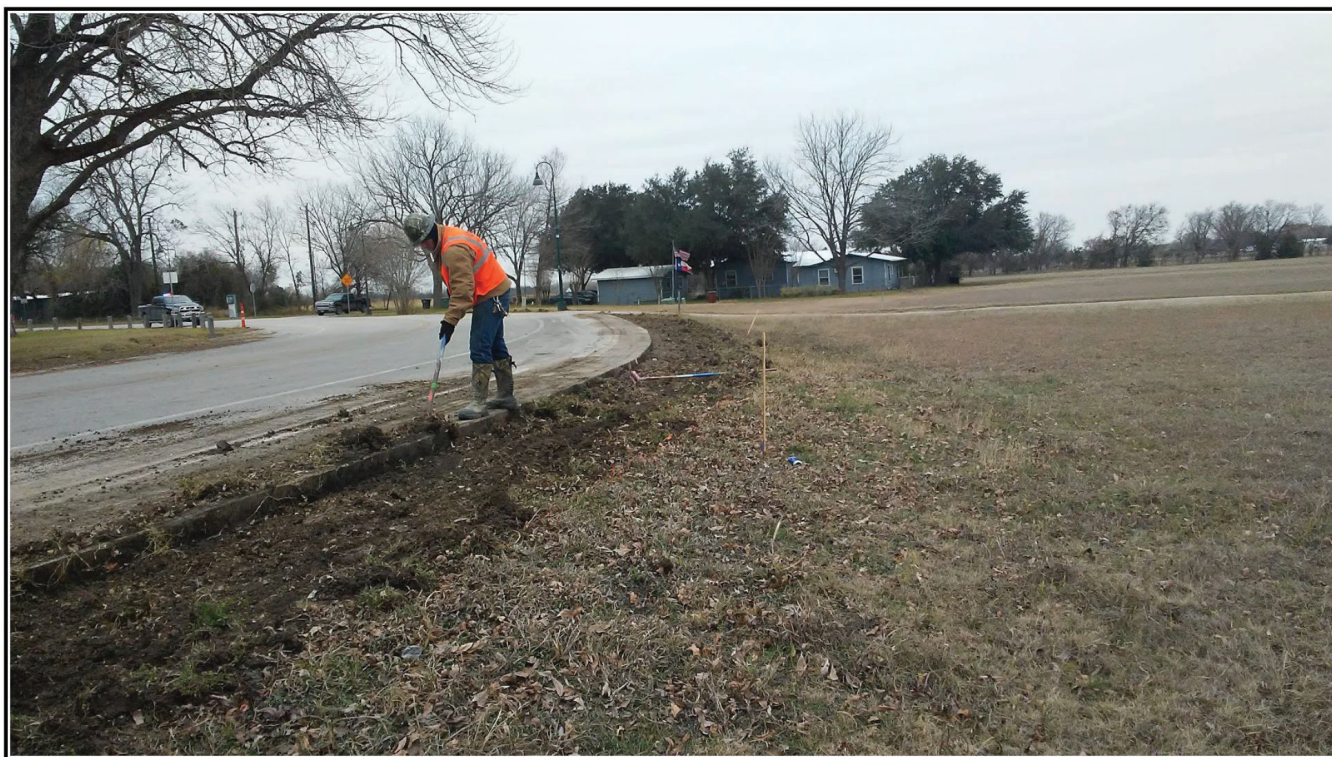
Figure 4-13. Excavations on the west side of Espada Road.

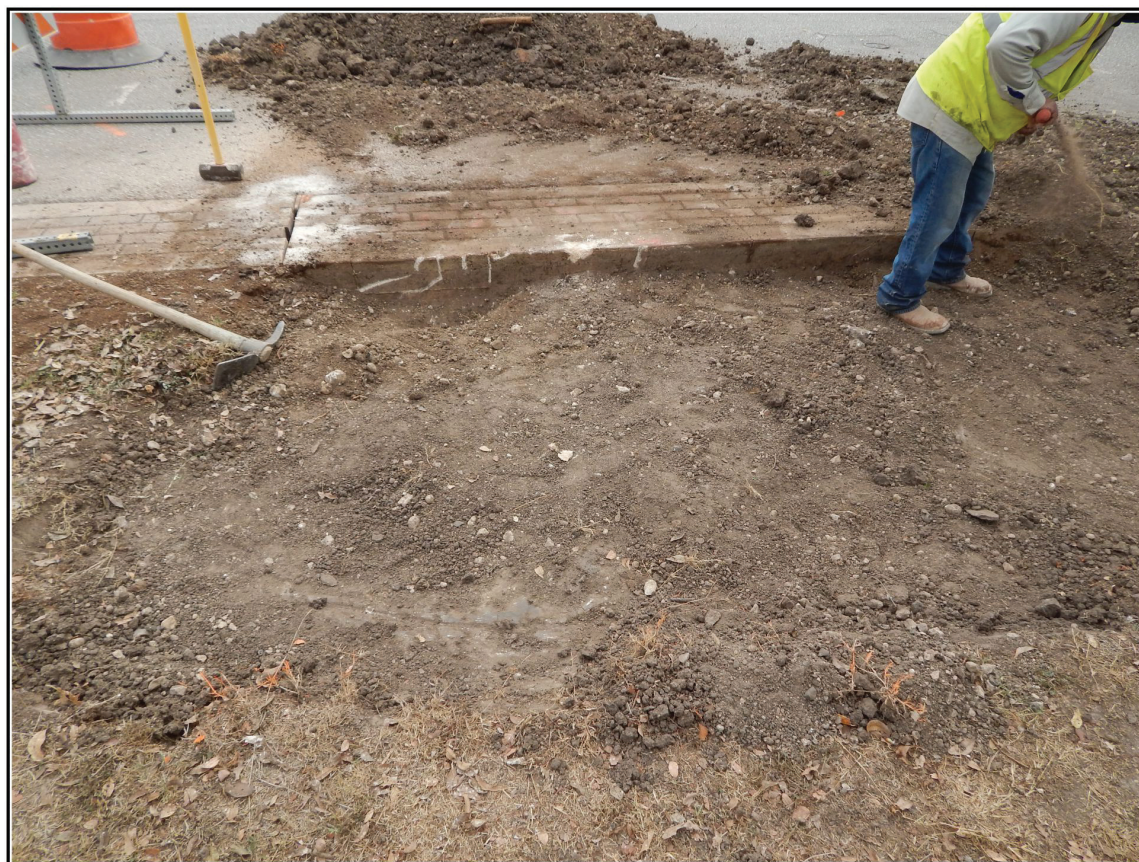
A small area directly across from and outside of the Espada Road entrance to Mission Espada was graded for sidewalk installation in November of 2020 (Figure 4-14). Numerous utilities were encountered on both sides of the street, indicating that the area was disturbed. A small amount of clear container glass and very large mammal bone was observed in the backdirt, but nothing was collected.

Figure 4-14. Graded area across from the entrance to Mission Espada.

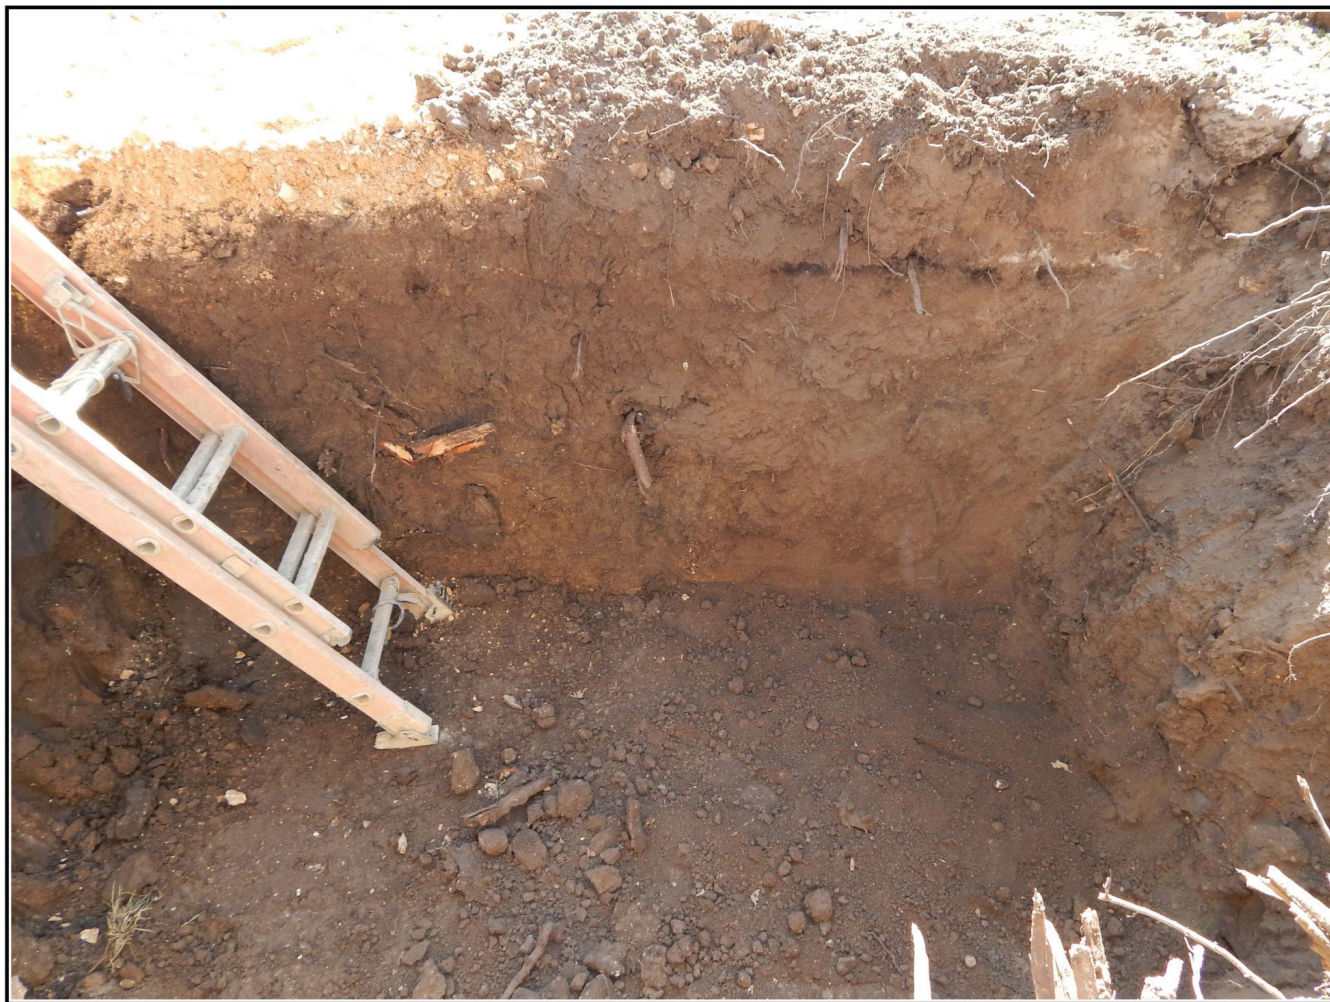
In December of 2020, CAR staff monitored excavations for a pedestrian bridge crossing the Espada Acequia (41BX269) across from the Espada Road entrance to Mission Espada. The trenches were located north and south of the *acequia* and measured 2.1 m by 1.2 m (7 ft. by 4 ft.), reaching depths of 1.5 m (5 ft.). Soils in both trenches were loamy brown silty clay (Figure 4-15), very soft with a large quantity of roots. Lighter, more compact soils were present from 1.2-1.5 m (4-5 ft.). A few loose limestone cobbles were present, as well as a single piece of clear container glass, which was not collected. The area was likely disturbed by installation of the culvert carrying the *acequia* below Espada Road.

Figure 4-15. Trench excavation for pedestrian bridge crossing the Espada Acequia.
