Archaeological Investigation of the O'Hara House Site (41BX2445), San Antonio, Bexar County, Texas

Prepared by:
Center for Archaeological Research
The University of Texas at San Antonio
One UTSA Circle
San Antonio, Texas 78249-1644
Archaeological Report, No. 491

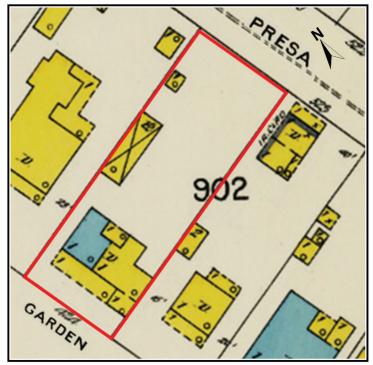
Figure 3-3. New City Block 902, Lot 24 (outlined in red), as depicted on the 1896 Sanborn Fire Insurance Map. Yellow indicates wood construction, while blue represents stone or caliche block construction.

Figure 3-3 shows the Mitchell home and property as depicted on the 1896 Sanborn Fire Insurance map (Sanborn 1896:31). The 1896 built environment on Lot 24 shows that a wood frame expansion was made to the south side of the original O'Hara L-plan caliche block house and a wooden porch was added across the majority of the west side of the residence, fronting onto Garden Street (now St. Mary's). A wooden carriage shed is shown along the northern property line and a single outhouse or privy is shown along the northern property line towards the rear yard along Presa Street. It is worth noting that the 1896

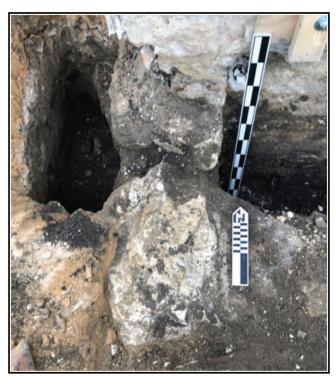
Figure 5-2. Feature 1, eastern wall foundation of original O'Hara House where it articulates with the remnant portion.

This east-to-west oriented trench along the south line of the O'Hara House exposed two architectural features, one at each corner. The western corner exposed the alignment of the original limestone foundation of the larger O'Hara House immediately beneath the current ground surface. This foundation alignment was designated as Feature 1 (see Figure 5-2). The foundation was a combination of rough ashlar and irregular limestone with a high-lime mortar, and was 18 in (46 cm) wide and 32 in (81 cm) in depth. The foundation extended south 41 in (1.04 m) where it was truncated by some prior subsurface impact.

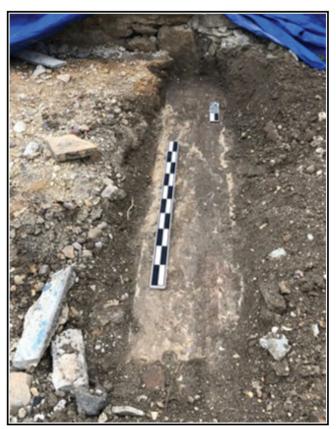
Figure 5-3. Feature 4, shallow brick beam with Roman cement veneer perpendicular to O'Hara House south wall, view facing north.

Feature 4, the second feature encountered along the south wall, was a shallow red and red-brown brick beam foundation with a Roman cement veneer projecting from the southeast corner of the structure (see Figure 5-3). The bricks were machine made but lacked any maker's imprints. Lateral excavation determined that this beam was only three un-mortared bricks in depth and not a structural beam. The beam aligns with the east wall of the wooden addition made by the Mitchell

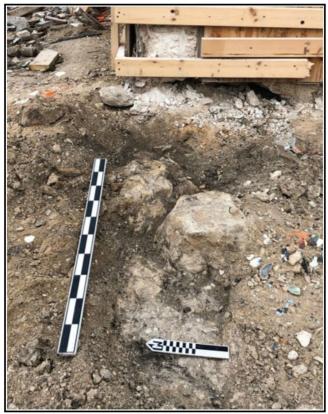
Figure 5-5. Feature 2, remnant of O'Hara House northern wall foundation, view facing east.

The western trench exposed the western face of Feature 1 as well as exposing the continuation of the original north wall of the O'Hara House. This northern foundation extension was designated Feature 2 (Figure 5-5) and matched the same construction method and dimensions reported for Feature 1 (18" in width and 32" or 43cm by 80cm in depth). Feature 2 extended 57 in (1.45 m) to the west before terminating. Like Feature 1, the northern foundation remnant was impacted at some prior time and is no longer extant along the remainder of its projected alignment.

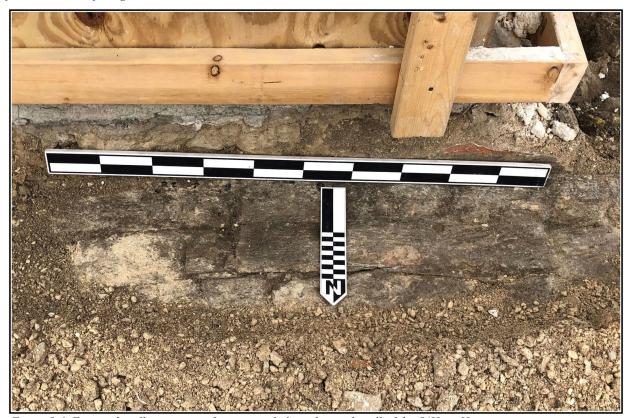
Figure 5-6. Feature 3 walk or patio surface exposed along the north wall of the O'Hara House.

the area of excavation (Figure 5-6). This walk or patio was labeled as Feature 3. The bricks were dry set over a thin sand base and were encountered approximately 4 in (10 cm) below the current surface. A slurry of sand was also atop the feature but this appears to have been base applied at a later, and undetermined, date. A single artifact, a 1921 Lincoln Wheat Cent, was recovered from within the sand base immediately below the bricks. This *terminus* post quem indicates that the earliest date for Feature 3 is 1921. Feature 3 continued to the east and wrapped around the east side of the structure where the arcaded portico and patio are shown on the 1949 Sanborn map (see Figure 5-4). These bricks were predominantly red with a minority of red-brown bricks, all of which lacked any maker's imprints. These bricks matched those that composed Feature 4 so it seems likely that Feature 3 and Feature 4 are contemporaneous and associated with the portico and patio to the rear of the main structures on Lot 24.

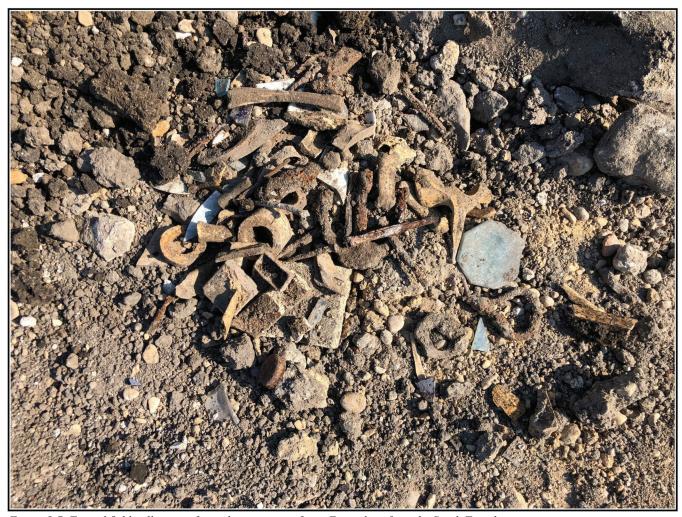
Figure 5-7. Typical field collection of non-diagnostic artifacts. Example is from the South Trench.

of smaller artifacts and accounts for the numerous buttons, toy marbles, coins, and small fragmentary bits of glass and ceramic recovered. Likewise, while faunal bone generally cannot fall through floorboard gaps and cracks, it can be transported beneath the structures via exposed skirting or crawlspace access beneath pier and beam raised floor or access openings in foundation walls or water tables.

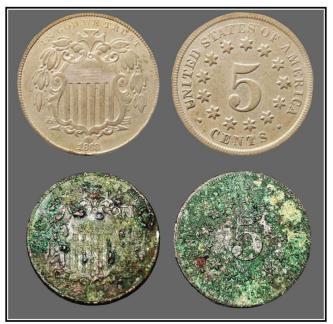
Figure 5-8. 1868 United States Shield Nickel type specimen (top) and recovered specimen (bottom).

Two coins were recovered from the work around the perimeter of the O'Hara House. The first coin encountered was an 1868 United States Shield Nickel found in the spoil from the south trench excavations. Shield nickels were in production from 1866 to 1883. Figure 5-8 provides the obverse and reverse of an 1868 type specimen contrasted with the example recovered. The presence of an 1868 coin is consistent with the period of use and occupation of the O'Hara House by the Mitchell family beginning in 1865 and continuing until 1902.

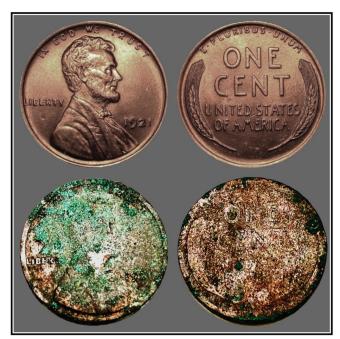
Figure 5-9. 1921 United States Lincoln Wheat cent, Philadelphia mint type specimen (top) and recovered specimen (bottom).

The second coin recovered (Figure 5-9) is the already discussed 1921 Lincoln Wheat cent recovered in the sand deposit immediately beneath the brick patio (Feature 3). Lincoln Wheat cents have a production range from 1909 to 1958 and those minted in 1921 derived from two sources—the Philadelphia and San Francisco mints. The recovered specimen bears no mint mark, indicating that it was from Philadelphia, as only San Francisco minted coins bore an "S" while the Philadelphia coins exhibit no mint mark. Figure 5-9 provides an image of

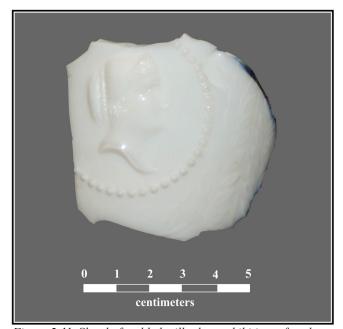
Figure 5-11. Shard of molded milk-glass exhibiting a female profile within a beaded cartouche surrounded by garlanding.

The collected specimen (Figure 5-11) is shard from a milk glass vase of mid-Victorian style (1850-1870). This was a molded glass vase depicting a profile bust of a woman surrounded within a beaded cartouche (portrait window), surrounded by a garlanding motif. While more common in the mid-century, these types of molded portrait vases continued in production beyond the 1870s so a specific date attribution cannot be made.

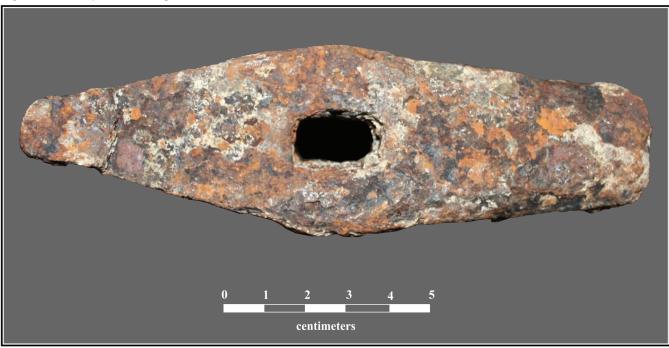
Figure 5-15. Two-pound stone facing hammer.

An intact but damaged stone facing hammer was recovered adjacent to the south face of the limestone foundation of the O'Hara House (Figure 5-15). The location suggests that this stone facing hammer was discarded during the construction of the residence in 1861. The purpose of a stone facing hammer, as implied by the name, is to break off rough and superfluous parts of stone. This hammer was likely used to dress the face of the foundation walls, as they were a combination of irregular stone and blocks as well as rough ashlar blocks
