# Archaeological Survey of the Highland Oaks Subdivision, Bexar County, Texas

Texas Antiquities Permit No. 8032

*Prepared by:*  
Center for Archaeological Research  
The University of Texas at San Antonio  
One UTSA Circle  
San Antonio, Texas 78249  
Technical Report, No. 71

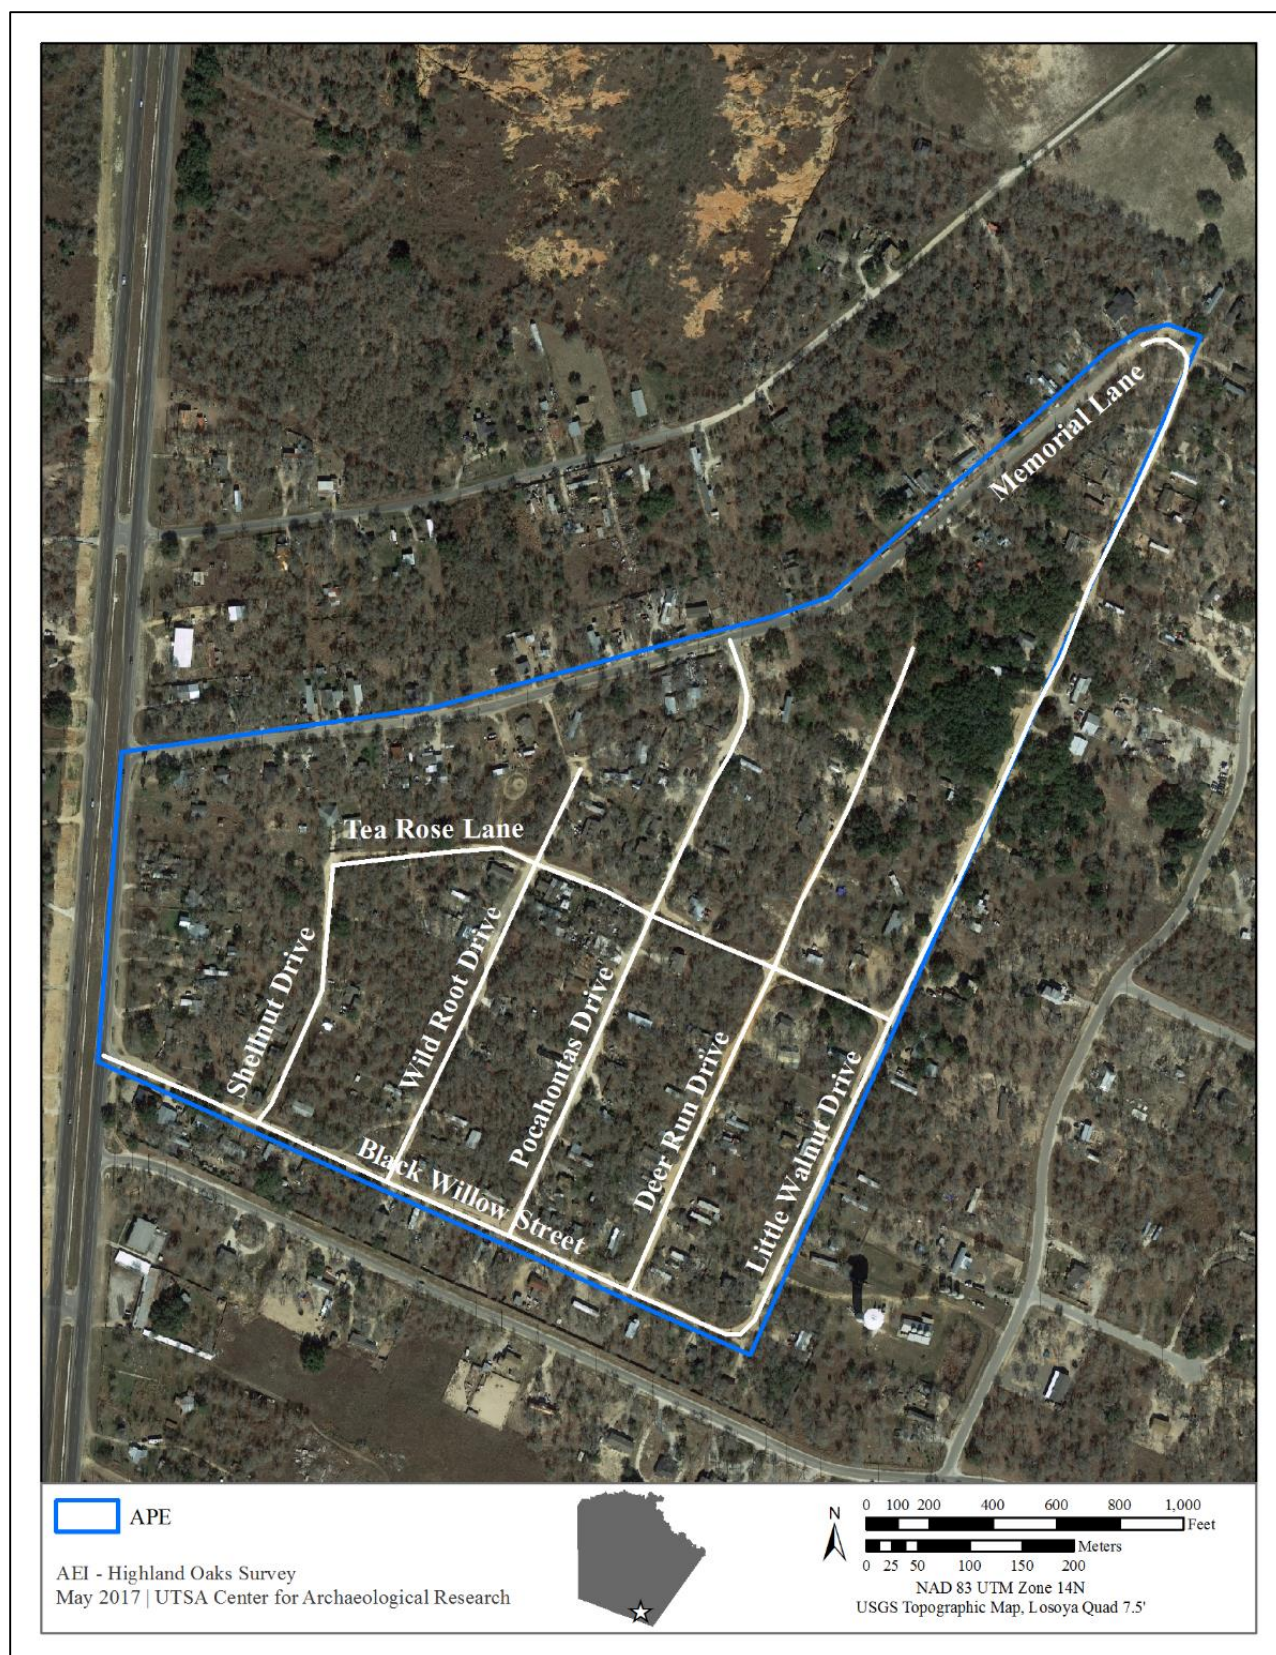
Figure 1-2. The APE depicted on an aerial map of the area (unimproved roads highlighted in white).

The Area of Potential Effect (APE) is defined by the unimproved roads in the Highland Oak subdivision in southern Bexar County, east of US Hwy 281, north of Hickory Pass, and south of Memorial Lane (Figures 1-1 and 1-2). CAR conducted shovel testing within the existing ROW, along the unimproved roads. Background research indicated no archaeological sites were previously documented within the APE. Currently, the APE is part of a residential subdivision adjacent to plots of land occupied primarily by mobile homes. Although the northern portion of Deer Run Drive is parceled, it has not been cleared for occupation, and it is heavily vegetated.

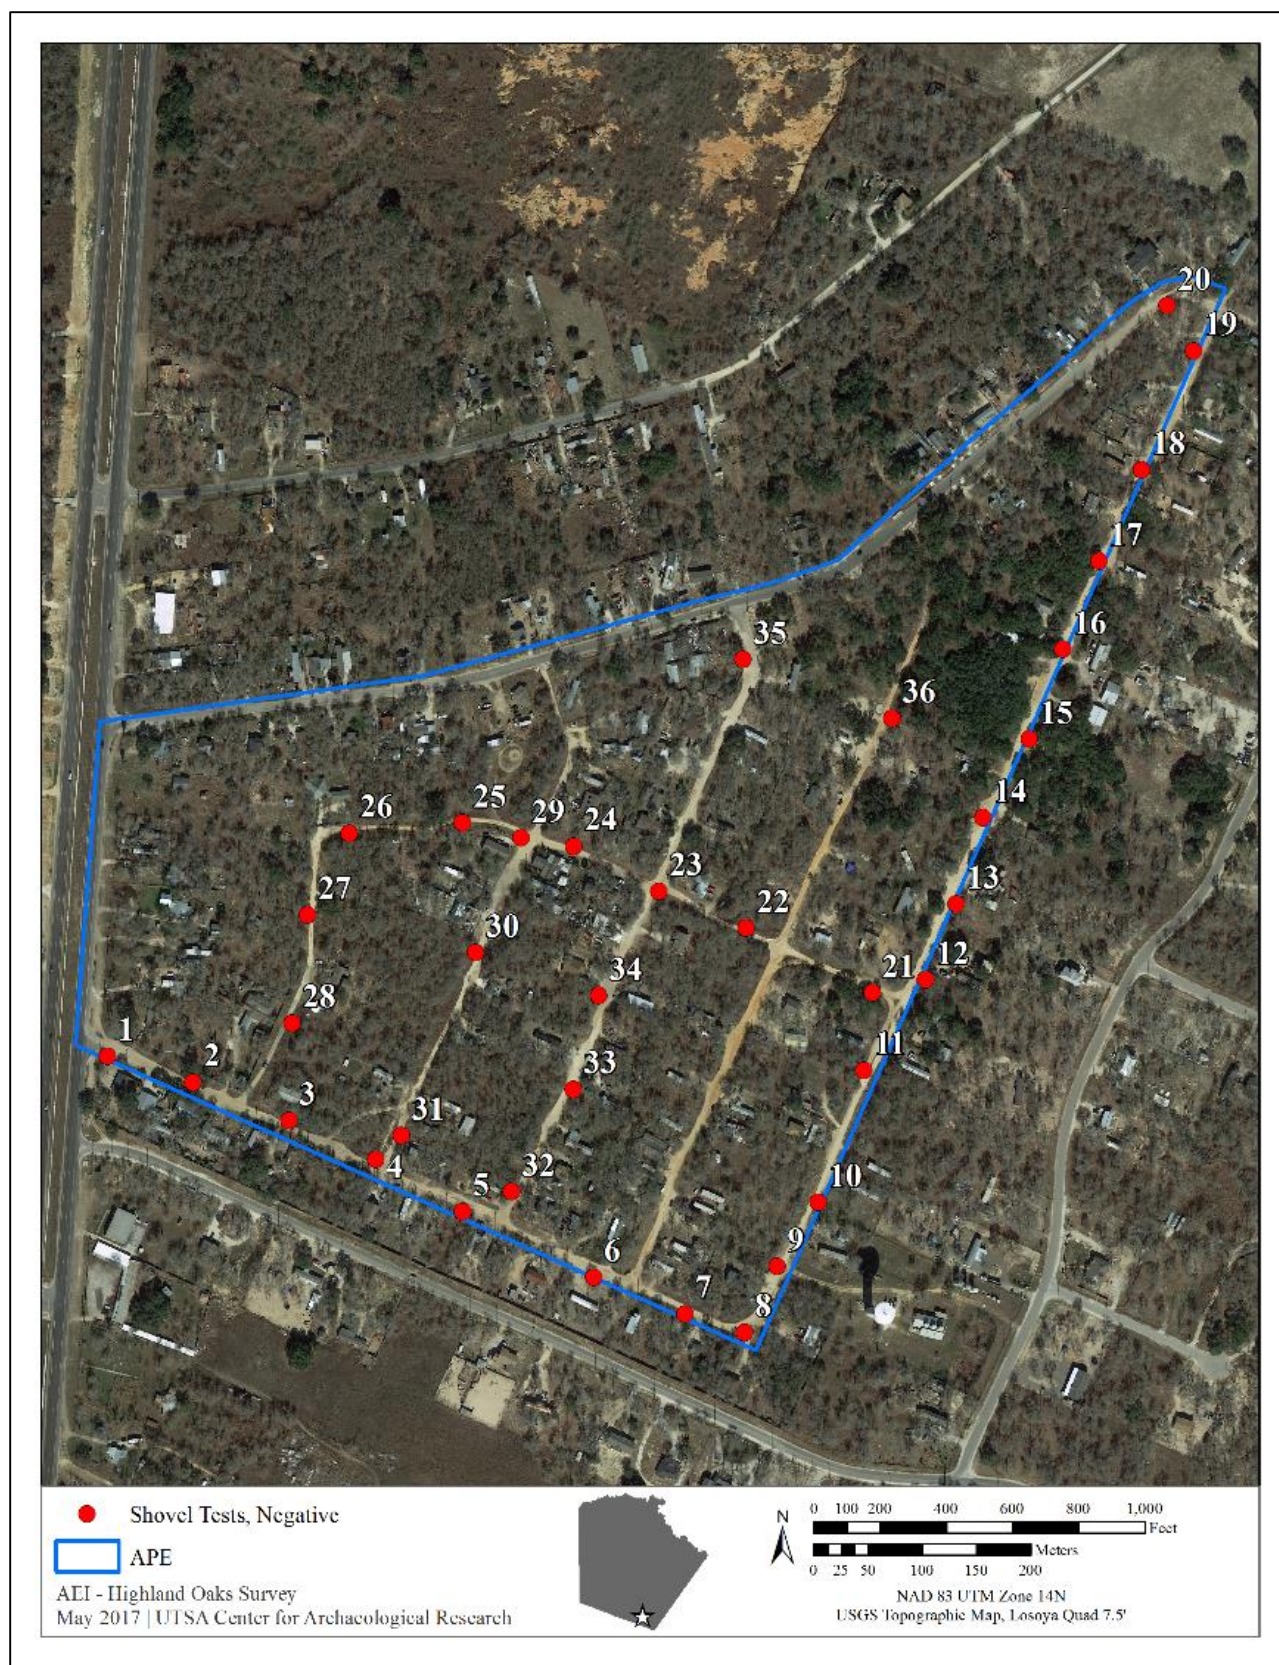
Figure 4-1. The APE with shovel tests in red.

On May 24 and 25, 2017, the CAR conducted a pedestrian survey of the APE that included the excavation of 36 shovel tests (STs; Figure 4-1). Figures 4-2 and 4-3 demonstrate the current conditions of the APE, which is defined by two-tract sand roads. The pedestrian survey and shovel testing began on May 24, 2017, from Black Willow Street, moving along Little Walnut Drive to Memorial Lane, with field crew excavating shovel tests every 100 m of the ROW. Placement of the shovel tests were not at exact intervals in every case due to obstacles such as vehicles, refuse, and landscaping.

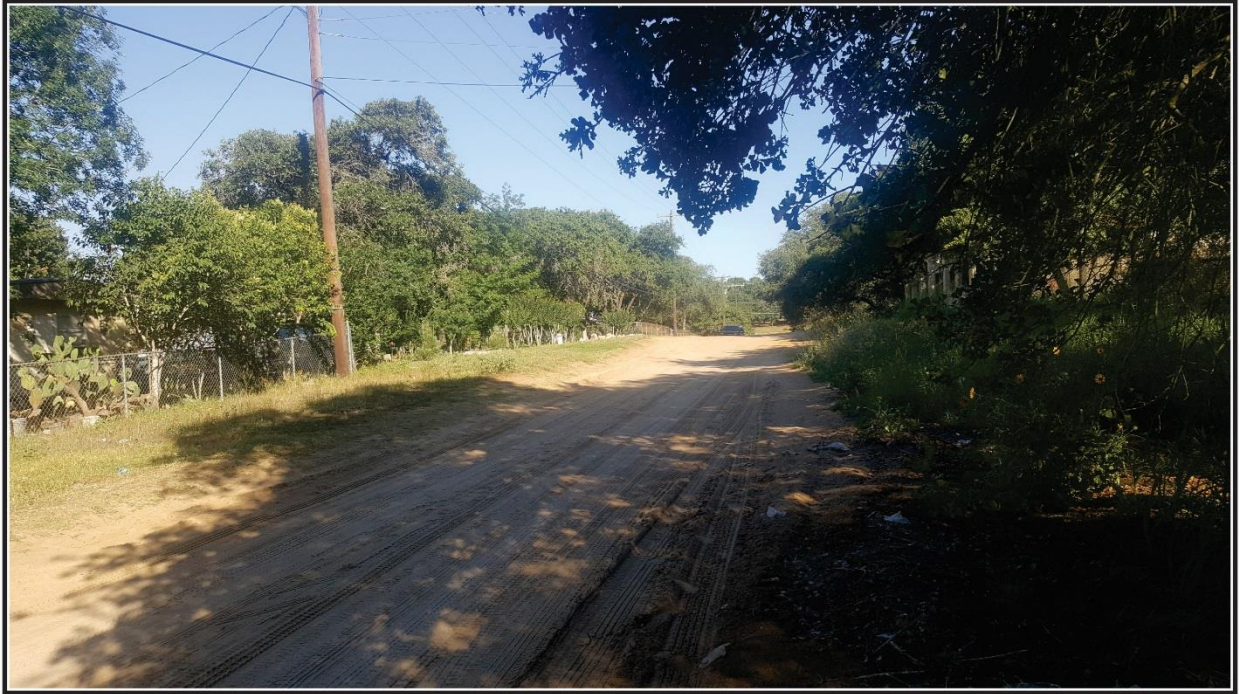
*Figure 4-2. Photograph of the APE on Black Willow Street, looking west.*

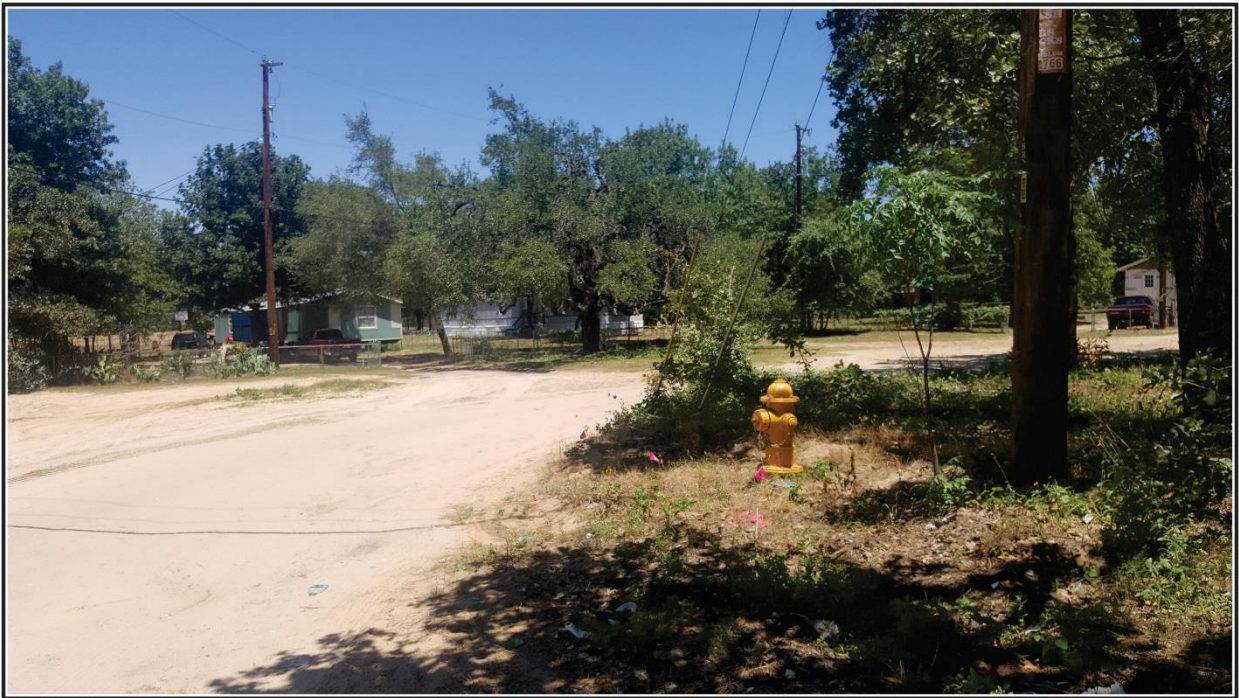
*Figure 4-3. Photograph of the APE on Little Walnut Drive, looking north.*

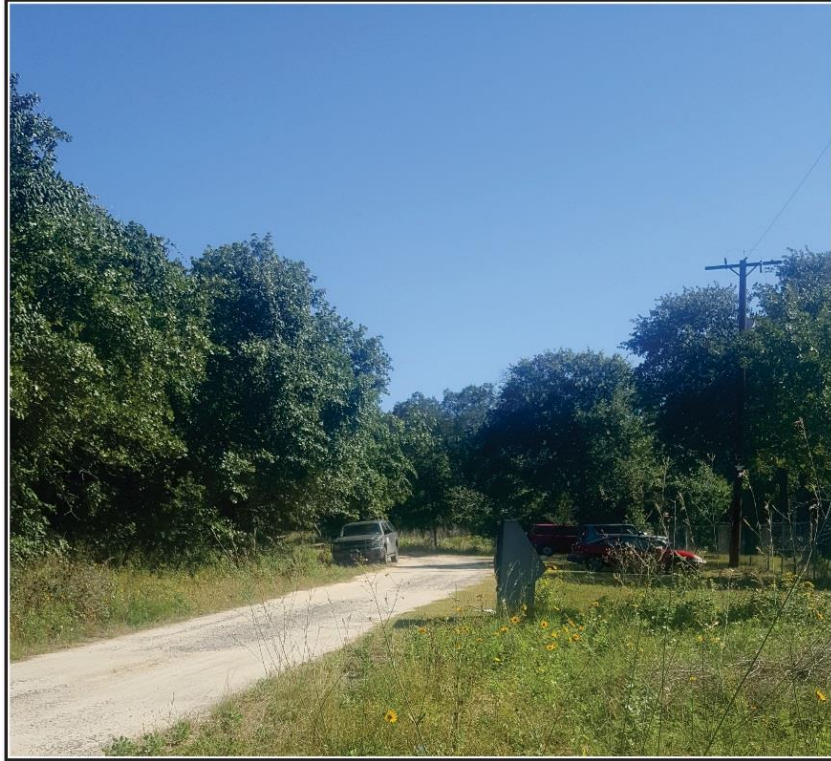
The remainder of the fieldwork was completed the following day (May 25, 2017). Shovel testing began at the east end of Tea Rose Lane and continued to Shellnut Drive. Segments of the road along Shellnut Drive contained patches of asphalt from previous paving (Figure 4-4). Shovel testing of the remaining streets continued, with Deer Run Drive being the last road subjected to shovel testing. Soils along this portion of the ROW were the same sandy soil found along Black Willow Street and Little Walnut Drive (Figure 4-5). No significant cultural material was observed during the excavation of these shovel tests, and all were dug to 60 cmbs.

*Figure 4-4. Photograph of the APE on Shellnut Drive, looking north.*

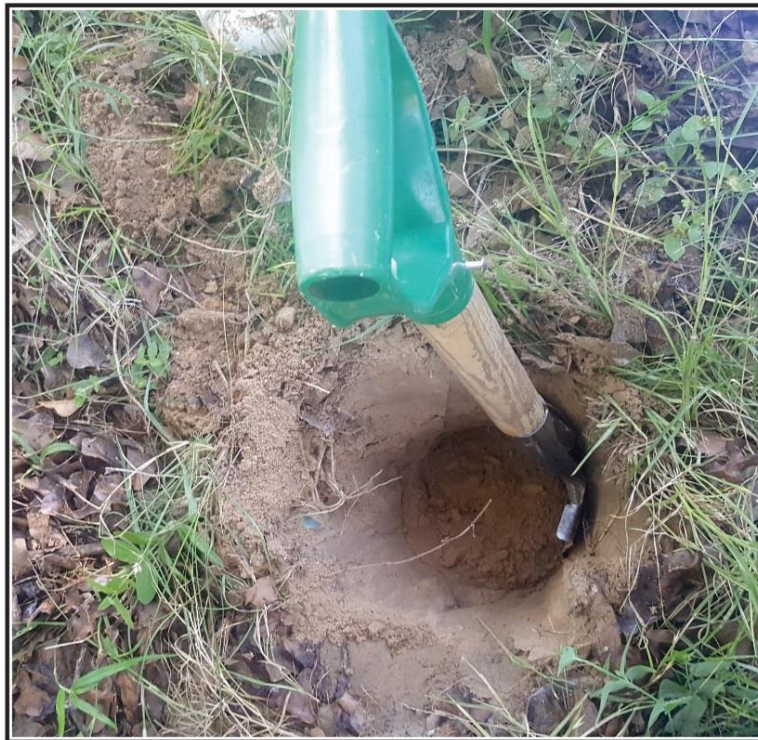
The typical shovel test soil profile revealed a brown sandy soil was present from 0-40 cmbs. When modern material was present, it was in this top soil profile. The second sandy soil typically found was yellowish brown and contained calcium carbonates, and it was found from 40-60 cmbs (the final depth of shovel tests). No material was encountered in this second stratum of sandy soils.

*Figure 4-5. Sandy soils encountered during CAR shovel testing.*
