Investigations of the Southeast Gateway at Mission San José, Bexar County, Texas

Texas Antiquities Permit No. 1649

©copyright
Center for Archaeological Research
The University of Texas at San Antonio
Archaeological Survey Report, No. 252
1998

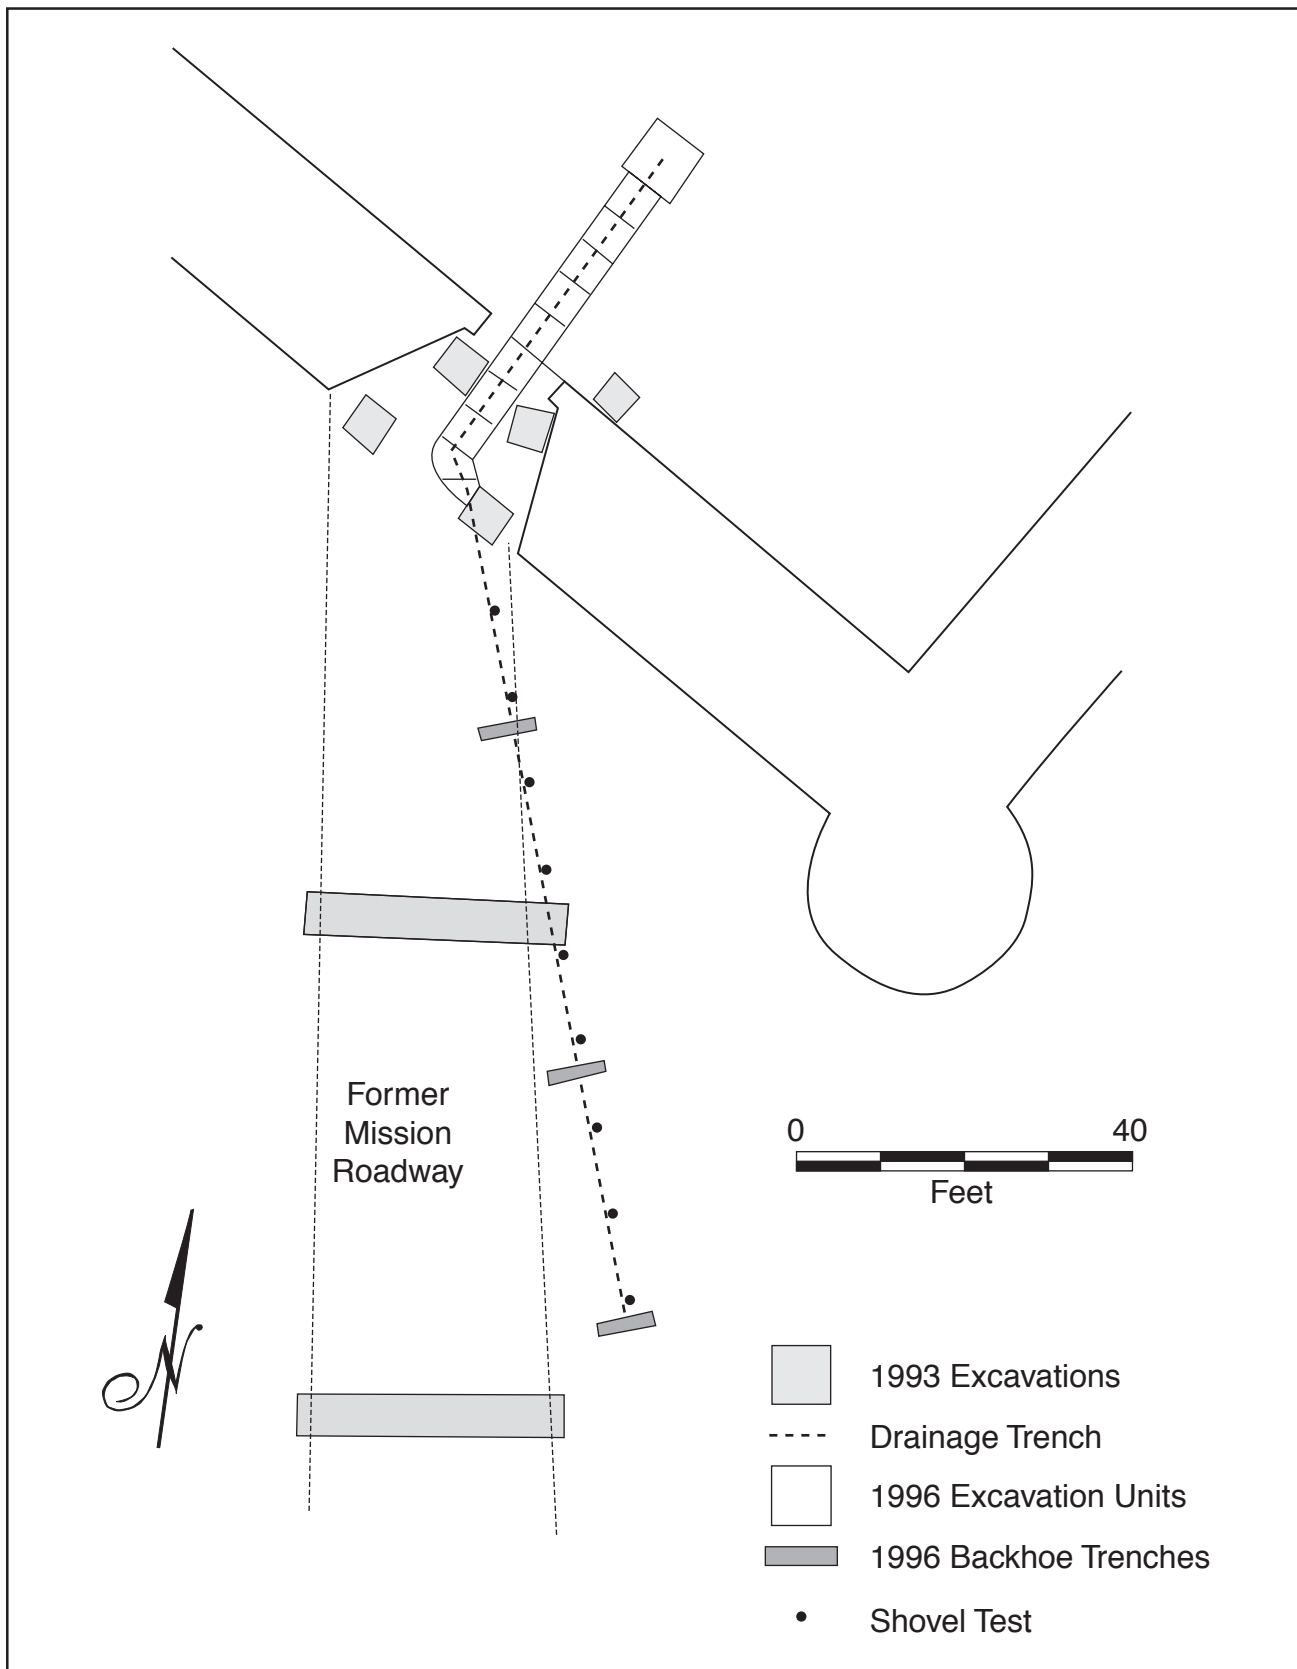
Figure 1. Areas of investigation in the southeast gateway.

placed along the portion of the drainage trench extending beyond the compound walls (Figure 1).

Based on the 1993 CAR investigations, a data recovery program was designed for the trench impact area within the compound and gateway. Because the impact area outside the compound walls had previously been disturbed by construction of Mission Road and the presence of commercial buildings and private residences, a testing and monitoring program was designed for this section of the drainage route. The fieldwork completed in 1996 consisted of the excavation of nine shovel tests and three backhoe trenches outside the mission compound. One 6-x-6-ft test unit, eight 4-x-4-ft test units, and two irregularly shaped units were excavated within the southeast gateway and southern section of the mission compound (Figure 1).

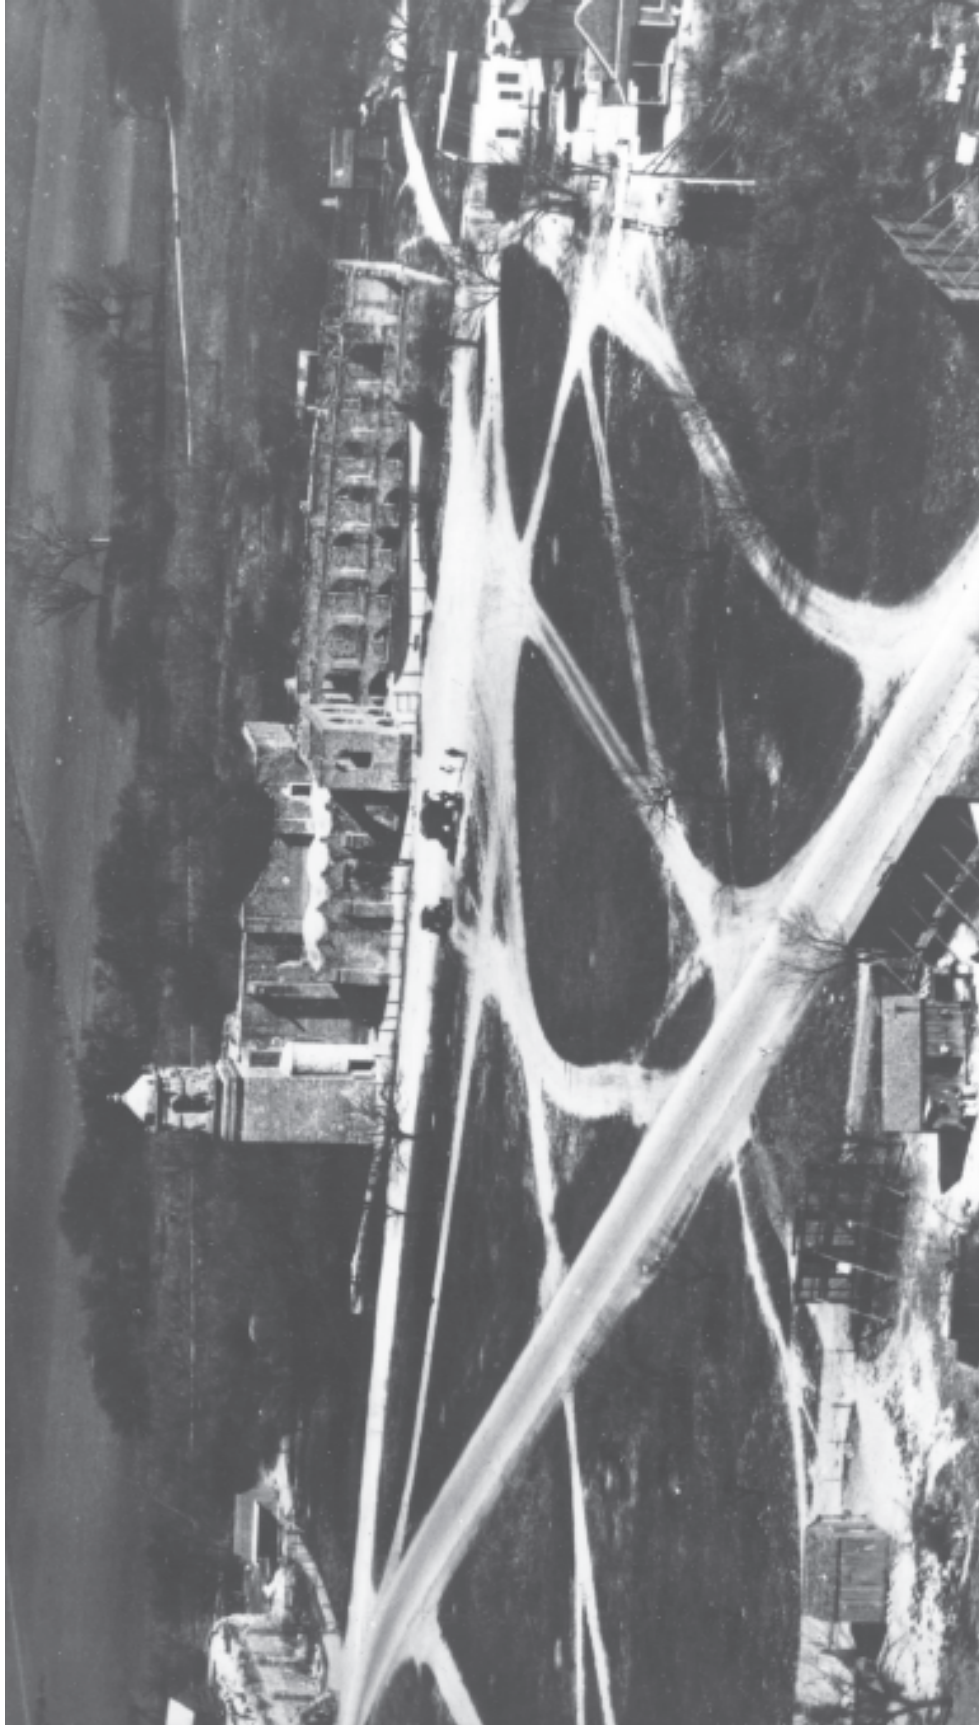
Figure 2. *Aerial photograph of Mission San José, ca. 1920, prior to reconstruction.* In this view, looking north, Mission Road runs diagonally across the courtyard. From the collection of the San Antonio Missions National Historical Park, San Antonio.

The mission compound was reconstructed in its present configuration in the 1930s–1940s based on research and designs by architect Harvey P. Smith, Sr. As early as 1918, Smith noted that huts had been built upon the ruins and that any remaining wall foundations would probably disappear within a few years (Clark 1978). Aerial photos of the mission from 1920 and 1932, prior to the Smith reconstruction, show the enclosing walls had entirely collapsed by this time and Mission Road is clearly visible running diagonally across the compound from what would have been the southeast corner to the front of the granary (Figures 2 and 3).

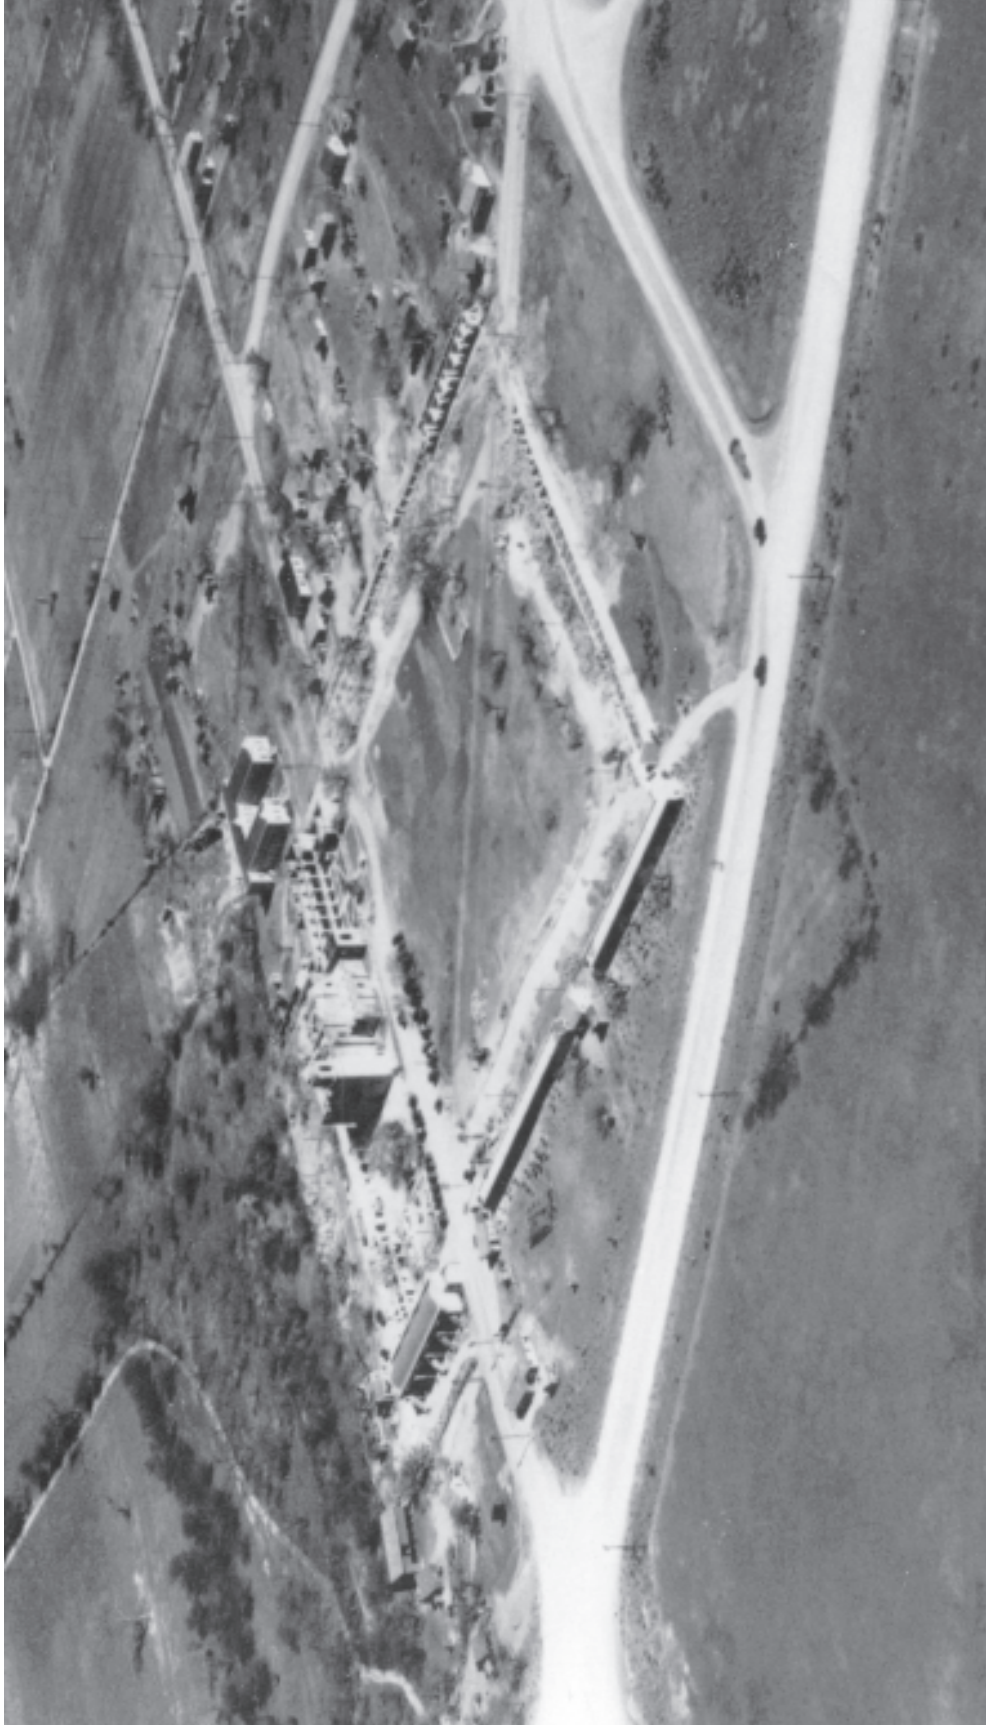
Figure 3. *Aerial photograph of Mission San José, ca. 1935, during reconstruction.* Mission Road can be seen running diagonally across the compound from what is now the southeast gateway on the right, to the granary on the left. From the collection of the San Antonio Missions National Historical Park, San Antonio.

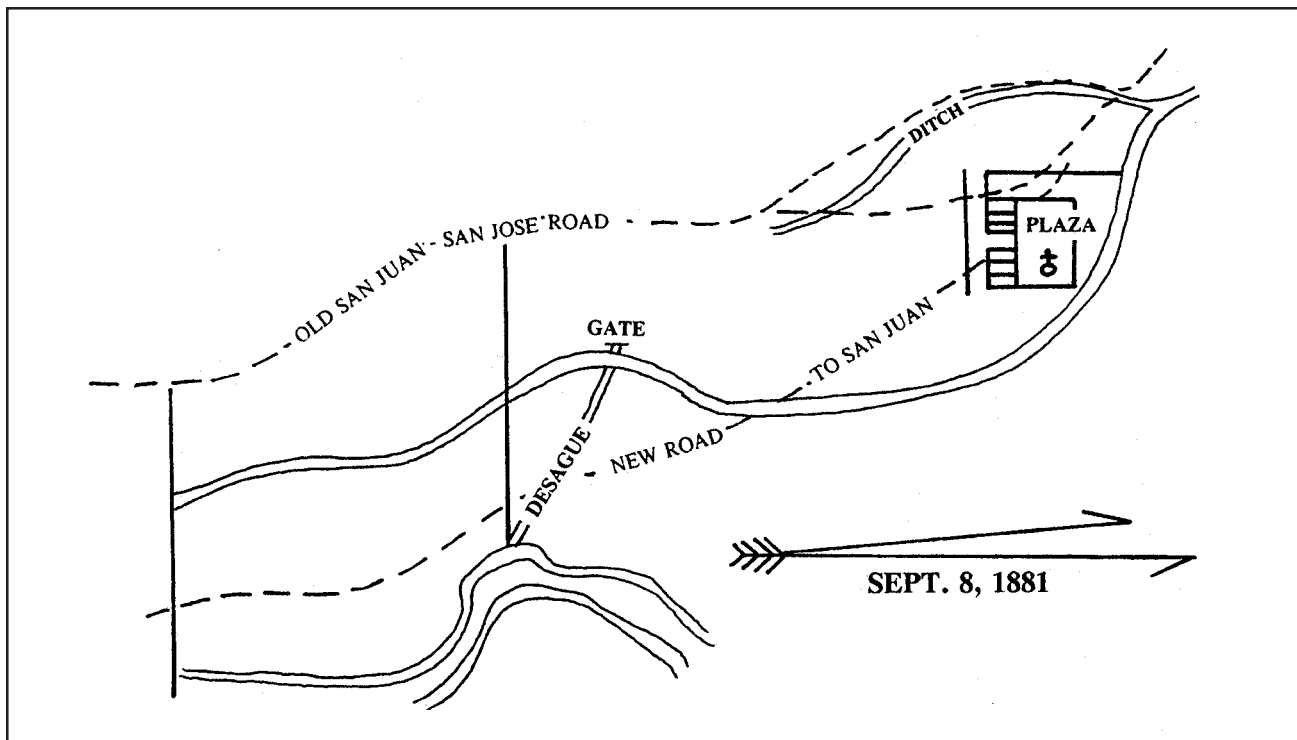
Figure 4. *Early location of New Road through Mission San José.* Adapted from the 1881 M. W. Merrich survey of the Lazzeler tract. DCR K:103.

A road into the mission appears on the 1881 Lazzeler tract map (Figure 4) labeled as the “new road to San Juan” (District Court Records [DCR], Office of the District Clerk, Bexar County Courthouse, San Antonio, Volume K:103). This “new” road appears to enter the mission compound through an opening close to the center of the south wall as suggested by Ivey et

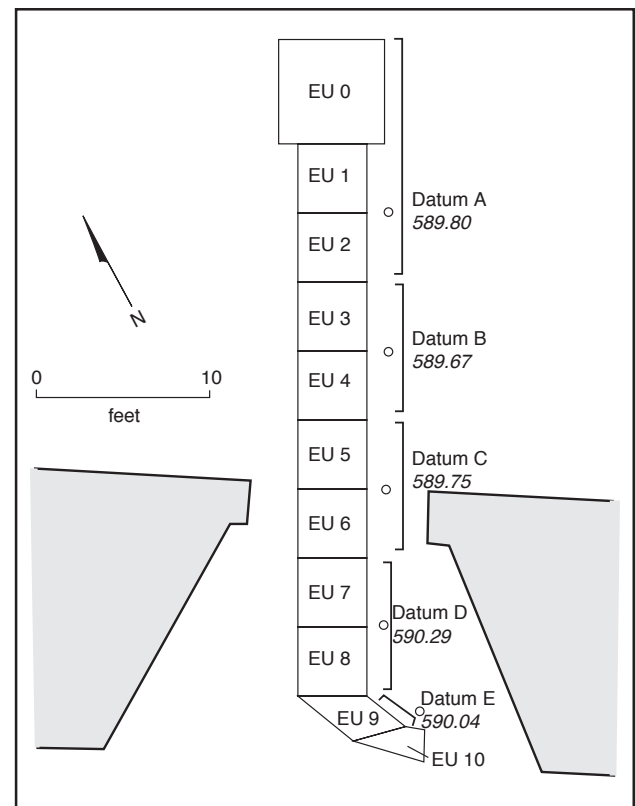
Figure 7. Layout of 1996 excavation units within the southeast gateway. Datum elevations (amsl) are given in italics.

One 6-x-6-ft excavation unit (EU), eight 4-x-4-ft EUs, and two irregularly shaped EUs were then laid out inside the trench cleared by the Bobcat. These units were labeled EU 0–EU 10, consecutively from north to south (Figure 7). Vertical datums were established three inches above original ground level along the east side of the cleared trench. Elevations were shot for datums and starting depths of excavations units. Starting elevations for EUs varied from 13–23 inches below datum (bd), 10–20 inches below the original surface (bs). The initial hand-excavated level of each unit was brought to a depth 20 inches bd, succeeding levels were five inches in depth. Excavations continued to sterile soil. All hand-excavated dirt was screened through ¼-inch hardware cloth and artifacts were bagged by level. All units were photographed

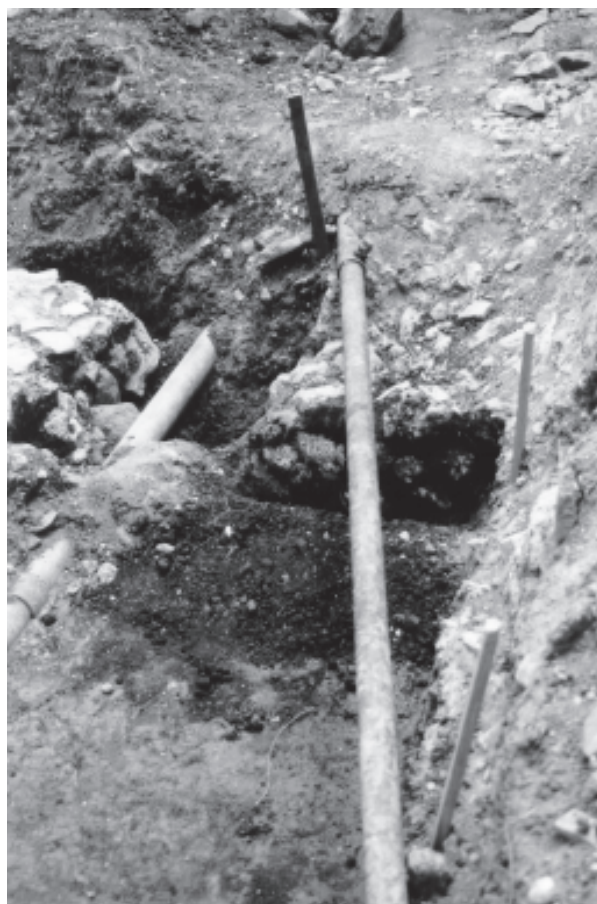
Figure 9. Exposed portion of the original exterior foundation. Looking south.

The exterior wall foundation identified during the 1993 CAR testing was relocated and an additional portion was exposed (Figure 9). This portion of the exterior foundation was exposed 19 inches below the surface at the southern limits of the project trench in EUs 9 and 10. It extends to a depth 35 inches below the surface and is approximately 35 inches wide. The foundation is composed of uncut sandstone and limestone held together by lime and sand mortar. Approximately 15 inches of this foundation had been removed during the installation of the four-inch main water line now serving the mission. Removal of the fill from the water-pipe trench provided a cross-section view of the foundation which shows the outline of the two-inch thick trench dug for construction of the original foundation (Figure 10).

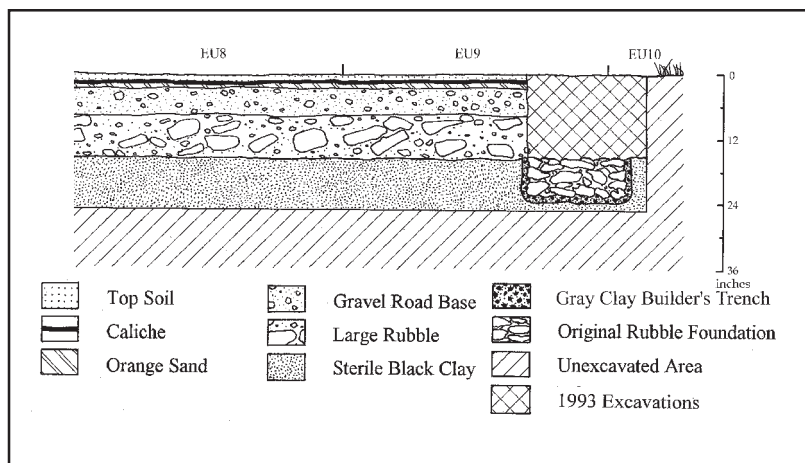
Figure 10. Profile of the east walls of EUs 8–10 within the gateway.

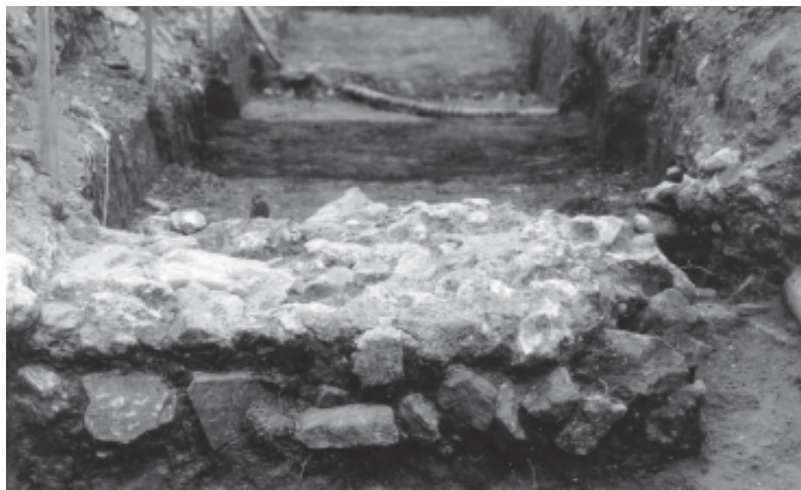
Figure 11. Exposed portion of the original interior wall foundation. Looking north.

A section of the interior wall foundation was also discovered 12 inches below the modern surface, in EUs 5 and 6, in line with the existing reconstructed interior wall of the compound (Figures 11 and 12). This foundation extends to a depth 25 inches below the surface and is 27 inches wide. The foundation is

composed of uncut pieces of sandstone and limestone that do not appear to have been laid systematically for the foundation. These stones are held together by uneven layers of fine-grained, lime and sand mortar. No evidence of a construction trench was found with the interior foundation.

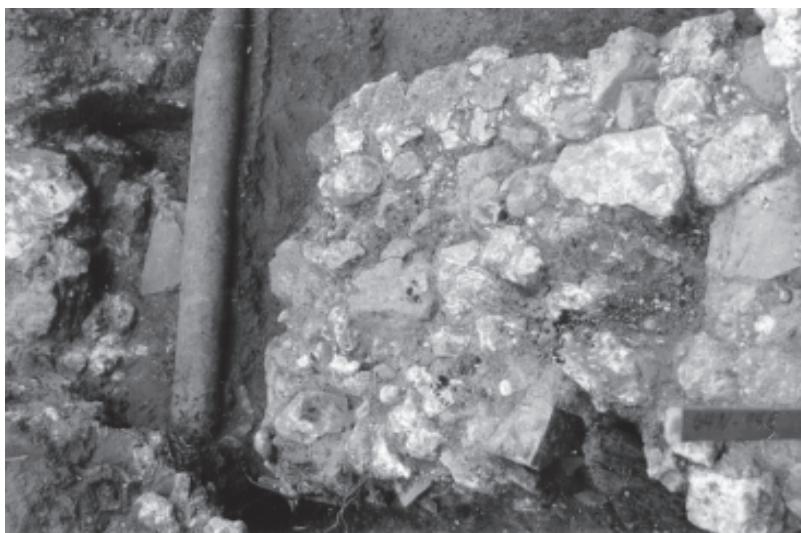
Figure 12. Exposed portion of interior wall foundation, top view.

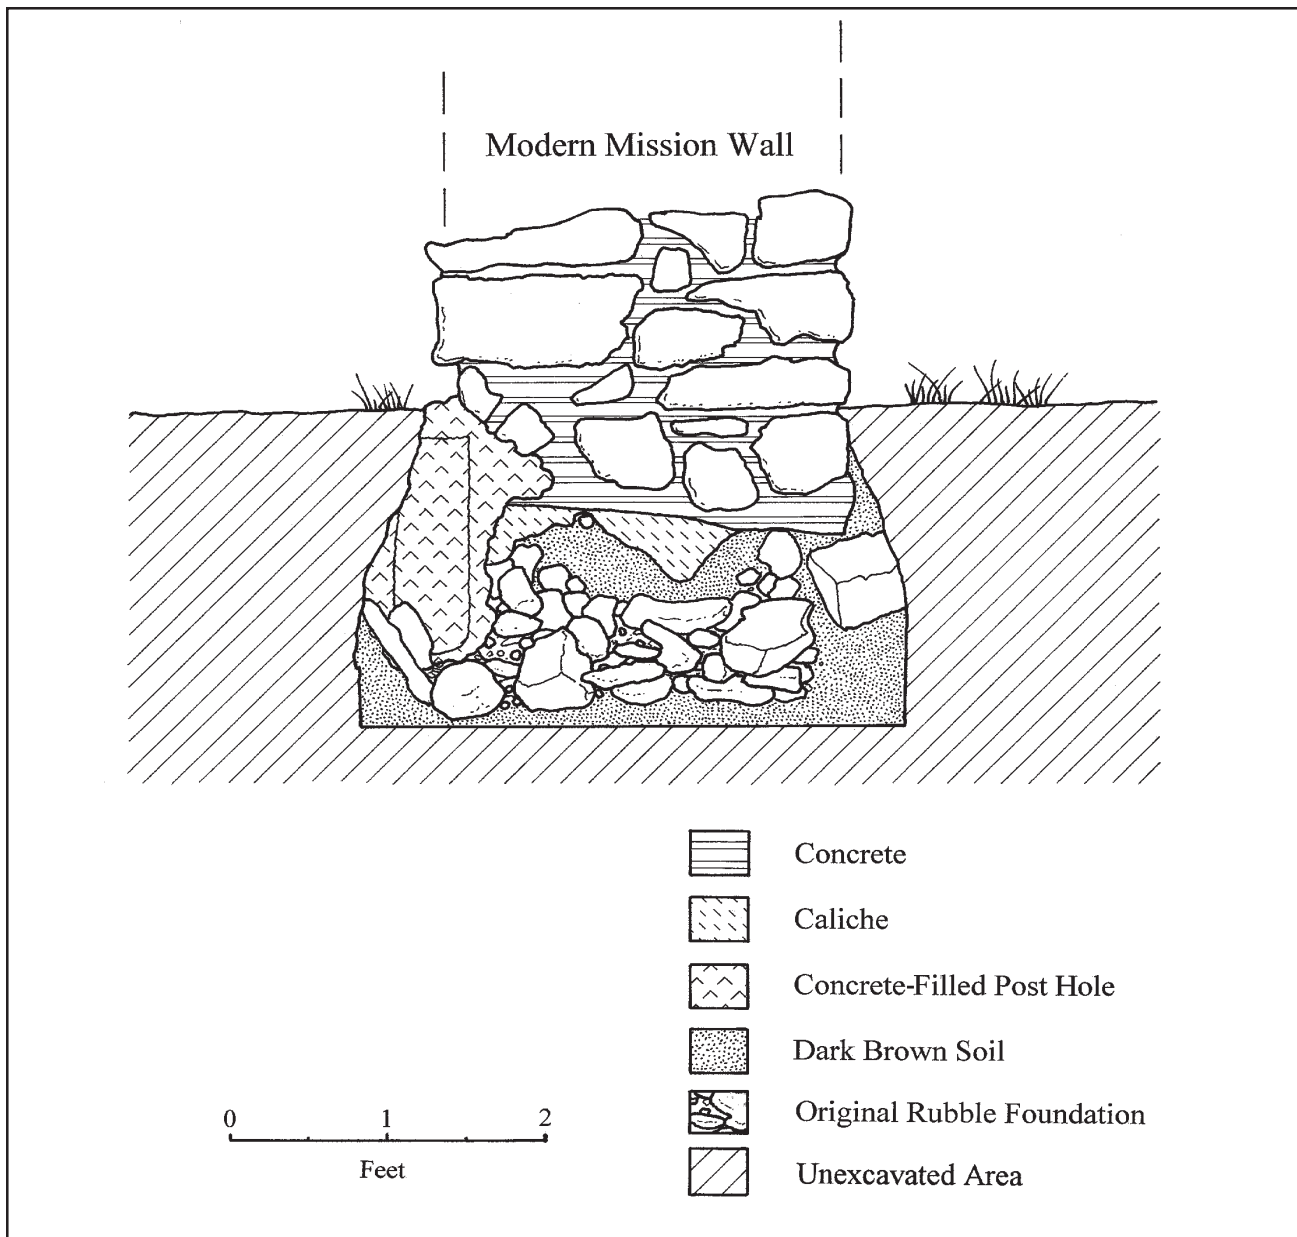
Figure 13. Profile of eastern gate archway showing connection of reconstructed and original portions of interior wall.

Approximately 12 inches of the interior foundation had also been removed during installation of main water line. The fill from this water-pipe trench was removed and excavations were extended eastward an additional 22 inches to the edge of the reconstructed mission archway. Figure 13 shows the reconstructed wall is joined to the original foundation by a layer of concrete 15 inches below the modern surface.

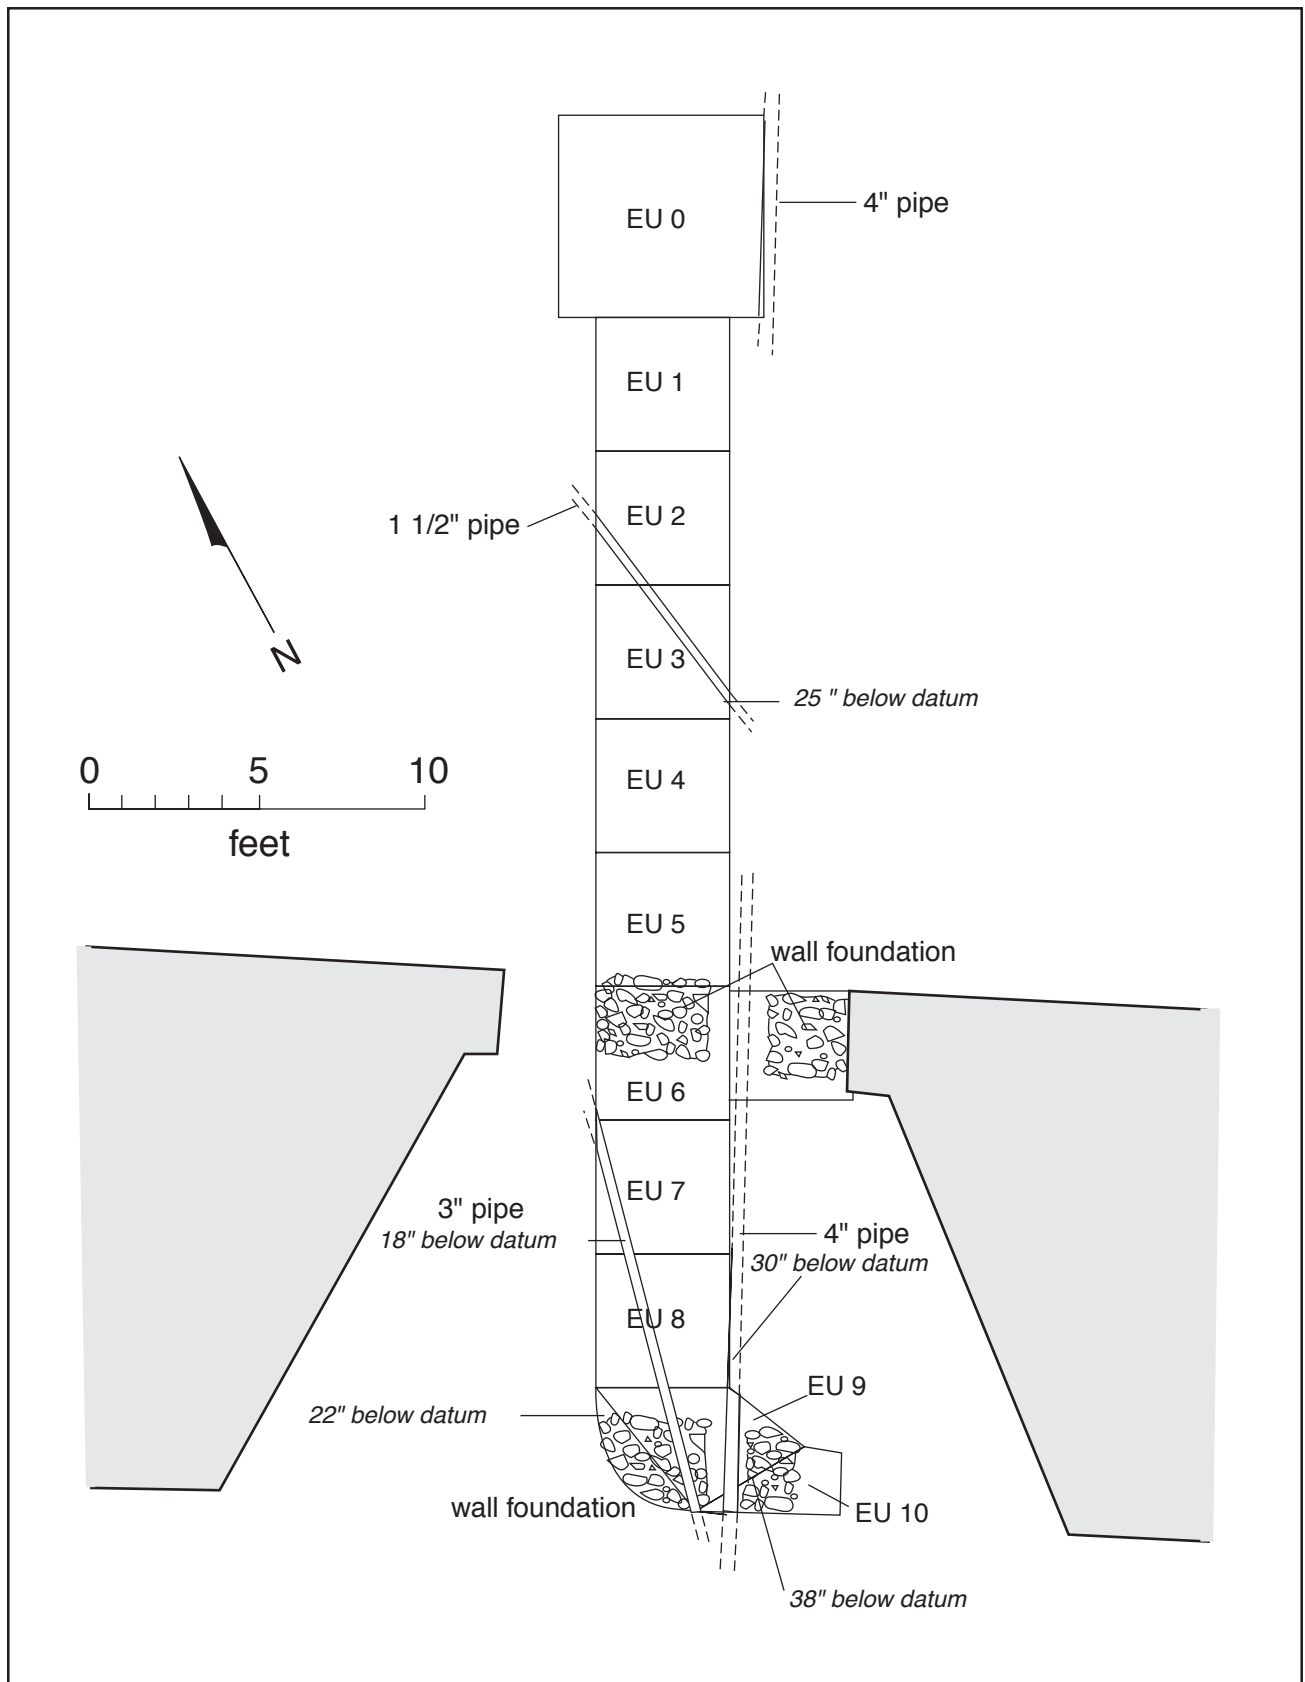
Figure 14. Plan map of excavated trench showing foundation sections and pipe trench disturbances.

Modern water and sprinkler pipes present in the project area are shown in Figure 14. The disturbance from these utilities was limited for the most part to the pipe trenches and left large sections of the Colonial deposit intact. However, the previous installation of the four-inch water pipe created a 15-inch opening in both the exterior and interior portions of the original wall foundations within the gateway.

The discovery of the breach in the Colonial foundations led to a reconsideration of the path of the new drainage system. With approval of THC and NPS representatives, the drainage trench was realigned to take advantage of the existing openings. Six inches of rock were removed from each side of the opening in the exterior foundation and 12 inches were trimmed from the western edge of the opening in the interior foundation to accommodate the new 26-inch drainage pipe. Park workers removed the soil adjacent to the exposed foundations by hand, leaving a five-foot-thick bulkhead

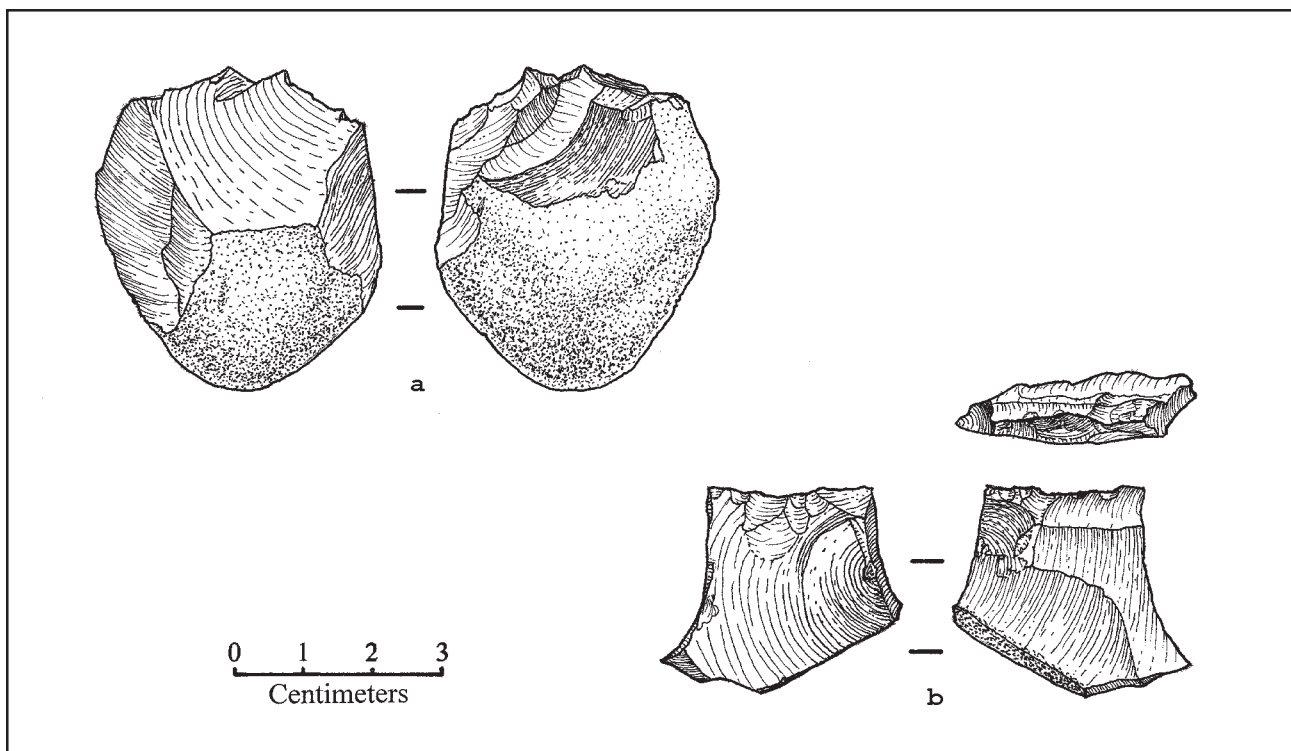
Figure 15. *Lithic tools: a. trimmed flake; b. small utilized cobble.*

EU 0: A flake (Figure 15a) which has been trimmed along one edge. This edge also exhibits some use-wear.

EU 0: A very small core (Figure 15b). Use-wear is present along one edge, but the raggedness of this edge suggests that the core was not originally intended for direct use, but rather picked up and used as an expedient tool. The frequent use of such small cobbles in Colonial-period sites has been noted (Hard et al. 1995:57).

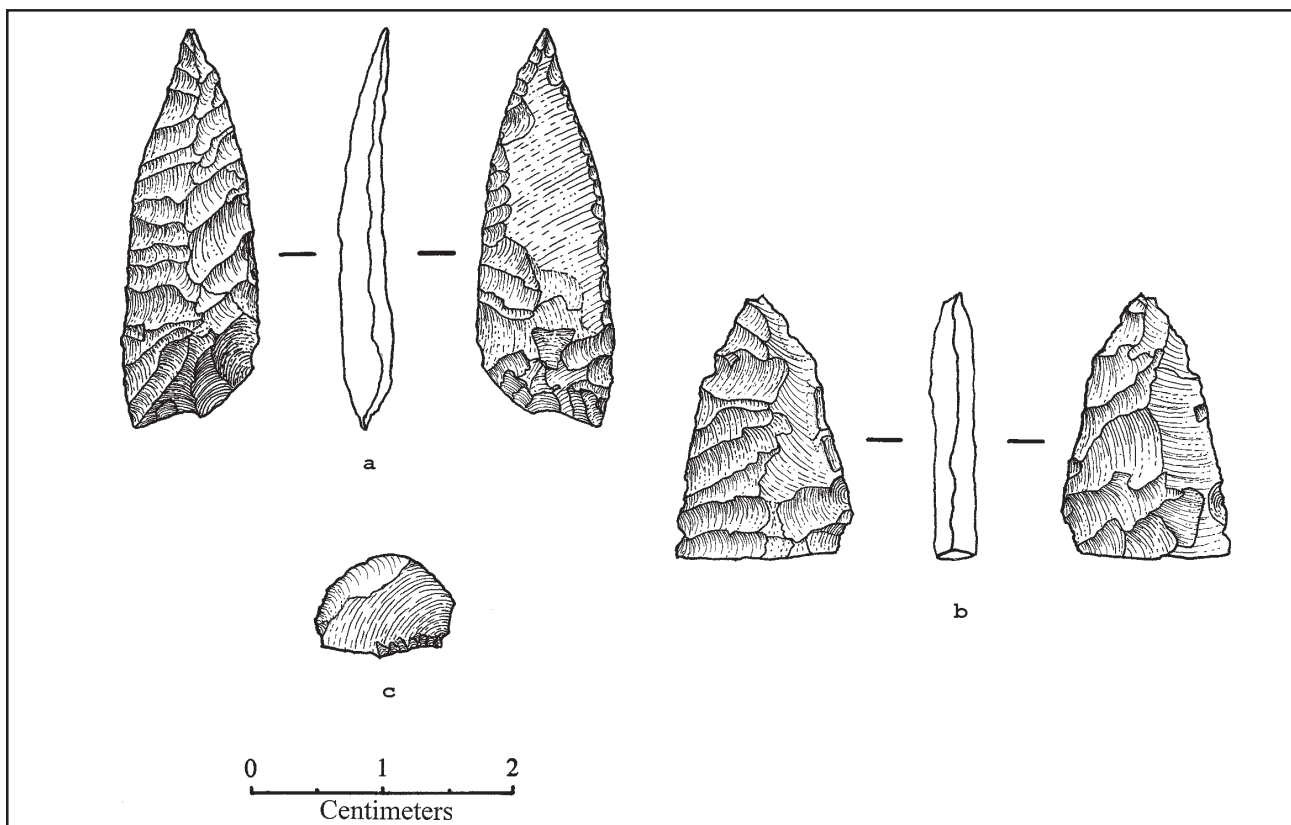
Figure 16. *Lithic tools: a. distal tip of biface; b. Guerrero projectile point; c. very small trimmed flake. Note: shown larger than actual size.*

EU 2: A Guerrero projectile point (Figure 16b). The point was clearly made on a flake, but is bifacially finished. It exhibits the typical fine workmanship and parallel flaking of the Guerrero point (Turner and Hester 1993:216). One corner of the base of this point was broken and carefully reworked.
