Archaeological Investigations for the Mother of the Americas Faith Formation Center, San Antonio, Bexar County, Texas

Acequia Madre de Valero (41BX8)

Prepared by:
Center for Archaeological Research
The University of Texas at San Antonio
One UTSA Circle
San Antonio, Texas 78249-1644
Archaeological Report, No. 458

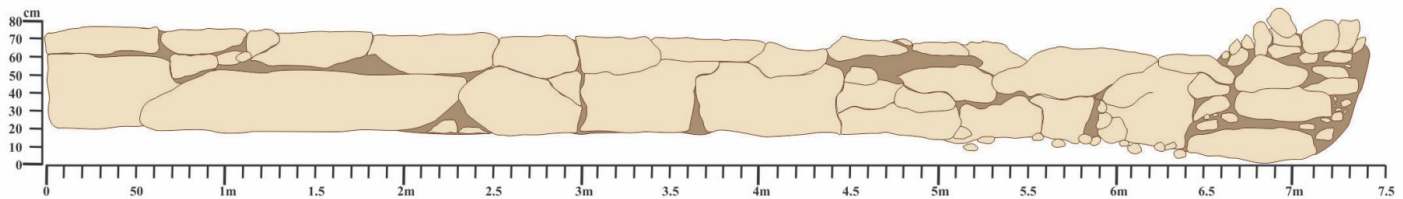
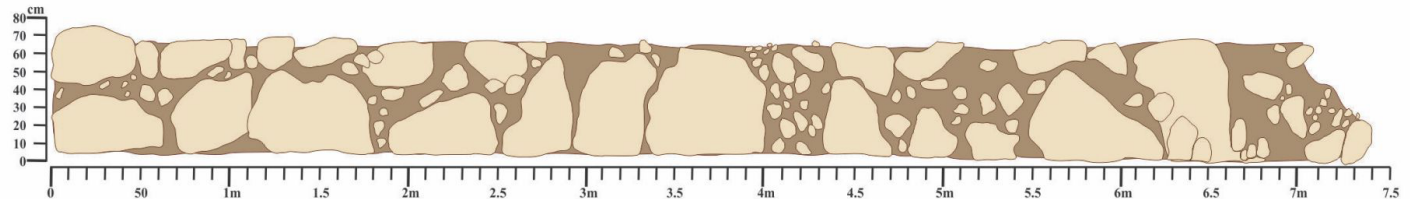
West Wall Profile

West Wall Plan View
