ARCHAEOLOGICAL INVESTIGATION TO LOCATE  
THE NORTHWEST CORNER OF  
MISSION CONCEPCIÓN  
SAN ANTONIO, BEXAR COUNTY, TEXAS

Center for Archaeological Research  
The University of Texas at San Antonio®  
Archaeological Survey Report, No. 212

1992

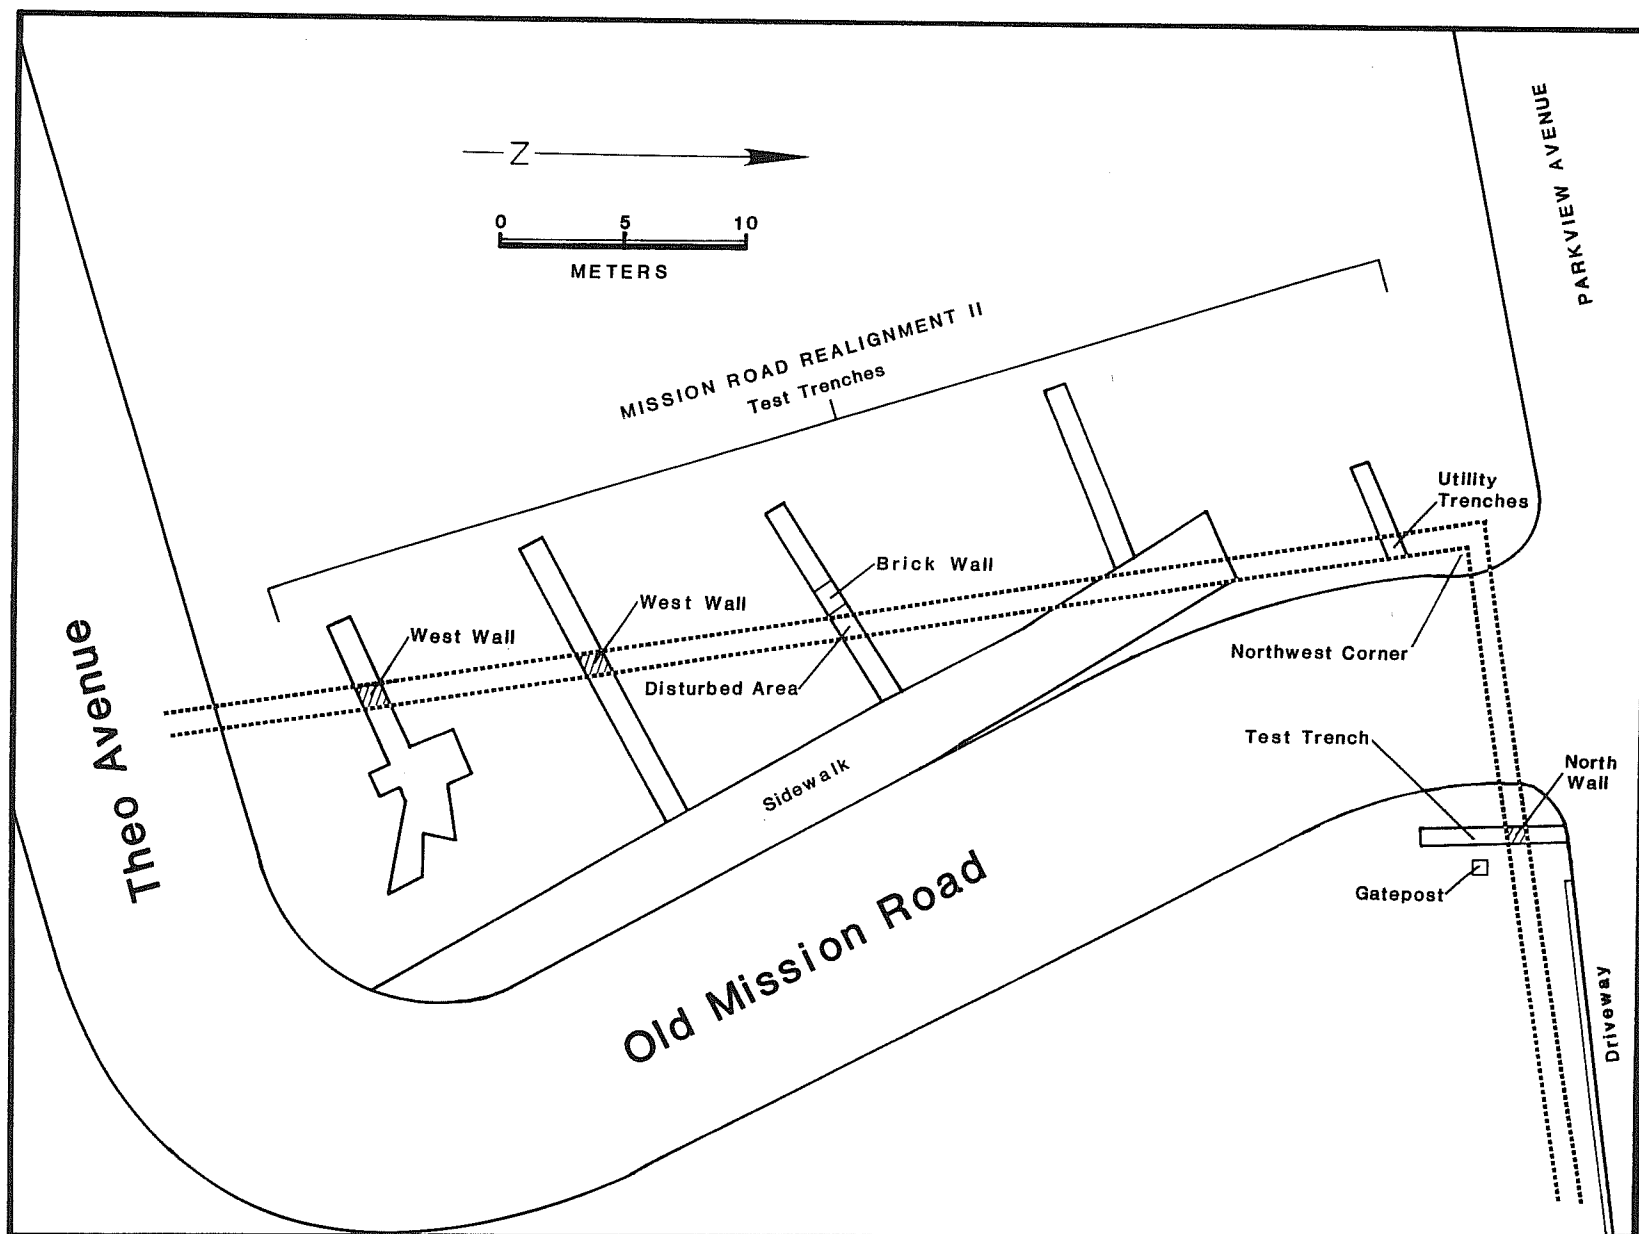
Figure 2. *Project Map*. Shown are previous and current test trenching that indicate the west and north wall alignments, and the projected northwest corner of the Mission Concepción quadrangle.

A backhoe trench 80 cm wide and approximately 5 m long was laid out 60 cm from the western face of the southernmost brick gatepost on the south side of the entrance drive to the St. John's Seminary buildings (Figure 2). The trench long axis was oriented to magnetic north. Approximately 1.25 m north of the gatepost, at ca. 75 cm below the surface, the top of the north wall of the compound was found. The wall was found to measure approximately 75 cm in thickness. The depth to the bottom of the wall was not determined, but it continued more than 1 m below the surface, where the trenching stopped.

The location of the northwest corner of the mission compound can be determined by projecting the lines of the west and north walls until they meet (Figure 2). This bit of information can now be added to the accumulated data about the outlines of the mission recovered by previous archaeological investigations. It can also be used in the future to relocate the northwest corner on the ground when the time comes to suitably indicate the mission walls on or above the ground surface.
