# Archaeological Testing in the Mission Concepción Courtyard (41BX12), San Antonio, Texas

Center for Archaeological Research  
The University of Texas at San Antonio  
Archaeological Survey Report, No. 304  
2001

Texas Antiquities Permit No. 2313

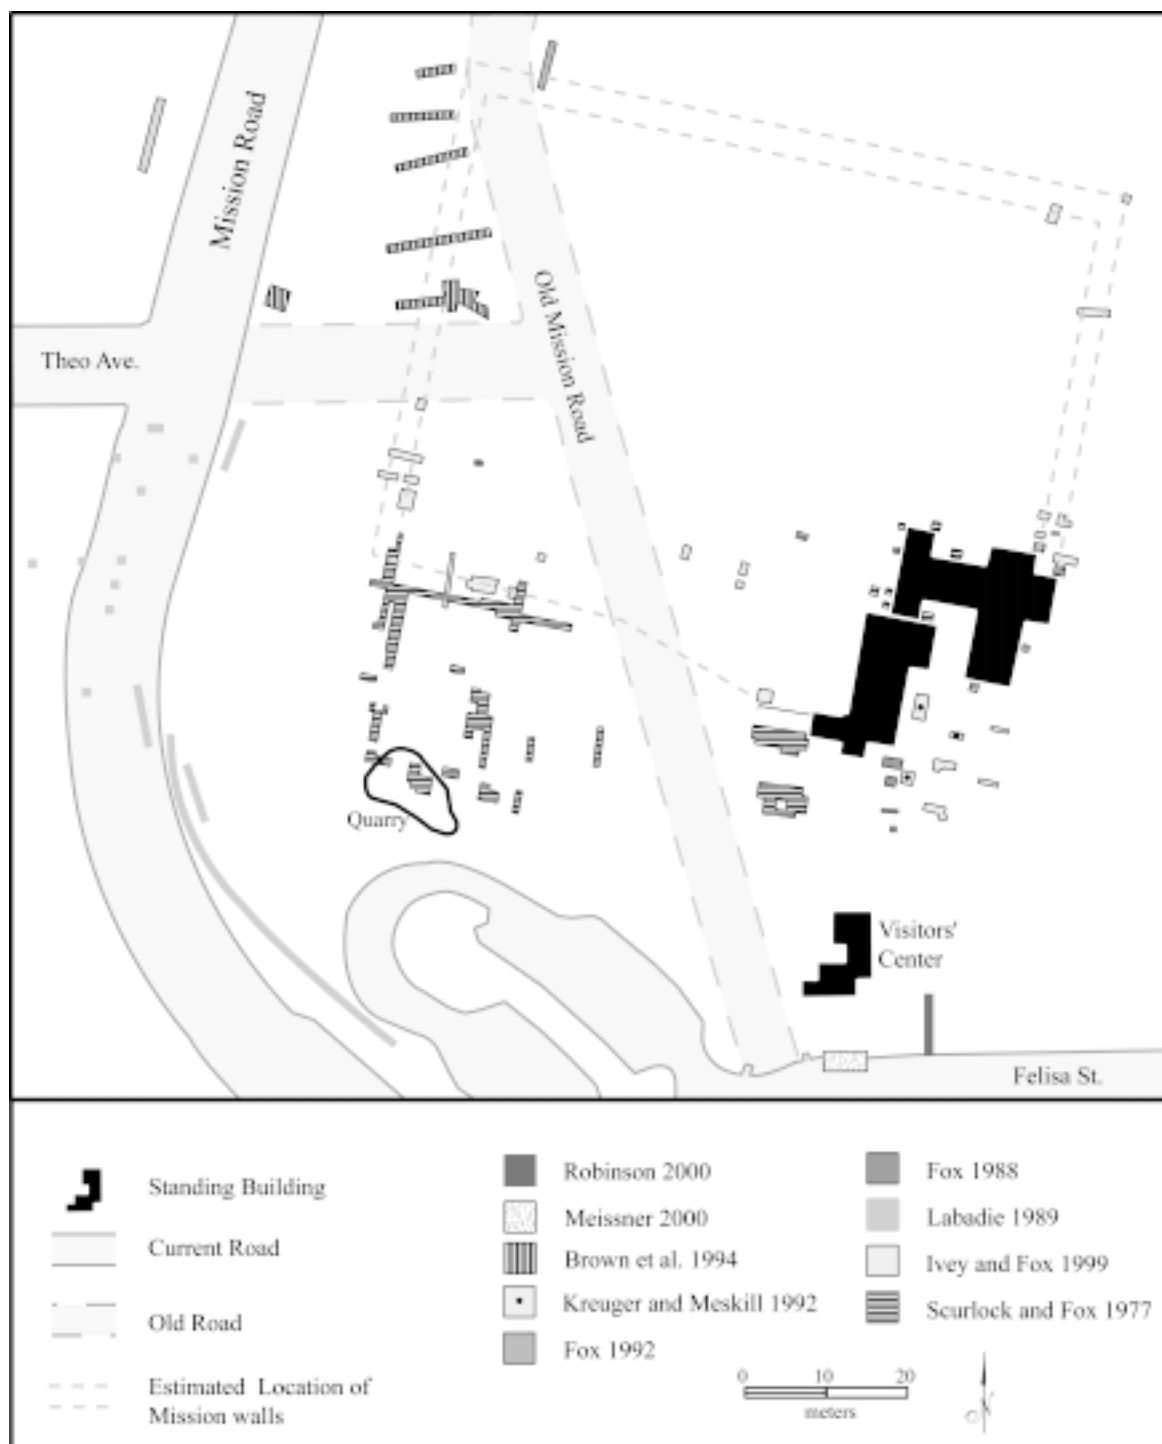
Figure 2. *Previous excavations.*

A number of archaeological investigations have taken place at Mission Concepción (Figure 2). They are briefly summarized here. In the 1930s, as part of a Works Progress Administration (WPA) project, archaeologists excavated around the standing mission walls, and documented foundations for many buildings that had long-since disappeared (Ivey and Fox 1999:4).

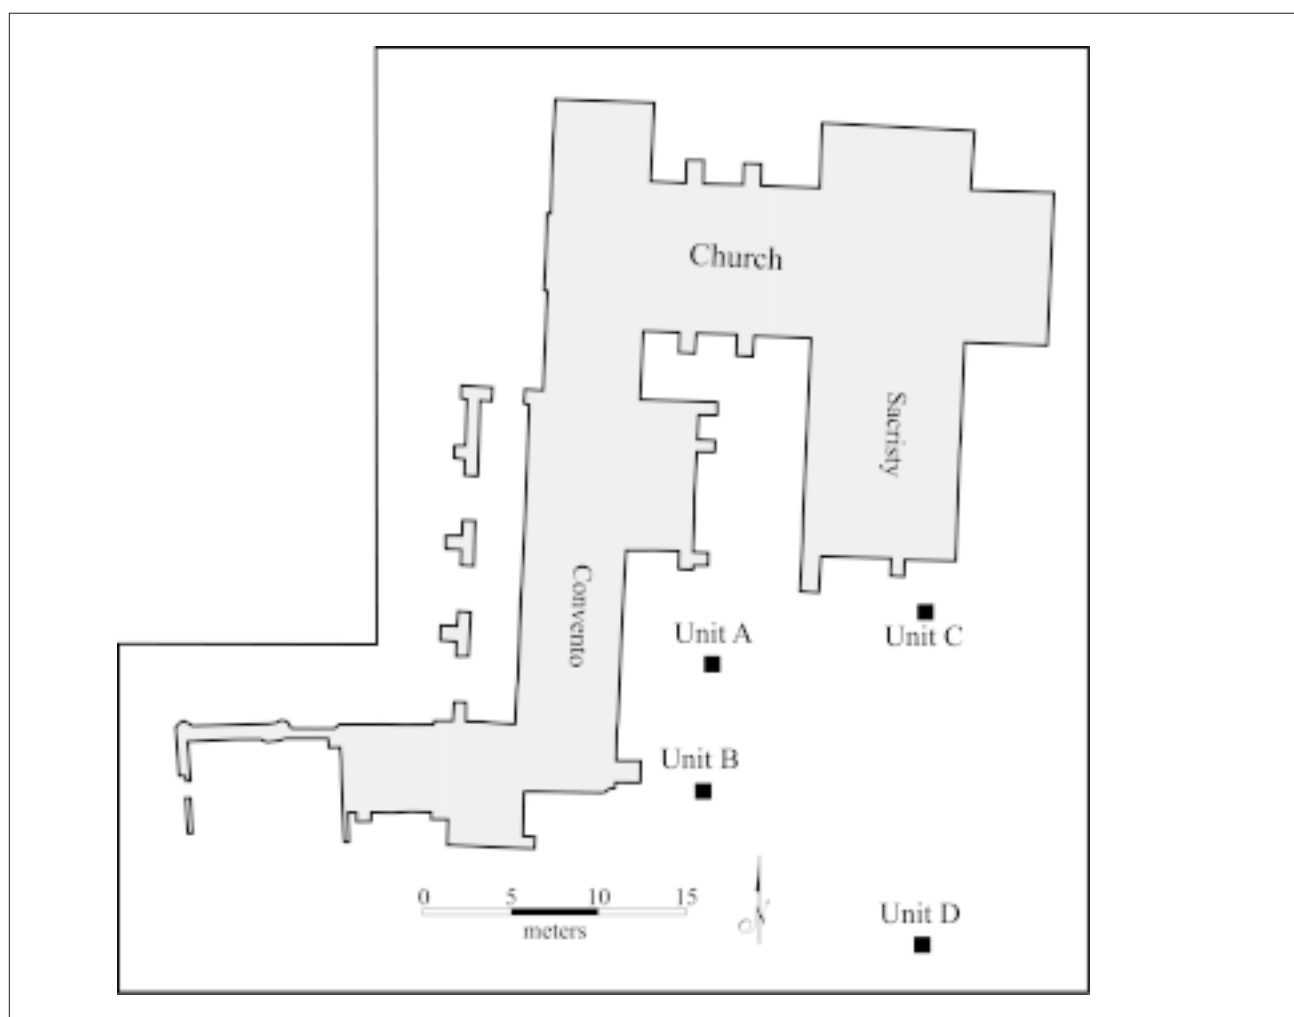
Figure 3. *Project map, showing location of the four test units.*

The CAR field investigations for this project were located in the courtyard area south of the current church (Figure 3). Measurements were taken according to the metric system. Four 1 x 1 m units were excavated by hand using shovels, trowels, and brushes. All matrix was sifted through ¼ inch (.64 cm) screen. All collections were processed, cataloged, and curated at the CAR laboratory.

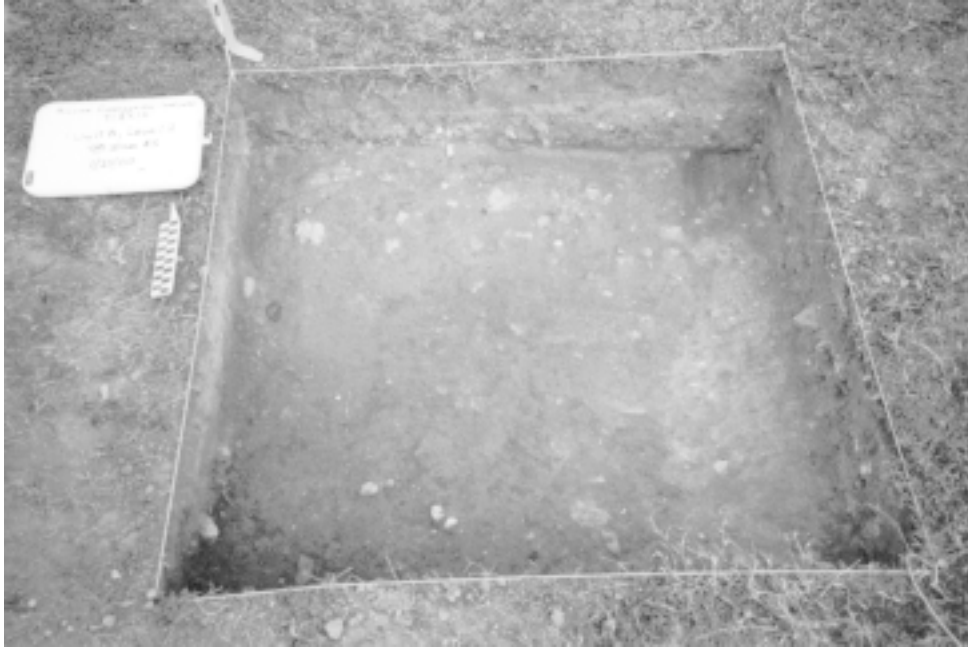
Figure 4. *Unit A, showing level of “adobe” floor.*

were recovered from this level. Level 2 (10–19 cm) yielded a mixture of modern and nineteenth century goods. Items recovered from this level include bone, ceramic fragments, glass fragments, a 1945 U.S. penny, a knife blade, brick and mortar fragments, and metal scrap. At approximately 19 cm below the surface, a floor was encountered in the northwest corner of the unit. This floor appeared to have been made by packing a mixture of clay, sand, and caliche, and allowing it to set into a fairly hard surface. Ivey and Fox (1999:15) refer to this type of floor as “hard-packed, tan adobe.” In the rest of the unit the floor was found at 20 cm below the surface. It appeared to have been somewhat disturbed in the middle section of the unit, and was hardest and least disturbed along the east side of the unit (Figure 4).

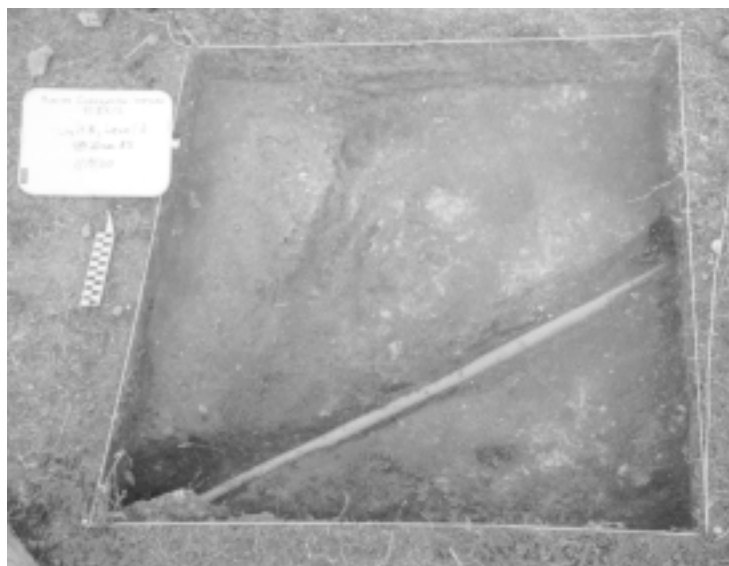
Figure 5. *Unit B, showing PVC pipe and other disturbances.*

Unit B was excavated in two levels. Level 1 (0–10 cm) yielded little cultural material. The level contained brick and mortar fragments, bone, chert flakes, ceramics, pull tabs, a porcelain doll foot, plastic fragments, and tar. Level 2 (10–20 cm) contained an increased number of ceramic fragments, along with glass fragments, brick and mortar fragments, bone, chert flakes, and a forged nail. A floor was revealed at approximately 12 cm below the surface in the southwest region of the unit, 15 cm below the surface in the northeast corner and at 17 cm below the surface in the northwest corner. A PVC pipe runs from the southwest corner of the unit at an angle to the west wall of the unit, and there is evidence of other disturbances affecting the floor. This floor had more caliche mixed into the clay, and was harder, whiter, and more easily defined even though it was in a more disturbed state than the floor in Unit A (Figure 5).

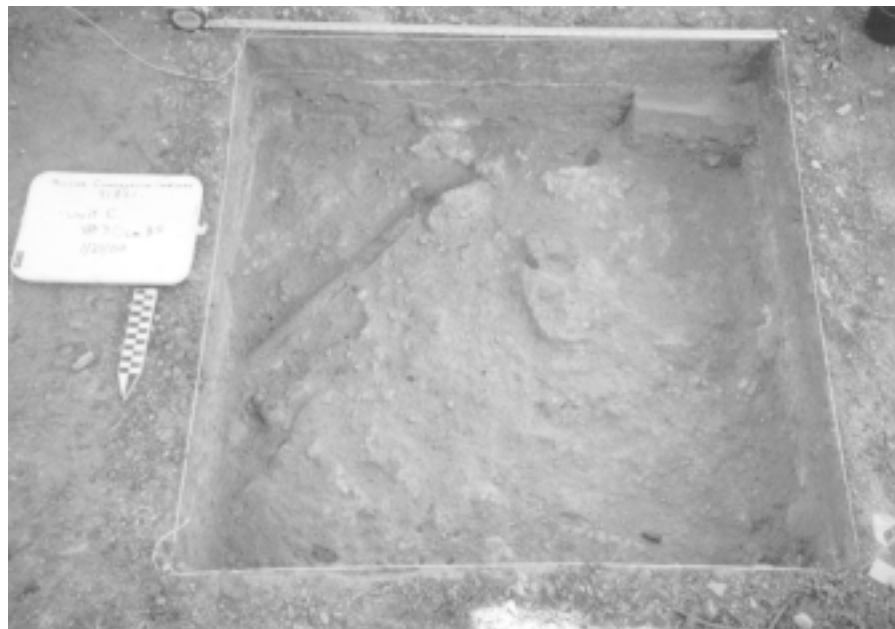
Level 3 (20–30 cm) contained glass fragments, chert flakes, bone, and ceramics. A cast iron pipe and associated trench was uncovered (Figure 6). It appeared that the packed caliche and bricks were part of a walkway along the southern edge of the unit (Figure 7). This walkway had been constructed in three episodes: 1) a layer of hard-packed caliche; 2) a layer of bricks set onto a layer of limestone gravel; and 3) another layer of packed caliche, laid down after the bricks had become covered with sediment (Figure 7). The “adobe” floor was uncovered intact in the southeast corner at 31 cm below the surface, directly beneath the packed caliche walkway. A somewhat larger area of intact floor was also uncovered in the southwest corner. In the northwest corner and throughout the center of the unit the flooring was disturbed, appearing in places at about 29–30 cm below the surface.

Figure 6. *Unit C, showing brick and caliche walkway in profile of south wall and cast iron pipe. Remnants of "adobe" floor are most visible in the northwestern quadrant of the unit. Looking south.*

ceramics, chert flakes, and wire nails. The southeast corner appeared to contain a caliche floor at 10 cm below the surface. Further excavations showed that the caliche was limited to the southern edge of the unit. Level 2 (10–20 cm) yielded chert flakes, ceramics, bone, glass fragments, a .22 caliber casing, and 2 bricks labeled “Corsican Brick.” The hard caliche surface along the southern edge of the unit covered the northern edge of a brick walkway.

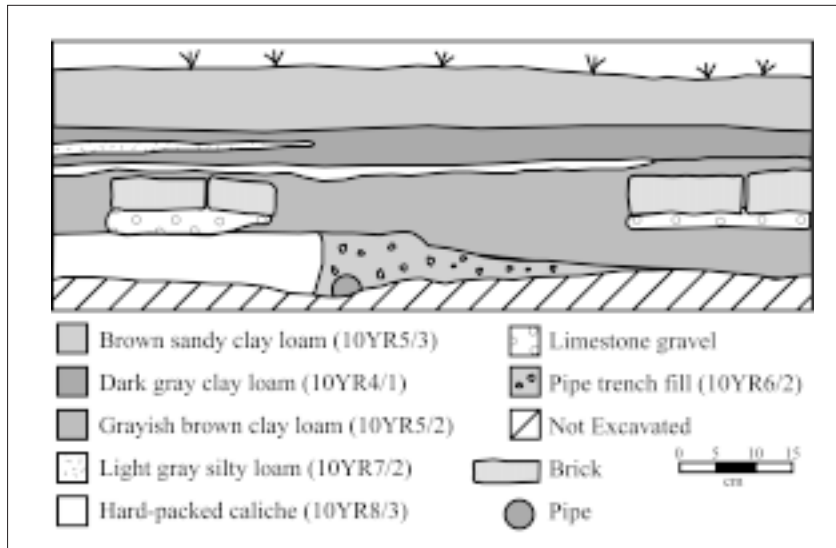
Figure 7. Profile of south wall of Unit C, showing edge of brick walkway.

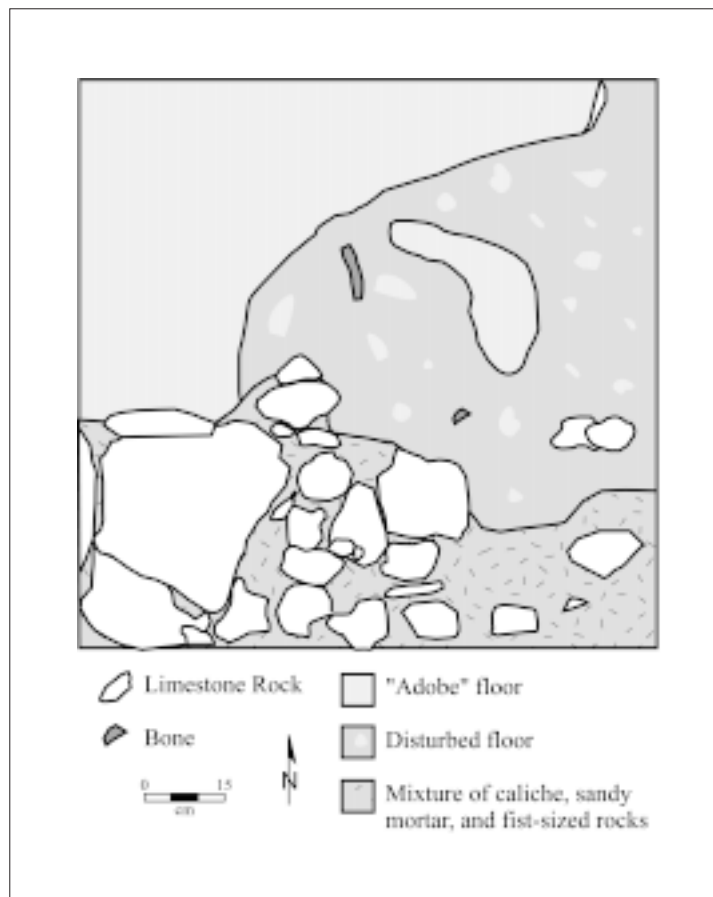
Figure 8. Plan of Unit D, showing remains of rock wall in southern part of unit and remains of floor in northwest corner.

Unit D was excavated in three levels. Level 1 (0–10 cm) contained glass fragments, bone, tar, nails, and one half of a shell button. Level 2 (10–20 cm) yielded an increased number of bone fragments and ceramics. It also contained glass fragments, brick and mortar fragments, and tar. At approximately 15 cm below the surface a concentration of rocks appeared in the southwest corner stretching to the southeast corner (Figure 8). This probably represents the south wall of the room described as Room 1 on the reconstruction of the mission illustrated in Figure 4 in Ivey and Fox (1999:9). Unit D is located east of Block 1 shown in Figure 5 of that same publication (Ivey and Fox 1999:11). In Level 3 (20–30 cm) the artifact inventory contained ceramics, bone, metal fragments, and mortar fragments. A floor was encountered at 25 cm below the surface in the northwest quadrant of the unit (Figure 9). Fragments of the floor appeared throughout the northeast portion, though it was highly disturbed.

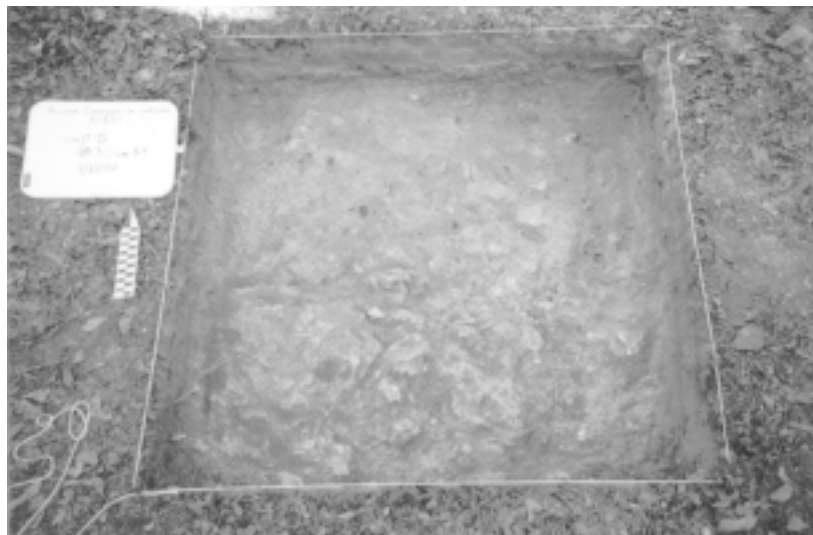
Figure 9. Unit D, showing rock concentration in southern half of unit and a remnant of floor in the northwest corner. Looking north.

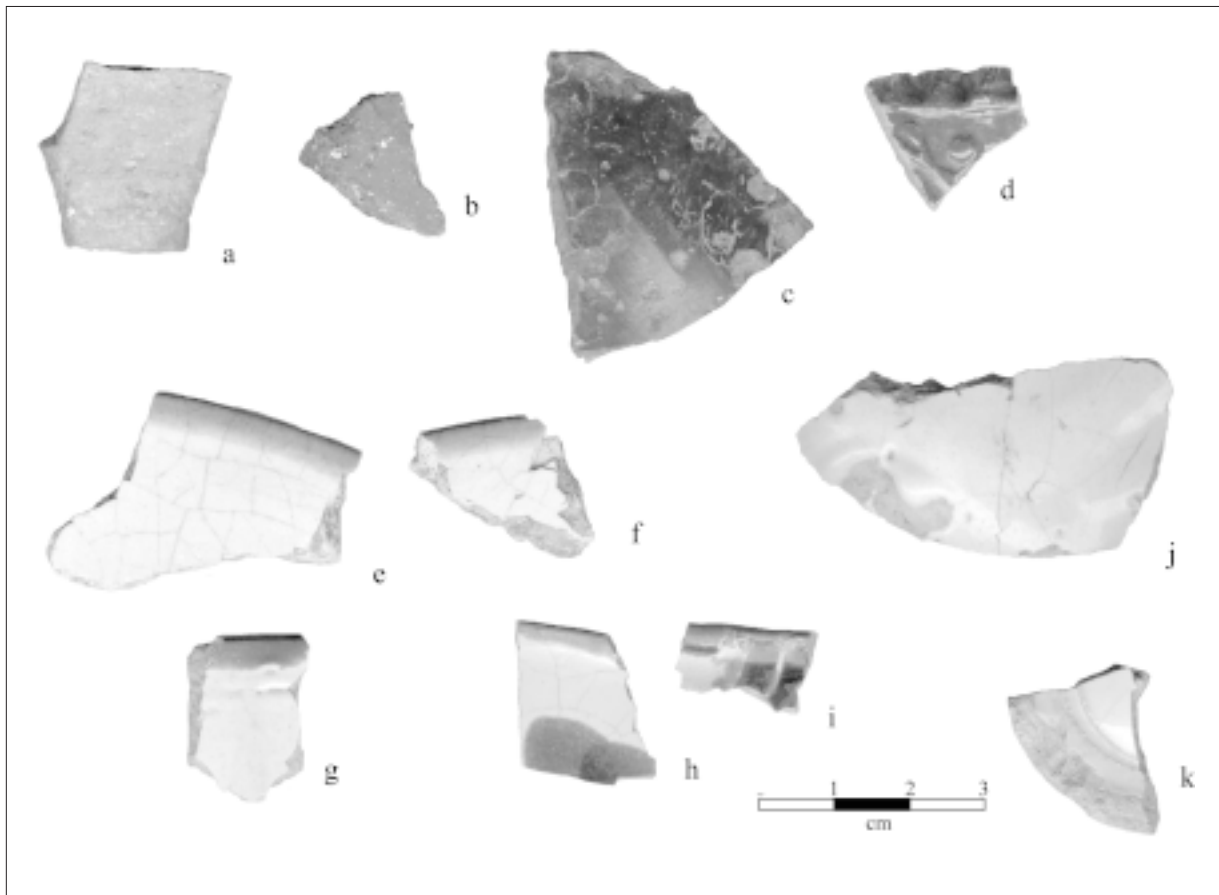
Figure 10. *Selected unrefined earthenware ceramics*: a) example of Valero ware, from Unit D, Level 2; b) example of Goliad ware, from Unit C, Level 3; c) example of Burnished ware, from Unit D, Level 2; d) molded lead-glazed rim sherd from Unit D, Level 3; e-g) Huejotzingo majolicas from Unit D (e-f are from Level 2 and g is from Level 3) ; h) Puebla Blue on White majolica from Unit D, Level 2; i) Puebla Blue on White majolica from Unit D, Level 3; j) two mended pieces of undecorated majolica, from Unit D, Level 3, showing poorly applied glaze; k) undecorated majolica fragment of foot ring from Unit A, Level 2.

were popular at the San Antonio missions from ca. 1730 to 1760 (Ivey and Fox 1999:37; Dial 1992:31). Twenty fragments of Valero ware were recovered (Figure 10a). In addition, 5 sherds of Goliad ware were recovered (Figure 10b). Goliad ware is a bone-tempered, hand-built ceramic type that is often associated with the mission Natives of Spanish Colonial times (Dial 1992:29). It is believed that Goliad ware is a direct continuation of the local *Leon Plain* prehistoric ceramic tradition (Ivey and Fox 1999:37).

Burnished wares present at Mission Concepción reflect pre-Columbian Mexican traditions that still persist to this day. Red Burnished wares exhibit a glossy surface on a fine-grained paste. This type may have been brought in from Mexico either by traveling Natives or by supply trains (Dial 1992:32). There are five pieces of Red Burnished ware in this collection (Figure 10c).

Lead-glazed wares often comprise a large portion of the ceramic assemblages of Spanish Colonial sites. These include: sandy paste utility wares, Olive jars, fine textured paste, and miscellaneous lead-glazed wares (Dial 1992:33–34). Five lead-glazed ceramic sherds were recovered, one of which is a rim sherd molded in a complex design (Figure 10d)

approximately dated to a time between the eighteenth and early-nineteenth centuries (Ivey and Fox 1999:40). Five fragments of Puebla Blue on White, which also can be dated to a time in the eighteenth century (Hard et al. 1995:47), were recovered (Figure 10h-i).

Seven pieces of unidentifiable majolica were present in the artifact inventory. These fragments contain no design and are white in color. Two of these, which mend together, form part of a bowl (Figure 10j), and are glazed with thick tin which was poorly applied. Another undecorated sherd is part of a foot ring (Figure 10k).

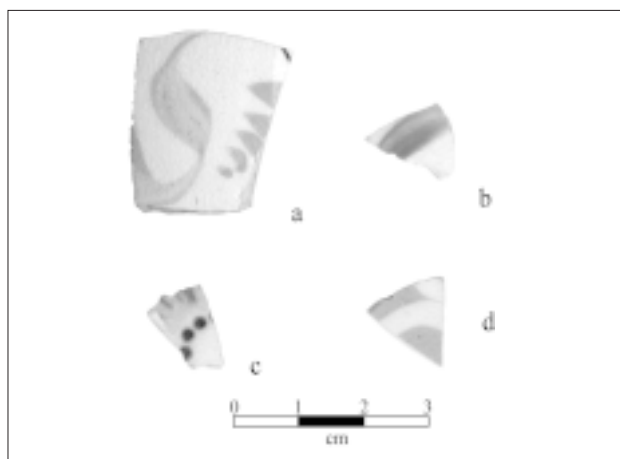
Figure 11. *Selected refined earthenwares*: **a)** hand-painted whiteware from Unit C, Level 3; **b)** handpainted whiteware from Unit B, Level 2; **c)** transfer decorated whiteware from Unit B, Level 2; **d)** banded slip decorated whiteware from Unit C, Level 2.

Whitewares were first manufactured in England and Europe, and were being made in the United States by the middle of the nineteenth century (Brown et al. 1994:16). Whitewares characteristically exhibit a hard cream to gray white paste that results from highly fired refined clays. Vitreous glazes—occasionally with a bluish tint—are commonly used on whiteware vessels (Tennis 1997:2; Dial 1992:38). These wares can be dated to the nineteenth and twentieth centuries, and are generally considered post-Colonial in San Antonio (Brown et al 1994:16). Eleven fragments of whiteware were recovered during this project. Of these, two were handpainted (Figure 11a–b), one was transfer decorated (Figure 11c), and three were banded slip decorated (see Figure 11d for example). Handpainted whitewares were popular in Texas during the 1800s (Dial 1992:41). Transfer decorated wares were first produced in England during the 1750s and were popular in the United States well into the 1850s. A resurgence of popularity occurred in the last quarter of the nineteenth century (Tennis 1997:6). Banded slip decorated wares with a simple blue banded theme were popular in Texas after 1840. Before 1840, the mocha variety (such as the sherd illustrated in Figure 10d) was popular in the state (Tennis 1997:6).

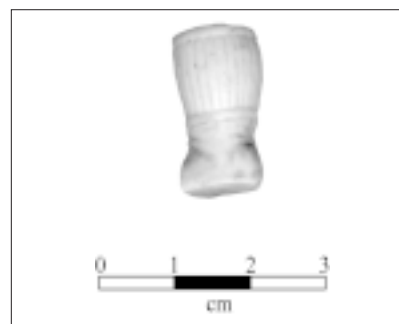
Figure 13. *Porcelain doll's foot.*

One porcelain doll foot was found in Unit B Level 1 (Figure 13). The fragment is approximately 1.9 cm in length with the shoe painted blue while the stocking portion is white. This foot would have been sewed to a cloth-bodied doll, along with porcelain arms and head. It belonged to a doll which was probably manufactured between about 1860 and 1910 (Meissner 1997b:59–76).

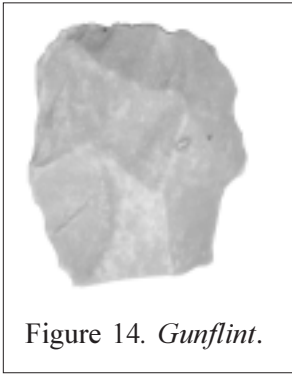
Figure 14. *Gunflint.*

The single gunflint is made on a short tertiary flake with a longitudinal break along one lateral edge. It has a roughly rectangular shape measuring 25 mm on each side. Crushing and small step-fractured flake scars indicative of use are present along three of the four edges. The flat break face is the only edge without use-wear. In addition, light polish is present on a number of the flake scar ridges on its dorsal surface. This polish is probably the product of the gunflint's movement against the leather patch which held it in place, and under pressure by the cap screw (see Kenmotsu 1990:Figure 3). Given that the blank is a flake rather than a blade, and given its expedient manufacture, it is probable that the specimen is a native-made gunflint.

A total of 23 chipped lithic artifacts was recovered during testing. Twenty-two of the artifacts are unmodified lithic debitage (see Appendix B). The remaining specimen is a gunflint (Figure 14).

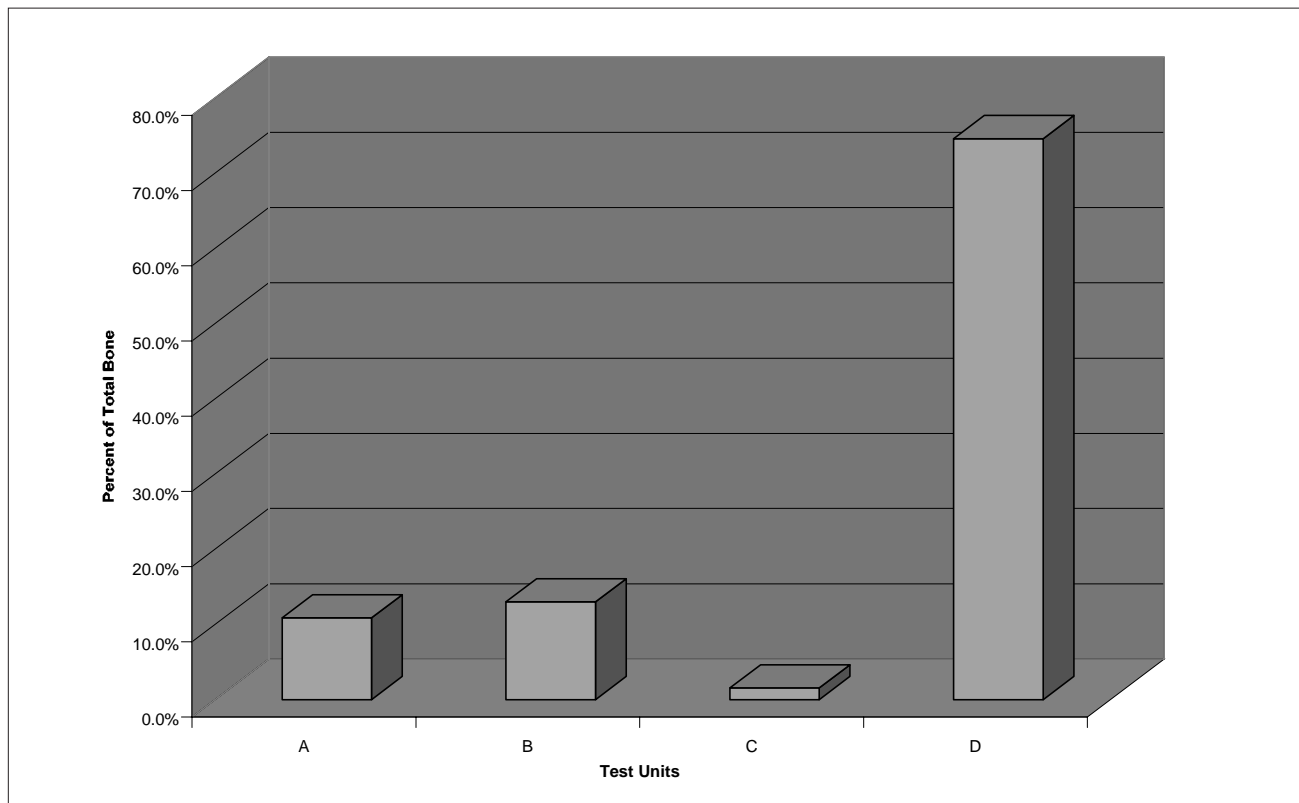
Figure 15. *Distribution of animal bone by test unit.*

Much of the bone is in very fragmented condition, with the average bone weight only 1.1 grams. The bone was not evenly distributed. Almost 75 percent of the bone came from Unit D (Figure 15). Only 14 bones (2 percent) could be identified to the genus taxonomic level.

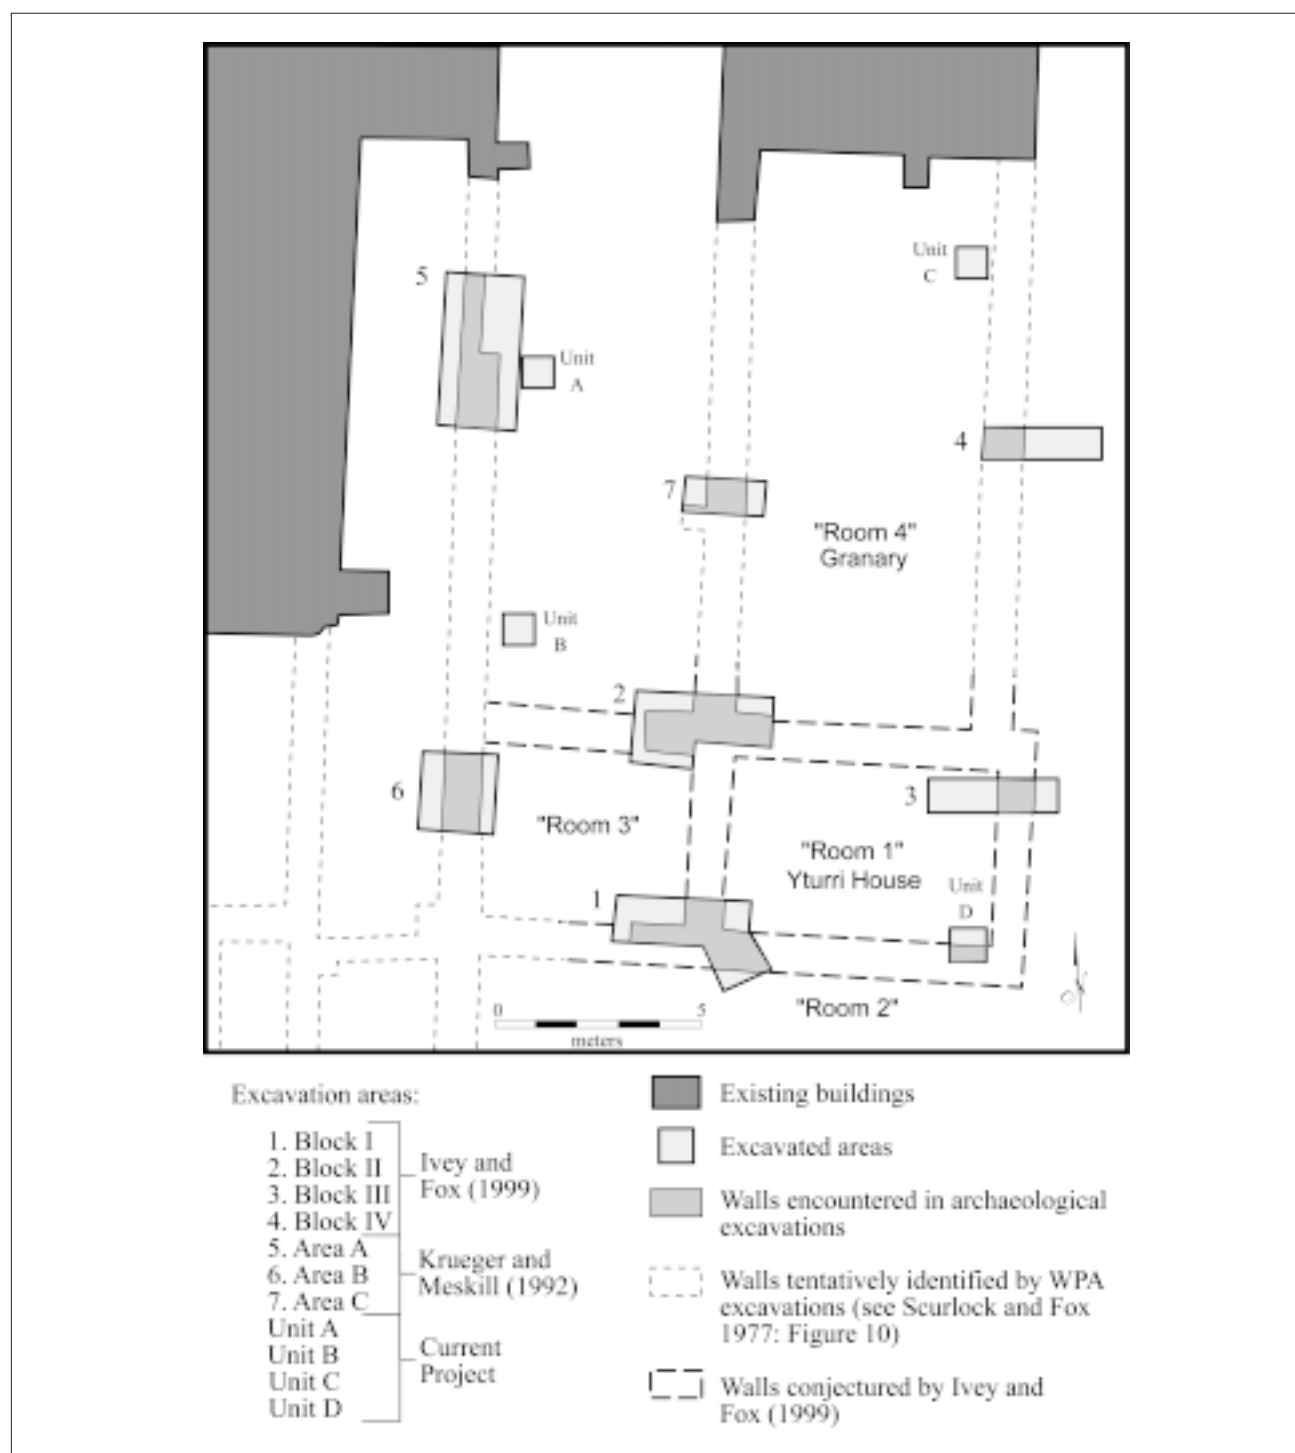
Figure 16 shows the rooms known to have been constructed and in use in the courtyard area in the latter part of the mission period, as well as walls of previous buildings in the area. What is not clear is whether the area defined by Ivey and Fox (1999:9) as Room 3 was actually used as an enclosed room after the earlier structures were torn down. Also in doubt is the existence of Room 2, as defined by Ivey and Fox (1999:9). This room was conjectured based on the presence of a “floor” of white caliche south of the south wall of Room 1 (Figure 16; see also the unit descriptions in Ivey and Fox 1999:10–13). While this is a reasonable conjecture, it should be noted that excavations at other mission sites in San Antonio have encountered a similar hard-packed caliche layer in areas that are known to have been outside. At Mission San Antonio de Valero (the Alamo), for instance, Meissner found similar hard-packed caliche floors both inside and outside the south transept of the church (Meissner 1996:101; see also Eaton 1980:52). It was apparently a common practice to use packed caliche

Figure 16. *Known and conjectured rooms in the courtyard area.*  
(Based on Figure 4 in Ivey and Fox 1999:11, with added information from Kreuger and Meskill 1992).

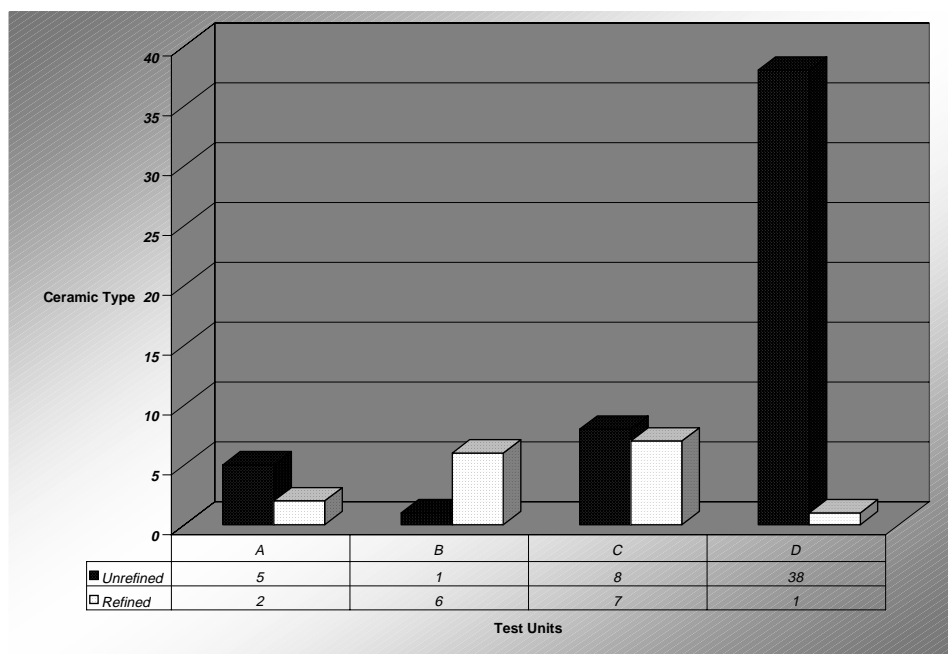
Figure 17. Comparison of refined versus unrefined wares in the four test units.
