ARCHAEOLOGICAL INVESTIGATIONS AT THE UNITED STATES ARSENAL SITE (41 BX 622), SAN ANTONIO, TEXAS

Center for Archaeological Research
The University of Texas at San Antonio
Archaeological Survey Report, No. 137

1986

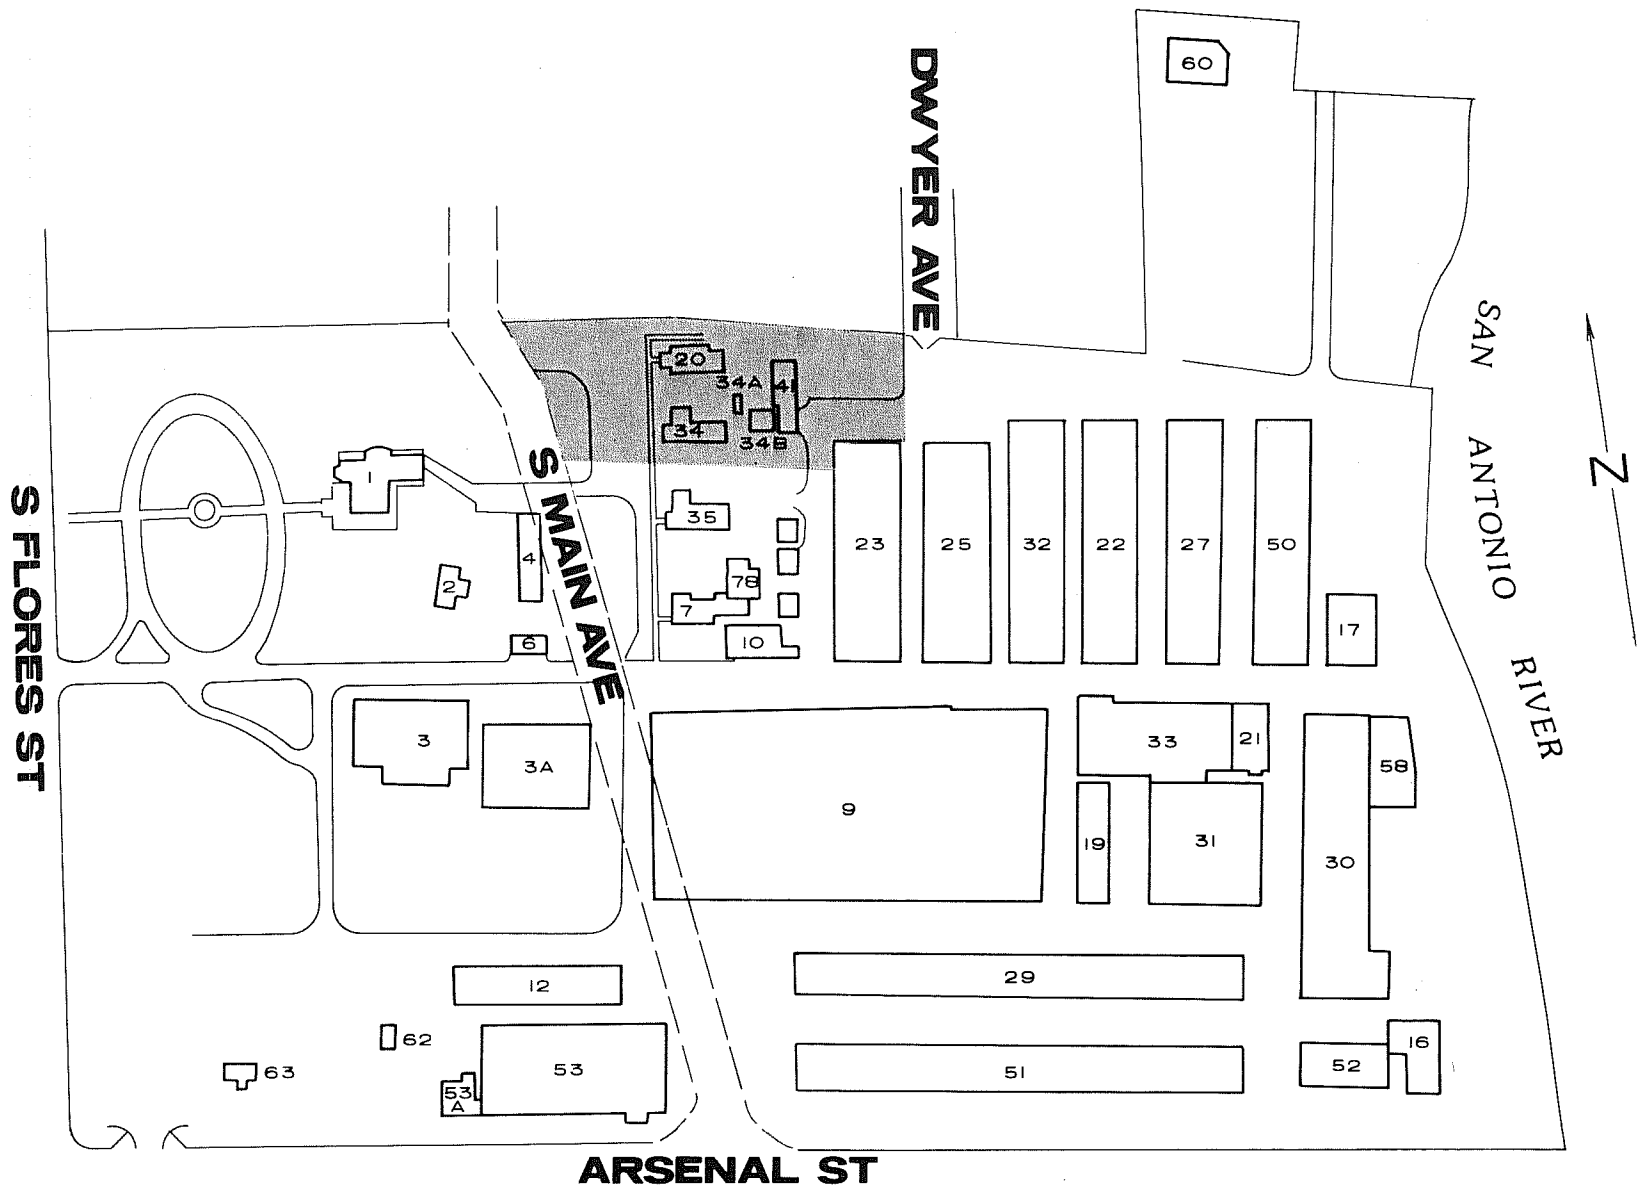
Figure 1. **Arsenal Site Plan.** Basic data and building identifications from 1946 road map (San Antonio Arsenal, Office of the Post Engineer 1946); location of South Main Avenue from 1961 site plan (General Services Administration 1961). The area investigated by trenching is indicated by darkened area.

Trench 2 ran east-west across most of the area under investigation. There were no signs of disturbance of any kind except for the presence of a number of two-foot-square concrete footing pads. These bore the marks of the 8- x 8-inch posts which once supported a temporary frame structure in this area (No. 20 in Fig. 1). Two small (2-1/2 inch) gas pipes and an electric line crossed (in a north-south direction) this trench. Caliche bedrock was found

In mid-February, the Center was requested to do additional testing at the south end of the old stone stable building (No. 21 in Fig. 1). It was hoped to determine if any indication remained of the location of an outside stairway providing access to the loft above the stable. A test pit measuring ca. 1-1/2 m x 3 m was excavated. The first level consisted of ca. 15 cm of gravel fill. A 1-m² concrete slab was found at the west end of the unit at this level, and a pipe trench at the opposite end. Excavation continued through several alternating layers of brown soil and gravel fill until a hard, cobble layer set into caliche at ca. 30 cm below the original ground surface was encountered in the area. No postholes or other traces of support for a stairway were found within this area. A profile of the south wall of this test unit is on file at the Center for Archaeological Research.

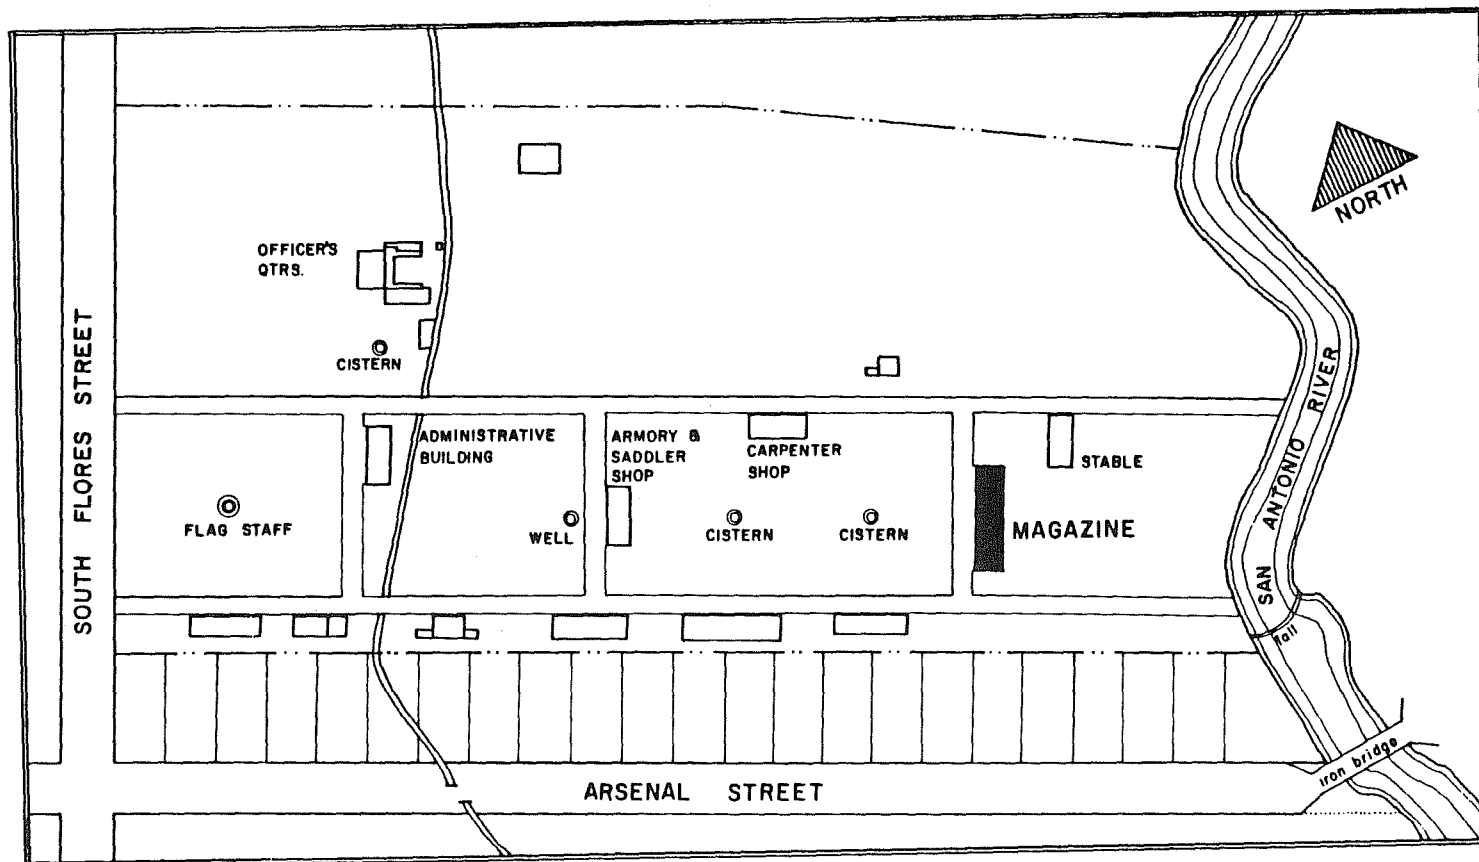
MAP DATED 1877
HOUSE EXEC. DOC. 48,
42nd CONG., 3rd SESSION,
SERIAL 1565, VOL. 7

Figure 2. Map of Arsenal in 1877.

In 1877, the Arsenal consisted of five permanent stone buildings, a row of frame buildings along the southern edge of the property, and the frame carpenter shop (Fig. 2). The Army had been trying to get permission to buy a narrow strip of land between the south boundary line of the Arsenal and Arsenal Street since 1872 (Belknap 1872). The property was finally purchased from the family of Toutant Beauregard in 1881 (Russell 1881).

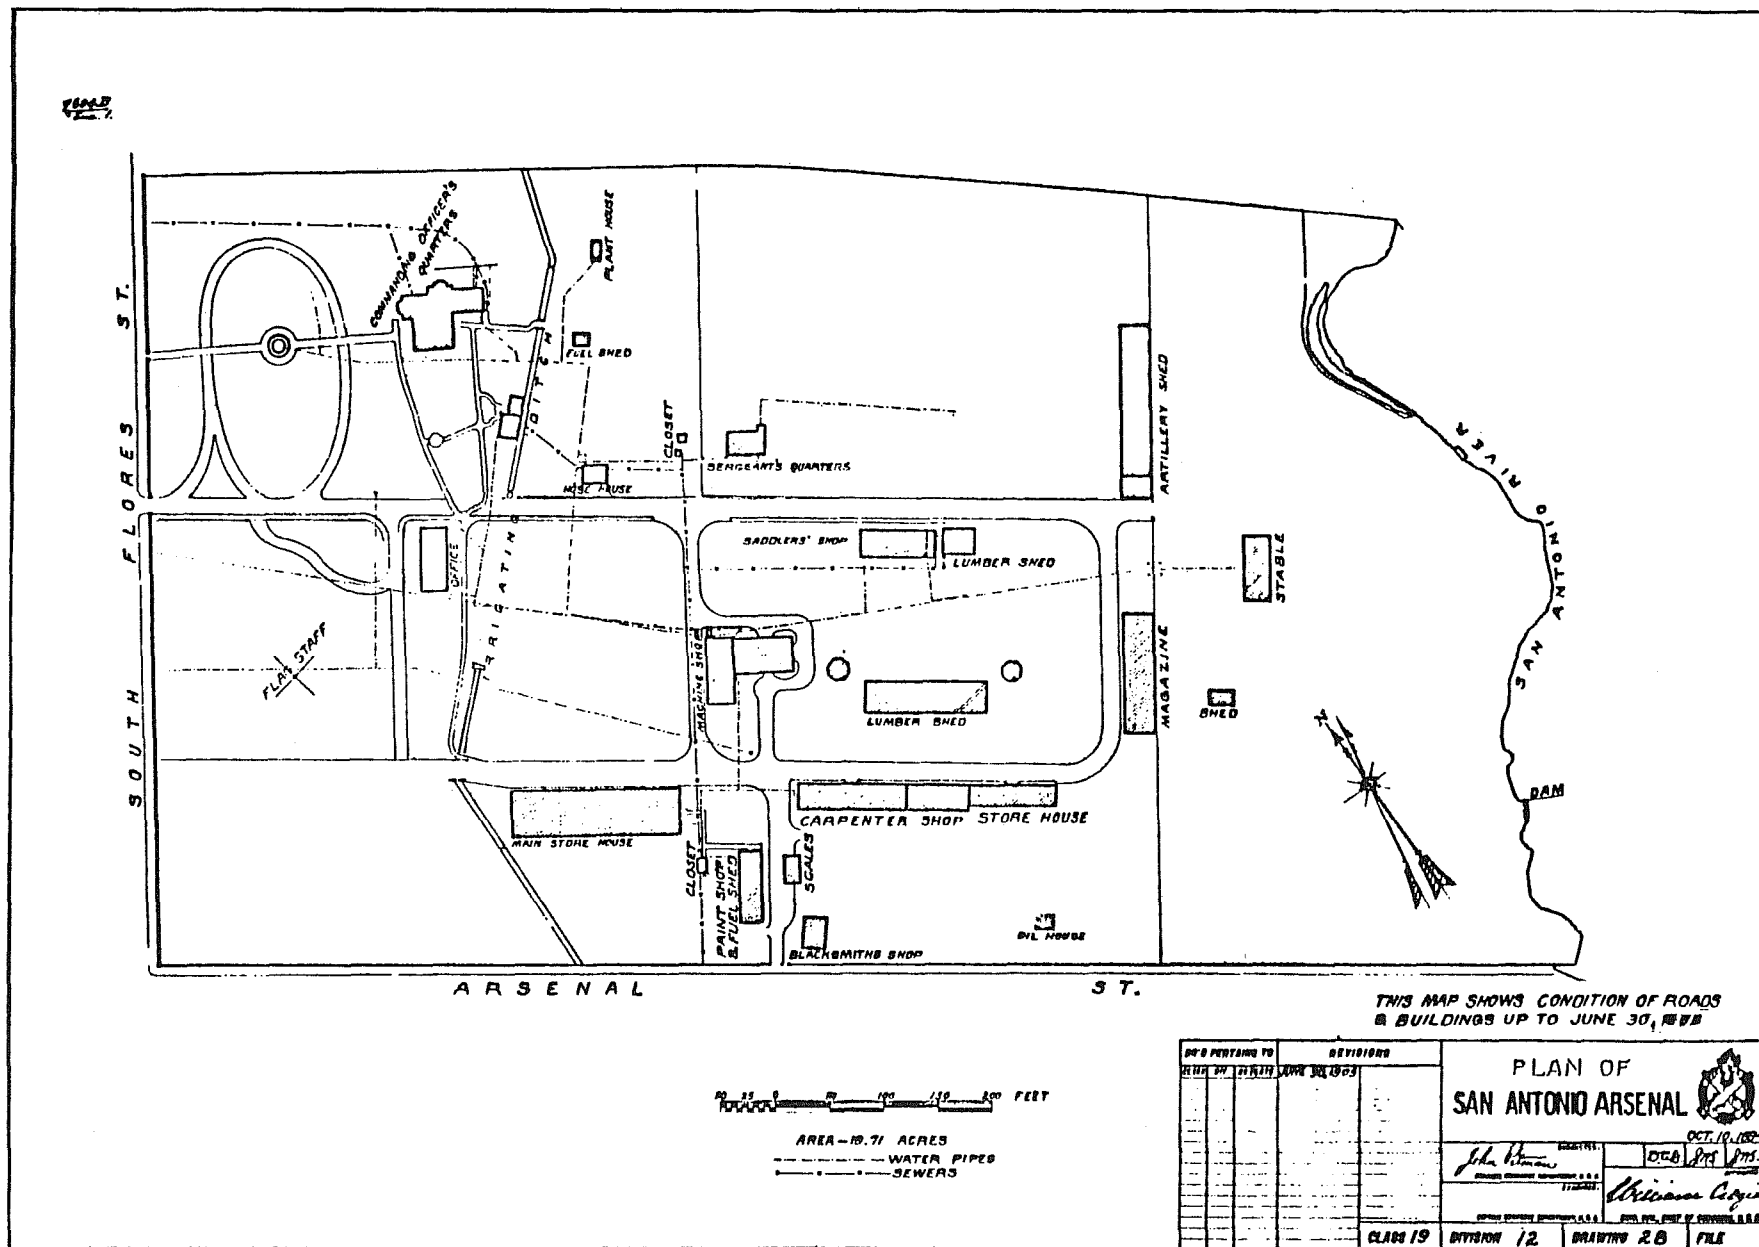
Figure 3. Plan of Arsenal from 1894-1905. From Department of the Army, Corps of Engineers (1905).

A stone storehouse was erected south of the administration building in 1883 (Fig. 3). This was the first permanent storehouse on the site, and served in that capacity until the deactivation of the Arsenal (Shank 1968; Garner 1969:6).

A plan of the Arsenal in 1894 (Fig. 3) shows the addition of a number of minor buildings and changes in the function of other buildings. However, it was not until 1919 to 1920 that another major building period occurred (**San Antonio Express** 1927). Three new storehouses, an oil house, a small arms shop, two magazines, a machine and equipment shop, barracks, and quarters eventually increased the number of buildings to 44 with a total value of \$900,000 (Garner 1969:6). The newest building on the grounds is the principal office structure, built in 1942 (Anonymous n.d.:2).

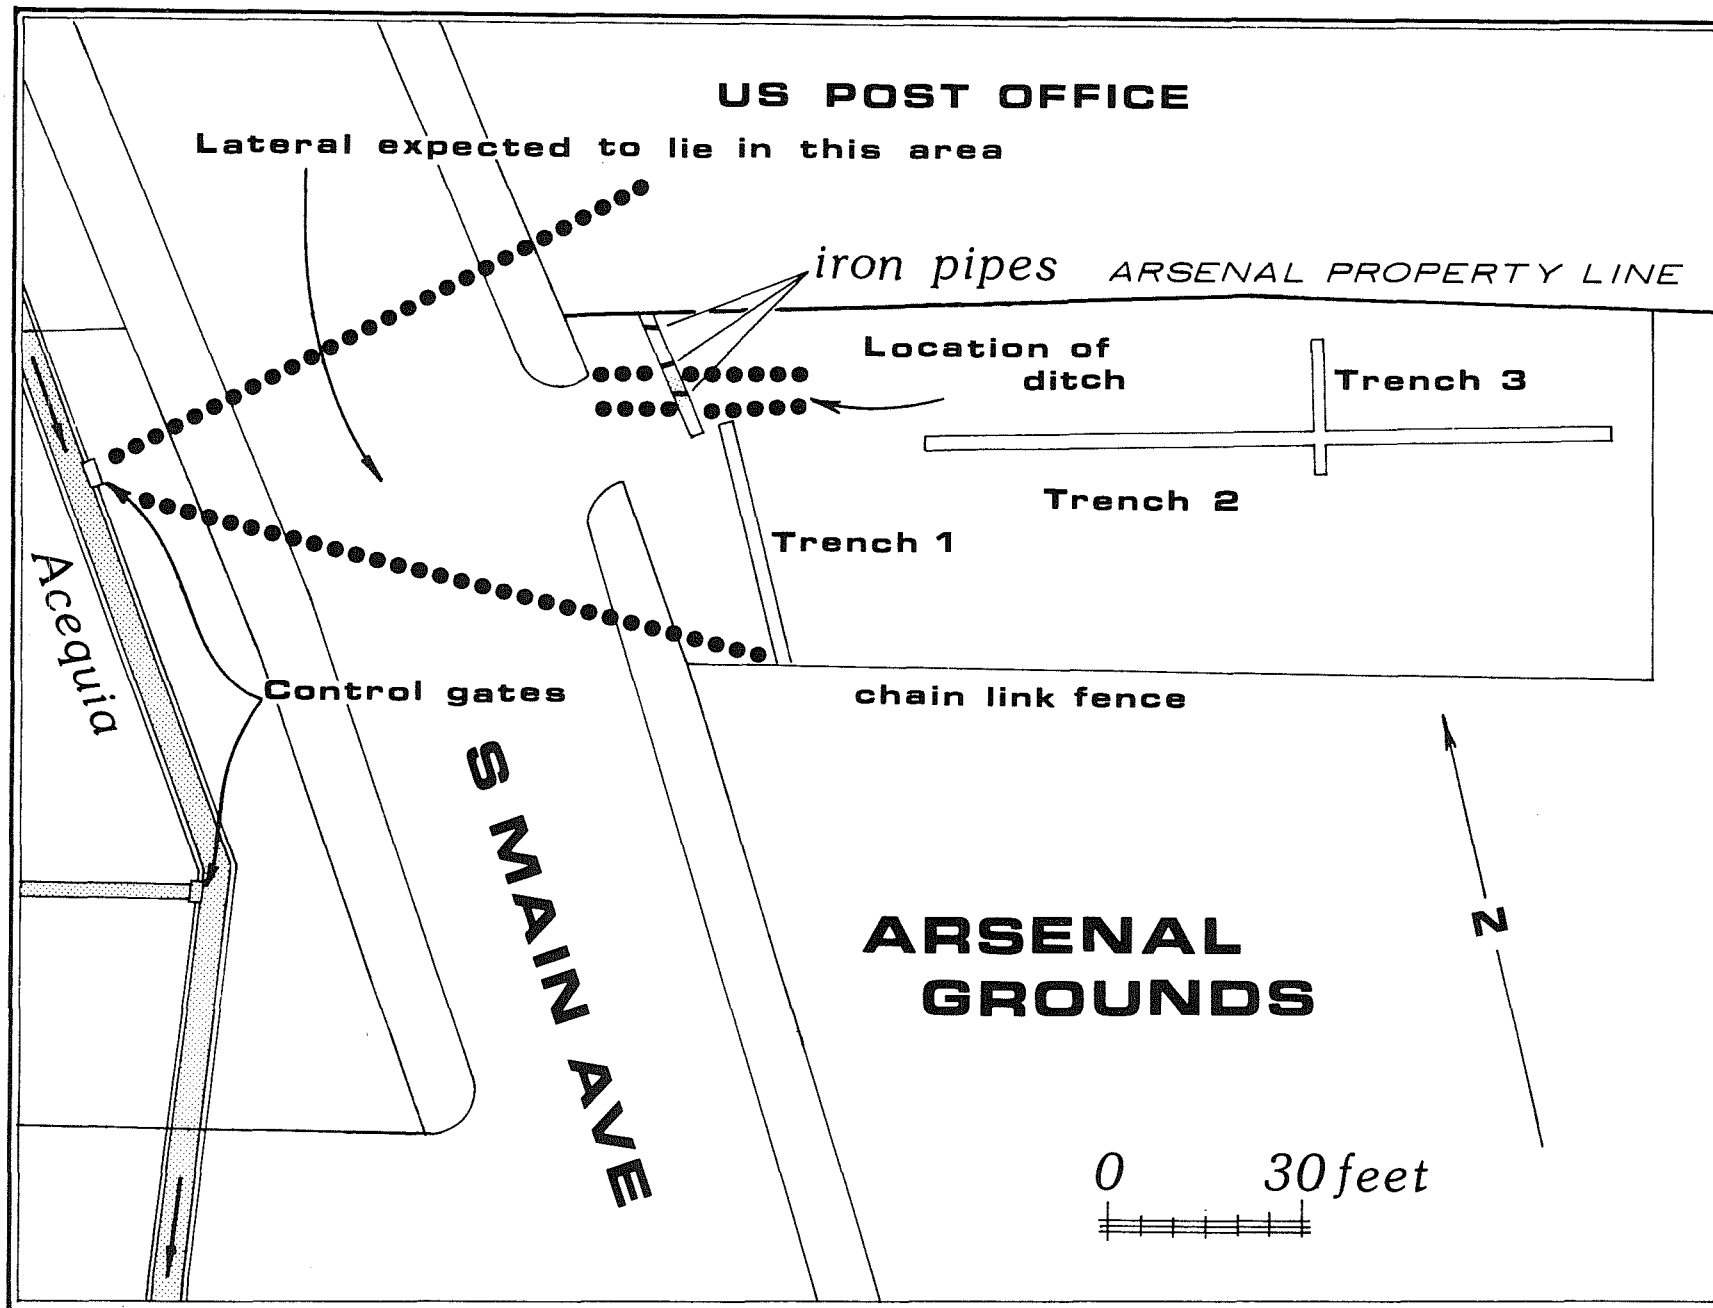
Figure 4. Plan of Backhoe Trenches.

On January 6, 1984, a series of backhoe trenches was excavated in the northwest corner of the development site, under the direction of the author and an assistant (Fig. 4). The first two trenches were positioned so as to determine whether the acequia lateral entered the area (Trench 1) or whether branches of the lateral intruded upon the site from the northern boundary (Trench 2).

In Trench 1, two gas lines were encountered which ran east-west across the area. A large disturbance six feet across was also found, which ran parallel to the gas line trenches. The trench was dug from the original ground level, which was beneath 10 inches of gravel fill laid for the asphalt paving on the western part of the lot. At first this disturbance was thought to be the acequia lateral, but a 5-1/2-inch iron pipe was found in a 15-inch trench in the bottom of the disturbance, at eight feet below the original surface.

in Trench 2 at ca. 30 inches below the present surface. The soil above is reddish brown loam with a medium clay content, grading to dark brown at the surface.

After the size and depth of the large disturbance in Trench 1 were noted, Trench 3 was excavated in order to determine if the deep pipe trench/disturbance could have preempted the original acequia lateral. If so, the lateral, with or without the pipe trench, might have continued toward a junction with the river to the east. Trench 3 revealed the same soil profile as that of Trench 2, with no disturbances.
