Archaeological Investigations for the Paso Real Subdivision Flood Mitigation Project, Cameron County, Texas

Texas Antiquities Permit No. 8103

Prepared by:
Center for Archaeological Research
The University of Texas at San Antonio
One UTSA Circle
San Antonio, Texas 78249
Technical Report, No. 76

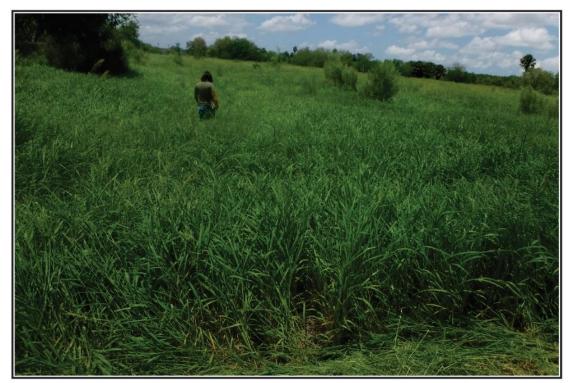
The first phase of the scope of work (SOW) required a pedestrian survey of the APE, and the second phase called for the excavation of three backhoe trenches. A reconnaissance of the project area was completed on July 18, 2017. At the time of the reconnaissance, the grass within the APE was 60- to 100-cm (2- to 3.5-ft.) high. There was zero surface visibility due to the density of the grass making it impossible to survey the APE (Figure 1-3).

Figure 1-3. Project Area with CAR staff member in the tall grass, view north (July 2017).

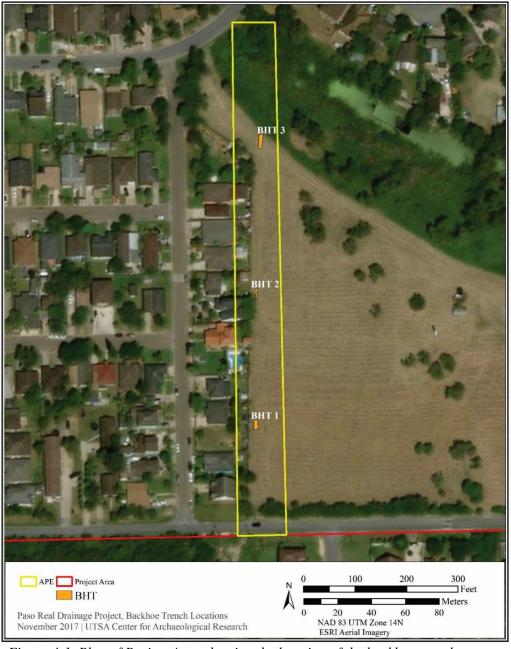
Three backhoe trenches were excavated along the length the APE, which was 5.5-m (18-ft.) wide and 289.5-m (950-ft.) long. The backhoe trenches were approximately 2.4-m (8-ft.) wide, 6-m (20-ft.) long, and 1.6-m (5.25-ft.) deep, and they were positioned in 75-m (246-ft.) intervals (Figure 4-1). The work was completed in two days with negative results in all three backhoe trenches. No cultural material or features were discerned.

Figure 4-1. Plan of Project Area showing the location of the backhoe trenches.

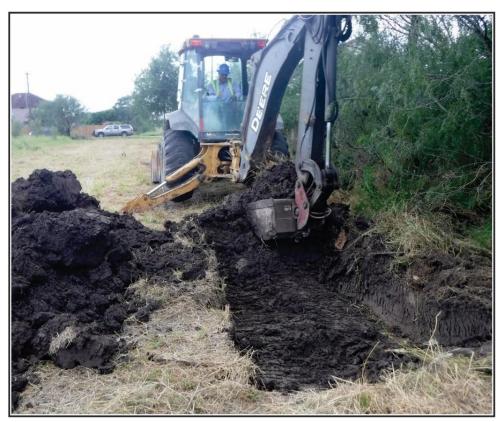
Backhoe trench 1 (BHT 1) was located 50 m (164 ft.) north of Houston Street. The trench was 6-m (20-ft.) in length and excavated to a depth of 1.6 m (5.25 ft.; Figure 4-2). The trench profile exhibited four distinct soils, and the top layer consisted of an 80-cm (31.5-in.) thick, dark gray, blocky clay. This top layer was followed by a 30-cm (11.8-in.) thick, pale brown, blocky silty clay, followed by another 30-cm (11.8-in.) thick layer of very pale brown silty clay with threads of calcium carbonate. The fourth and final layer was a 20-cm (7.9-in.) thick, very pale brown, soft, and very silty clay. No cultural material or features were observed in BHT 1 (Figure 4-3).

Figure 4-2. BHT 1, excavation in-progress.

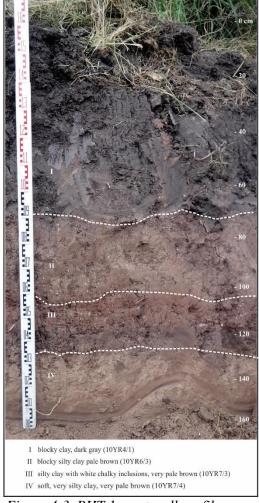
Figure 4-3. BHT 1, west wall profile.

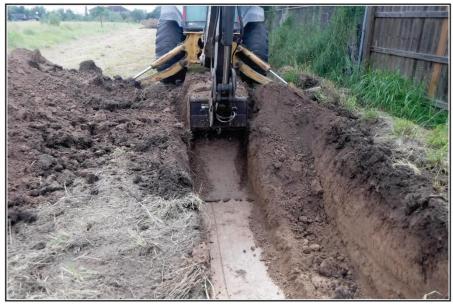
Backhoe trench 2 was located 124 m (406.82 ft.) north of Houston Street. The trench was 6-m (20-ft.) in length and excavated to a depth of 1.6 m (5.25-ft.; Figure 4-4). The trench profile exhibited five distinct soils, and the top layer was a 40-cm (15.75-in.) thick, very dark gray, loose silty clay. This top layer was followed by a 30-cm (11.8-in.) thick, pale brown to very dark grayish brown, loose silty with threads of calcium carbonate, followed by a 60-cm (23.6-in.) thick, very pale brown, soft silty clay with threads of calcium carbonate. The fourth layer was a 25-cm (9.8-in.) thick, pale brown, blocky silty clay with continuing threads of calcium carbonate. The last 5 cm (1.9 in.) exposed were a mottled, brown to pale brown, compact silty clay, with inclusions of calcium carbonate. No cultural material or features were observed in BHT 2 (Figure 4-5).

Figure 4-4. BHT 2, excavation in-progress.

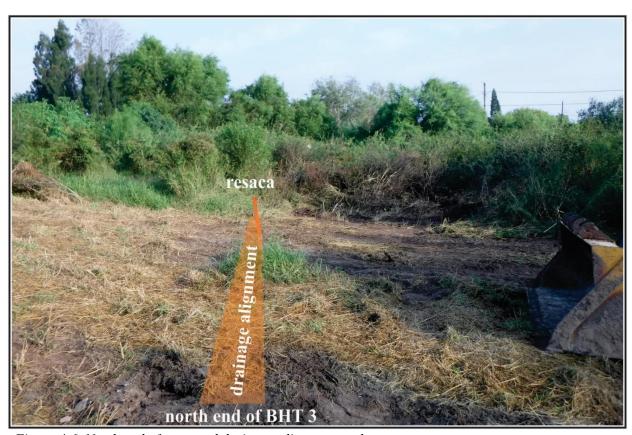
Backhoe trench 3 was located 220 m (721.8 ft.) north of Houston Street and within 30 m (98.4 ft.) of the *resaca* (Figures 4-6 and 4-7). The trench was 6-m (20-ft.) in length and was excavated to a depth of 1.8 m (5.9 ft.). The profile exhibited six distinct soils, and the top layer was a 40-cm (15.75-in.) thick, dark gray, blocky silty clay. This top layer was followed by a 25-cm (9.8-in.) thick, dark grayish brown, compact, blocky silty clay, followed by a 35-cm (13.8-in.) thick, yellow with pockets of sandy nodules, soft compact silty clay with calcium carbonate inclusions. A circular concrete pad was exposed at 60 cm (24 in.) below the surface. This isolated find appeared to be an outrigger pad, 10-cm (4-in.) thick and 1 m (40 in.) in diameter. The concrete pad may have served as a footing for a drilling rig. The sediments above and below the concrete pad were culturally sterile (Figure 4-8). The fourth layer was 60-cm (23.6-in.) thick, yellow silty clay with calcium carbonate inclusions. The fifth layer was a 10-cm (3.9-in.) thick mix of pale brown, yellow nodules of sand and light gray, soft, silty nodules. The last layer was 20-cm (7.9-in.) thick, pale brown to yellow with light gray nodules of eroded sandstone in a soft silty clay. No cultural material or features were observed in BHT 3 (Figure 4-9).

Figure 4-6. North end of proposed drainage alignment at the resaca.

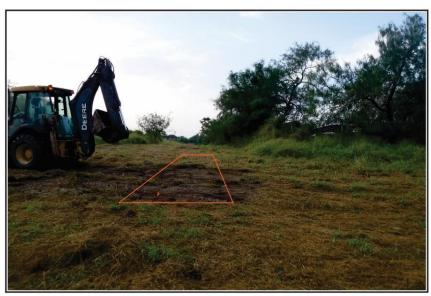
Figure 4-7. BHT 3, prior to excavation. Location outlined in orange.

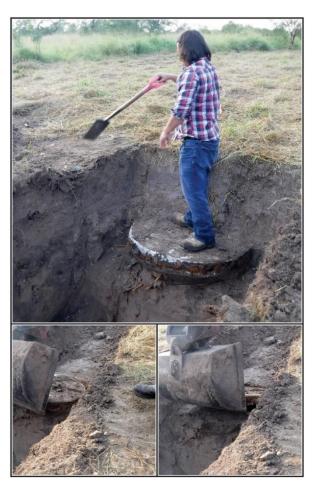
Figure 4-8. Isolated find, possible outrigger pad, in BHT 3 (facing east).
