# **Archaeological Assessment of Three Locations on the San Antonio River, San Antonio, Bexar County, Texas**

Texas Antiquities Committee Permit No. 5622

*Prepared by:*  
Center for Archaeological Research  
The University of Texas at San Antonio  
One UTSA Circle  
San Antonio, Texas 78249  
Technical Report, No. 23

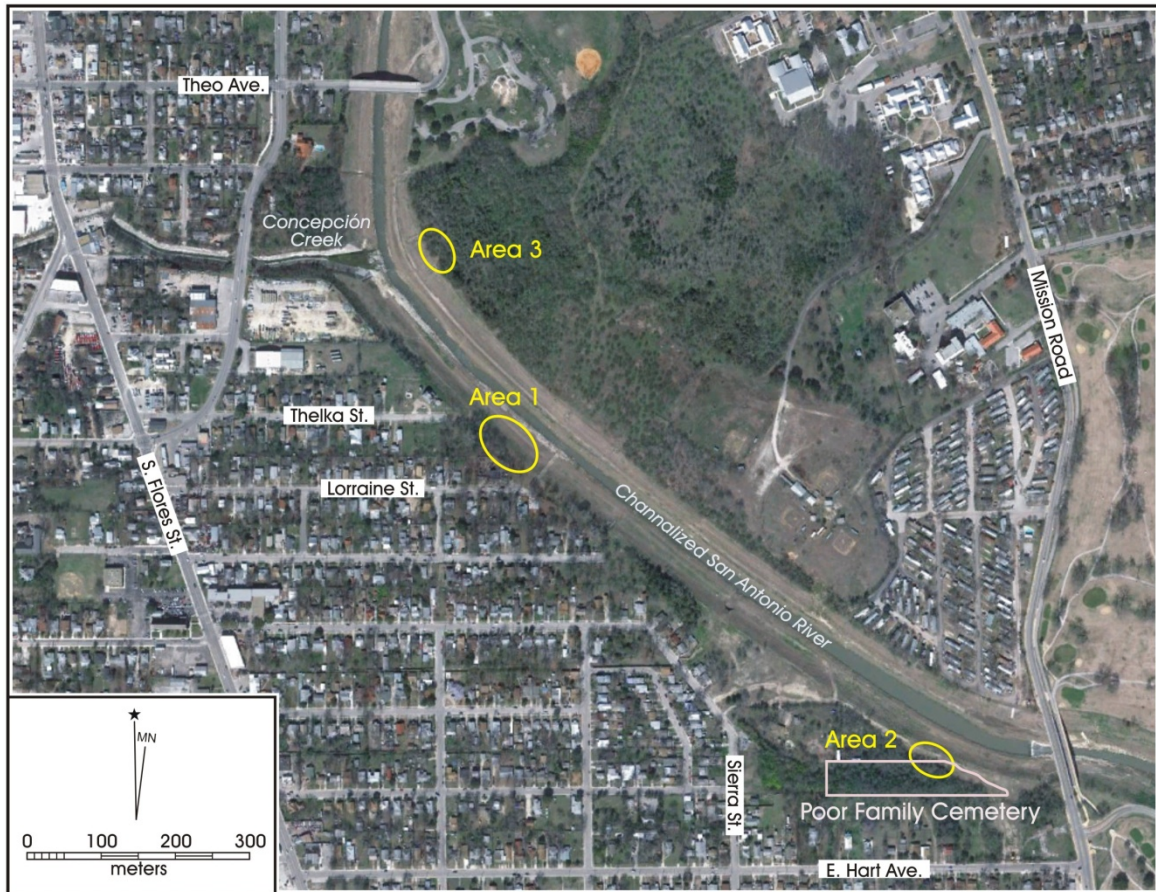
Figure 1-2. Aerial photograph of project area showing the location of three areas investigated.

This project consisted of detailed examination of three areas along the San Antonio River between Theo Avenue and Mission Road (Figure 1-1). In all three cases, concerns had been raised that the SARIP would damage or destroy important historic or prehistoric sites. In this chapter we examine each of the “areas of concern,” summarize the reason that archaeological assessment of each was considered necessary, and provide brief backgrounds on previous archeological investigations in the vicinity of these areas. The areas of concern are shown in Figure 1-2.

During preliminary construction along the west bank of the river between Thelka Avenue and Lorraine Avenue (see Figure 1-2), a number of large limestone rocks were uncovered (Figure 1-3).

In April 2010, while visiting the area where preliminary grading of the rechannelized riverbank between Mission Road and Theo Avenue was underway, City Archaeologist Kay Hindes noted an area south of Concepción Park (see Figure 1-2) where she observed a few prehistoric artifacts and fragments of burned rocks, in what appeared to be an organically enriched sediment that had been graded to build a temporary construction road along the river (Figure 1-8).

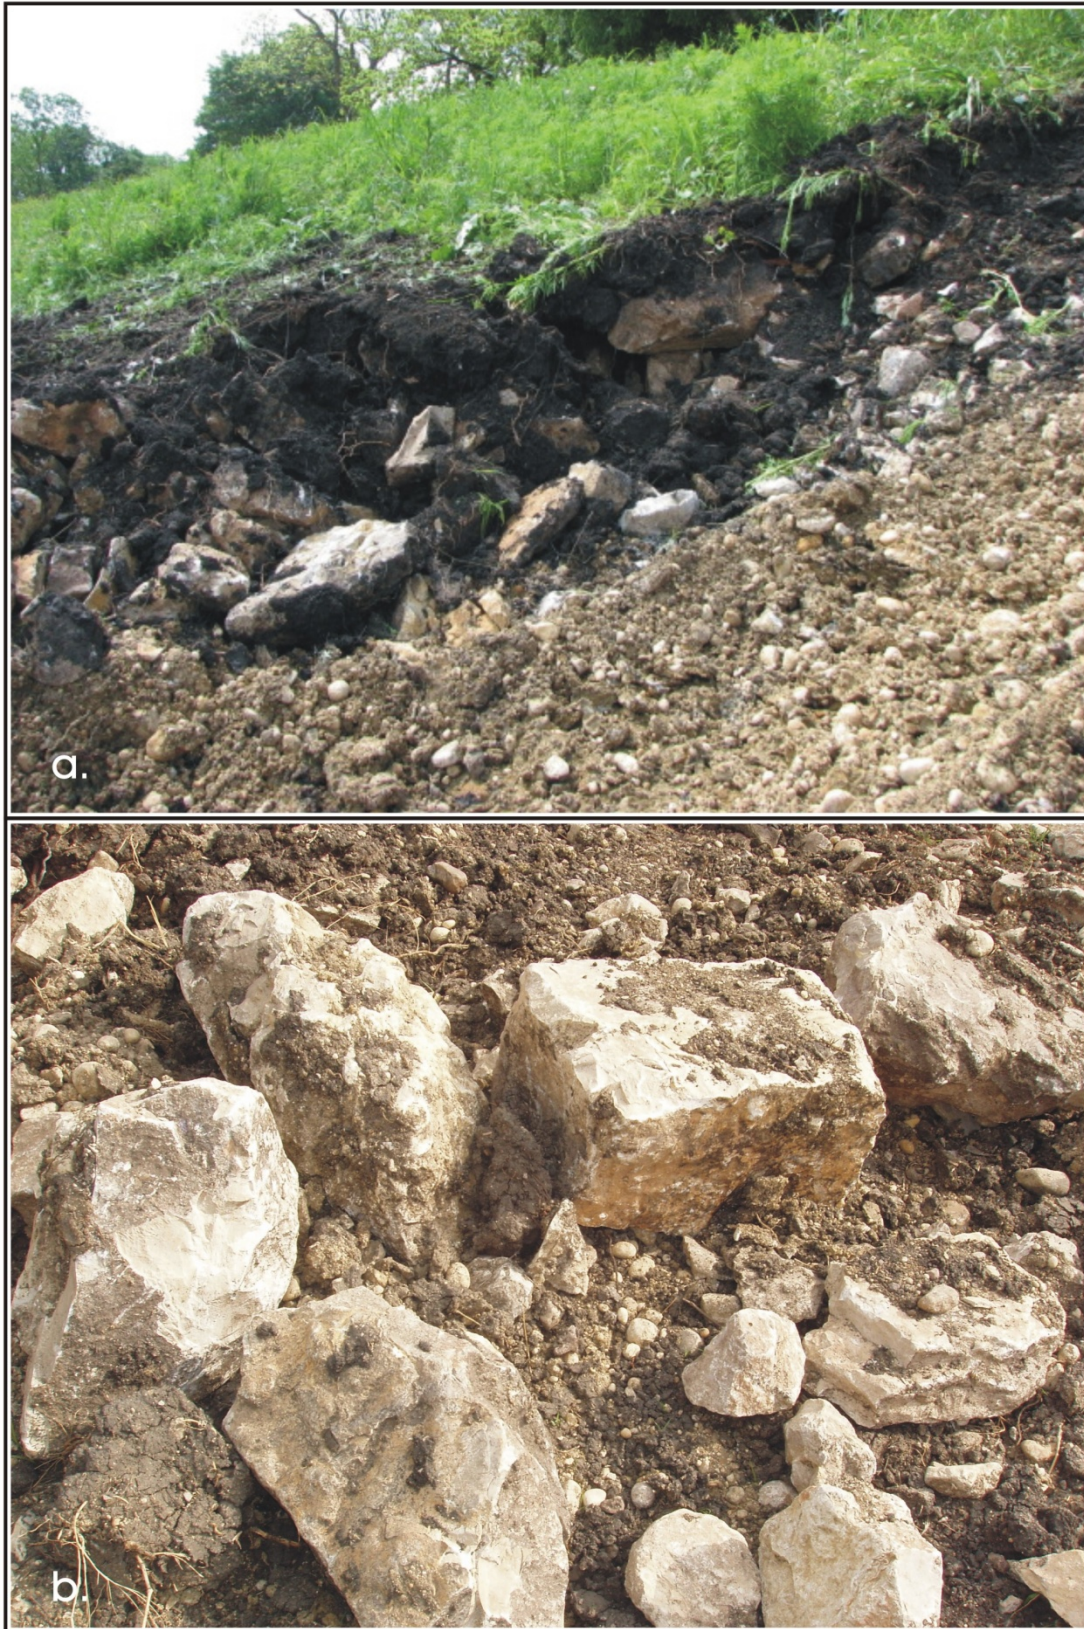
Figure 1-3. Possible area of San José Dam: a) overview of the area, showing large limestone rocks, facing southwest; b) close-up of limestone rocks that have been trimmed.

Some of these rocks appeared to be stacked (Figure 1-3a) and some were clearly trimmed (Figure 1-3b). As this area was near the known location of the Colonial Period San José Dam, constructed to divert water into the San José Acequia (Figure 1-4), there was concern that the construction had uncovered a remnant of the dam.

Three BHTs were dug in Area 1. No evidence of a remnant of the San José Dam was encountered. All sediment in the three trenches was fill. The large limestone rocks observed in Area 1 were determined to be placed during the rechannelization to prevent erosion of the lower banks during flood events.

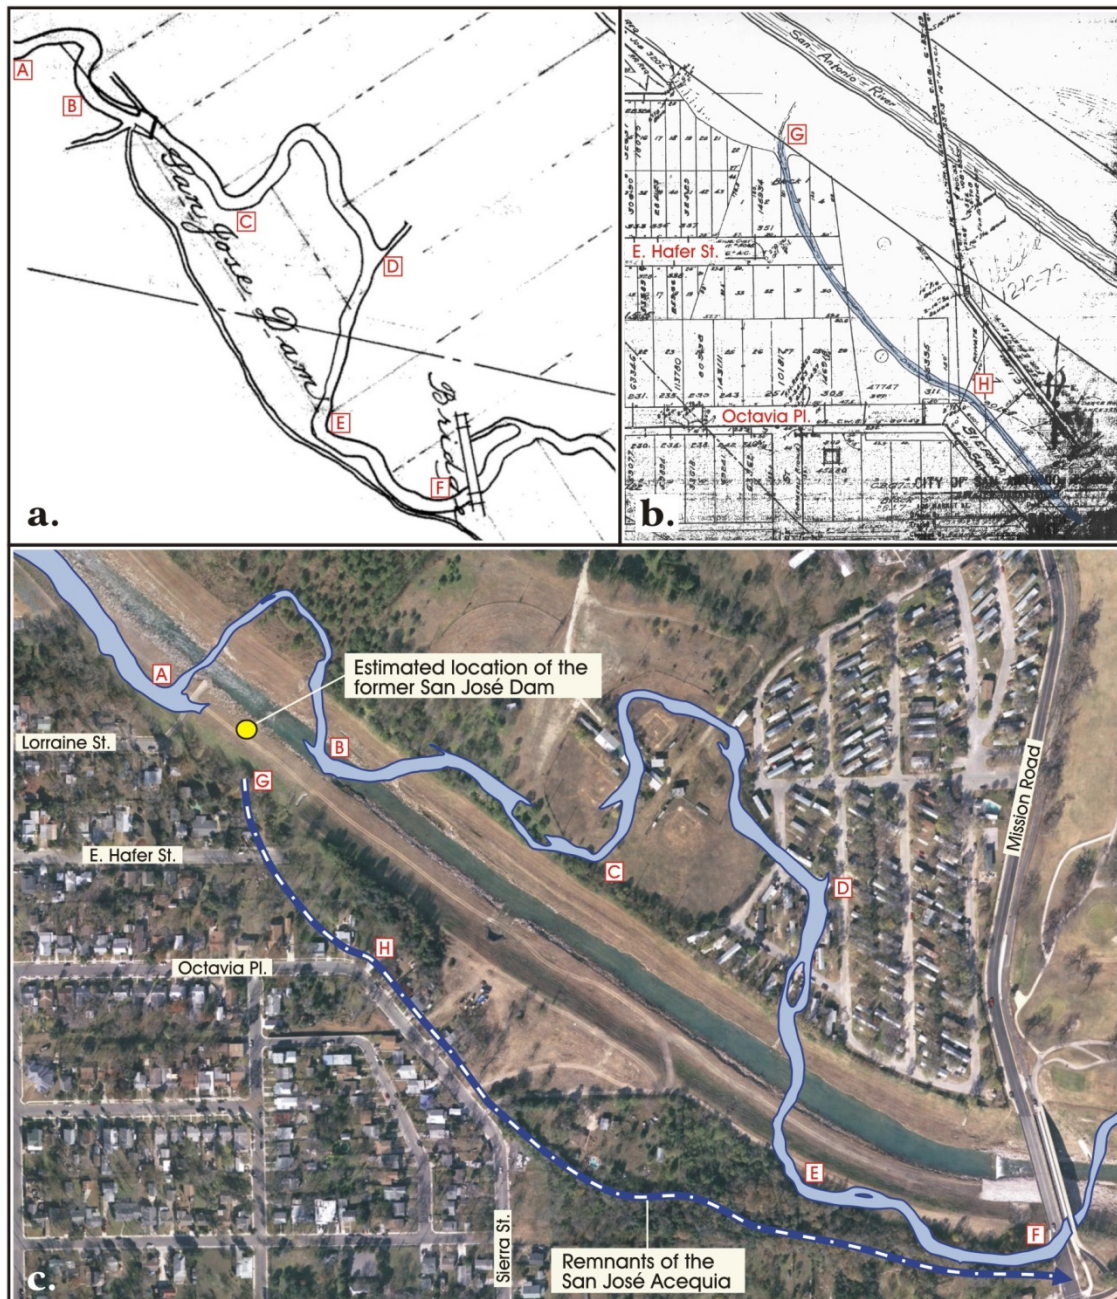
Figure 1-4. a) Detail of a measured drawing made by Harvey Smith in the 1930s showing his interpretation of the location of the San José Dam and Acequia; b) City of San Antonio Water Department map showing the location of the San José Acequia in 1933; c) overlay showing the San Antonio River prior to channelization, the location of the San José Acequia, and the likely location of the San José Dam.

The San José Dam (Figure 1-4) was constructed sometime between 1724 and 1727, shortly after Mission San José y San Miguel de Aguayo, was moved to its second location on the west bank of the San Antonio River (Habig 1968:86). The site of this location is not known, though it is believed to have been no more than a quarter-mile from the current location (Habig 1968:86) where the mission was moved about a year later (Ivey et al. 1990:107). Since the mission would need irrigation for its fields, it is likely that the new acequia was begun immediately.

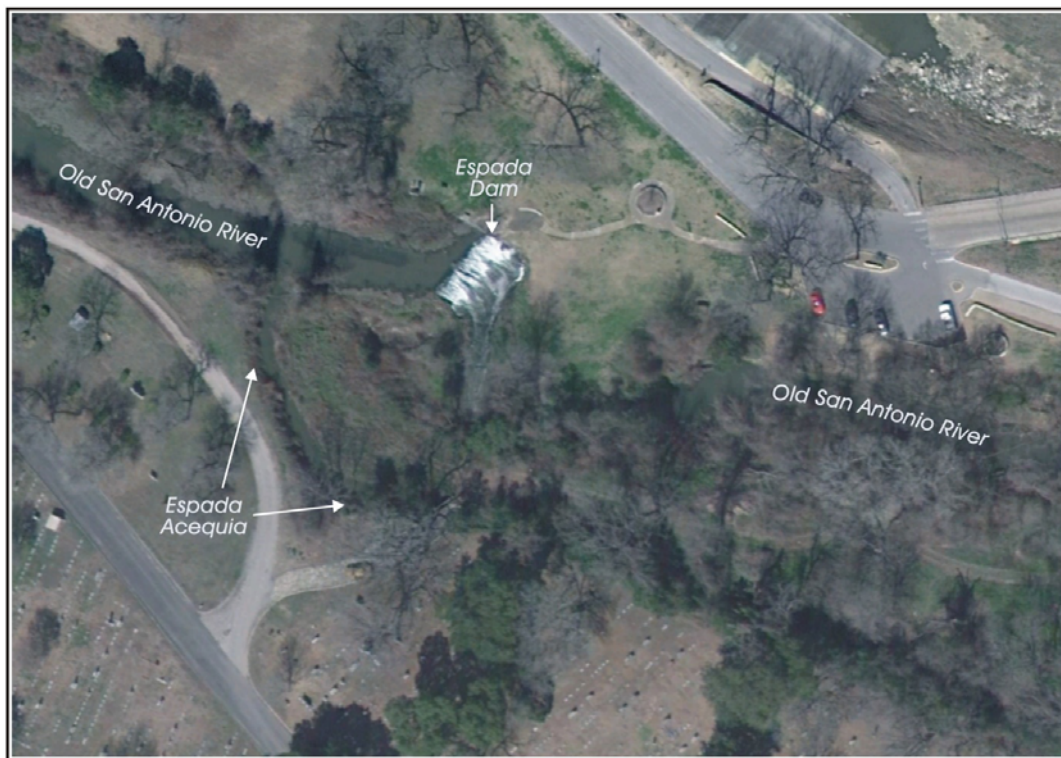
The San José Dam was a weir or low-head dam. Spanish weir-dams in San Antonio were piles of undressed limestone rock built across the river in a location where the banks were relatively high (see Cox et al. 1999), creating a pool behind the dam that raised the water level so that water could be diverted into the mouth of an acequia. Though much more substantial, the San José Dam was probably somewhat like the Espada Dam, located about 5.5 km (3.3 miles) further downstream. Espada Dam is the only Colonial-period dam on the San Antonio River still in use for its original purpose. Figure 1-5 shows how the Espada Dam, by raising the water level of a remnant of the original unchannelized San Antonio River, feeds water into the Espada acequia, which is still used as it has been for more than 250 years, to bring irrigation water to fields near Mission Espada.

Figure 1-5. Aerial view of Espada Dam and the beginning of the Espada Acequia, a design very similar to the San José Dam.

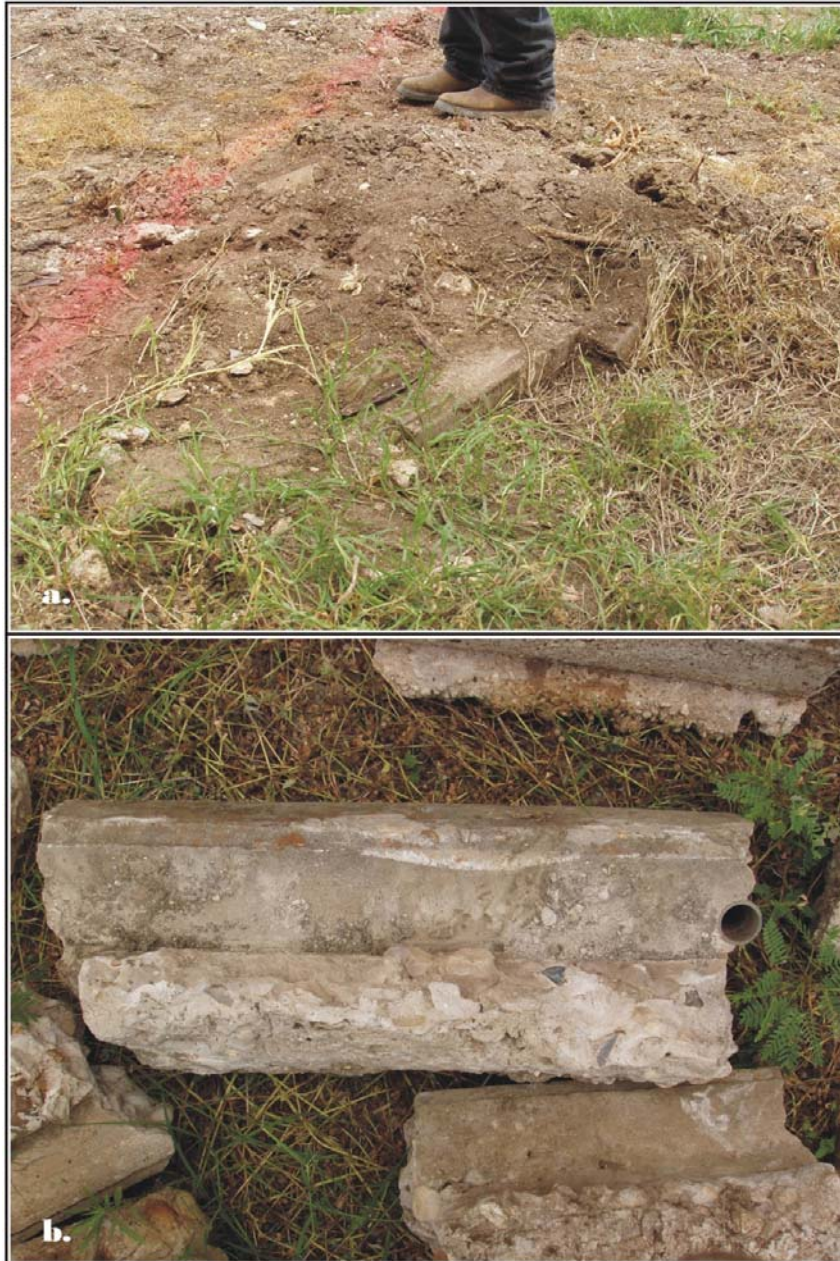
In April 2010, City Archaeologist Kay Hinds was notified by a concerned citizen that a group of concrete curb-like pieces were present on the rechannelized river bank, near the presumed location of the Poor Family Cemetery. These “curbs” appeared to be out of place, apparently disturbed when the area was mechanically cleared of vegetation (Figure 1-7a); however, the characteristics of the concrete, and the overall shape of the curbing (Figure 1-7b) suggested that these may not have been street curbs and were reminiscent of the concrete curbs sometimes placed around grave sites in the 1920–1940s, usually to hold marble or limestone chips as part of a decoration of the gravesite (K. Hinds, personal communication 2010). The location of the Poor Family Cemetery nearby made the finding of these curbs a matter of concern, even though maps indicated that this area was at or very near the original river course that had been filled in during the river rechannelization project (Figure 1-6).

Figure 1-7. Concrete "curbs" found near Poor Family Cemetery: a) "curbs" as they were facing south. (Note: red paint on ground on left side of photograph indicates location of Trench 3); b) "curbs" after they had been moved aside before trenching began.

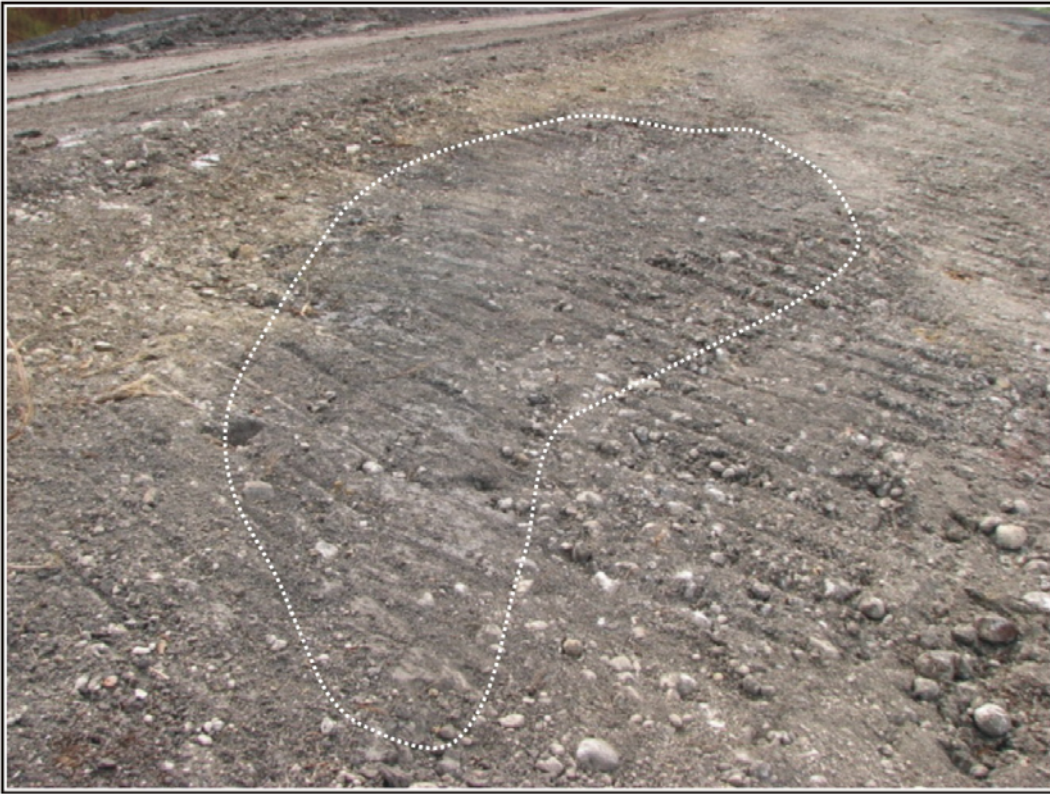
*Figure 1-8. Location where burned rock and chert artifacts were noted on the disturbed surface in Area 3. Facing south-southeast.*

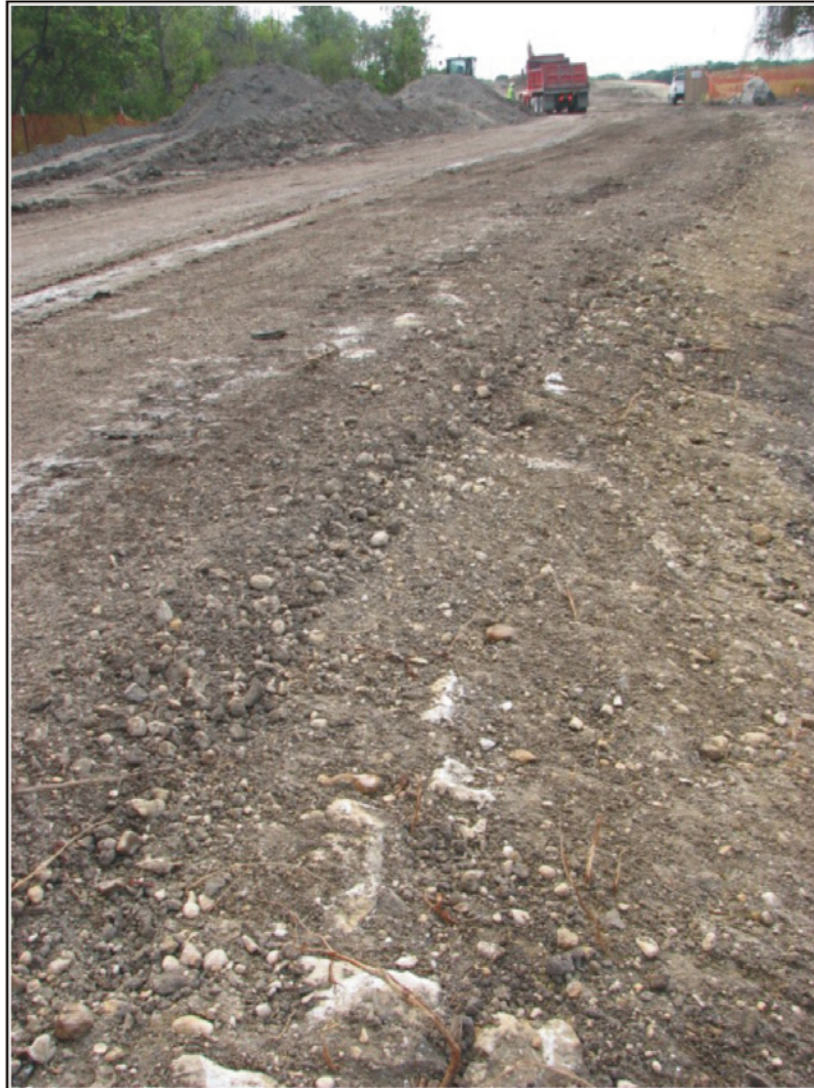
In addition, she observed an apparent alignment of large limestone rocks (Figure 1-9). Only the tops of the rocks were exposed by the grading of the bank to create a passable road surface for heavy construction equipment.

Figure 1-9. Possible rock alignment on east bank of San Antonio River in Area 3, as originally seen, facing southeast.

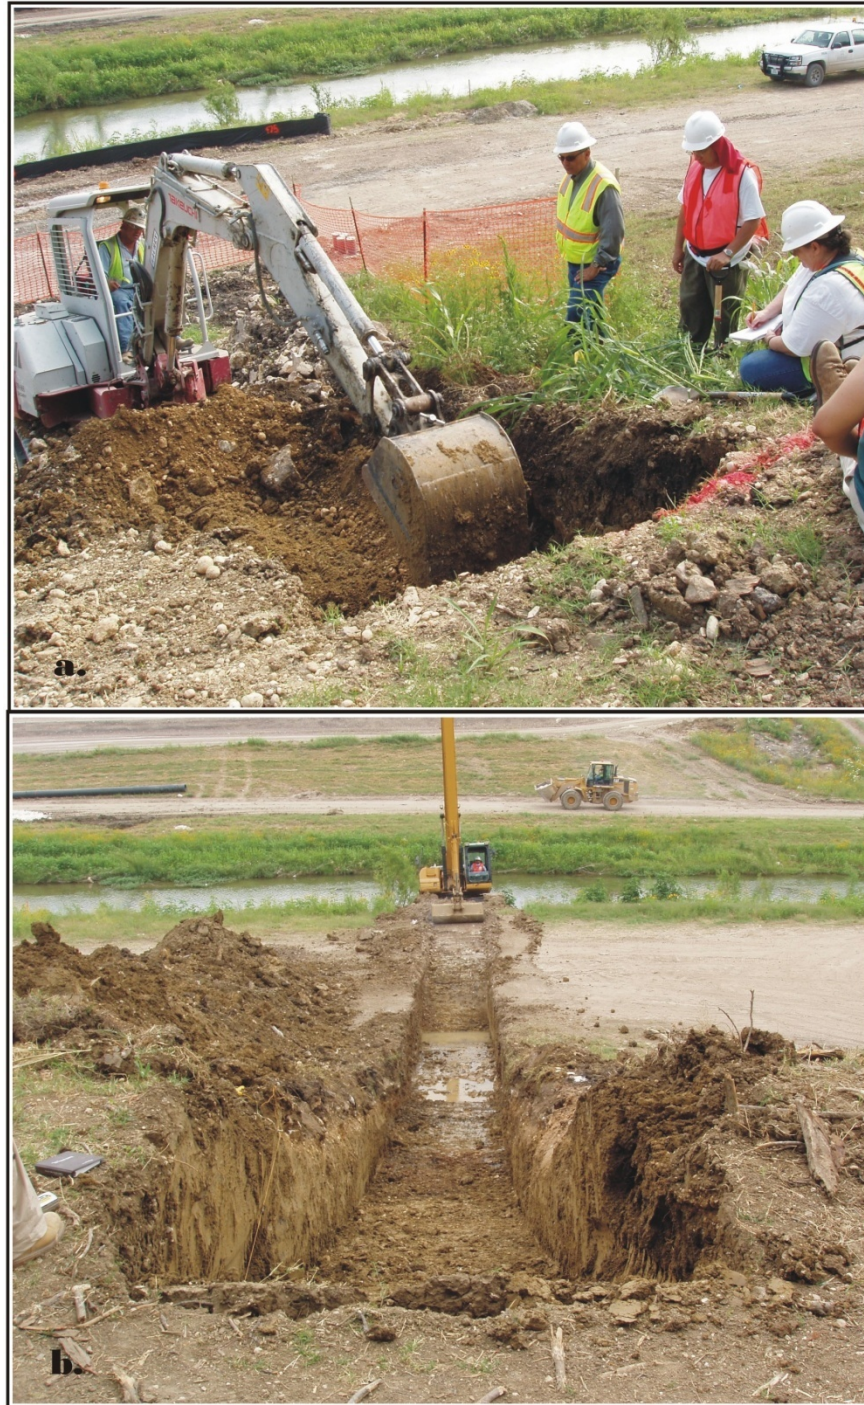
1 was dug with a small excavator with a 1.5-foot (0.46 m) bucket (Figure 2-1a), while the remainder of the trenches were dug with a track excavator with a 3-foot (0.9 m) bucket (Figure 2-1b). As the ground was heavily sloped in some parts of these trenches, the bottom of the trenches was also sloped.

Figure 2-1. Digging trenches: a) Trench 1, near possible remnant of San José Dam, facing east; b) Trench 2, showing slope of trench bottom, water running into lower part of the trench. Facing northeast.

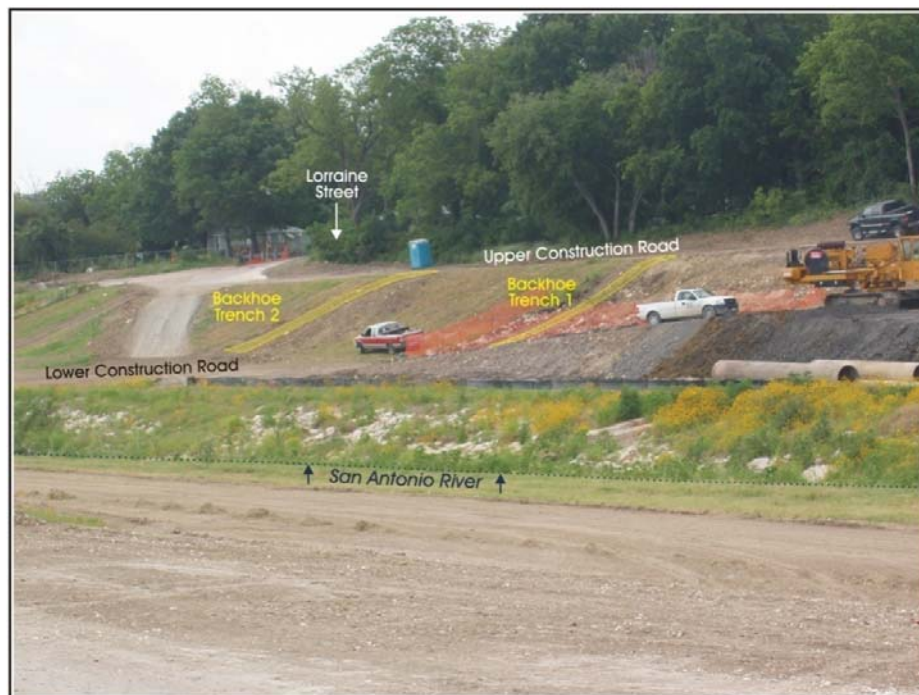
The river bank at Area 1 had already been modified to a limited extent by the construction of two dirt roads: one near the top of the river embankment and a second not far above the level of the river. The latter sometimes climbed higher on the embankment, as can be seen in Figure 3-1. Some cases involved three dirt roads.

Figure 3-1. Area 1, seen from across the river, after Trenches 1 and 2 had been backfilled. Note the two levels of construction roads. The San Antonio River, not visible in this photograph, runs just below the line of concrete and limestone crossing the middle of the picture. Facing south-southeast.

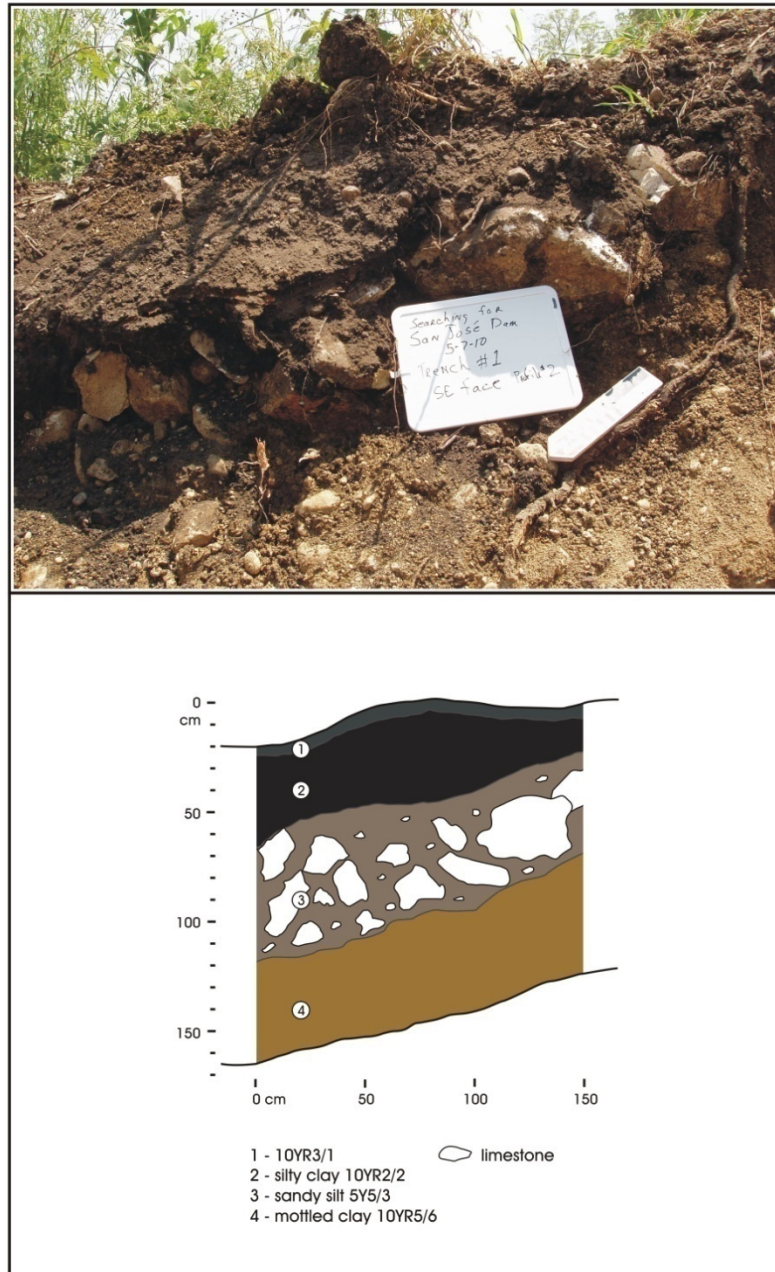
BHT 1 was dug about 2 m north of, and parallel to, the line of limestone rocks uncovered during grading of the river bank. It began at the edge of the upper construction road and was dug to the edge of the plastic fencing seen in Figure 2-1, just above the lower construction road (see also Figure 3-1a). Figure 3-2 shows the upper segment of the south wall of BHT 1.

Figure 3-2. South wall of Trench 1: a) photograph, and b) profile of upper part of trench.

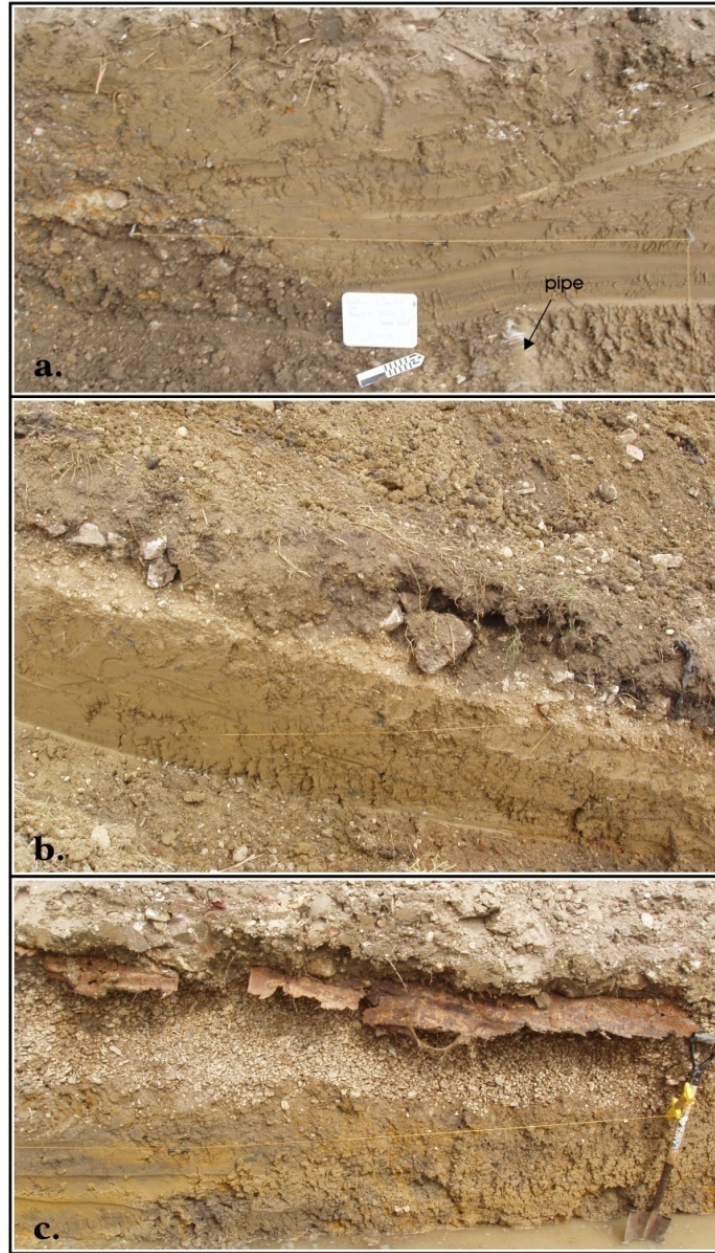
Although there was some variation in the nature of the sediments seen in BHTs 1 and 2, both trenches showed that approximately one-third down the slope from the upper construction road there was a layer of large rock and occasional large chunks of concrete placed on the slope. This was clearly seen during excavation of the trenches and in the profiles.

Figure 3-3. The north wall of Trench 2: a) west end of trench, under upper road; b) middle section with large rocks; c) trench under lower road.

The three trenches excavated to examine the sediments in this area have demonstrated that the entire river bank in this area has been constructed by shaping fill into the steeply sloped embankment. The upper and lower portions of the embankment are protected from erosion during flood events by a layer of large limestone and concrete riprap. No evidence of any remaining portion of the San José Dam was observed.

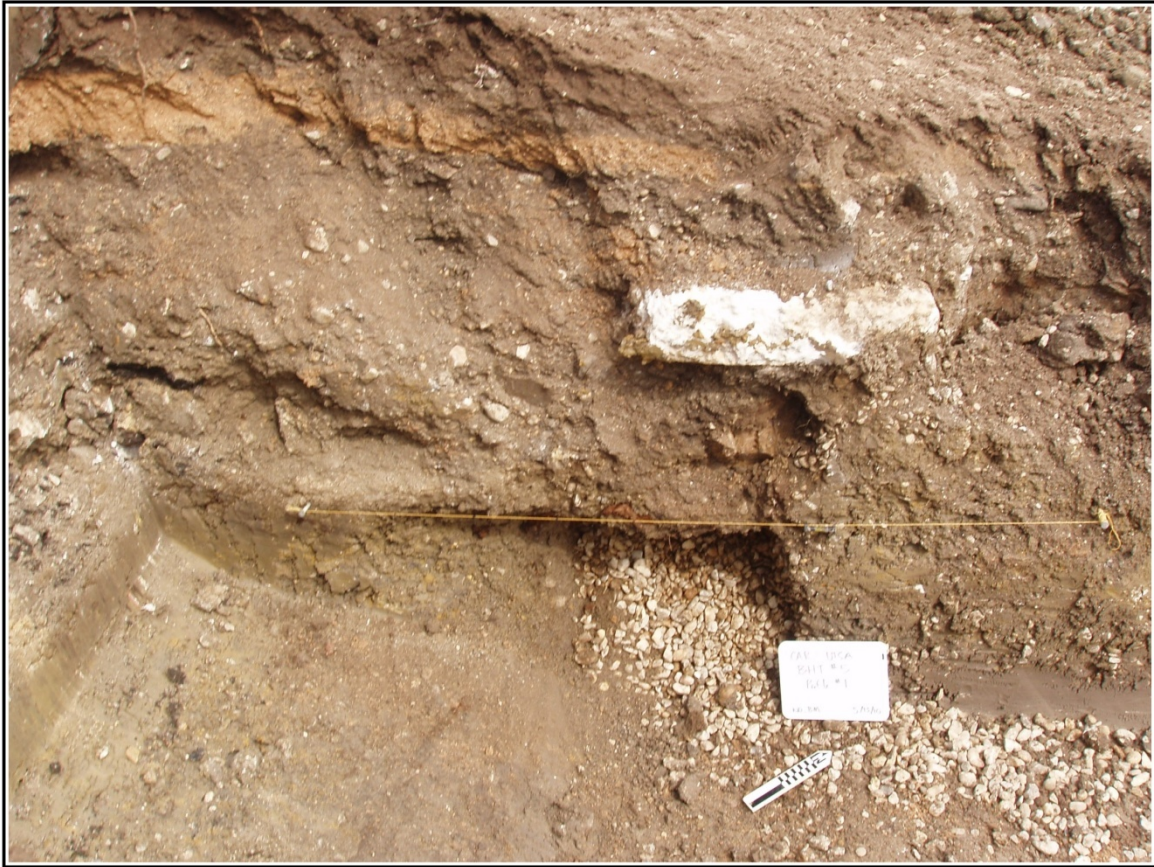
BHT 5 was dug in order to determine if the slope of the river bank above the upper construction road was also fill. The trench was only 3.5 m long. The entire profile was fill material. Figure 3-4 is a photograph of a portion of the south wall of BHT 5, showing multiple layers of fill, large concrete slabs, and a pocket of gravel.

Figure 3-4. *South wall of Trench 5 in Area 1. Note disturbed deposits.*

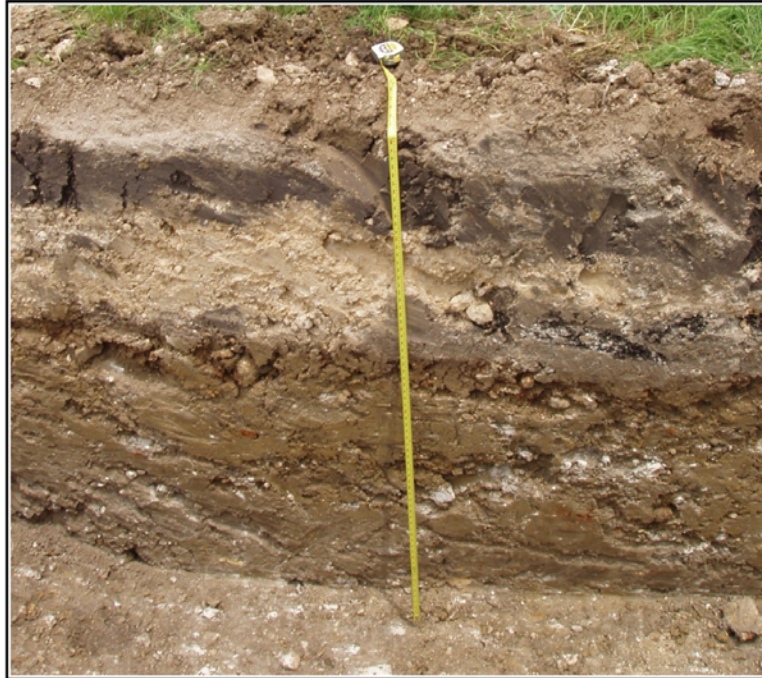
BHT 3 was dug immediately adjacent to one area where the concrete curbs had been seen (Figure 1-7a). The southern part of BHT 3 was dug to a depth of 1.8 m (6 ft.). Figure 3-5 shows a photograph of this part of the trench. All sediments were either clays not seen in natural soils in the area, mixtures of gravels in sandy clay loams, or caliche, all typical fill materials. This part of the trench was backfilled and the northern half was dug the next day.

Figure 3-5. East wall of the south half of Trench 3, showing layers of fill to 1.8 m below surface.

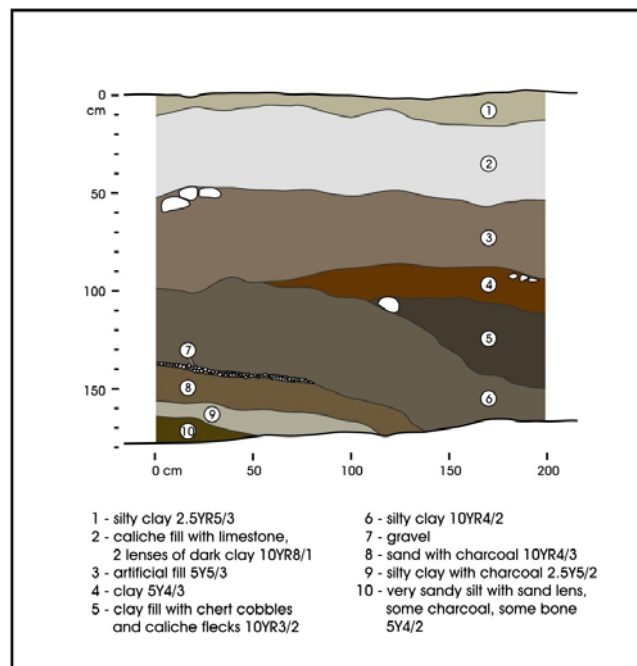
Figure 3-6 shows the profile of the east wall of BHT 3, exhibiting the various layers of fill. The sandy clay loam in the bottom layers of the northern part of the trench may be natural sediments, the result of over-bank flooding near the old river channel.

Figure 3-6. Profile of the east wall of Trench 3.

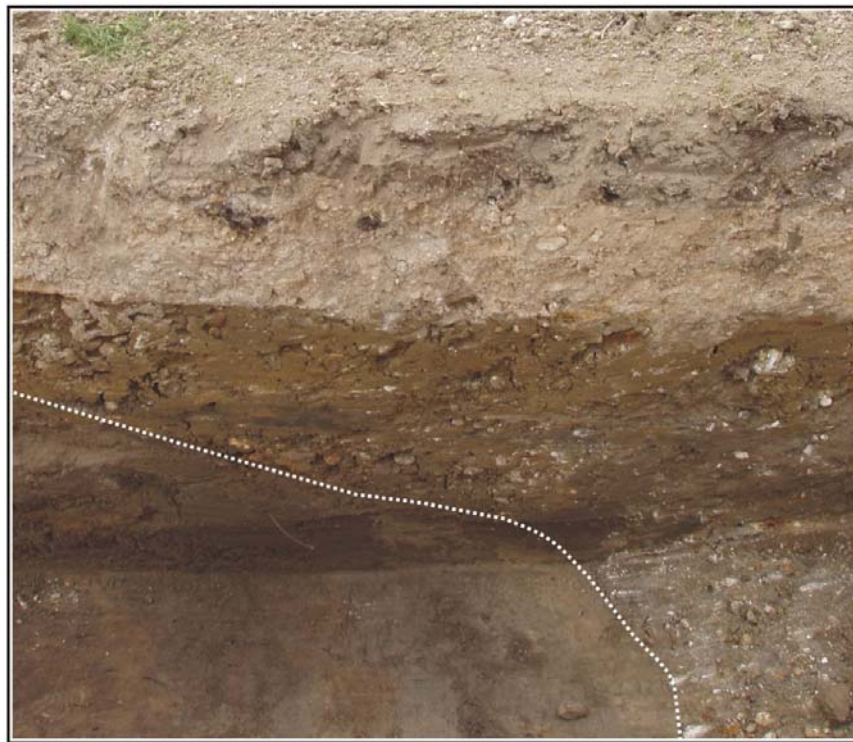
These layers contained scatters of charcoal as well as sparse artifacts, all of which appeared to be modern or historic, dating back to no later than the last quarter of the nineteenth century. Each was isolated, unrelated to the others. A piece of copper wire, two pieces of barbed wire and the distal end of the femur of a cow or bison, along with other bone fragments, were recovered from the lowest two levels of BHT 3. One piece of the barbed wire is identifiable as a variation of Patent #176,120, April 11, 1876 (Devil's Rope Museum 2007). The other was too rusted to be identified. The copper wire is a pulled wire; therefore, it almost certainly arrived in San Antonio after trains began to bring manufactured goods into San Antonio in the late 1870s. These artifacts were located in the walls of the trench ranging in depths from 138 to 170 cm. Figure 3-7 shows the slope of the sandy clay loams that may be natural sediments with the layers of fill seen in Figure 3-6 above them. These materials do not seem to be part of a trash midden since they are sparse and lack concentration.

Figure 3-7. *East wall of Trench 3. White line marks sloping sediments with layers of fill above them.*

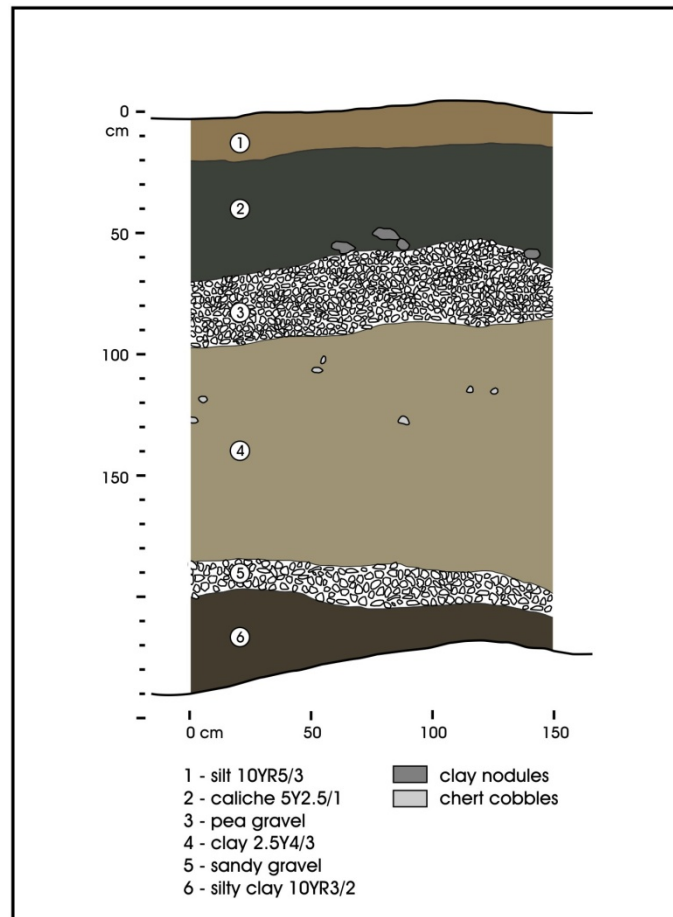
BHT 4 was dug approximately 6 m west of BHT 3, originally to a depth of 1.9 m. In BHT 4, only the northern-most part of the trench showed any sign of the sandy clay loam seen in parts of BHT 3 that may have been natural sediments (Figure 3-8). The remainder of BHT 4 contained the same kinds of fill seen in BHT 3.

Figure 3-8. *East wall of Trench 4, showing layers of fill (Zones 1-4) above natural deposits.*

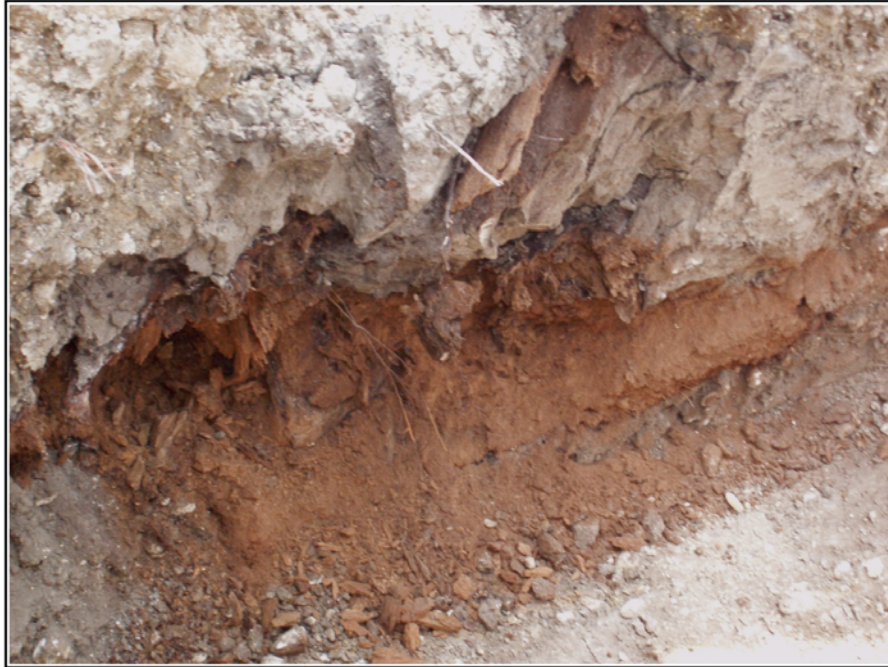
To verify that this part of the riverbank was part of the old river course that had been filled during rechannelization, the southern third of BHT 4 was dug to 3.1 m (10 ft). The layers of fill continued to that depth, and contained the remains of several tree trunks (Figure 3-9).

Figure 3-9. The west wall of Trench 4, showing several tree trunks buried in the fill at a depth of 3.8 m.

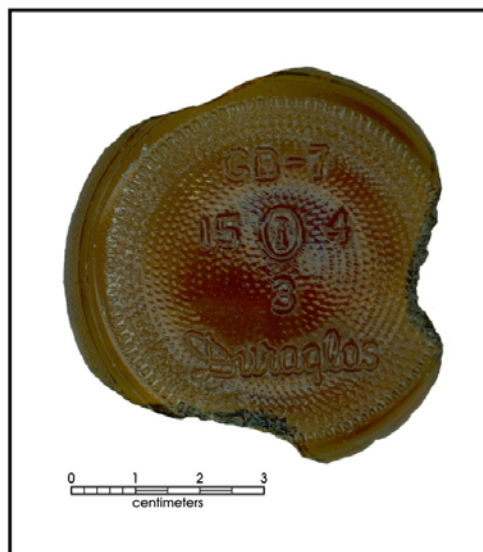
A layer of limestone gravel at 3 mbs contained a number of modern artifacts, including bits of rusted metal and bottle glass. Two fragments of glass bottles were collected. The trench was ended at this point and backfilled. One dark amber bottle base recovered from BHT 4 has a “I-in-an-oval” makers’ mark (Figure 3-10), indicating it was made by the Owens-Illinois Glass Company sometime after 1954 (Witten 2010).

Figure 3-10. Bottle bottom found in Trench 4 at 3 m below ground surface in a gravel lens.

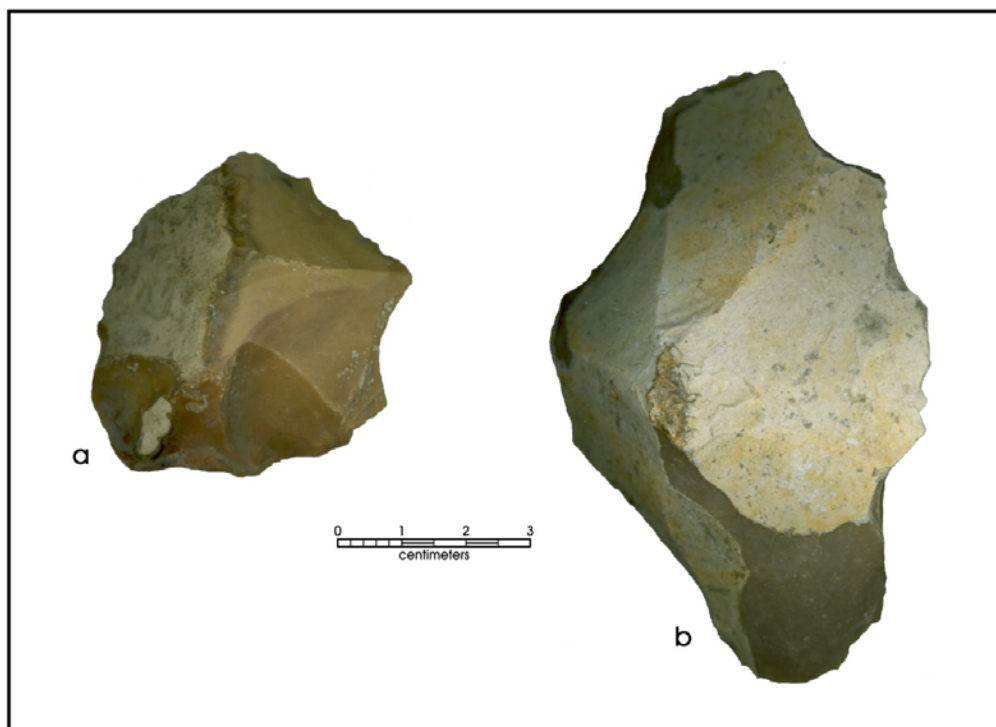
BHTs 6 and 7 were dug to determine whether the chert artifacts, burned rock, and what appeared to be organically enriched sediment seen on the surface of Area 3 were part of a previously unknown prehistoric site. Before the trenches were dug, CAR staff carefully examined the ground surface in Area 3. The area had been graded, though it did not appear that the current ground level was more than 10 to 15 cm lower than the ground level before the area was scraped. Only two prehistoric artifacts were seen and recovered, both close to the area where BHT 6 was later dug. One was a retouched flake (Figure 3-11a) and the other a biface (Figure 3-11b). The latter showed a heavy patina over the majority of the flake scars except two removals that were caused by mechanical means (i.e., post-depositions).

Figure 3-11. Two prehistoric artifacts from the ground surface in Area 3: a) retouched flake; b) biface. Note heavy patina and fresh scars on biface.

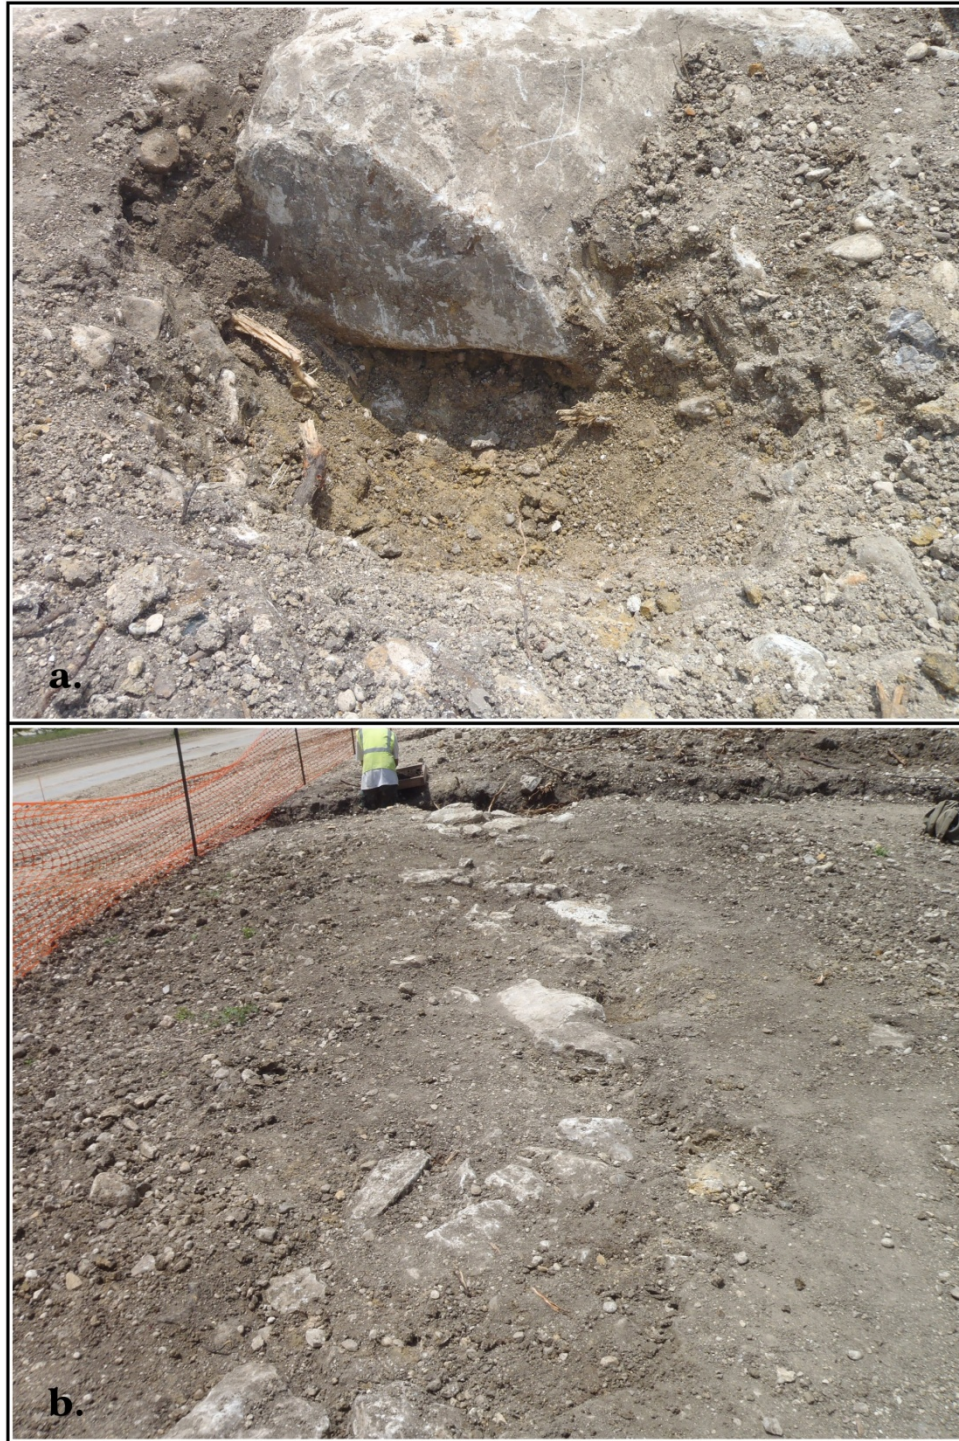
historic structure. The stones were cleared with hand tools enough to show that they were not stacked but instead formed a single layer (Figure 3-12a). Furthermore, it appeared that they were only roughly aligned along the edge of the rechannelized river embankment (Figure 3-12b).

Figure 3-12. *The limestone rocks in Area 3: a) single layer of rocks; b) view of cleared rocks, showing they are only roughly aligned.*

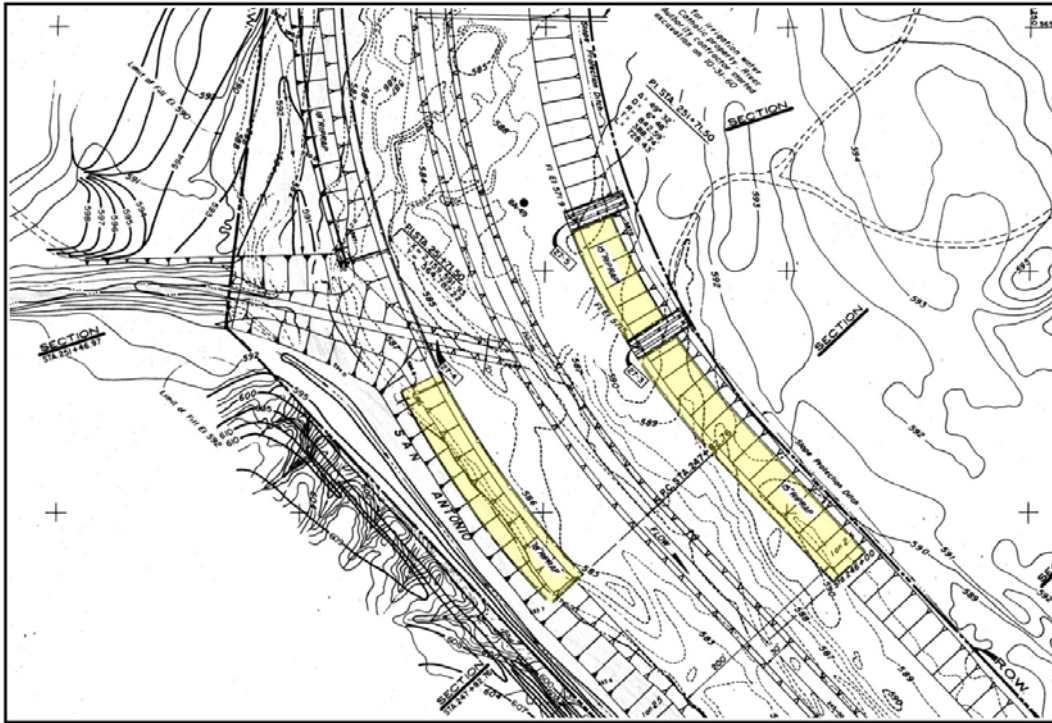
We did not determine how far up the bank of the river these rocks extended. However, examination of the detailed schematic sheet of the original channel improvement project shows that riprap was to be placed along the upper part of the new river embankment (Figure 3-13) at this location. The limestone shown in Figure 3-13 appears to be part of that riprap.

Figure 3-13. Detail plan for Area 3, from original plans for rechannelization of the river. Note reference to riprap along embankment walls (U.S. Army Corps of Engineers, Ft. Worth District, San Antonio River Channel Improvements Detail Plan, Sheet 27.2, 1957).
