# **Archaeological Assessment of Three Locations on the San Antonio River, San Antonio, Bexar County, Texas**

Texas Antiquities Committee Permit No. 5622

*Prepared by:*  
Center for Archaeological Research  
The University of Texas at San Antonio  
One UTSA Circle  
San Antonio, Texas 78249  
Technical Report, No. 23

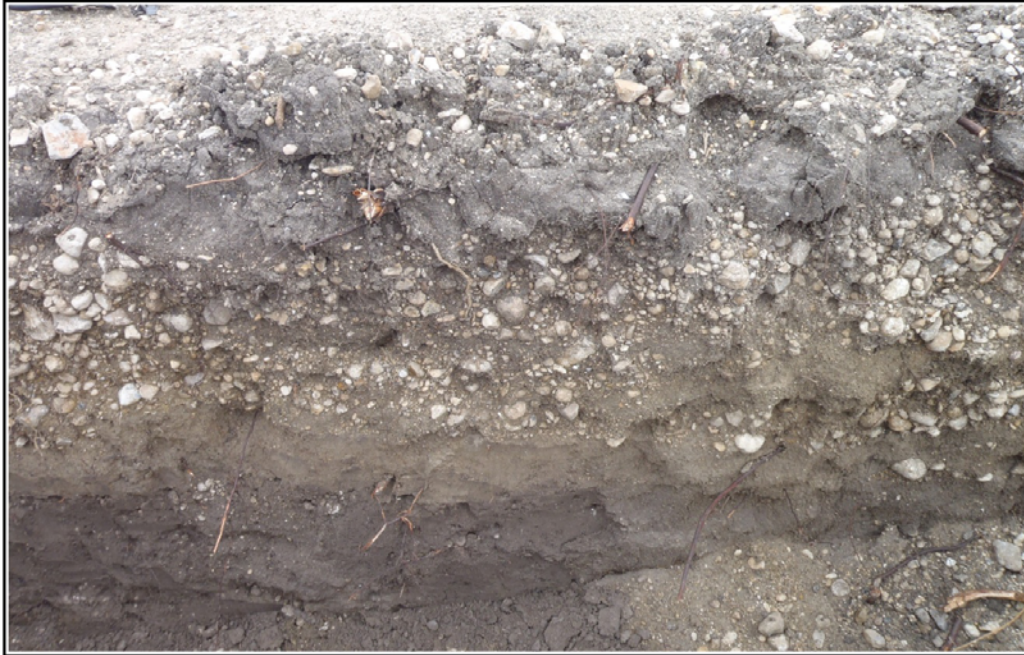
BHT 6 was 8.6 m long and 1.4 m deep. The uppermost layer of silty clay loam in which the prehistoric artifacts and burned rock had been observed on the surface was found to vary in thickness from about 3 cm to 20 cm, and overlay a series of layers of gravel, and other fill (Figure 3-14).

Figure 3-14. *South wall of Trench 6 in Area 3. Note gray clay layer at bottom of trench.*

Not surprisingly, descriptions of the profiles from BHTs E and L (Meissner et al. 2007:58) are very similar to the profiles shown in Figure 3-14 and 3-15. It should be noted that BHTs E and L were 1.7 m and 3.5 m deep respectively and that the mix of gravel and sandy clay seen in the lower part of the profiles of both BHTs 6 and 7 continued to the bottom of the older trenches.

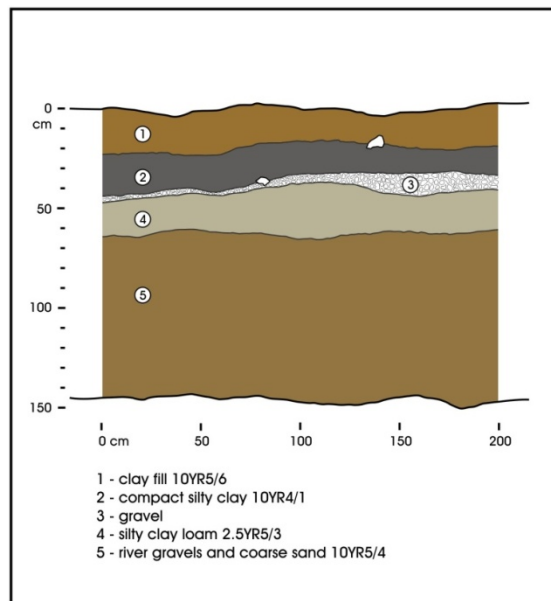
BHT 7 was placed approximately 6 m north of BHT 6 and was 9.2 m long and 1.45 m deep. Figure 3-15 shows a profile drawing of a portion of the north wall of the trench. Note that though BHTs 6 and 7 are quite close together, the profiles are somewhat different. The layer of silty clay loam that contained the artifacts found on the surface near BHT 6 is beneath a layer of reddish clay fill in BHT 7.

Figure 3-15. *North wall of Trench 7 in Area 3.*

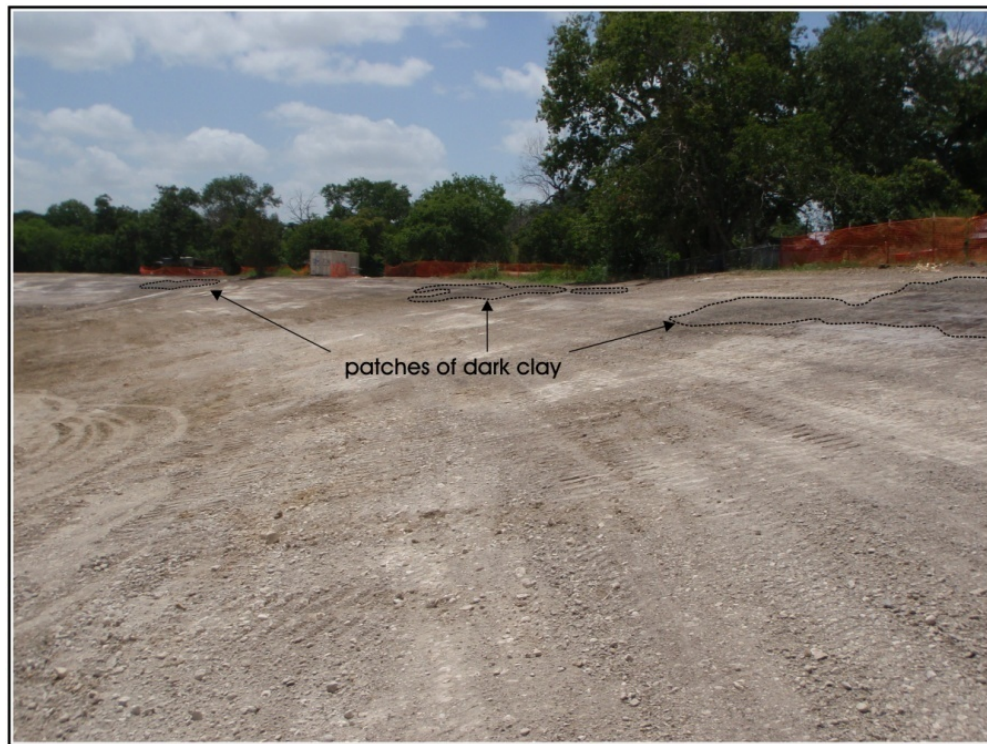
The association of the two lithic tools and few fragments of burned rock with the clay loam present on the surface is a strong indication of the fact that these artifacts were likely introduced to the location. However, this did not explain the presence of a layer of matrix that appeared to be organically enriched in the area. It is this dark gray deposit that is seen at the base of BHT 6 in Figure 3-14 and would suggest that there was an archaeological deposit in the area. However, no artifacts were noted upon careful examination of the gray layer in the bottom of either trench. Later examination of other graded portions of the river bank allowed us to identify several patches of dark gray deposits (Figure 3-16).

Figure 3-16. *Patches of dark clay soils exposed along west bank of river just south of Lorraine Street. These are natural deposits and contain no cultural materials.*
