Archaeological Monitoring Associated with the Installation of Conserved Cannon in the Alamo Complex, San Antonio, Bexar County, Texas

Texas Antiquities Permit No. 8335

Prepared by:
**Center for Archaeological Research
The University of Texas at San Antonio
One UTSA Circle
San Antonio, Texas 78249
Technical Report, No. 77**

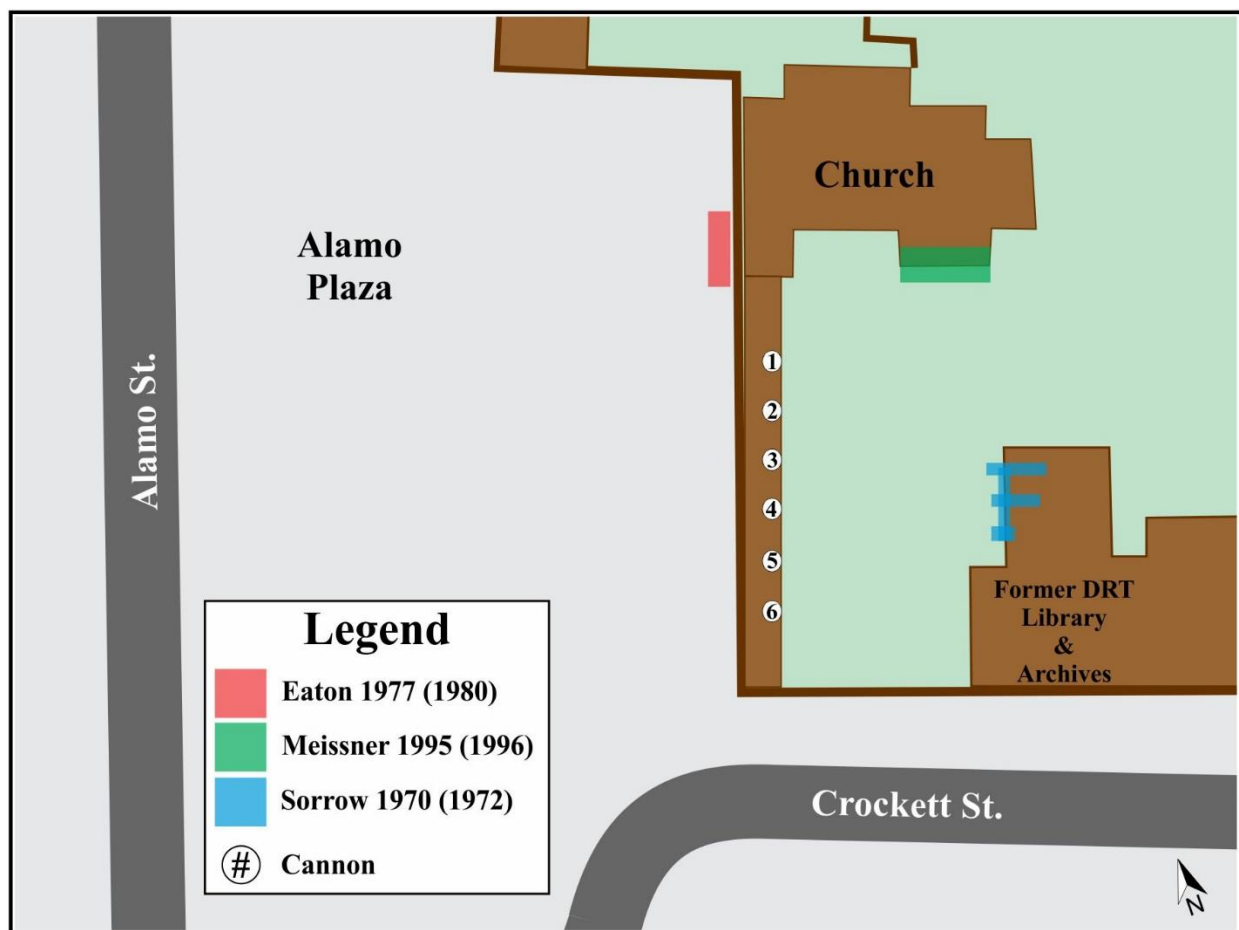
Figure 2-1. Previous archaeology in relation to the cannon installations south of the church.

The area directly south of the church and along the footprint of the Alamo Arcade has not been studied through archaeological investigation. However, three nearby areas were the subject of previous archaeological investigations. As shown in Figure 2-1, one investigation took place in an area adjacent to

the former Daughters of the Republic of Texas (DRT) library and archives (Sorrow 1972). A second nearby investigation was located along the west elevation (southwest corner) of the church (Eaton 1980), and a third study was conducted along the south elevation of the transept (Meissner 1996).

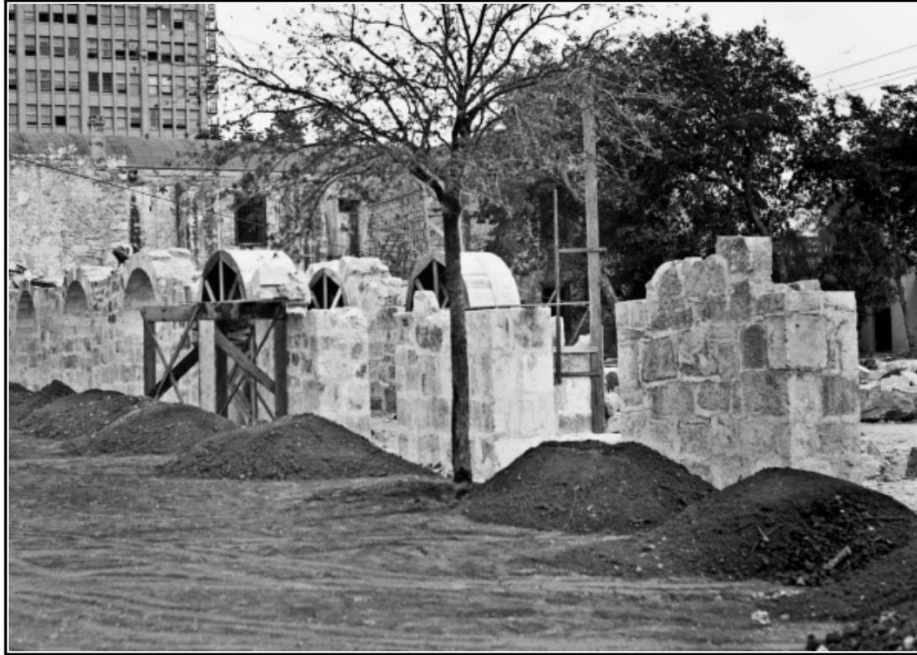
*Figure 2-6. Photograph of arcade construction in September 1934.
Original San Antonio Light caption: "Weathered limestone, salvaged
from buildings previously located on the site, is used for the arcade"
(courtesy of UTSA-ITC, San Antonio Light Collection L-0342-D).*

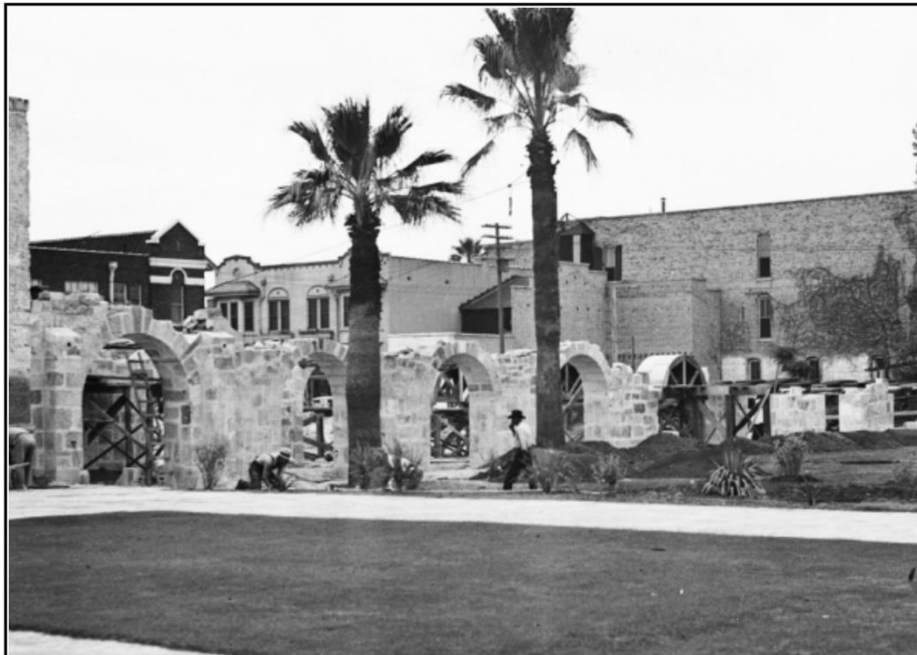
*Figure 2-7. Photograph of arcade construction in September 1934.
Original San Antonio Light caption: "Construction of the Alamo Arcade,
with arches evocative of the conventos at Mission San Jose and
Concepcion" (courtesy of UTSA-ITC, San Antonio Light Collection L-
0342-E).*

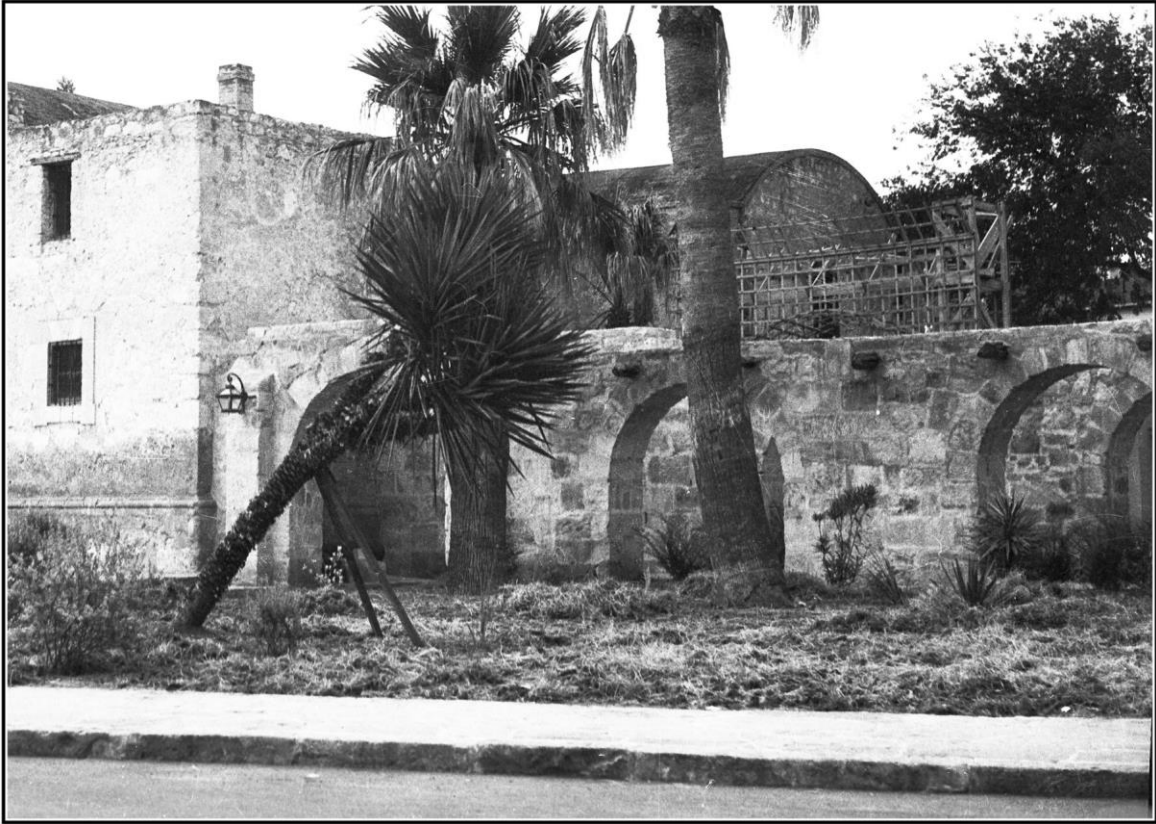
Figure 2-8. Photograph of completed arcade in 1934. Original San Antonio Light caption: "Plants, contributed by Texas residents, are planted in front of the arcade and in the Alamo garden" (courtesy of UTSA-ITC, San Antonio Light Collection L-1547-H).

Figures 2-6 and 2-7 show the progression of the Alamo Arcade construction progress. Figure 2-8 shows a completed view of the arcade.

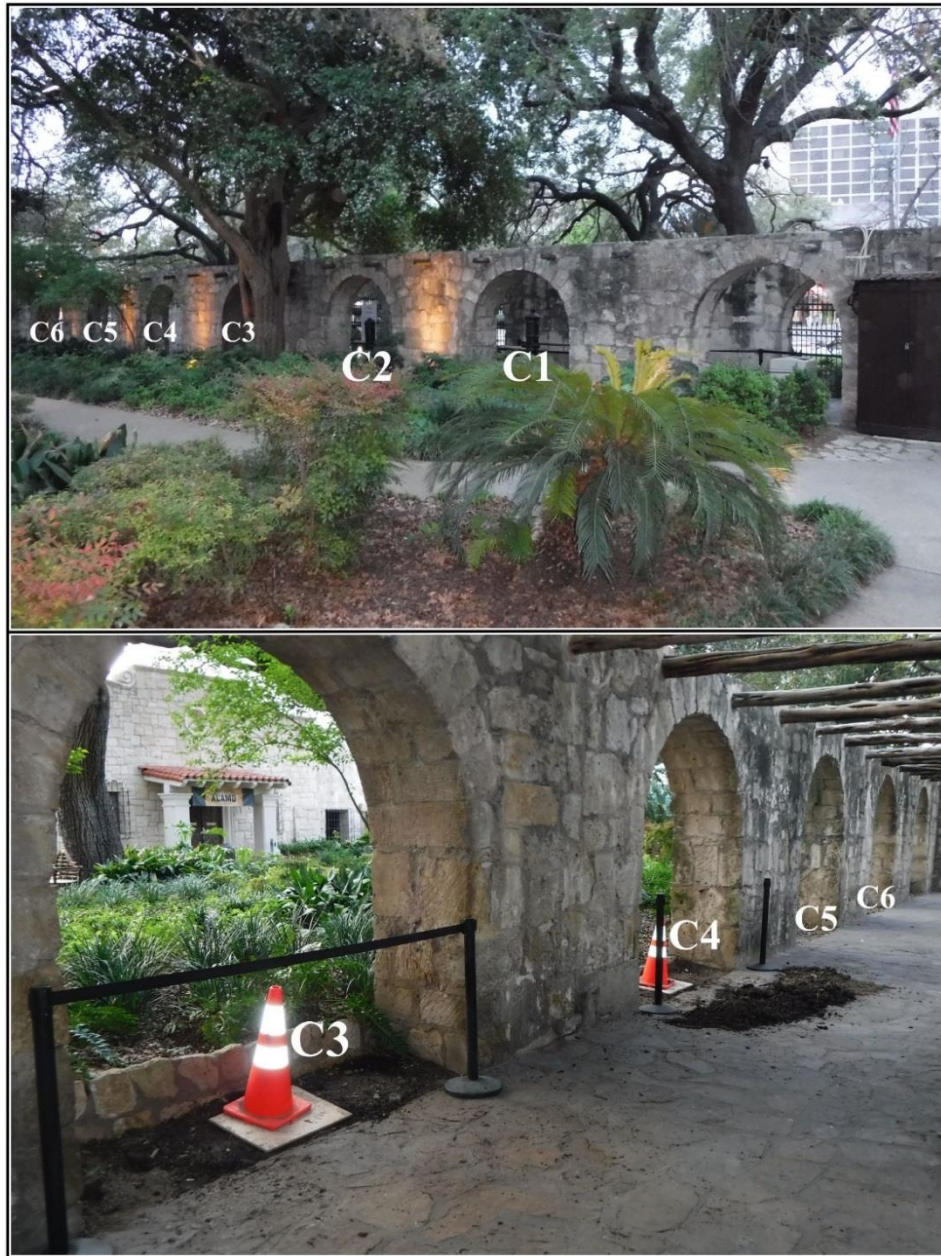
Archaeological monitoring for the hand-excavated holes was completed at three different times. Excavations and installations occurred as the cannon were returned from conservation. Excluding the main arch at the north end, there are eight arches at either side of the Alamo Arcade. The six cannon were installed under six of the arches (Figure 4-1).

Figure 4-1. Project area showing a view of Alamo Arcade. Exterior (top) with first two (C1 and C2) cannon installed and locations for cannon C3 through C6. Interior (bottom) with holes for C3 and C4 completed and locations of C5 and C6 (view south).

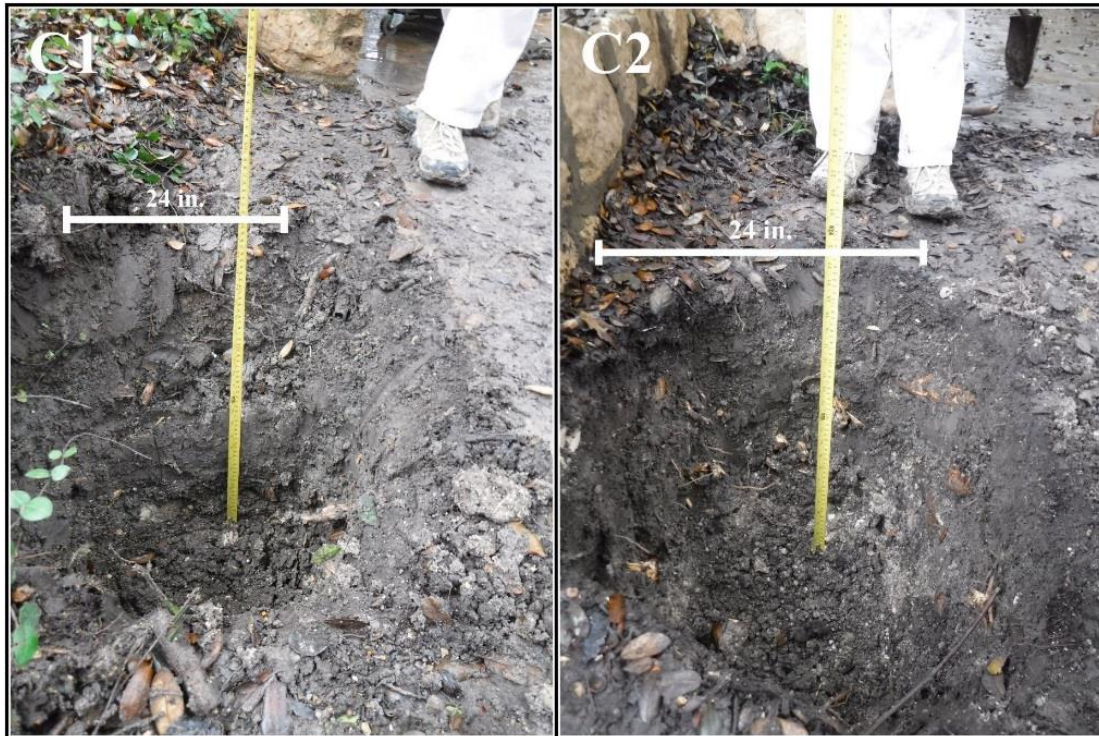
The first two cannon support holes (C1 and C2) were located at the north end of the arcade and along the east side of the arcade walkway. The holes were 24-in. (61-cm) in diameter and 24-in. (61-cm) deep. A 12-in. (30.5-cm) layer of mulch was removed, exposing a 6-in. (15.2-cm) layer of dark clay. A light colored, mix of sandy soil and limestone gravel and dark clay was exposed at 18 in. (45.7 cm), which continued to 24 in. (61 cm) below the surface (Figure 4-2).

Figure 4-2. C1(left) and C2 (right) holes excavated to 24 in. (61 cm) below the surface.

The first cannon support hole (C1) produced artifacts between 18 and 24 in. (45.7 and 61 cm) below the surface. The second cannon support hole (C2) produced artifacts between 14 in. and 24 in. (35.5 and 61 cm) below the surface. Very few artifacts were recovered.

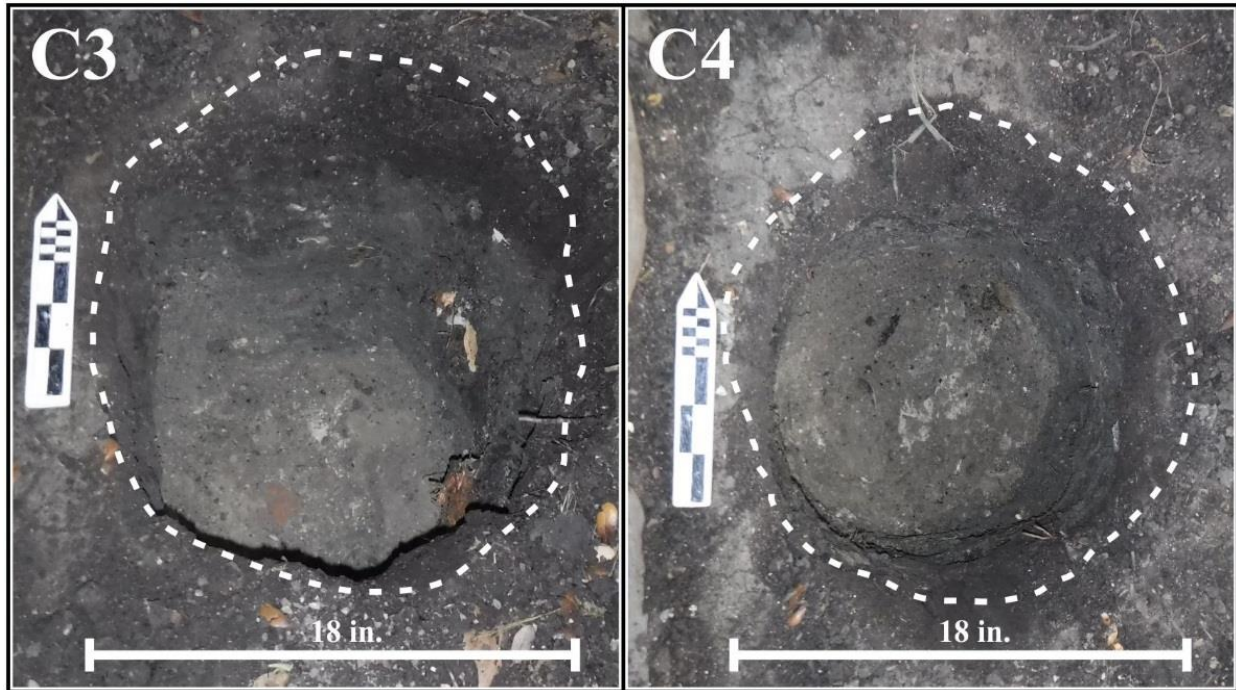
The two holes excavated for C3 and C4 were located mid-way through the arcade and along the east side of the arcade walkway. Both holes were 18-in. (45.7-cm) in diameter and 18-in. (45.7-cm) deep. A 6-in. (15.2 cm) layer of mulch was removed, exposing a light to dark colored clay with 10 percent gravels. This stratum continued to 18 in. (45.7 cm) below the surface. Once the Alamo staff completed hand-excavating C3 and C4, CAR staff cleaned the walls and floor (Figure 4-3). As seen in Figure 4-3, the strata was mixed

and mottled, dark to light colored clays, with bits and pieces of charcoal imbedded. Cannon support hole 3 (C3) and C4 produced few artifacts. The recovered artifacts were in mixed deposits between 6 in. and 18 in. (15.2-45.7 cm) below the surface.

Figure 4-3. C3 (left) and C4 (right) holes excavated to 18 in. (45.7 cm) below the surface and 18 in. (45.7 cm) in diameter. Note mottled sediments.

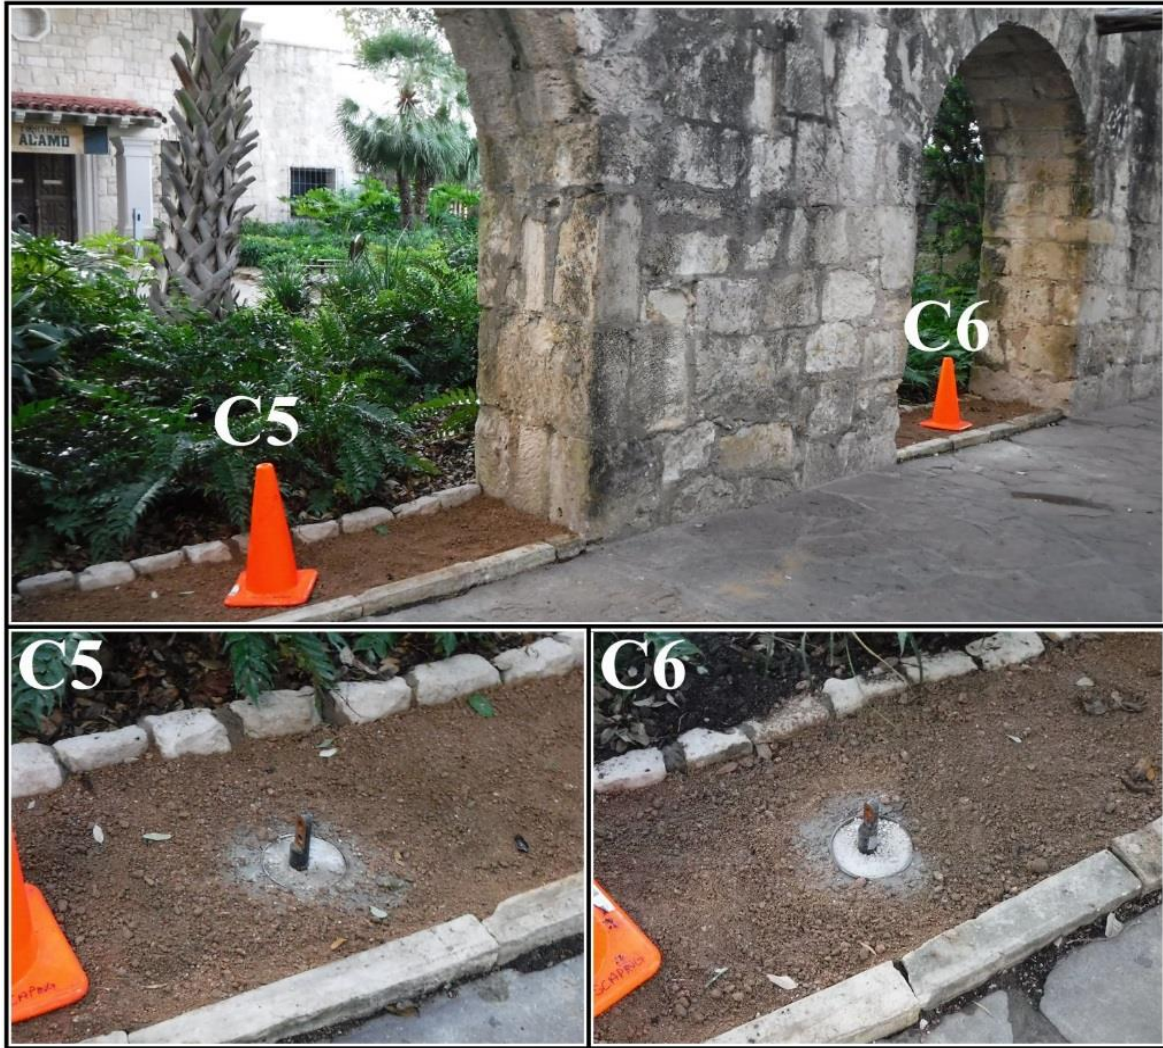
Cannon support holes C5 and C6 were not monitored by archaeologists as excavations took place prior to notification. CAR staff were informed the afternoon of June 7 that Alamo staff had hand-excavated two additional holes (C5 and C6) to 12 in. (30.5 cm) below the surface. It was the understanding of the Alamo staff that disturbance no greater than 12 in. (30.5 cm) below the ground surface did not require archaeological monitoring. This misunderstanding was communicated to the THC, and CAR staff visited the site on the morning of June 8. CAR staff noted that cement had already been poured into the C5 and C6 holes, and the metal supports for the cannon were already in place (Figure 4-4). The excavated soils had been spread into the garden area. CAR staff investigated the soils and observed no artifacts in the garden.

Figure 4-4. C5 and C6 locations prepared for cannon installation (facing south).

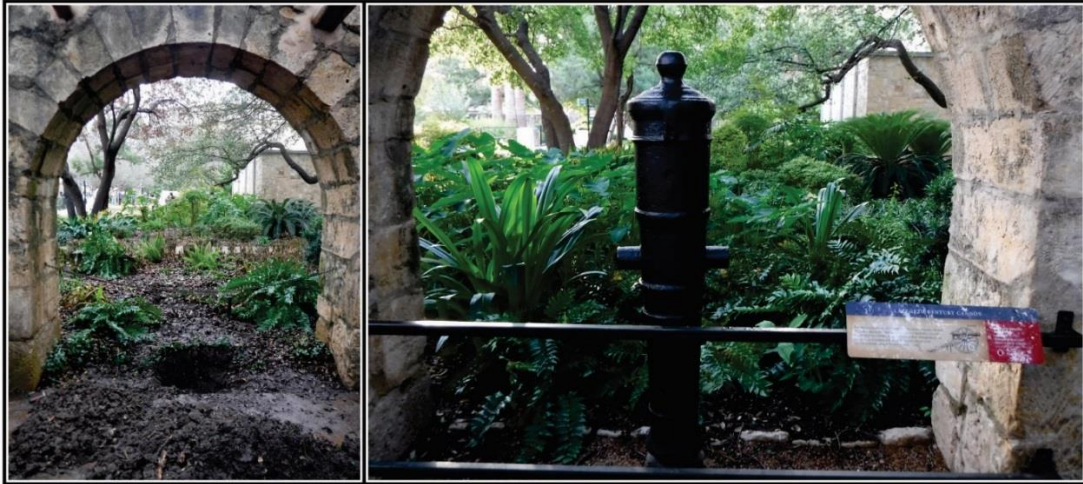
The hand-excavated holes did not adversely impact any buried cultural deposits. The last two hand-excavated holes should have been monitored, or at the least, the THC should have been consulted. Figure 4-5 illustrates the result of the C1 installation, which is representative of the other cannon installations.

Figure 4-5. C1 before (left) and after (right) with interpretive signage installed (view east).
