Monitoring the Planting and Removal of Plants at the Commander's House (41BX351) San Antonio, Bexar County, Texas

Texas Antiquities Committee Permit No. 5595

Prepared by:
Center for Archaeological Research
The University of Texas at San Antonio
One UTSA Circle
San Antonio, Texas 78249
Technical Report, No. 19

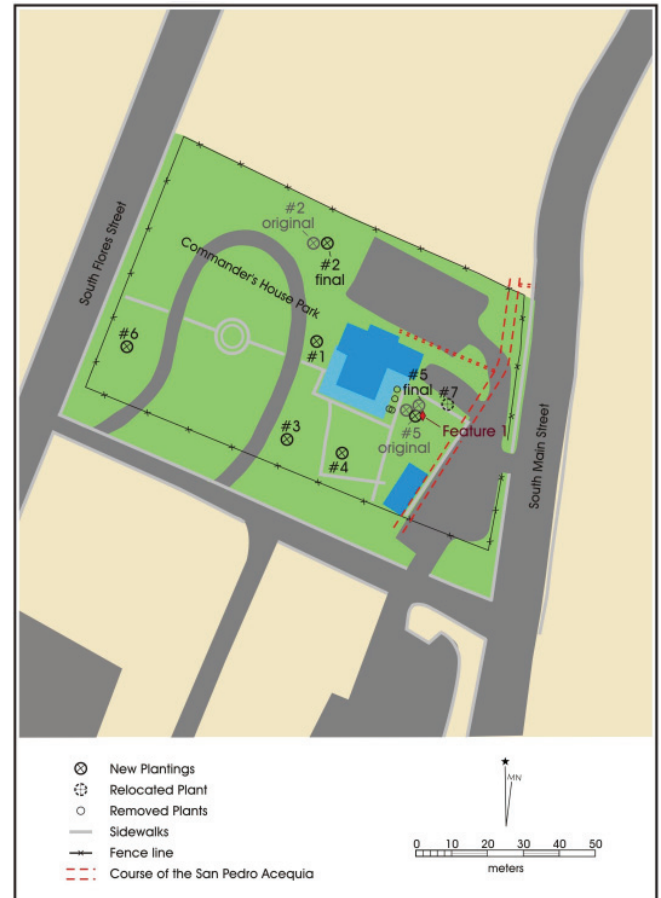
Figure 1-2. Map of Commander's House Park, showing the location of planted and removed plantings, and the location of the San Pedro Acequia and laterals encountered by Fox (1978).

Two cycads and one palm were removed during the project. The palm was replanted in a side flowerbed (see location #7 in Figure 1-2). They were removed by digging around them enough to cut most of the roots and then pulling them free of the ground with a backhoe (Figure 3-1). No artifacts of any kind were observed during this operation, nor were any cultural features impacted.

During the day, holes were excavated for three new palms and three new trees. Hole #1, dug to plant a pine tree, was excavated near the house in what is now considered the back of the house, facing South Flores (Figure 1-2). The hole was originally excavated to a depth of approximately 55 cm below surface. However, following initial inspection, it was determined that the hole was too shallow. When the hole was expanded, an unmarked electrical conduit was encountered. The final depth of the hole was approximately 70 cm. The sediment removed from this hole was dark gray-brown silty clay loam with few inclusions. No historic cultural materials were observed.

Hole #3 was dug to place a pecan tree south of the house (Figure 1-2). The hole was 68 cm deep. The sediment was similar to that in Hole #1. No historic cultural materials were observed.

Hole #4 was dug to plant a palm south of the house (Figure 1-2). The sediment was slightly darker and contained a higher proportion of clay than the sediments in Holes #1 and #3. The hole was 58 cm deep. No historic cultural materials were observed.

Hole #6 was dug in the southwestern part of the park (Figure 1-2). The removal of the stump required the digging of a much larger hole than the previous holes (Figure 3-4). The final hole measured 3.45 m by 3.95 m and was 1.25 m deep. The sediment was medium brown silty clay loam to about 60 cm bs and then changed to a much lighter gray very sandy clay with approximately 50 percent gravels most of which were 5 to 7 cm in maximum diameter. This layer continued to the bottom of the hole and appeared to be a natural sediment. No cultural materials were observed.

Hole #7 was dug to replant the palm removed from the front flowerbed to a flowerbed along the east/west-running sidewalk (Figure 1-2). The hole was smaller than the others, measuring only approximately 60 cm in diameter and was only 50 cm deep. No cultural materials were observed.

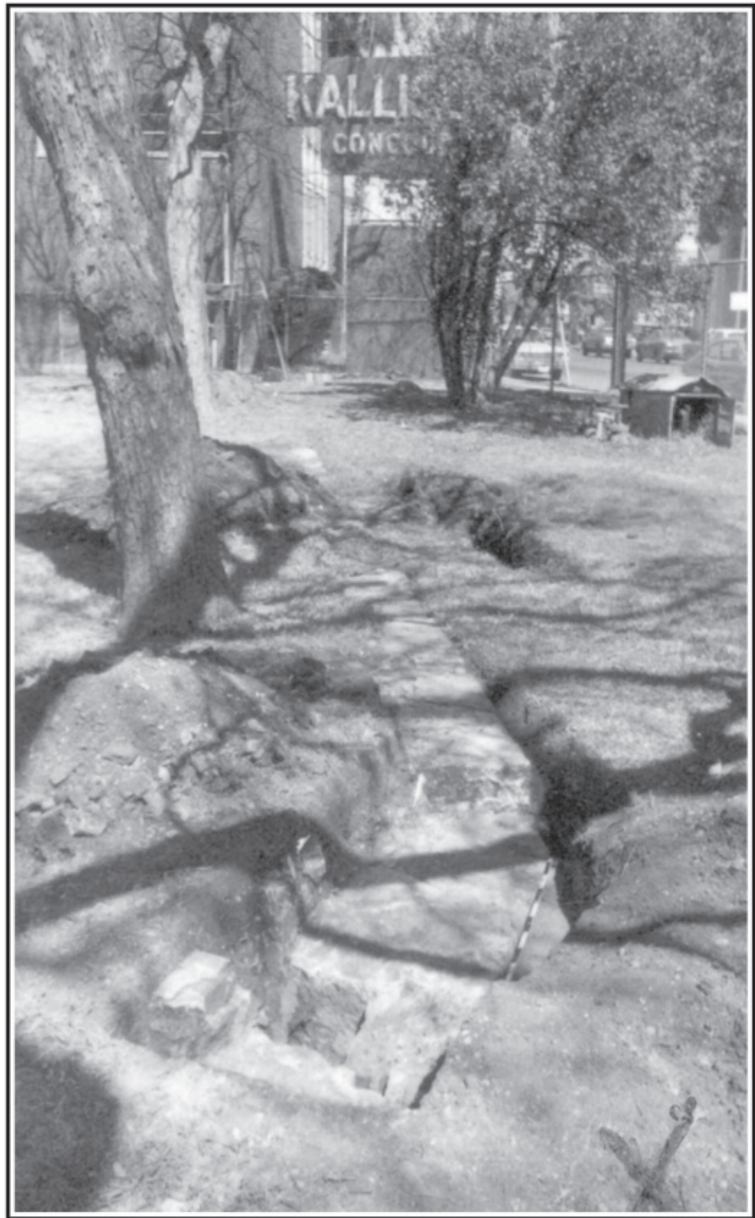
Figure 1-3. Photograph of the west wall of the San Pedro Acequia on the grounds of the Commander's House taken during excavation by CAR, showing curve of the acequia and a gate to a lateral that led west (foreground). Facing North.

The excavations showed that this portion of the acequia was stone-lined with a cement cap that had been added on top of the walls at some point in the past (Fox 1978:3). The excavations also found cement plugs at each end of the acequia. Fox (1978:7) speculated that this closed-off portion had been used as a fish pond after the acequia was no longer in use. There were also cement plugs blocking the two laterals that were encountered, one going west and the other east (Figures 1-2 and 1-3).

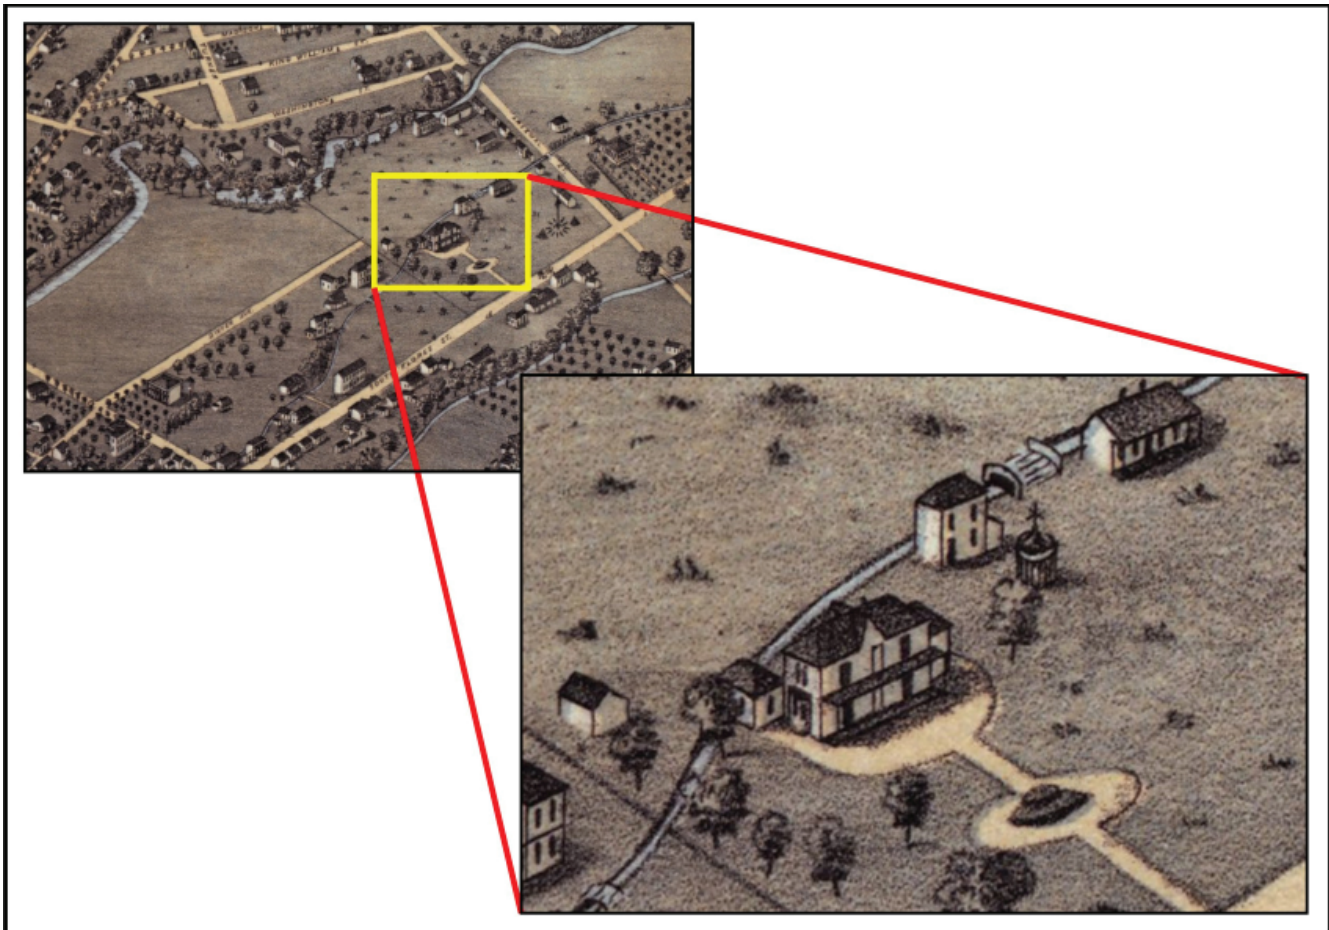
Figure 2-1. *The Commander's House in 1873, from a Bird's Eye map of San Antonio. The inset is a closer view of the grounds. Note the San Pedro Acequia and the small house built adjacent to it. Map faces southeast.*

A note should be made that the Commander’s House originally fronted on South Flores Street, as can be seen in Figure 2-1. Today the “front” of the house is considered to face South Main, which did not exist at the time the house was built and for some time thereafter (Figure 2-2). Unfortunately, the Sanborn Fire Insurance maps are of no value in this case. Beginning with the earliest available Sanborn maps, the project area is shown only as a blank labeled “U. S. Government” (Digital Sanborn Maps 2010).

to replace decrepit temporary structures, "The buildings and grounds are in good order and the stores are well cared for. The office books and papers are neatly kept and accounts and public funds are in a satisfactory condition" (Garner 1968:6). The 1873 Bird's Eye map shows no railed balcony on the front of the building (Figure 2-1).

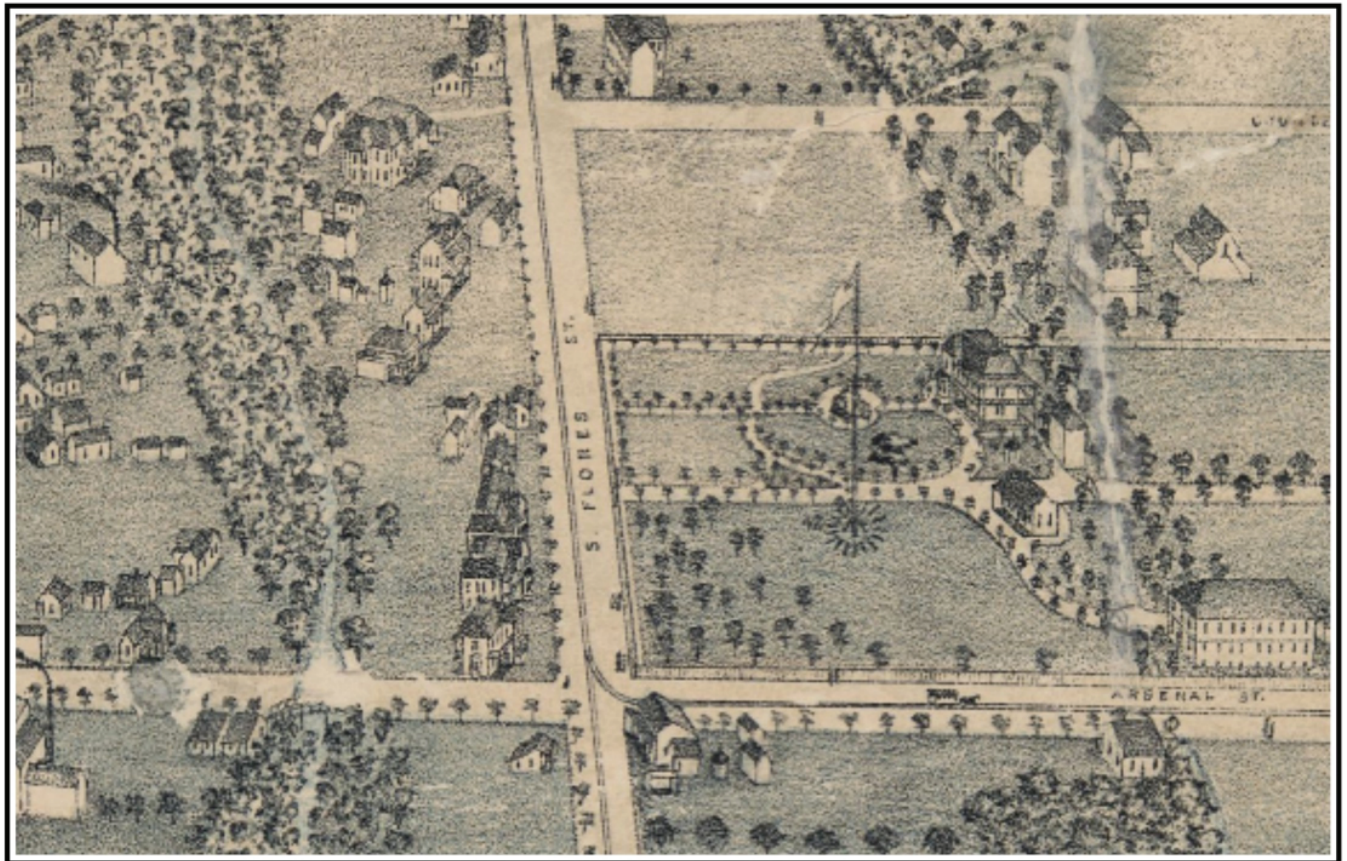
Figure 2-2. Detail of the 1886 Bird's Eye map of San Antonio, showing the Commander's House. Map faces northeast.

Another Bird's Eye map of San Antonio drawn in 1886 shows that the balcony has been rebuilt on at least the visible sides of the house (Figure 2-2). A photograph, taken about 1888, shows the balconies, as well as the landscaping surrounding the building. Figure 2-2 clearly shows that the wing extending from the east side of the building had not been built at this time, though a bay window had been added on the ground floor room at the northwest corner of

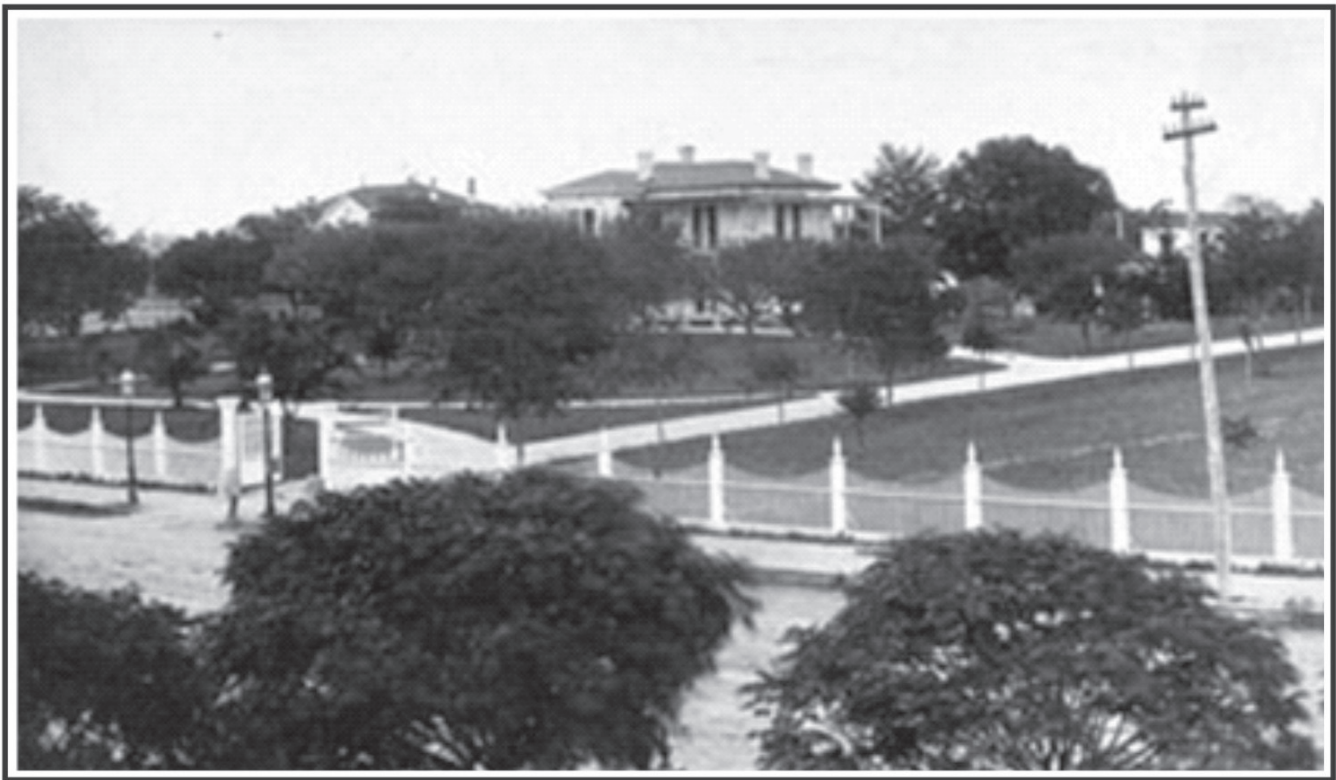
Figure 2-3. Photograph of the Commander's House taken about 1888 (Photograph is in the collection of the Institute of Texan Cultures, #073-1684).

Several references, in particular the web site of the Office of Historic Preservation (City of San Antonio 2010b), state that the house was completely rebuilt about 1883. However, the drawing of the building in the 1886 Bird's Eye map (Figure 2-2) appears to show the same building as that seen in the 1873 Bird's Eye map (Figure 2-1), with the exception of the bay window, including the double narrow windows at the north and south ends of the building. Note that these windows are clearly evident in a photograph taken about 1888 (Figure 2-3).

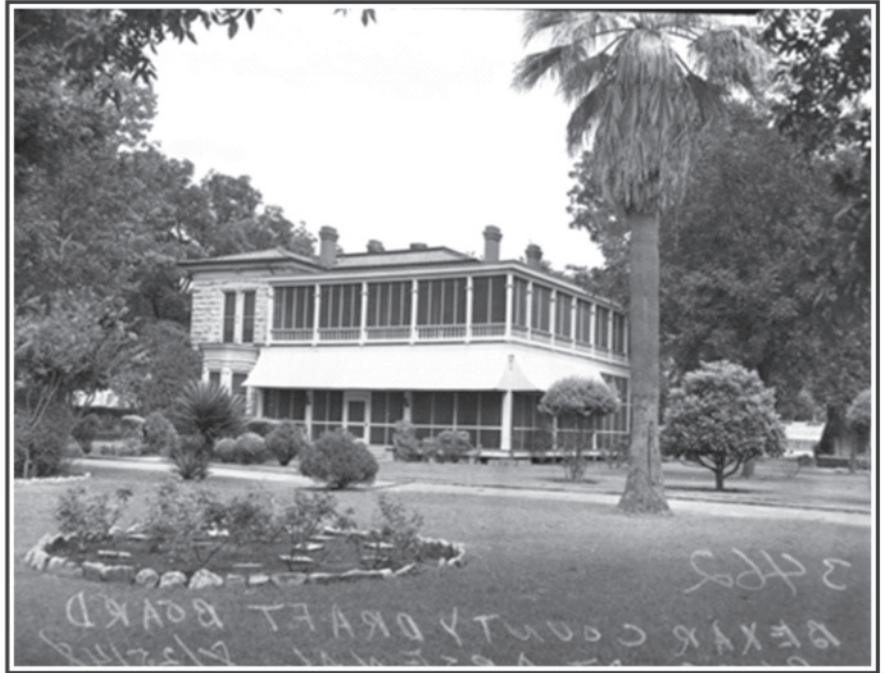
Figure 2-4. Photograph of the Commanders House taken in 1948. Note that the balconies have been enclosed (Photograph is in the collection of the Institute of Texan Cultures, #L-6432-F).

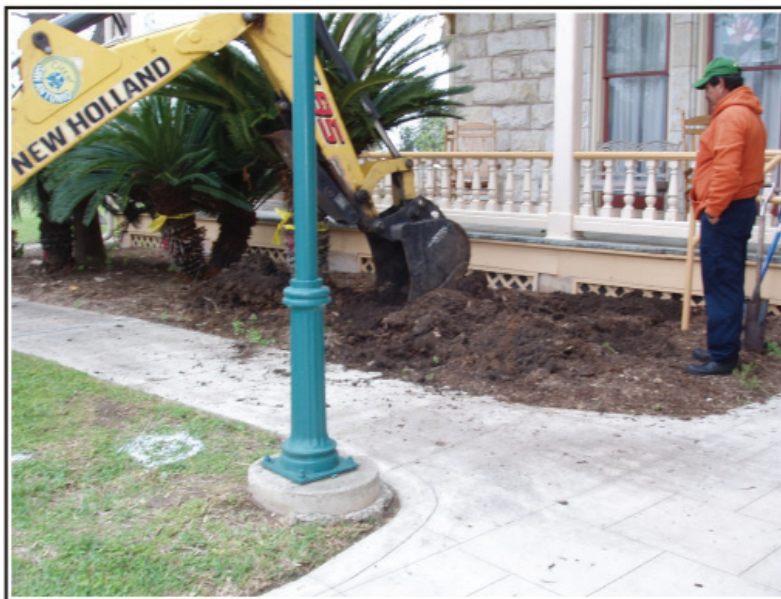
Figure 3-1. Removing plantings from the front flower bed. The twin trunk of the final cycad to be removed is visible at the upper left of the photograph.

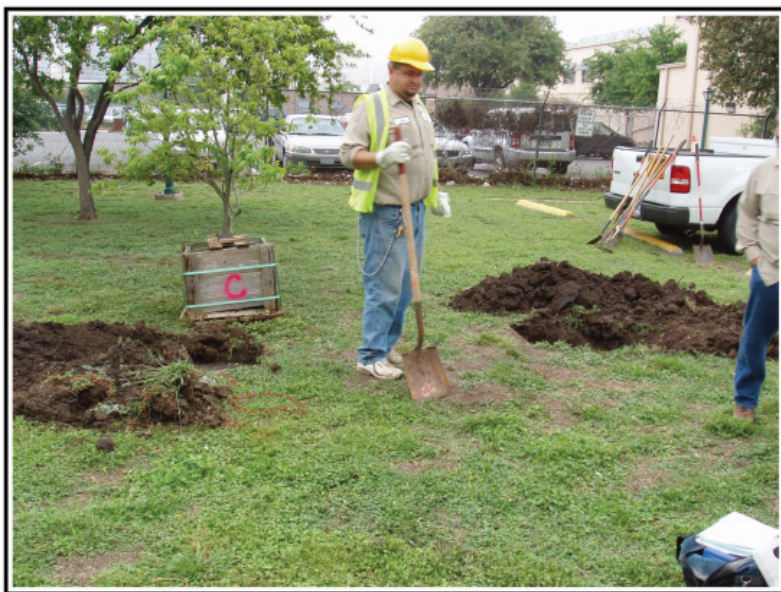
Figure 3-2. Moving Hole #2 after encountering an irrigation line. The final location is on the right. Facing North.

Hole #2 was dug to plant a Mexican Buckeye (*Unquadia speciosa*) tree west of the northern parking lot (Figure 1-2). The original hole had to be abandoned when the backhoe struck a 2-inch PVC water line that fed the irrigation system (Figure 3-2). The final depth of the hole was 58 cm. The sediment was brown sandy clay loam with ca. 5 percent small

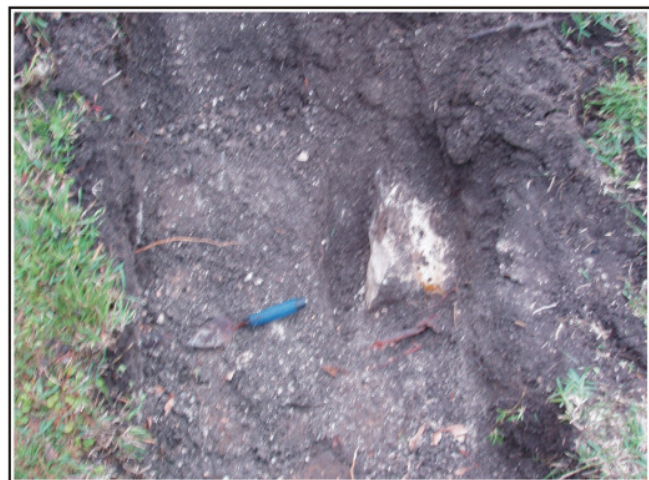
Hole #5 was dug in front of the house (though, as noted above, historically this would have been considered the back of the house) (Figure 1-2). The sediment in the original location of the hole, which was southeast of the stump of a dead palm, was medium brown sandy clay loam with ca. 5 percent small gravels. The percentage of gravel increased and numerous caliche nodules became apparent with increasing depth. At 45 cm bs, the excavation exposed a large limestone block. The block was very roughly shaped into a rectangle and was stacked onto another large rock (Figure 3-3).

To limit disturbing this apparent architectural feature, Feature 1, the upper limestone block was not uncovered completely. The exposed portion measured 23 cm by 31 cm. Its location was measured from the sidewalks found to its west and north (Figure 1-2). The corner of the stone was 2.97 m east of the north/south running sidewalk and 3.25 m south of the sidewalk running east/west. The hole that exposed the limestone block was backfilled without disturbing the stones.

The limestone blocks appear to be part of an architectural feature such as the corner of the foundation of a structure of some kind,

Figure3-3. Limestone block in Hole #5.

possibly an outbuilding or the footer for a wall. Given the location, behind the house as it was originally used, it is possible that it is the upper part of a stone-lined privy. However, as the purpose of the project was not to investigate this feature, it was simply recorded, and an alternate hole was excavated.

Cultural materials and/or features were encountered in only one hole, #5. This hole, located in front of the house, encountered two roughly trimmed limestone blocks set on top of each other (Figure 3-3). The feature appears to be part of a foundation although this cannot be determined with certainty unless and until a larger area is exposed in the future

The Commander's House, site 41BX351, represents an important part of San Antonio's history. It was originally built as the home of Doctor James M. Devine, three-time mayor of the city, and was later used as the home of the Commander of the U.S. Army Arsenal. In addition, the San Pedro Acequia (41BX337) runs through the eastern side of the property and a lateral of the acequia runs just north of the house. Because of the importance of this site and the associated acequia, we recommend that any future projects involving sub-surface disturbances in the park be assessed for their potential to disturb historic features and/or deposits. At a minimum, any project that requires disturbance of the ground within the park should be monitored by an archaeologist. If future opportunities arise, also we recommend that the nature of the stacked limestone blocks found in the vicinity of planting Hole #5 be more fully investigated.

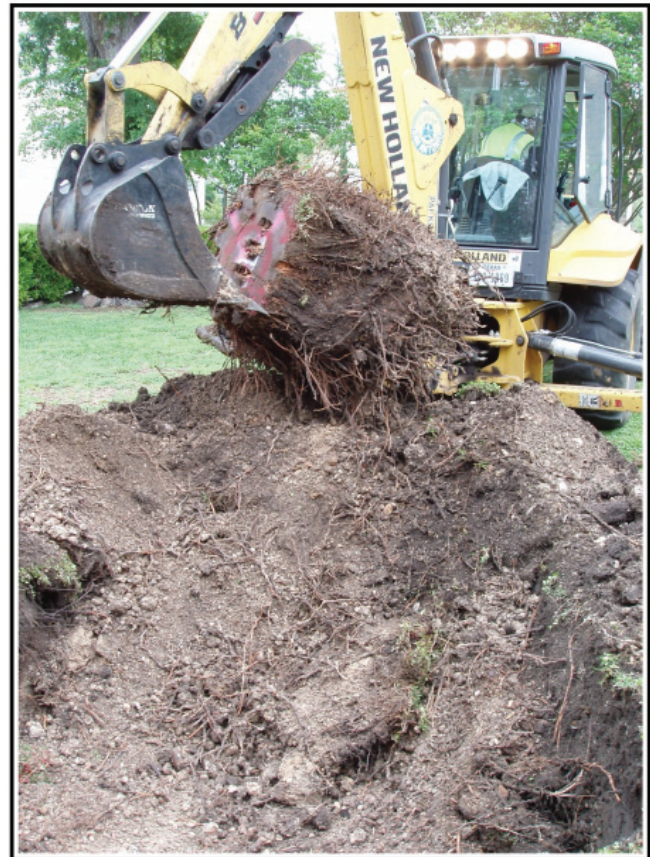
Figure3-4. Removal of palm stump prior to planting of new palm.
