# Archaeological Monitoring of the Caldwell County Courthouse Rehabilitation, Lockhart, Texas

Texas Antiquities Permit No. 2117

©copyright 2000  
Center for Archaeological Research  
The University of Texas at San Antonio  
Archaeological Survey Report, No. 306

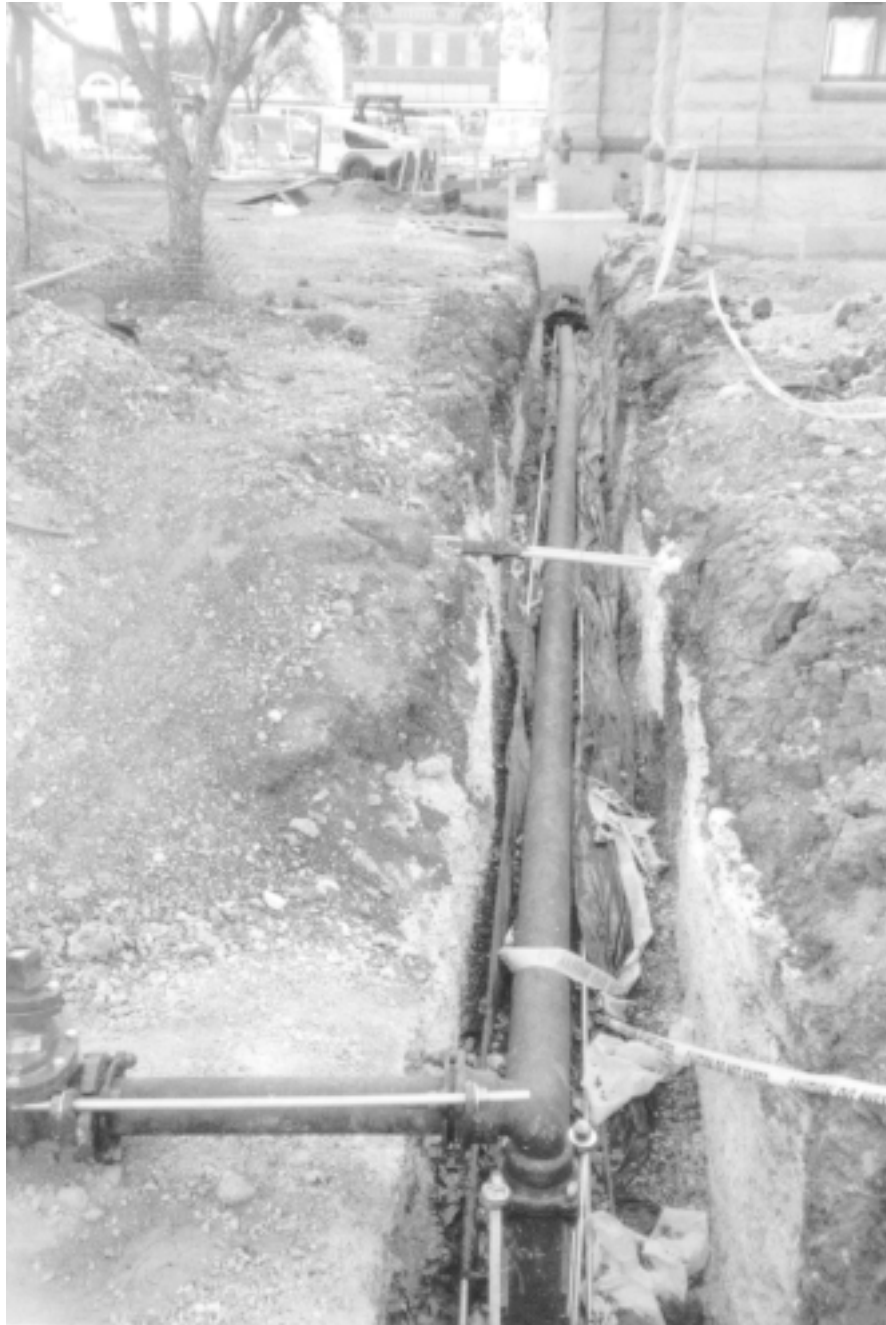
Figure 2. *Fire line trench on NW side of courthouse lot.*

In general, water, sewage, and drain lines required the excavation of 12–16 inch wide and 36–inch deep trenches (Figure 2). The installation of electric lines, encased in 1", 2" and 4" (under sidewalks) diameter PVC conduit, required the excavation of 6–inch wide and 18–24 inch deep trenches (Figure 3).

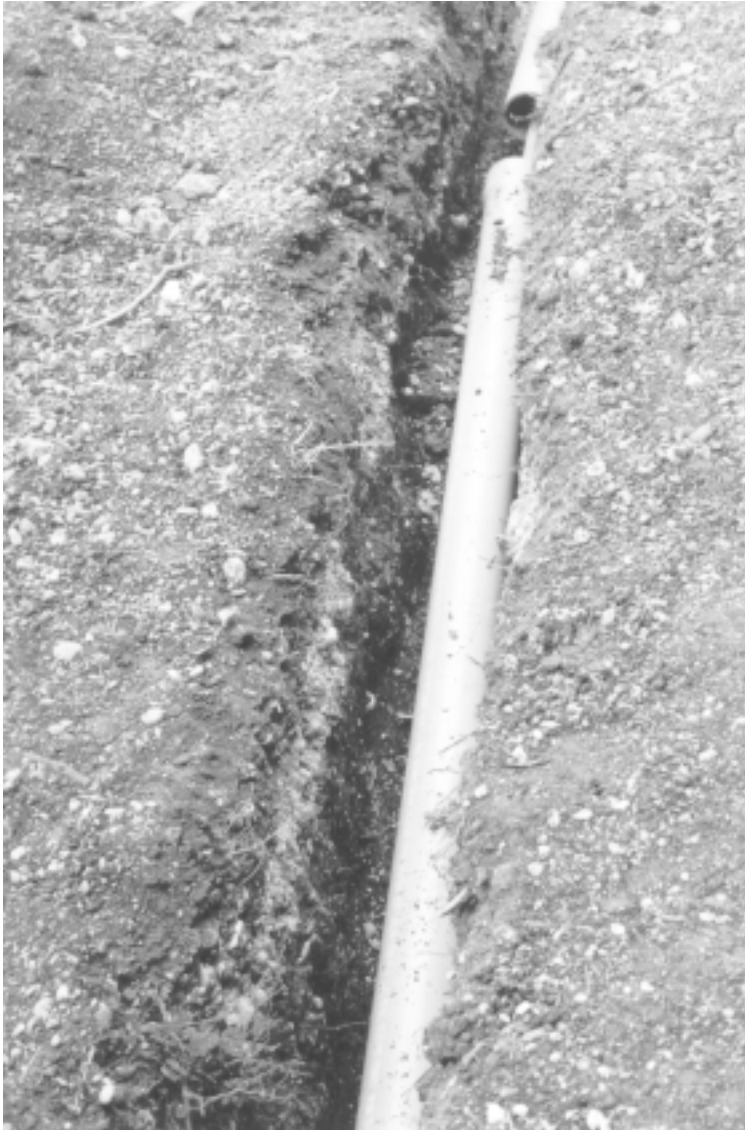
Figure 3. *Electric line in 2-inch and 4-inch PVC conduit in Trench F.*

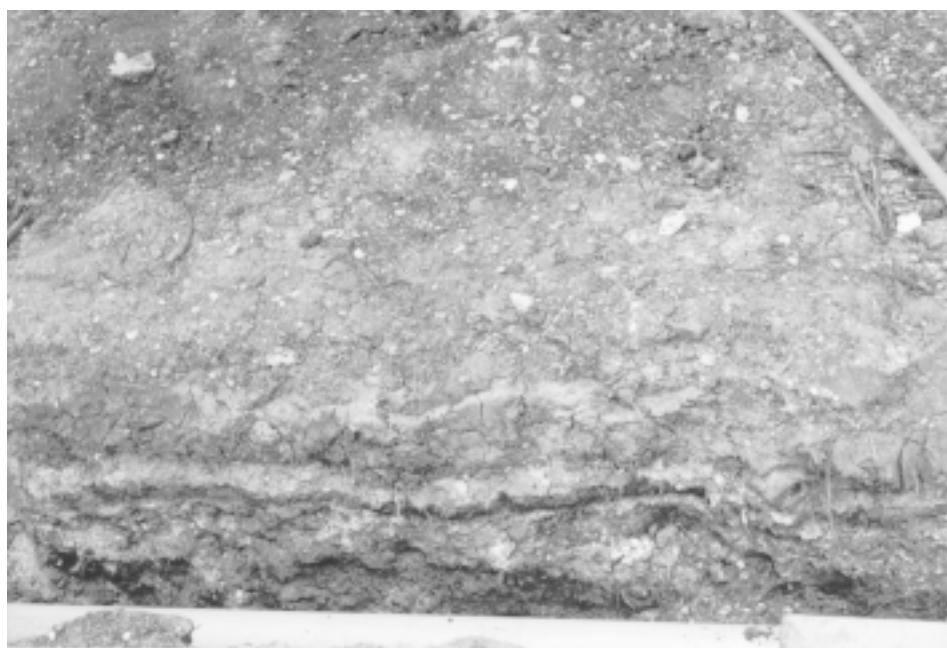
Figure 5. *Superimposed construction layers and underlying disturbed zones in Trench F.*

Although landscaping-related disturbances were not noted on the other sides of the courthouse lot, the profiles examined showed other substantial disturbances. In general, the stratigraphy noted along the northern, eastern, and western sides of the courthouse consisted of between 6–12 inches of relatively recent dark brown clay loam introduced as fill. This fill is underlain by between 2–6 inches of disturbed matrix containing chunks of concrete (i.e., old sidewalk), gravel and/or caliche fill (Figure 5), electrical conduit, piping, and other modern materials. A lens of Houston black clay, ranging from 3–7 inches in thickness is found under this disturbed zone. Close examination of the profiles on each of the three sides of the courthouse revealed no artifacts in this zone.

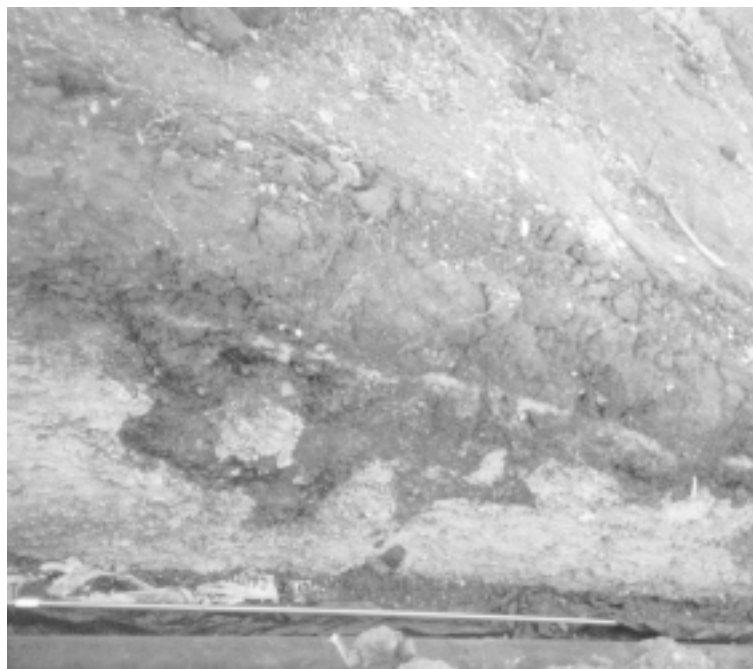
Figure 6. Close-up of fire line trench showing level of disturbance into underlying caliche.

This layer of clay sits on caliche bedrock around the entire perimeter of the lot. In some instances the apparently sterile clay zone on top of the caliche is itself dug through by the previous trenching associated with the installation of water lines (Figure 6).
