Archaeological Monitoring of Drainage Pipe Trenching in the Vicinity of the San Pedro Playhouse, San Pedro Springs Park, San Antonio, Bexar County, Texas

Alexandria N. Wadley and Steve A. Tomka

Prepared by:
Center for Archaeological Research
The University of Texas at San Antonio
One UTSA Circle
San Antonio, Texas 78249
Technical Report, No. 52

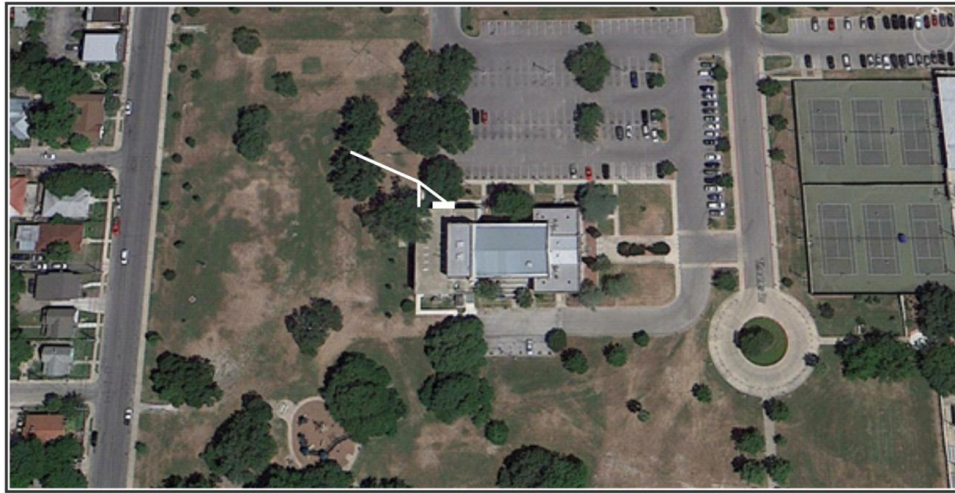
Figure 1-2. Overview of the San Pedro Playhouse with proposed drainage line installation (white line).

The Area of Potential Effect (APE) consists of planned drainage improvements along the parameters of the San Pedro Playhouse (Figure 1-2). The original gutter downspouts ran underground to the north, emptying in the parking lot of the San Pedro Playhouse. Because the subsurface downspouts frequently clogged with sediment, they were abandoned in favor of downspouts that simply ended at ground level and emptied onto the existing concrete sidewalk along the exterior walls (Figures 1-3 and 1-4). These existing downspouts were installed within the last 20 years (Bill Pennell, San Antonio Parks and Recreation, personal communication 2013).

To prevent further damage to the Playhouse, the San Antonio Parks and Recreation Department planned to improve drainage associated with three downspouts located on the northern face of the Playhouse building. Specifically, the entire existing concrete walkway extending along the northern wall between the downspouts would be demolished (Figure 1-5). Adhesive tar paper was to be placed along the 12-m wall to a depth of 1.5 m below the ground surface. Also, a 1.2-m tall concrete barrier would be constructed to further prevent water seepage. Two of the downspouts were to be connected to underground drainage pipes, which in turn would channel water to the north-northwest field and into an

existing grated drainage culvert (Figure 1-2). The underground drainage pipes were to be installed at a depth of approximately 35-41 cm below the surface (cmbs) and covered with at least 30 cm of topsoil. The total length of the underground drainage lines was estimated to be 37 m. Trenches were to be excavated by hand to ensure no damage to other utilities in the vicinity. Once the installation was completed, a new 3-m wide sidewalk would be built against the northern wall to replace the existing walkway.

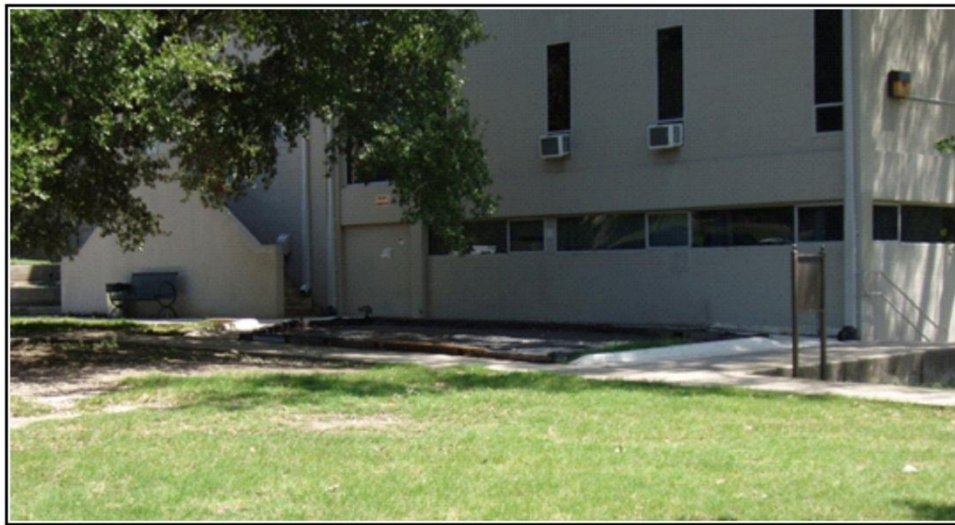
Figure 1-3. The northwest portion of the Playhouse showing the three downspouts to be redirected.

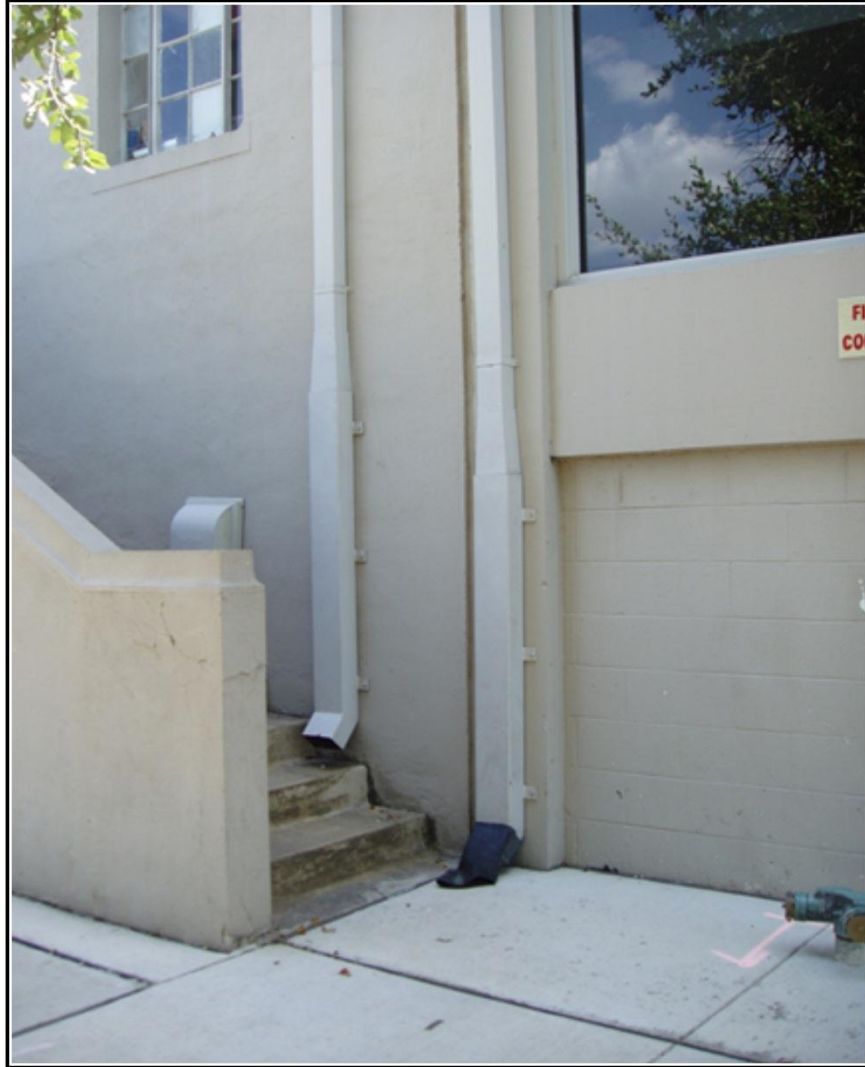
Figure 1-4. *Close-up of two downspouts at the base of the stairs.*

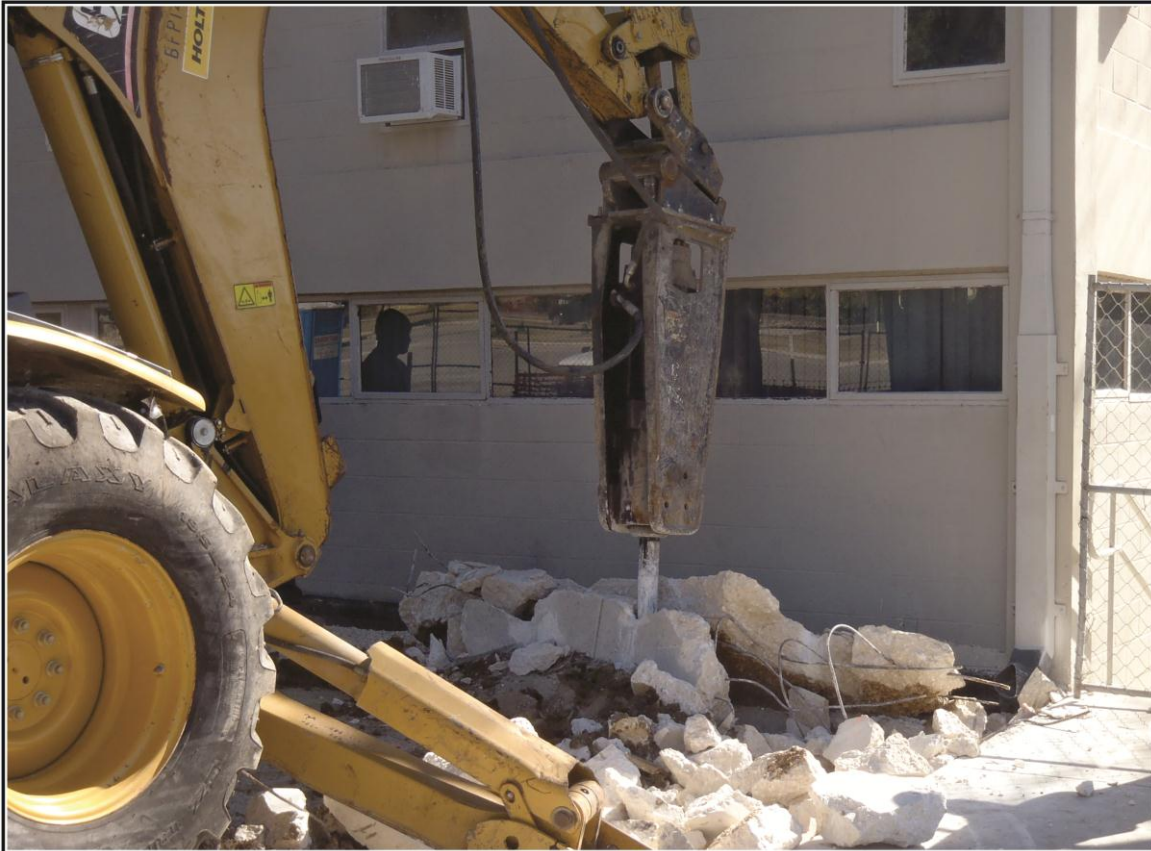
Figure 1-5. *Demolition associated with the planned drainage improvements.*

Trench 1 was excavated to allow access to the north wall of the Playhouse for water proofing (Figure 4-1). Prior to any excavations, the existing concrete sidewalk was removed (Figure 1-5). The sidewalk along the north wall measured approximately 12 m in length and 2.4 m in width. It was demolished with a backhoe-mounted jackhammer. Trench 1 was parallel to the north wall of the Playhouse.

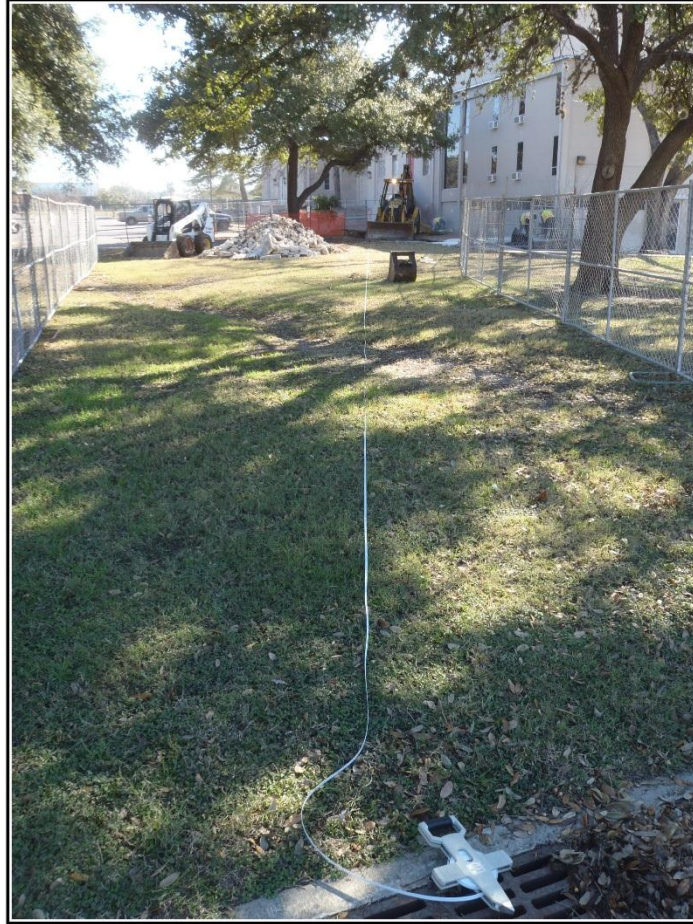
Figure 4-2. *Overview of the project area from drainage culvert to the Playhouse.*

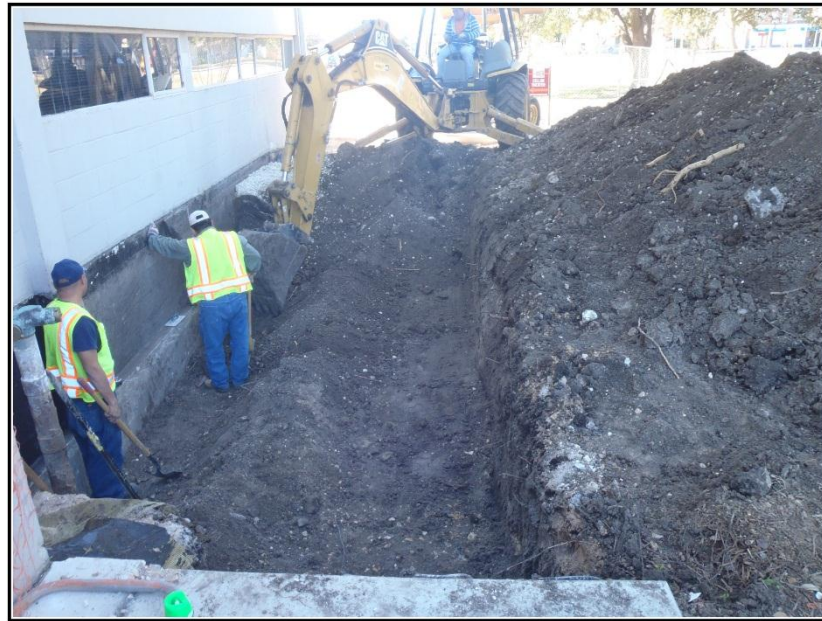
Figure 4-3. *Trench 1 being excavated by backhoe and shovels.*

The original project schematics called for two trenches. One trench would allow access to the north wall of the Playhouse to install the moisture barrier on the face of the wall, and second would be for the installation of a moisture barrier wall in front of the Playhouse wall. Once the excavations began, the construction contractor revised the plans and excavated a single 3-m wide trench along the wall. The trench was 1.5-m deep over the first 2.4 m from the base of the wall. Over the next 0.6 m, the trench was only 1.2-m deep (Figure 4-3). A backhoe and shovels were used in the excavation process.

The soils in Trench 1 were disturbed as a result of previous construction activities adjacent to the base of the foundation. The stratigraphy consisted of a 13-cm thick caliche and gravel layer beneath the sidewalk and a light tan soil below the gravel layer averaging 15 cm in depth. Directly below the light tan soil was a dark brown, silty clay fill that continued to the base of the excavations.

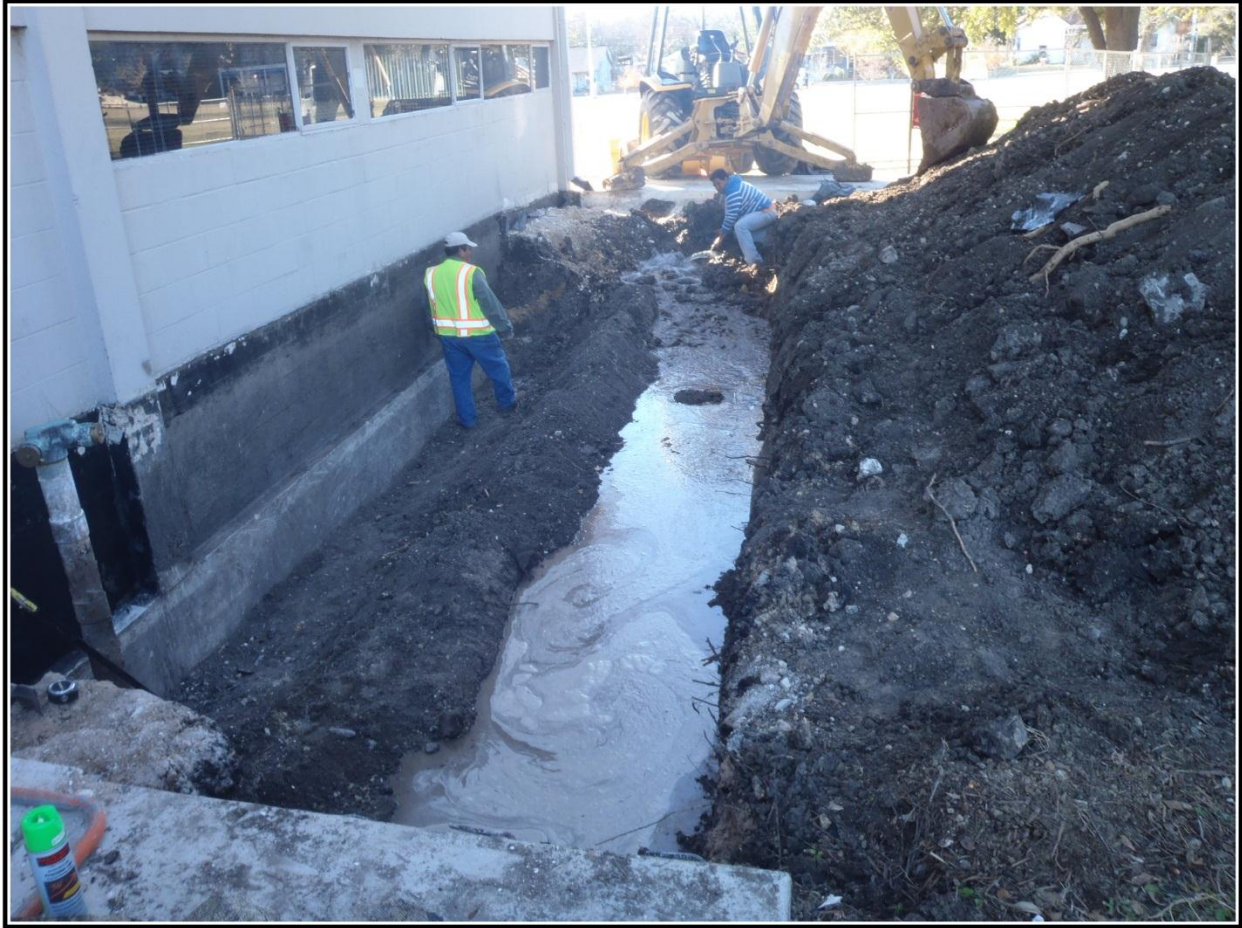
Figure 4-4. Trench 1 flooded along the 1.2-m deep side.

During the excavation of Trench 1, a PVC main waterline that connected to the Playhouse was damaged, flooding a portion of Trench 1 (Figure 4-4). The repair of the pipe necessitated additional excavations that were monitored by CAR staff. No artifacts were noted during the excavations around the broken PVC pipe.

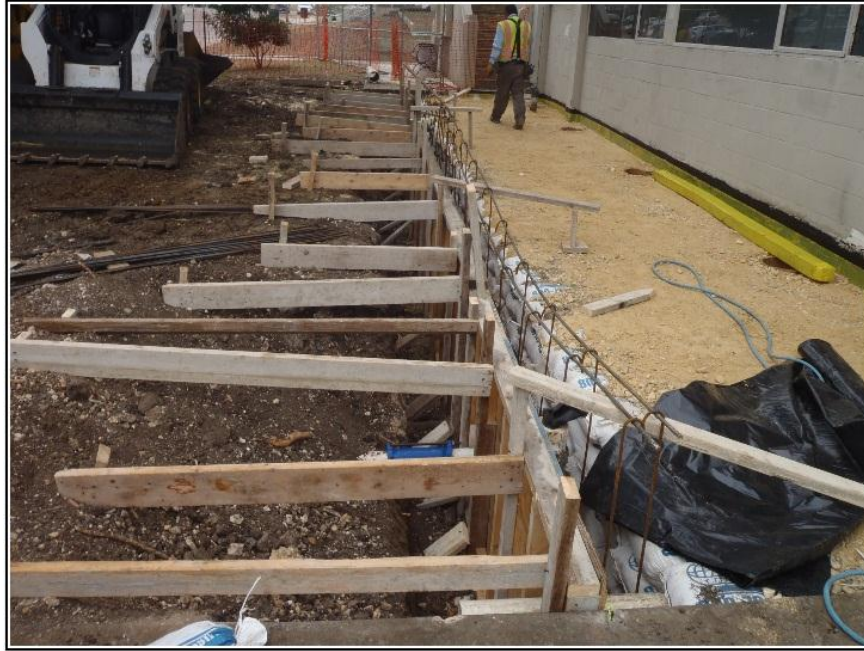
Figure 4-5. Stacked sand bags against the north wall of the Playhouse.

Following the repairs, the north wall was covered with adhesive tar paper, and a row of sand bags was stacked against the northern portion of the trench. Reinforced rebar was placed along the trench, while the spaces between the stacked sandbags and the base of the wall was filled with matrix originally removed from the trench. The fill extended to approximately 41 cm from the eventual height of the sidewalk. At this point, the PVC drainage pipes connecting to the downspouts were positioned on top of the fill and secured in place with additional sandbags near the edge of the trench. Next, a layer of crushed limestone gravel was placed on top of the pipes (Figure 4-5). The two drainage lines were to intersect some 11 m from the base of the wall and to continue as a single line toward the culvert west of the building.

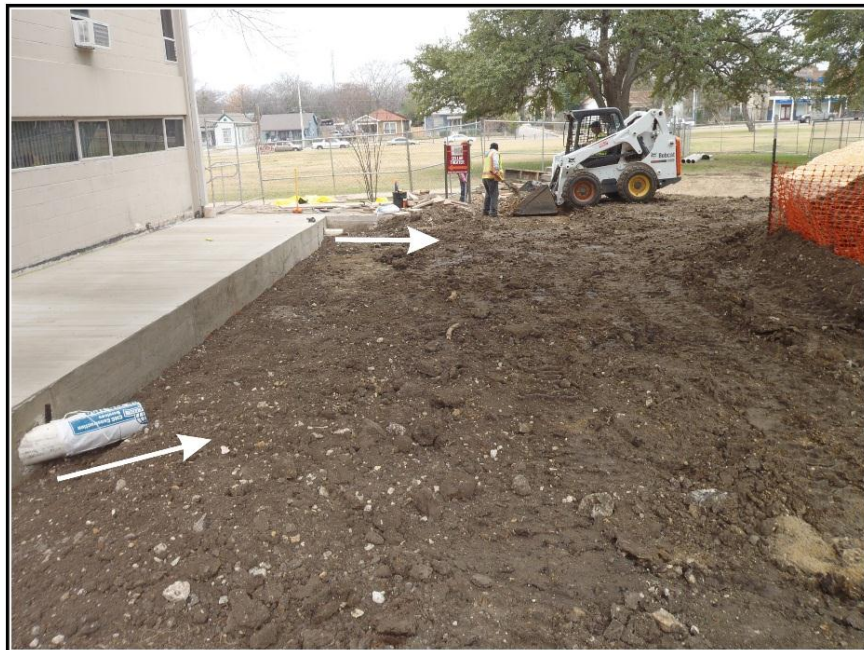
Figure 4-6. New sidewalk against north wall of Playhouse. Note drainage pipes extending from sidewalk.

Next, concrete was poured on top of the bags and fill, and the concrete was held in place by a temporary form placed along the north edge of the trench. The top of the concrete layer was to serve as the new sidewalk along the north wall of the Playhouse. The layer of concrete was approximately 46-cm thick and reached to the top of the moisture barrier installed on the north wall of the structure (Figure 4-6).

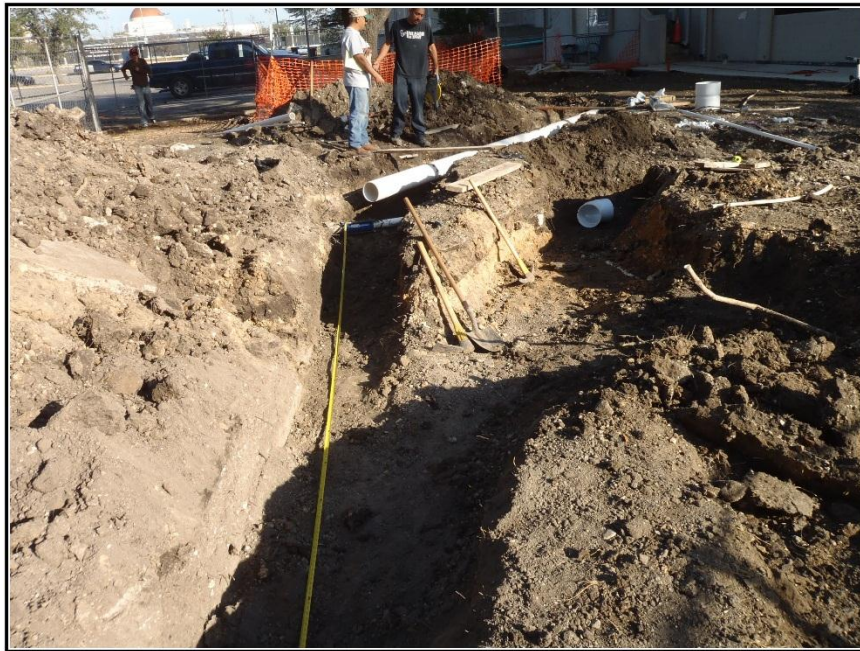
Figure 4-7. *Intersection of Trench 2 (on the left) and Trench 3 (on the right).*

Trench 2 was intended to house the extension of the PVC pipe emanating from the concrete sidewalk adjacent to the stairs near the eastern edge of the project area (Figure 4-1). Trench 3 was to house the extension of the PVC pipe connecting from the sidewalk at the northwest corner of the structure (Figure 4-1). Both trenches were approximately 61 cm in width and 46-66 cm in depth. Trench 2 extended northwest at a 45 degree angle for a distance of 12 m from the concrete sidewalk. Trench 3 extended 6 m north, beyond the edge of the new sidewalk away from the Playhouse. Eleven meters away from the building, Trench 2 and Trench 3 intersected (Figure 4-7). The drainage line in Trench 2 continued for another 31 m past this intersection to the culvert northwest of the Playhouse.

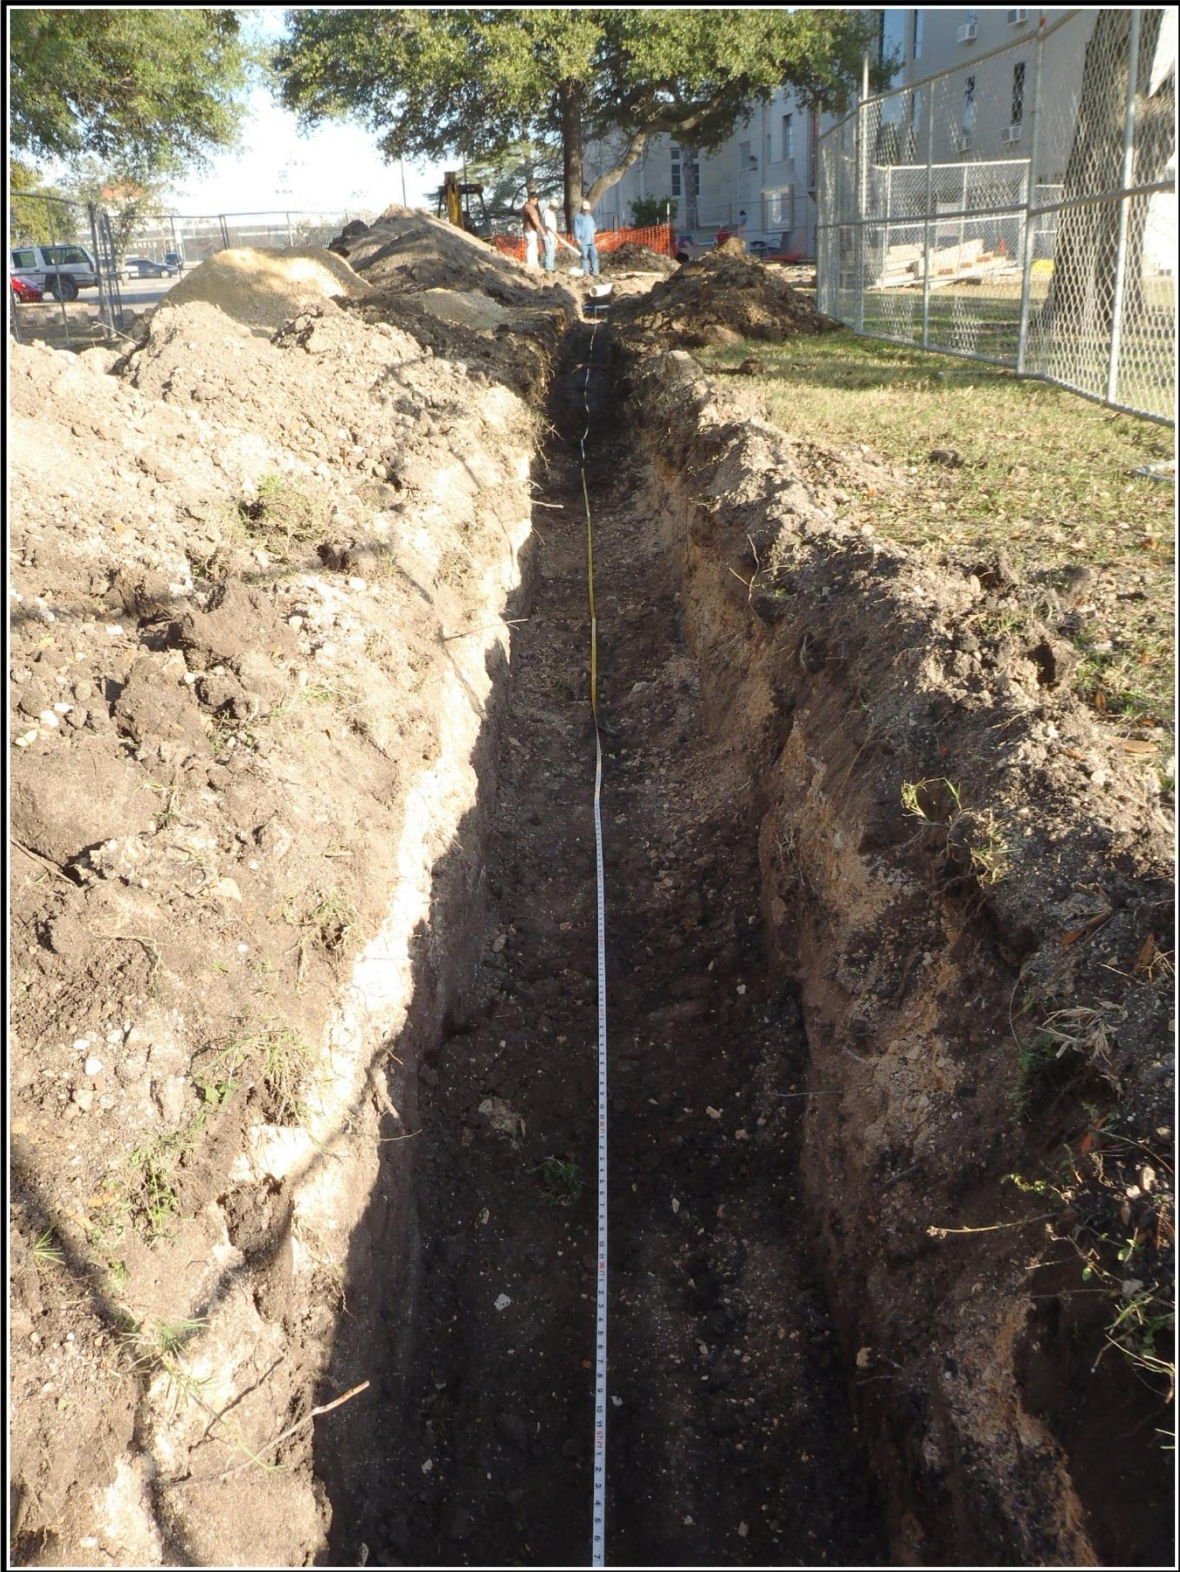
Figure 4-8. Trench 2 complete (facing east). View from grated drainage gutter towards the Playhouse.

The excavations of the two trenches that started at the edge of the newly laid sidewalk and continued to the pipe intersections were not monitored since these areas had been previously disturbed. Beginning at the intersection of the two trenches to the culvert, the excavation of the trench was monitored by CAR staff. The stratigraphy revealed in the trench wall consisted of a 6-cm thick layer of dark brown, silty clay top soil (Figure 4-8). Below this layer was a 30-cm thick zone of mixed orange sand, crushed limestone gravels, and light tan, silty soil. At 40 cmbs was a homogeneous, 8-cm thick caliche layer throughout the trench. Beneath the caliche layer at 43 cmbs a brown, silty soil continued to the base of the trench (70 cmbs).

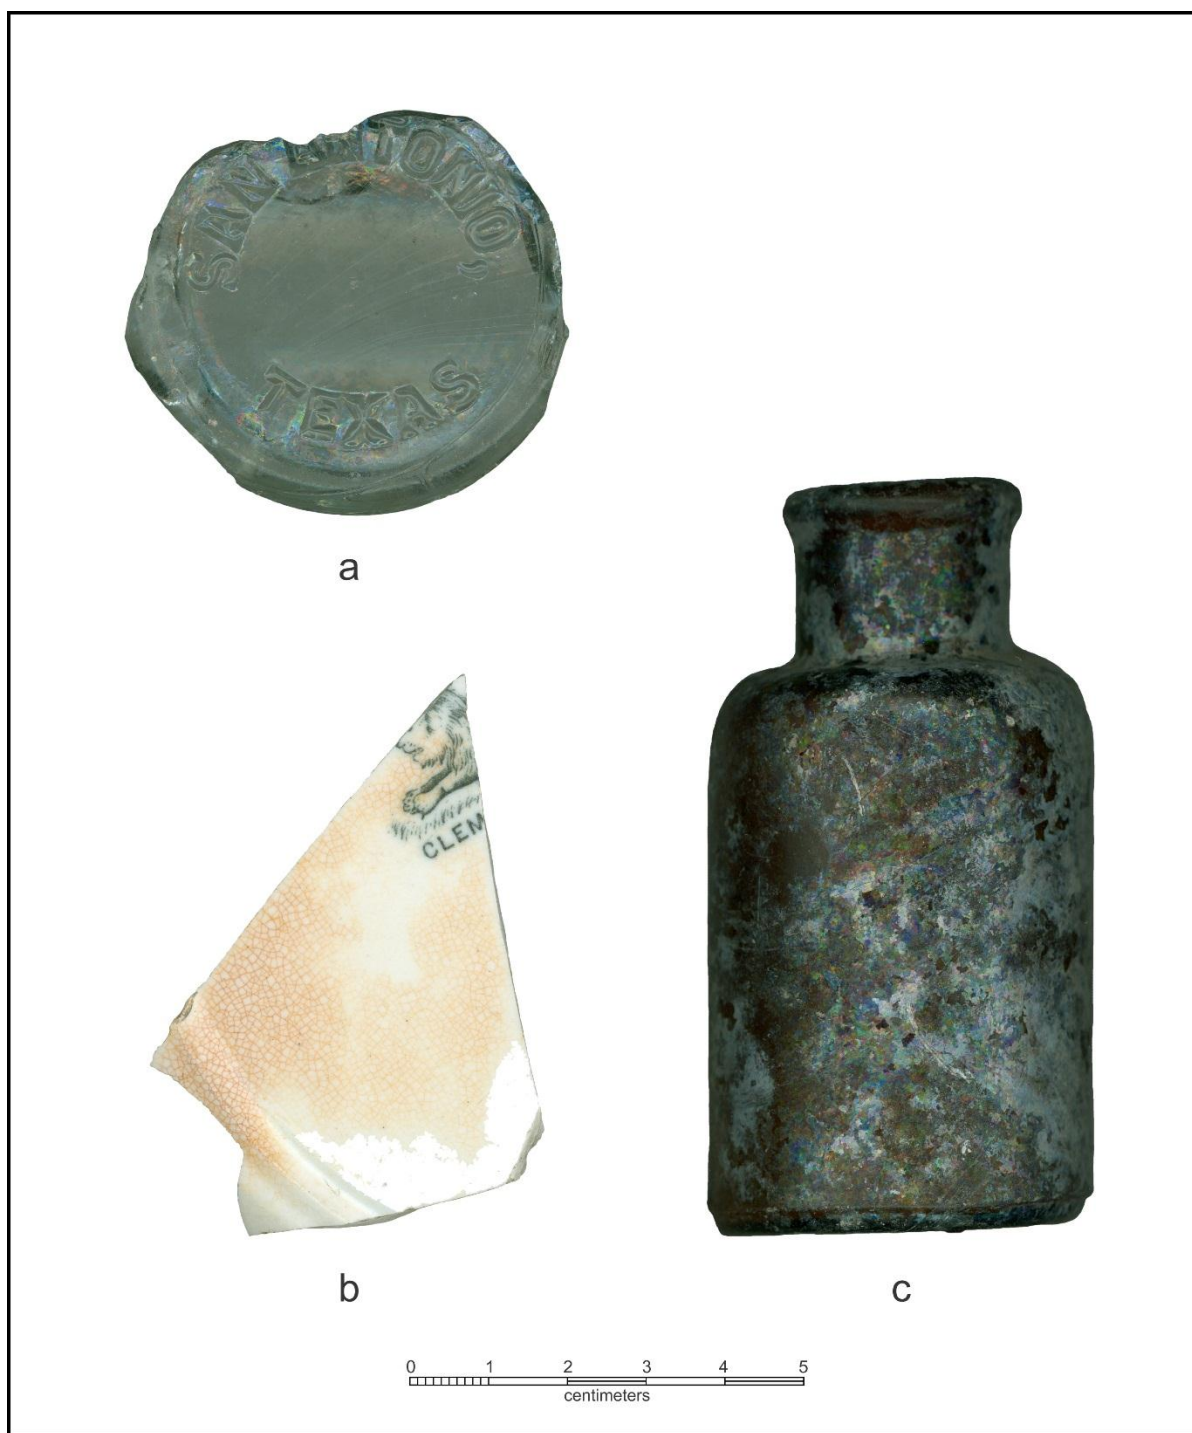
Figure 5-1. *Selected diagnostic artifacts. a.) "San Antonio, Texas" clear bottle base; b.) Ironstone ceramic with makers mark, "CLEM" with left-facing lion; c.) "Bixby" amber colored bottle circa 1890.*

A clear bottle base, 5.6 cm in diameter, was recovered. Circling the base is embossed writing, “San Antonio, Texas” (Figure 5-1a) indicating that it was locally produced. A small portion of the body of the bottle that is still intact shows a mold seam. Machine-made bottles frequently have embossing on the base. The base was molded onto the body of the bottle. The clear color and the narrow diameter indicate that it was most likely a soda bottle. Improved chemical and glass making techniques in the late nineteenth century and early twentieth century made it possible to make clear glass without imperfections, resulting in a completely clear bottle (Munsey 1970).

One piece of undecorated white ironstone ceramic also was recovered. The fragment displays a partial maker’s mark with letters “CLEM...” and a left-facing lion (Figure 5-1b). To date, research by the CAR staff has not been able to identify this specific maker’s mark.

A complete, amber colored bottle was found in Trench 2 (Figure 5-1c). The bottle has embossed lettering on the base that reads “BiXby 12”. Further research shows that this bottle originated circa 1890 and was a shoe polish ink container. The bottle was manufactured in New York State. The bottle shows a molded line along the side of the body. The mold seam ends at the shoulder portion of the bottle. The bottle neck and lip are uniform, but no mold seam is present. This may be due to the use of a lipping tool. These characteristics suggest the use of a three-piece mold. The three-piece mold was used before machine manufacturing in the nineteenth century (Kendrick 1966).
