TESTING FOR THE LOCATION OF THE ALAMO ACEQUIA (41 BX 8) AT HEMISFAIR PLAZA, SAN ANTONIO, TEXAS

Center for Archaeological Research The University of Texas at San Antonio Archaeological Survey Report, No. 142

Texas Antiquities Committee Permit No. 396 Thomas R. Hester, Principal Investigator

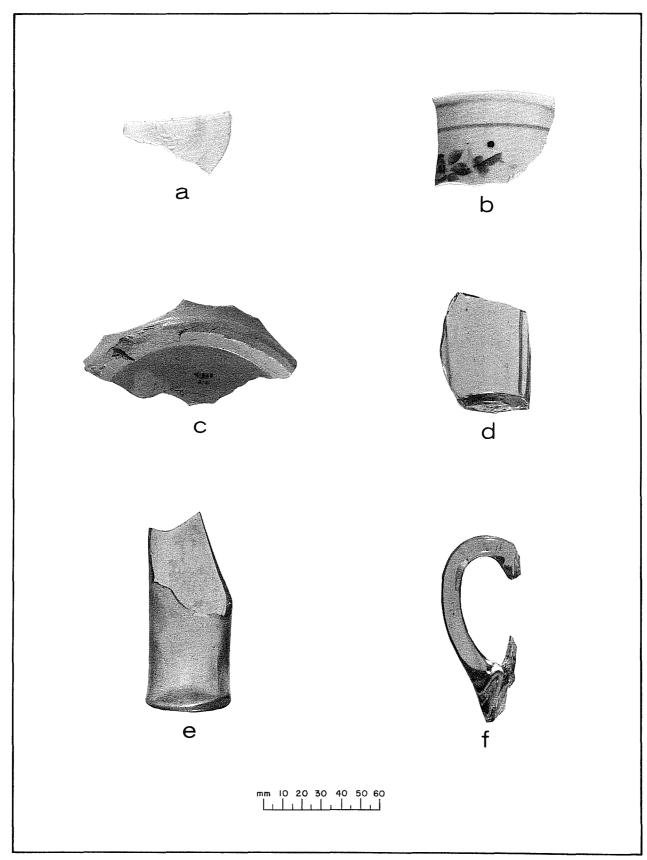
Figure 5. Sample of Artifacts Recovered. a, fragment of white glass jar lid liner; b, hand-painted porcelain cup or mug sherd; c, yellow ware mixing bowl sherd; d, green, ribbed tumbler fragment; e, hand-blown aqua bottle fragment; f, lavender glass mug handle.

Quantity	Item	Description
1 1 1 1 1 2	undecorated porcelain white glass clear glass lavender glass flat glass white glass button clay tile, yellow tan	indeterminate jar lid liner, "YORK" (Fig. 5,a) cylindrical bottle mug handle (Fig. 5,f) window pane 2-hole, 5/8-inch flat paving tile

Quantity	Item	Description
2	undecorated white	
-	earthenware	plates
1	gold-banded white	·
	earthenware	plate/saucer
6	undecorated ironstone	plate, cup, pitcher
1	undecorated white porcelain	saucer
1	hand-painted porcelain	cup/mug, aqua band, green and rose (Fig. 5,b)
1	yellow ware	mixing bowl (Fig. 5,c)
