Hemisfair Park Area Redevelopment Corporation (HPARC) P3 Project: Testing and Monitoring for the Acequia Lofts Site Development, San Antonio, Bexar County, Texas

Texas Antiquities Permit No. 7852

Prepared by:
Center for Archaeological Research
The University of Texas at San Antonio
One UTSA Circle
San Antonio, Texas 78249-1644
Archaeological Report, No. 464

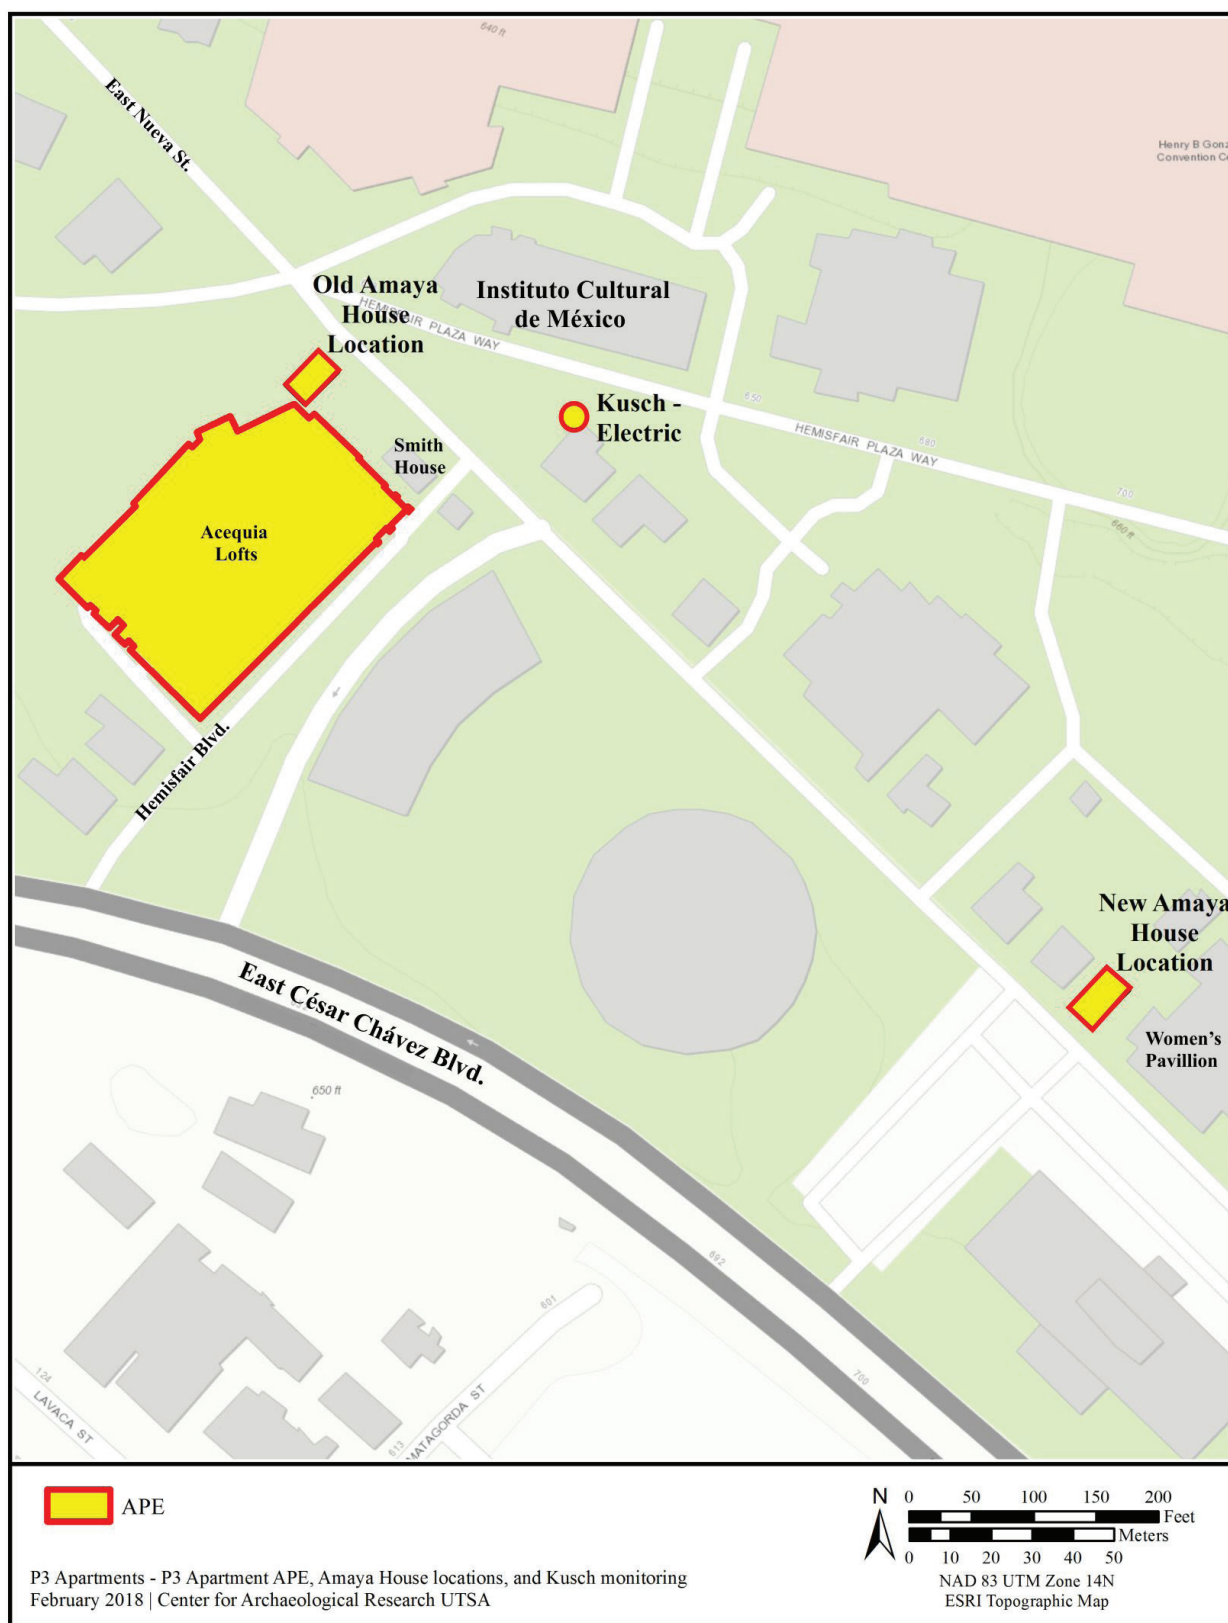
Figure 1-1. Project APE: Acequia Lofts, Old Amaya House location, Kusch House, and New Amaya House location.

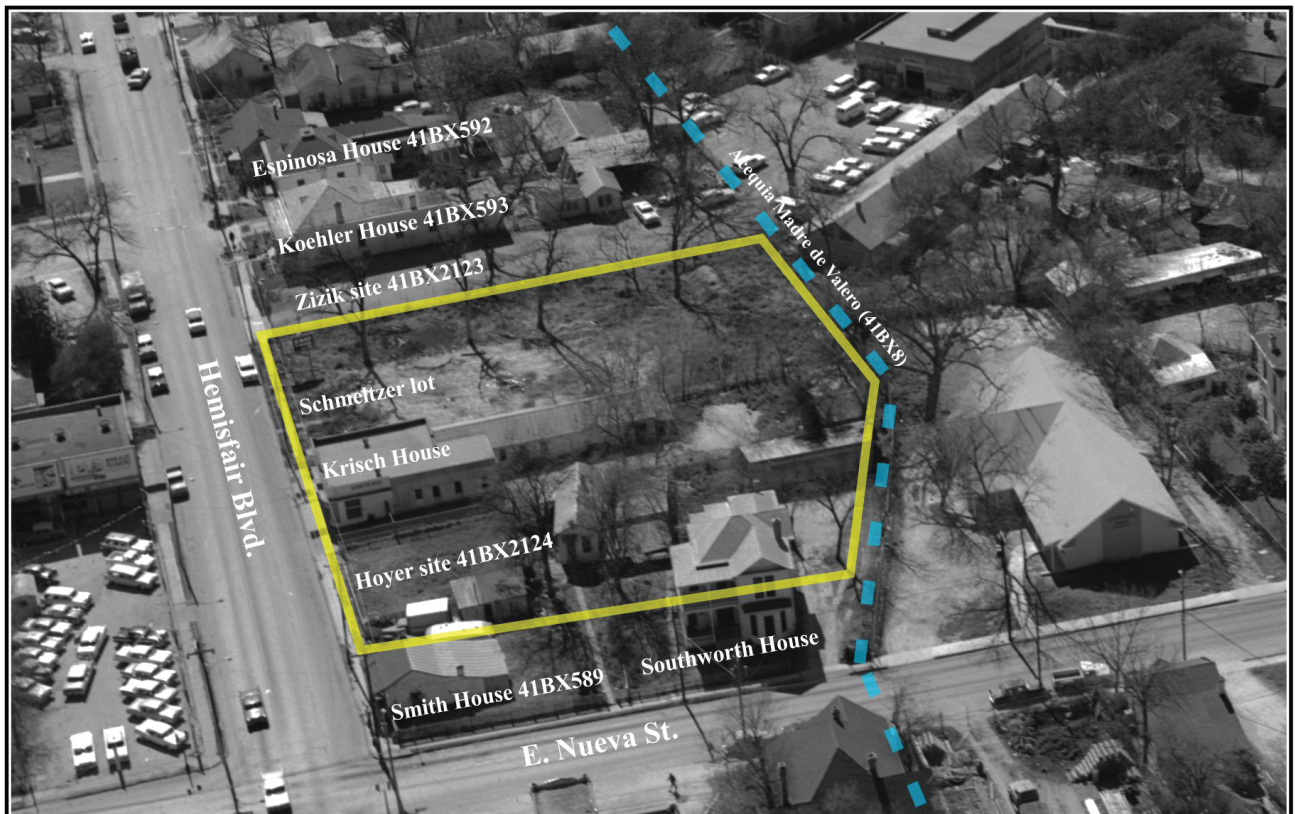
Figure 3-1. Acequia Lofts APE approximation outlined in yellow; course of the acequia outlined in blue dashed line (c.1965 aerial – view south; courtesy of UTSA Institute of Texan Cultures [ITC], H-0746-0348).

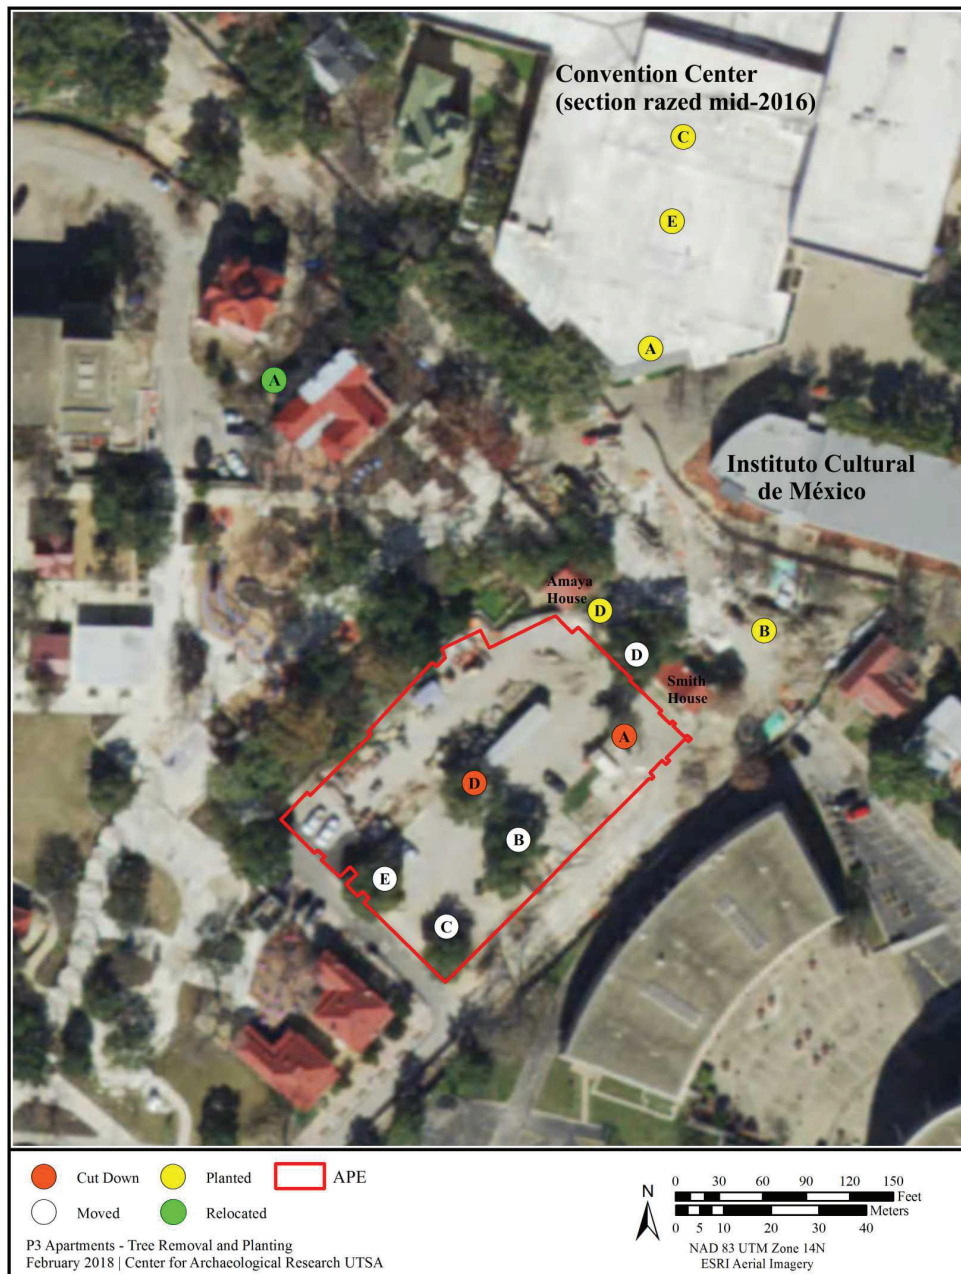
Figure 4-1. Final tree transplantation configuration; note change in Tree A replacement and relocation area, and Tree D replacement tree. Satellite image used for this figure, still shows a convention center building (razed in mid-2016) where Trees A, C, and E were planted.

Trees A and D were not moved, due to the roots being entangled in wall footings (large limestone blocks), and both were consequently cut down. A new tree was donated to replace Tree A, and the oak tree directly behind the Smith House replaced Tree D (Figure 4-1).

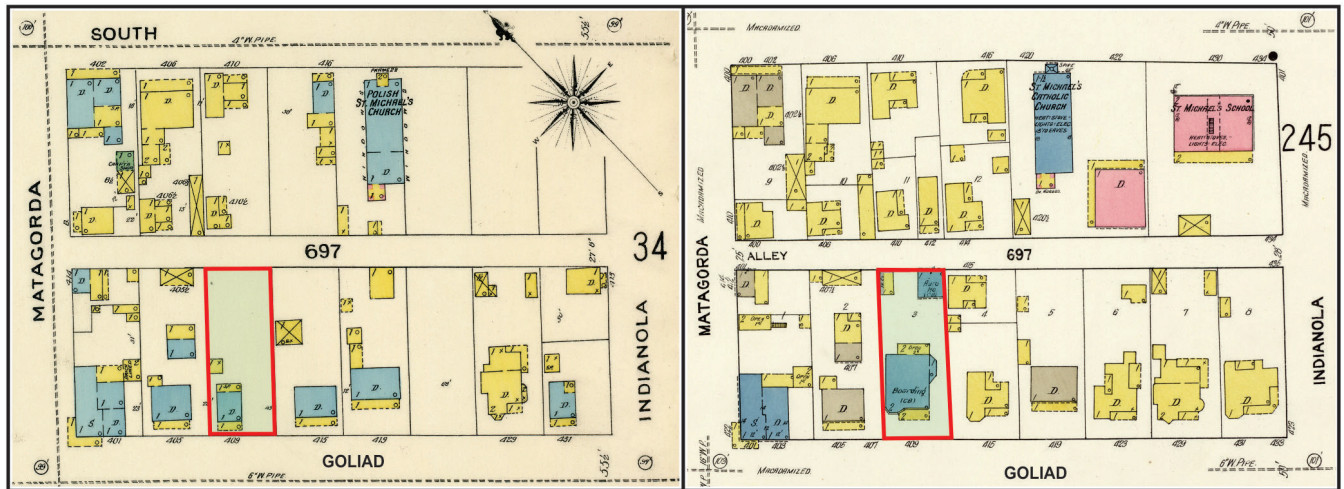
Figure 4-2. Comparison of Lot 3, 409 Goliad Street (box outlined in red), as depicted on the 1896 Sanborn Map (left, cropped) and the 1912 Sanborn Map (right, cropped; 1896 Sanborn Map, Sheet 29, and 1912, Volume 3, Sheet 243; Perry-Castañeda Library Map Collection, The University of Texas at Austin).

In comparing the 1896 and 1912 Sanborn Maps, it was noted that the earlier map showed a rectangular floor plan of a one-story, stone cottage. The 1912 Sanborn Map showed a large rectangular floor plan with a distinct bay window outlined on the left front of a two-story, concrete-block house (see Figure 4-2).

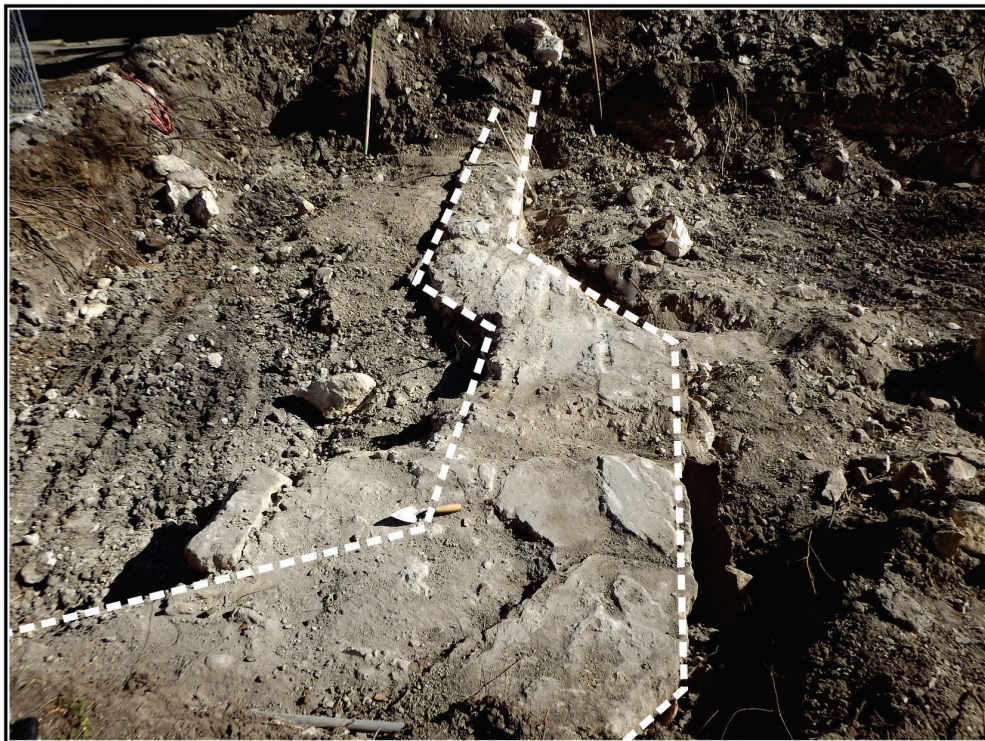
Figure 4-3. Exposed wall footing revealing bay window outline (view east).

At the north end of the APE, the first day of monitoring resulted in the location of wall footings with a north-south orientation. An assortment of bottle glass shards, unidentifiable metal, and whiteware sherds were observed in the excavated soils. These artifacts were noted, but nothing was collected. On the second day of monitoring, mechanical excavation moved to the south end of the APE to the front, or street side, of the property. Excavation in this area continued to expose limestone-block wall footings and included an east-

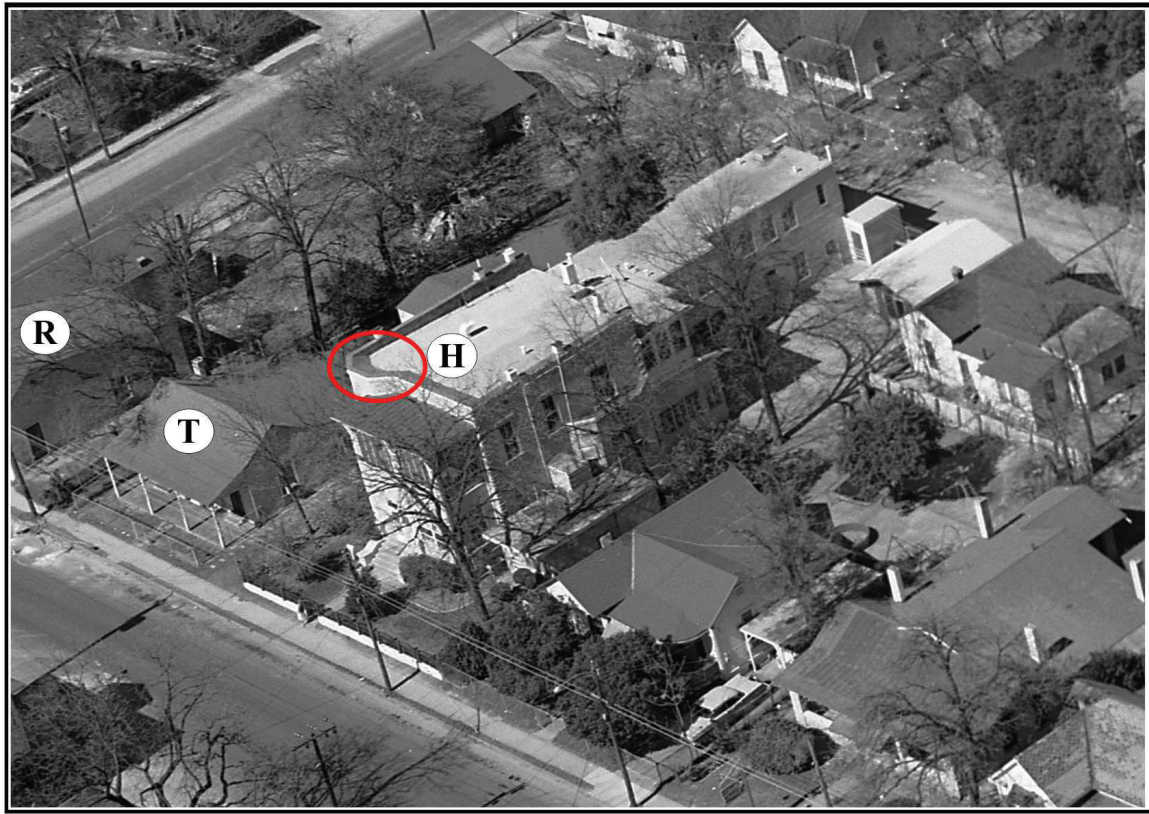
Figure 4-5. Aerial view of the H: Holmgreen House, T: Tynan House (41BX582), and R: Richter House (41BX581). Note distinctive bay window front (red outline) on the Holmgreen House (courtesy of UTSA ITC photo collection, H-0746-0361).

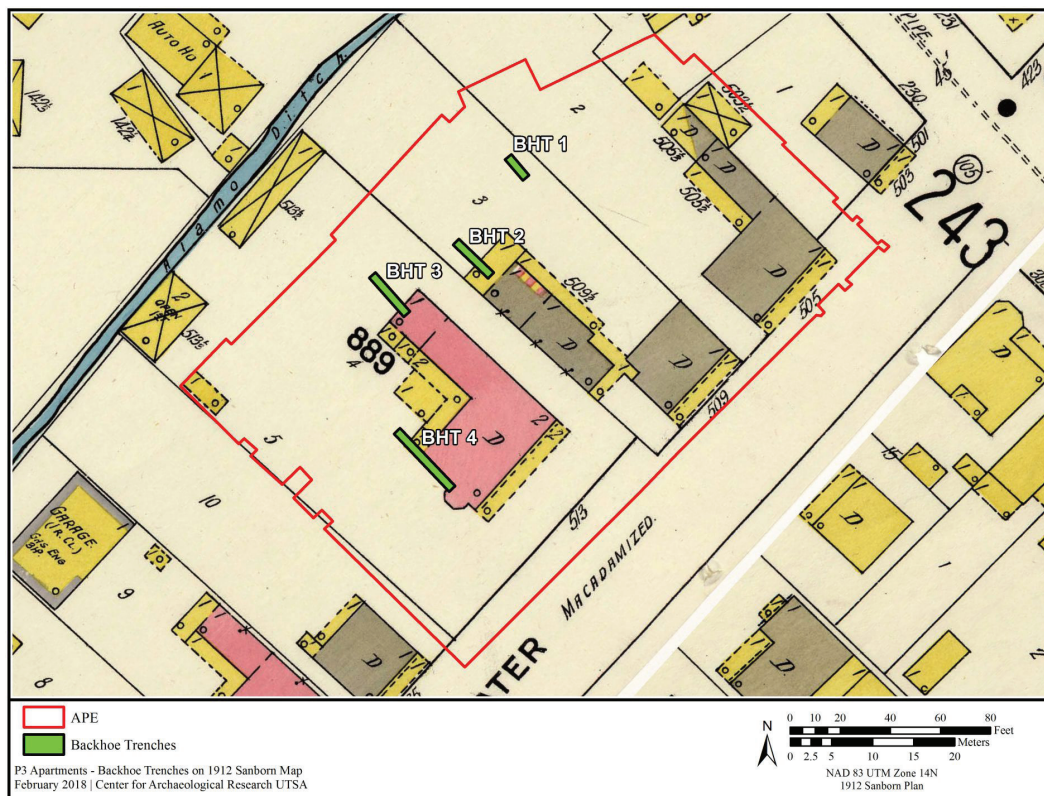
Figure 4-6. 1912 Sanborn Map (cropped) showing the Acequia Lofts construction footprint and BHTs (Volume 3, Sheet 243; Perry-Castañeda Library Map Collection, The University of Texas at Austin).

was then produced, which was used to locate the placement of the BHTs and served as an on-site reference (Figure 4-6). The first two trenches (BHTs 1 and 2) were placed on Lot 3, NCB 889, in an effort to located features associated with the caliche-block house at 509 Water Street. The next two trenches (BHTs 3 and 4) were placed on Lot 4, NCB 889, in an effort to located features associated with the brick-house at 513 Water Street. The final trench (BHT 5) was supposed to be placed at the rear of Lot 5, NCB 889, over an outbuilding shown on the 1912 Sanborn Map. However, the planned location of BHT 5 was in an area that had already been improved, so only four BHTs were excavated.

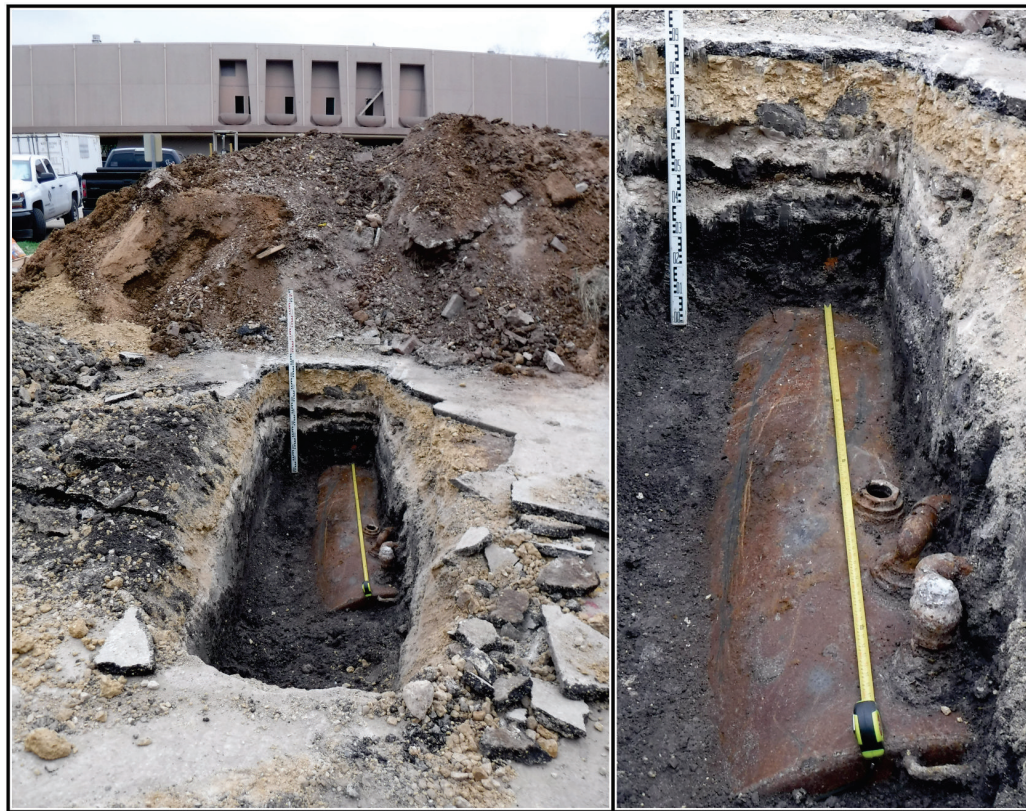
Figure 4-7. Feature 1, fuel tank; close-up at right (view east).

Backhoe Trench 1 was 1.1-m (3.6-ft.) wide, 4-m (13.1-ft.) long, and 0.9-m (2.9-ft.) deep. Excavation of BHT 1 was shallow, as a result of having encountered a fuel storage tank. Although rusty, the storage tank appeared to be intact and in good condition (Figure 4-7). After having probed inside the storage tank through an inlet, CAR staff determined that the fuel storage tank, designated Feature 1, was empty and that there were no toxic smells emitting from the tank (see Figure 4-7). Aside from errant construction debris, no other cultural material was noted.

Based on the GPS data collected on site, Feature 1 was located at 509 Water Street. On November 1, 1945, the City granted the petition of Humble Oil to install a gasoline tank at 509 Water Street (CCM1945:520-521). Schmidt Electric Company was doing business out of 509 Water Street (Ord. 9701; CCM 1949). After consulting with HPARC and 1968 HemisFair LP, it was decided to mark and backfill the feature so that a qualified hazardous material contractor could remove the storage tank during site preparation work scheduled for August 2017. Even though the trench was shallow, CAR staff identified six distinct layers of soil (Table 4-1). It is likely that the fill identified as Strata 3, 4, and 5 relate to the installation of the storage tank.

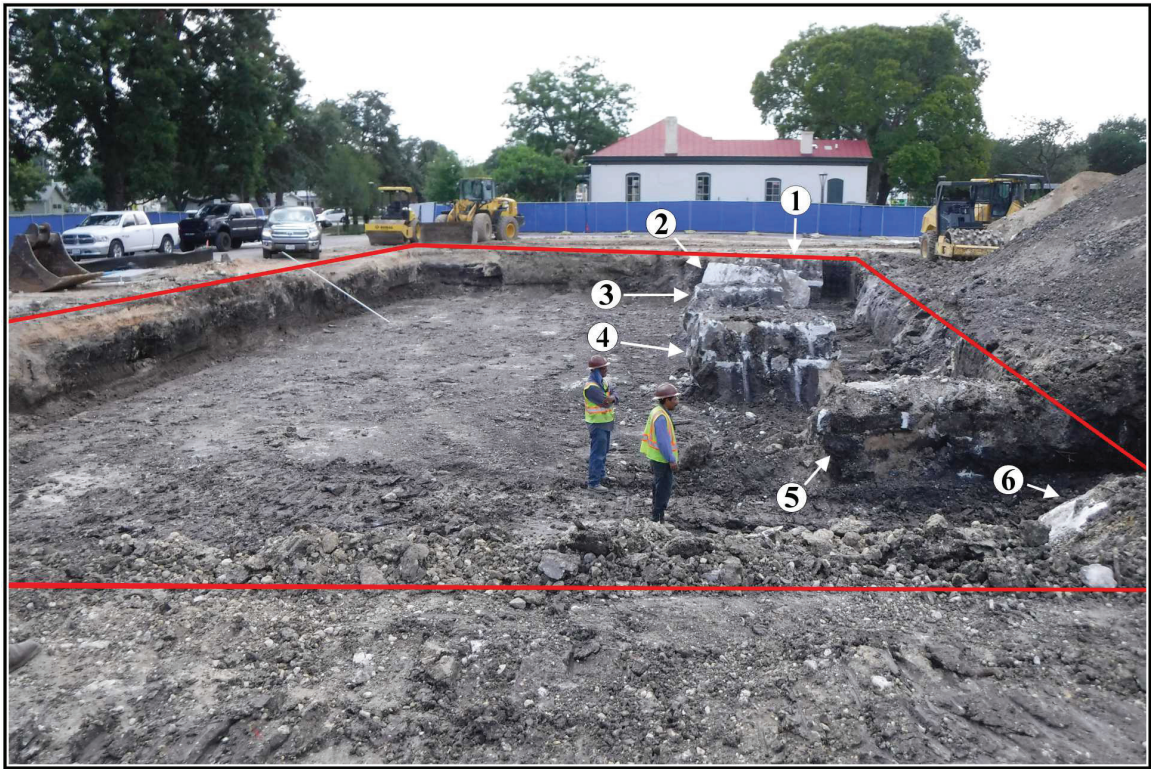
Figure 4-8. Excavated pit, outlined in red; note series of six concrete support piers. Koehler House (41BX592) in background, (view south).
