Archaeological Monitoring for the Buena Vista Corridor Project, San Antonio, Bexar County, Texas

Texas Antiquities Permit No. 8950

Prepared by:
Center for Archaeological Research
The University of Texas at San Antonio
One UTSA Circle
San Antonio, Texas 78249
Archaeological Report, No. 483

© January 2021

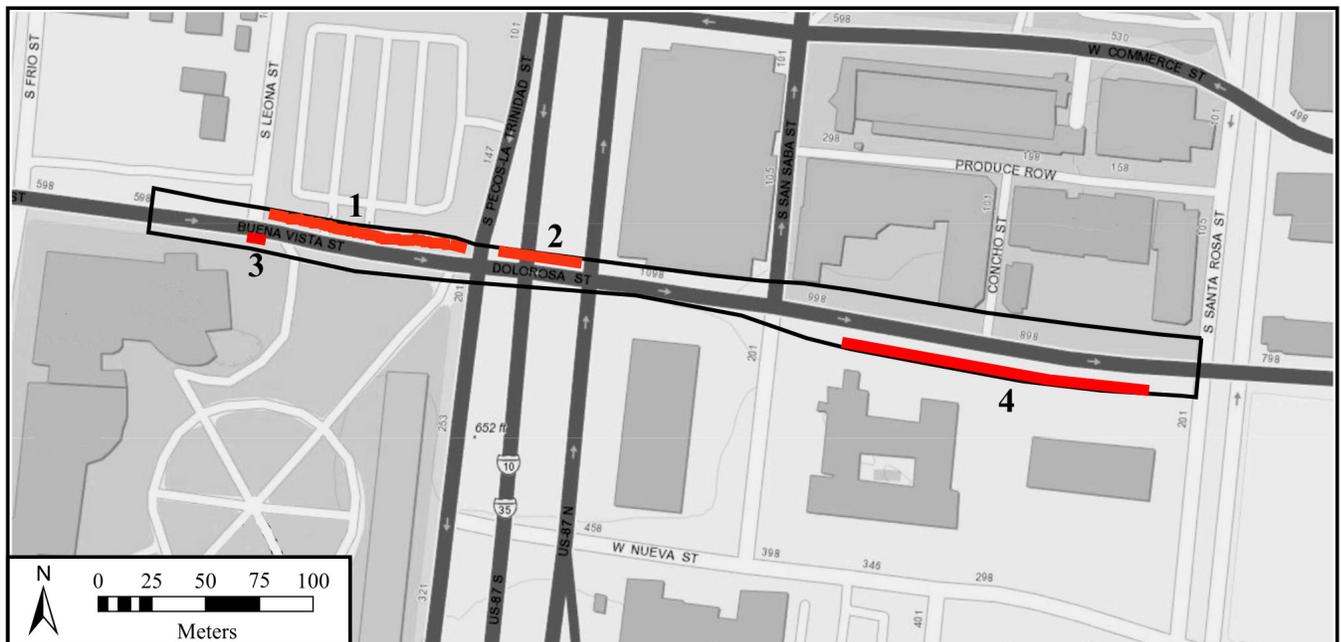
Figure 6-1. Trench locations excavated in the BV Corridor project. Trench numbers are keyed to date of excavation.

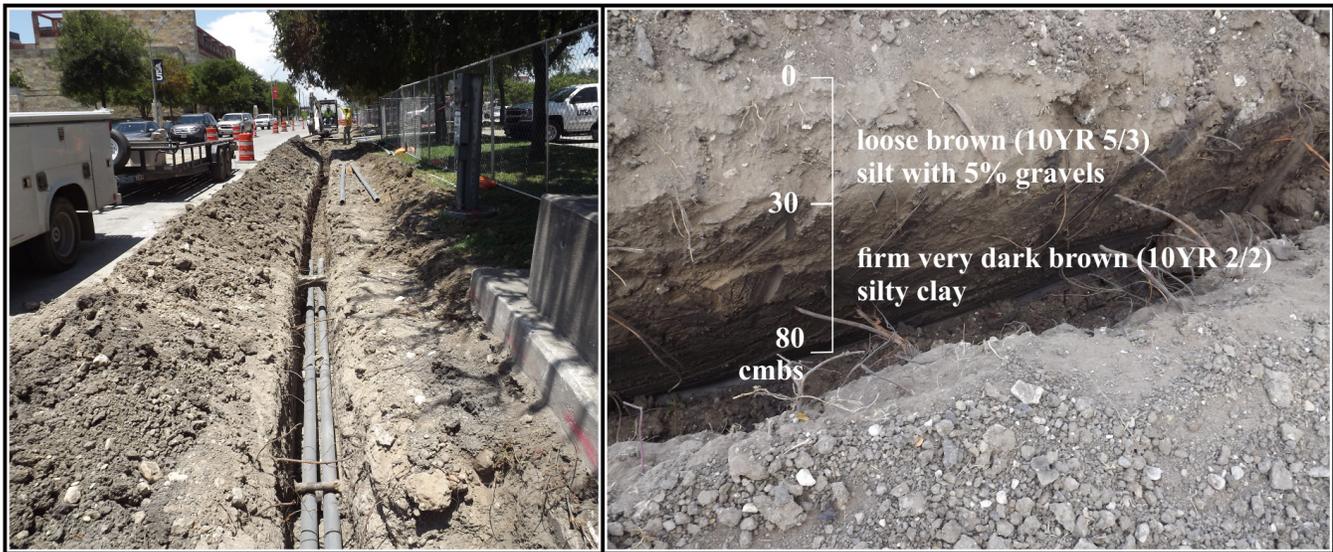
very dark (10YR 2/2) brown to black (10YR 2/1) silty clays. The trench revealed numerous utilities running north to south that serviced the former building(s) in the current UTSA parking lot. Fragments of red brick and non-diagnostic clear glass were observed in the trench backfill.

Figure 6-2. Trench 1 excavated on the north side of Buena Vista Street (left). Profile of the southern trench wall (right).

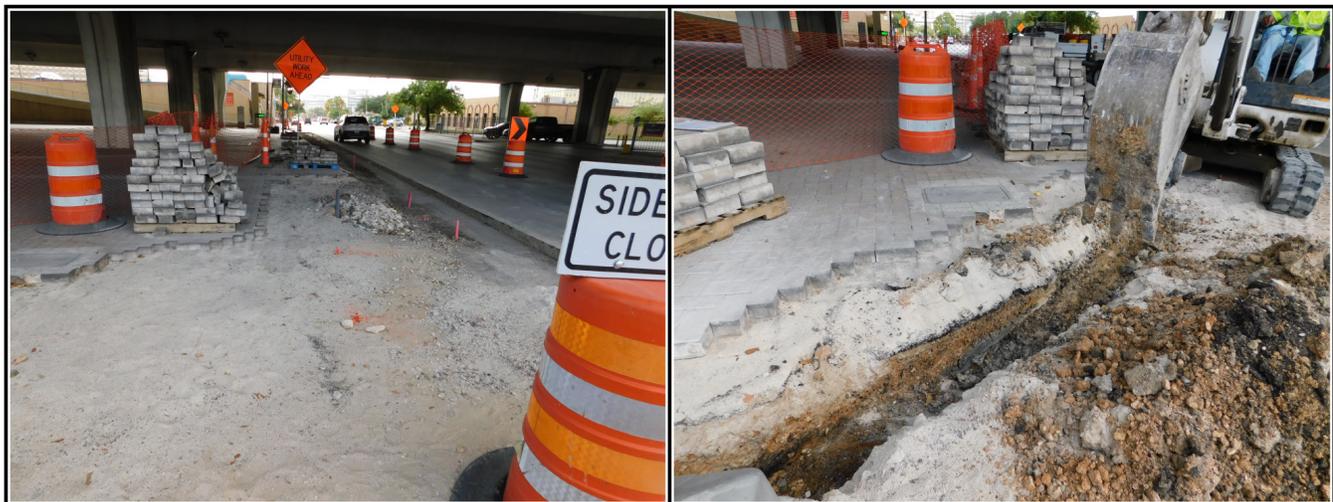
Trench 2 was excavated on the north side of Dolorosa Street under the Pan Am Expressway overpass to the Framers Market Building entrance on August 21 and September 9, 2019 (Figure 6-3, left). The trench was excavated to connect existing utilities from Buena Vista and Dolorosa streets. The trench were 37 m (121.3 ft.) long, 50 cm (19.6 in.) wide, and 30 cm (11.8 in.) deep. The trench matrix consisted of construction fill with the bottom 5 cm (1.9 in.) revealing a dark brown clay (Figure 6-3, right). No artifacts or features were observed in the profiles or backfill.

Figure 6-3. The image on the left shows the layout of the trench under the Pan Am Expressway. The image on the right shows the profile of the northern trench wall.

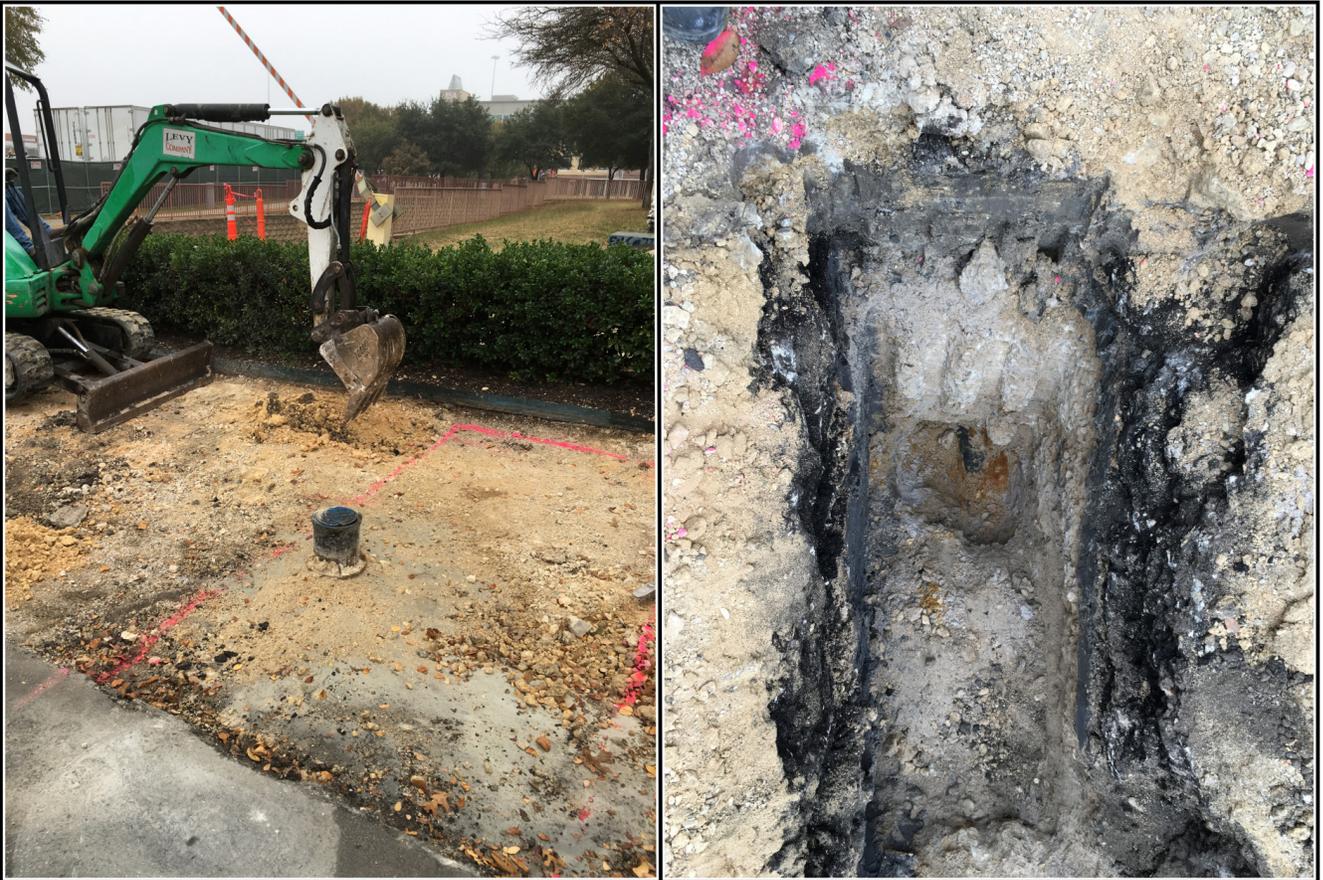
Trench 3 for a crossing walk signal was excavated on December 5, 2019, on the south portion of Buena Vista Street across from its intersection with S. Leona Street (Figure 6-4). The trench measured 3 m (9.8 ft.) long, 70 cm (27.5 in.) wide, and 1.82 m (5.9 ft.) deep. The trench contained asphalt to 60.9 cm (24 in.) below the grade followed by flowable fill. A cast iron pipe was found at 1.82 m (5.9 ft.) deep. No artifacts or features were observed in the profiles or backfill.

Figure 6-4. Excavation of Trench 3 on the south side of Buena Vista and S. Leona streets (left). The right image shows the trench with asphalt and flowable fill over an existing cast iron pipe.

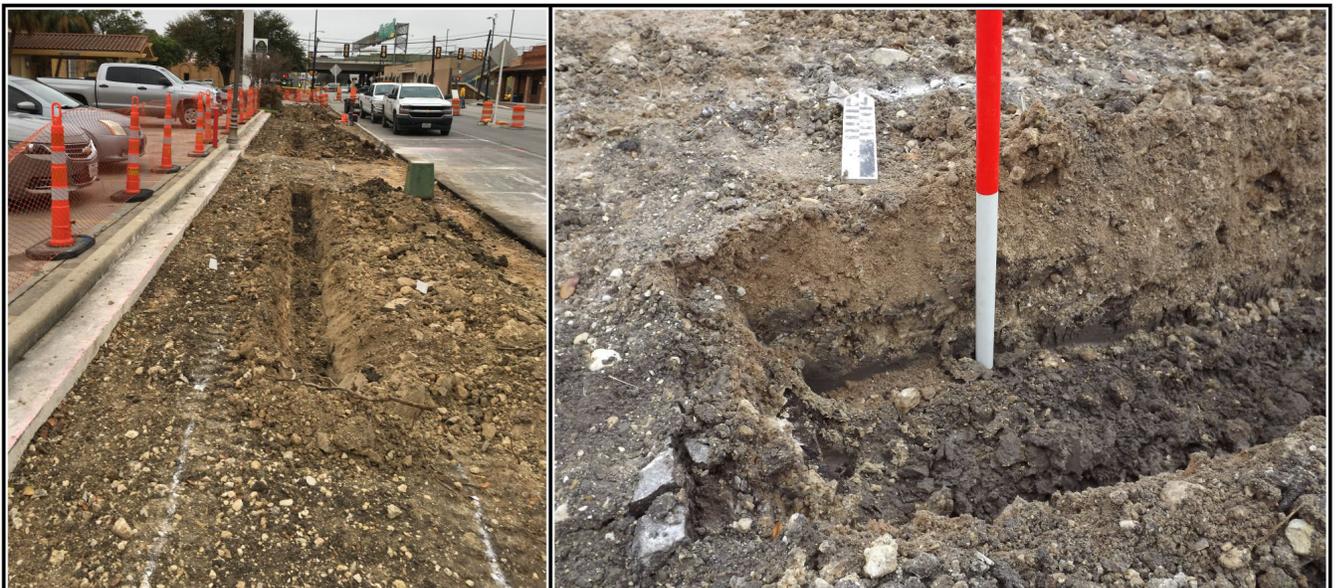
Trench 4 was excavated on February 19, 2020, on the south side of Dolorosa Street between San Saba and Santa Rosa streets for an irrigation line (Figure 6-5, left). The trench is 140 m (459.3 ft.) in long, 30 cm (11.8 in.) wide, and 30 cm (11.8 in.) deep. The top 25 cm (9.8 in.) of the trench consisted of construction fill and asphalt over a dark brown silty clay (Figure 6-5, right). No artifacts or features were observed in the profiles or backfill.

Figure 6-5. View to the west of the irrigation trench excavation with layout for planter boxes painted in white (left). Typical profile of irrigation wall view with construction fill to 25 cm (9.8 in.) below the grade followed by 5 cm (1.9 in.) of silty clay (right).

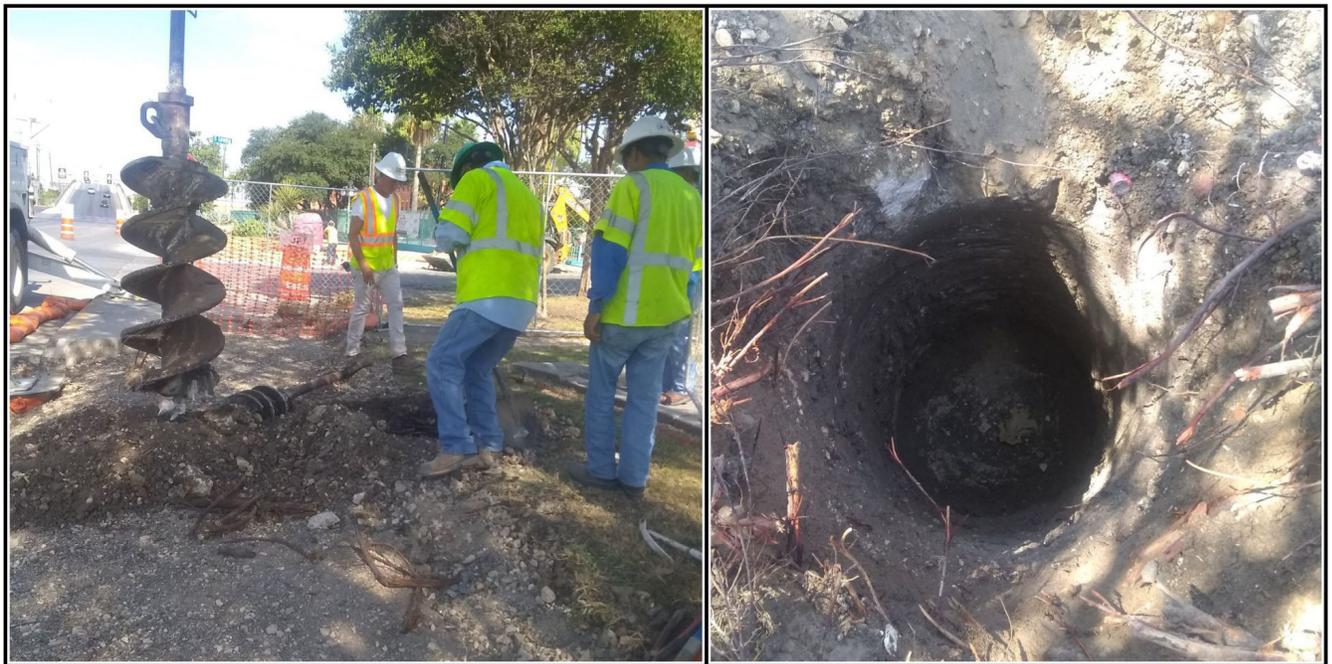
Auger excavations in Areas 1 revealed past construction activities with construction fill and concrete. The auger location at S. Leona and Buena Vista streets contained rebar and unidentifiable metal at 1.2 m (4 ft.) and concrete at 1.52 cm (5 ft.) below the surface (Figure 6-7). The auger excavation at Buena Vista and Pecos streets encountered concrete 60.96 cm (2 ft.) below the surface followed by soils. The final auger

Figure 6-7. Auger excavation at S. Leona and Buena Vista streets (left). The image of the right shows concrete at 152.4 cm (5 ft.) below the surface.

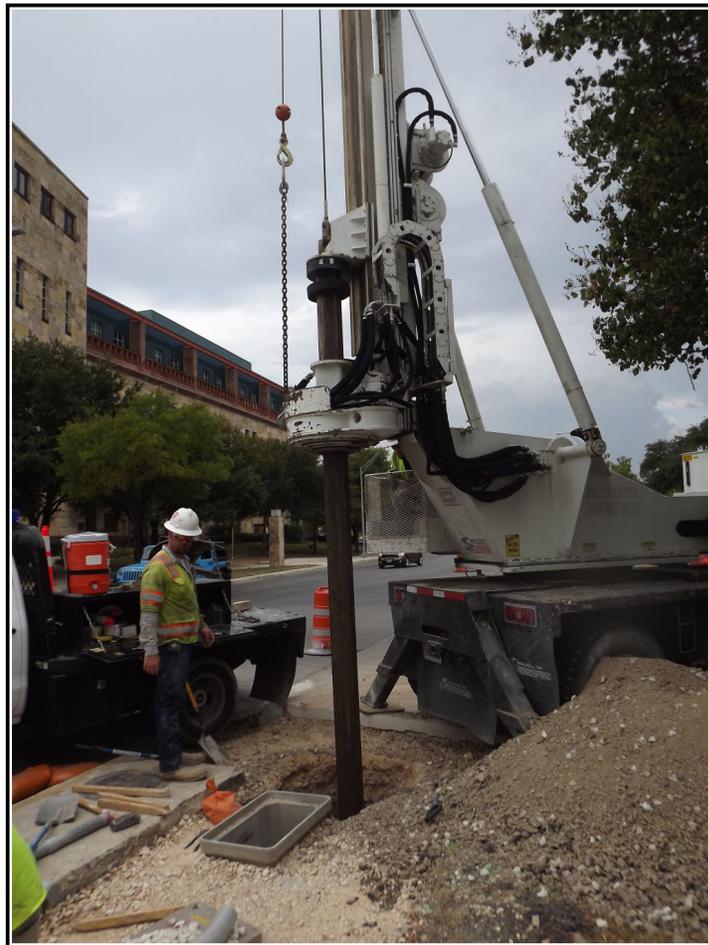
Figure 6-8. Excavation of the auger in Area 2 showing spoil pile.

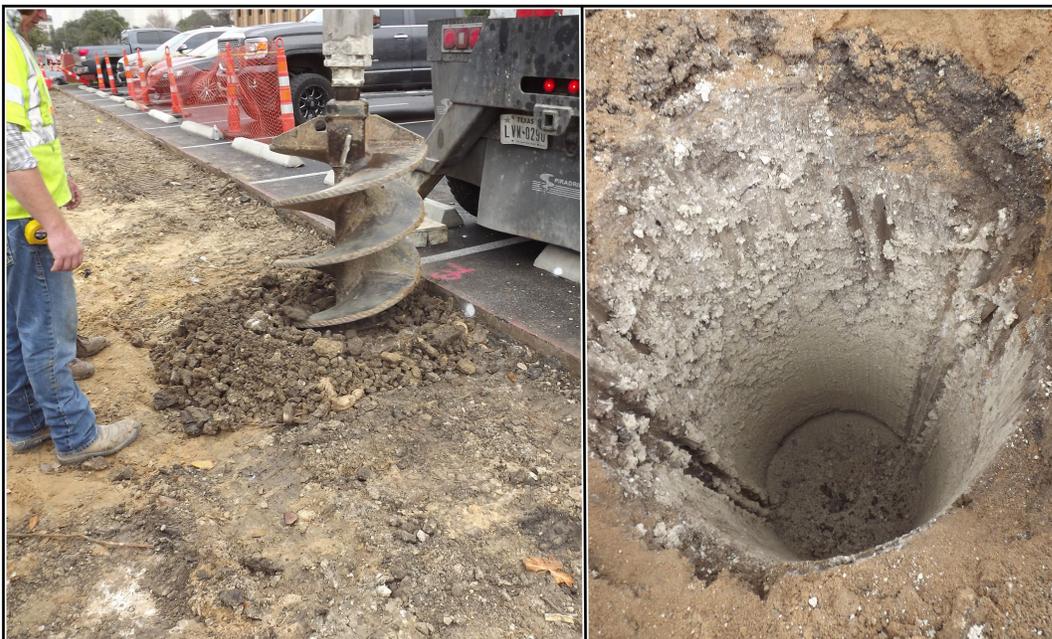
Figure 6-9. Image on the right shows location of Area 5 view to the southeast. Profile view of auger in Area 5.

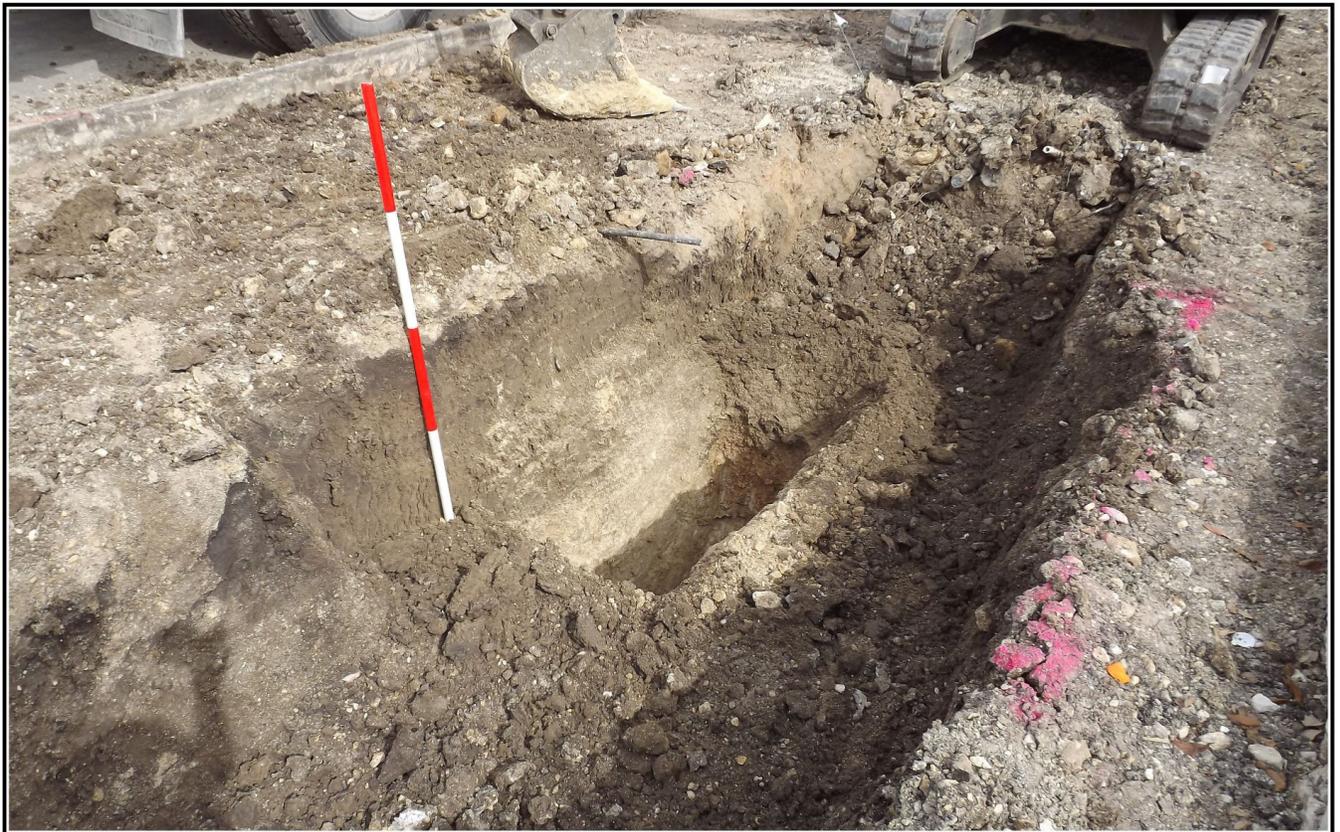
Figure 6-11. Typical pit excavation with deeper drainage pit against the wall and soil profile.

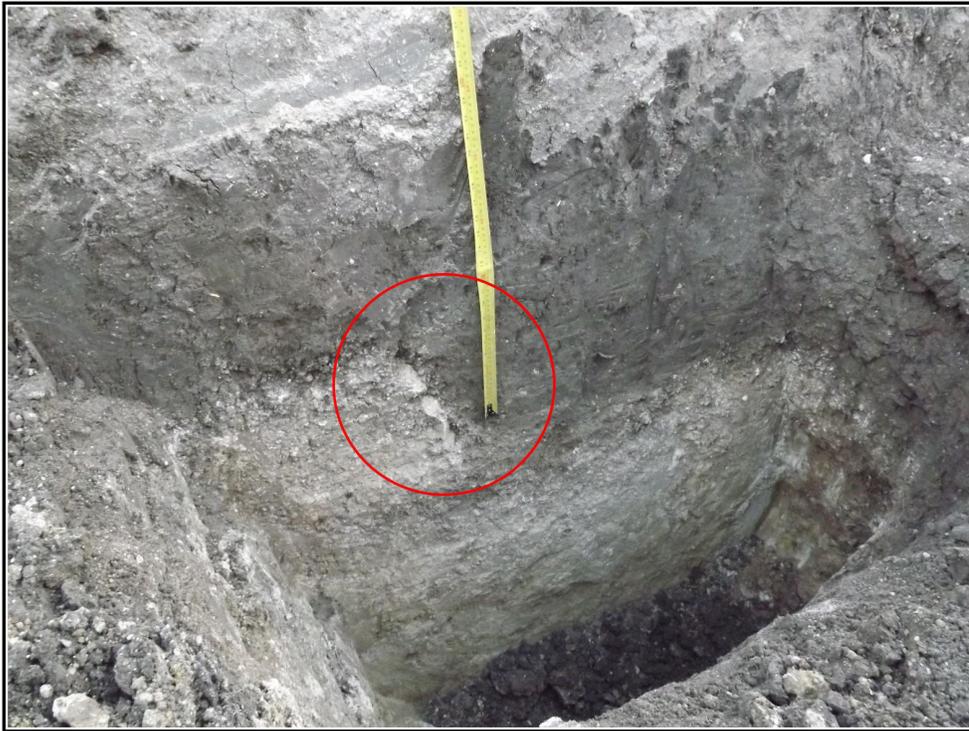
Figure 6-14. Detail of the east portion of the north profile highlight the stones.

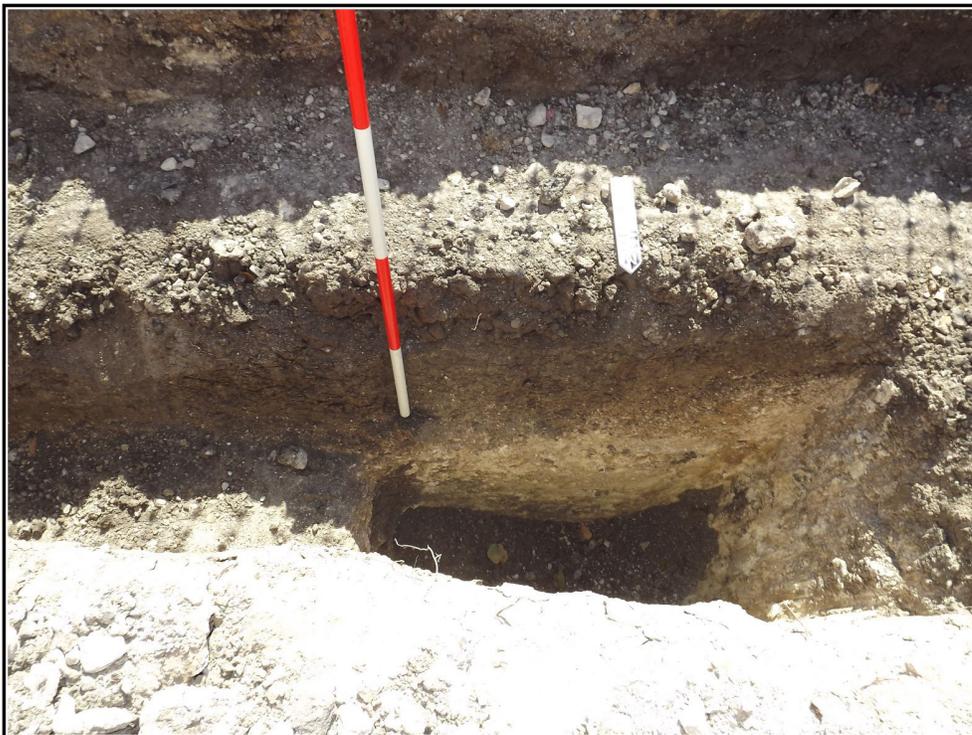
Figure 6-15. South profile of 41BX2345.

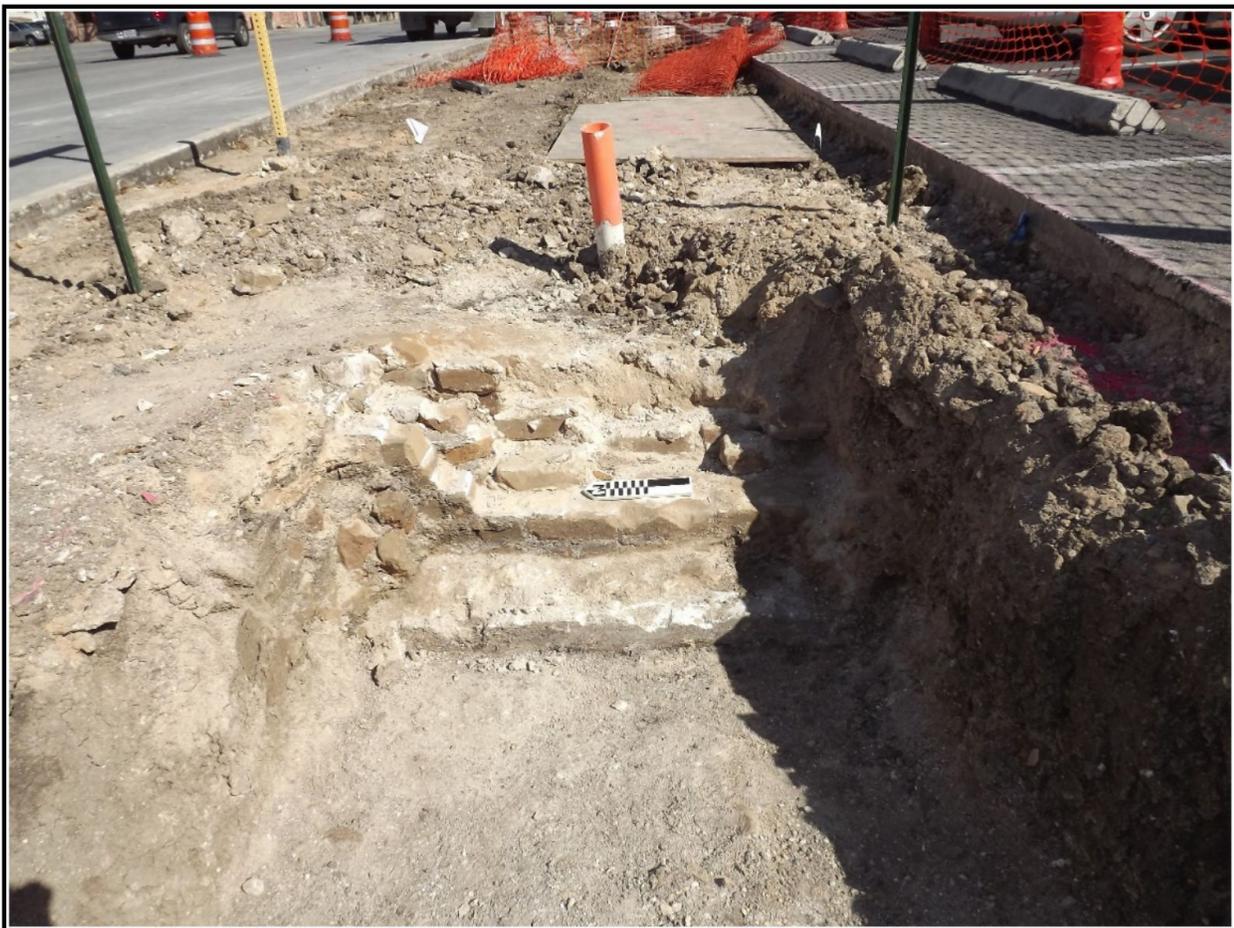
Figure 6-18. A view to the east of the brick foundation comprising 41BX2346.

Site 41BX2346 was documented in the field and with archival research. Following field documentation, the portion of the foundation within the excavation footprint was removed. The THC and COSA-OHP approved of this action during

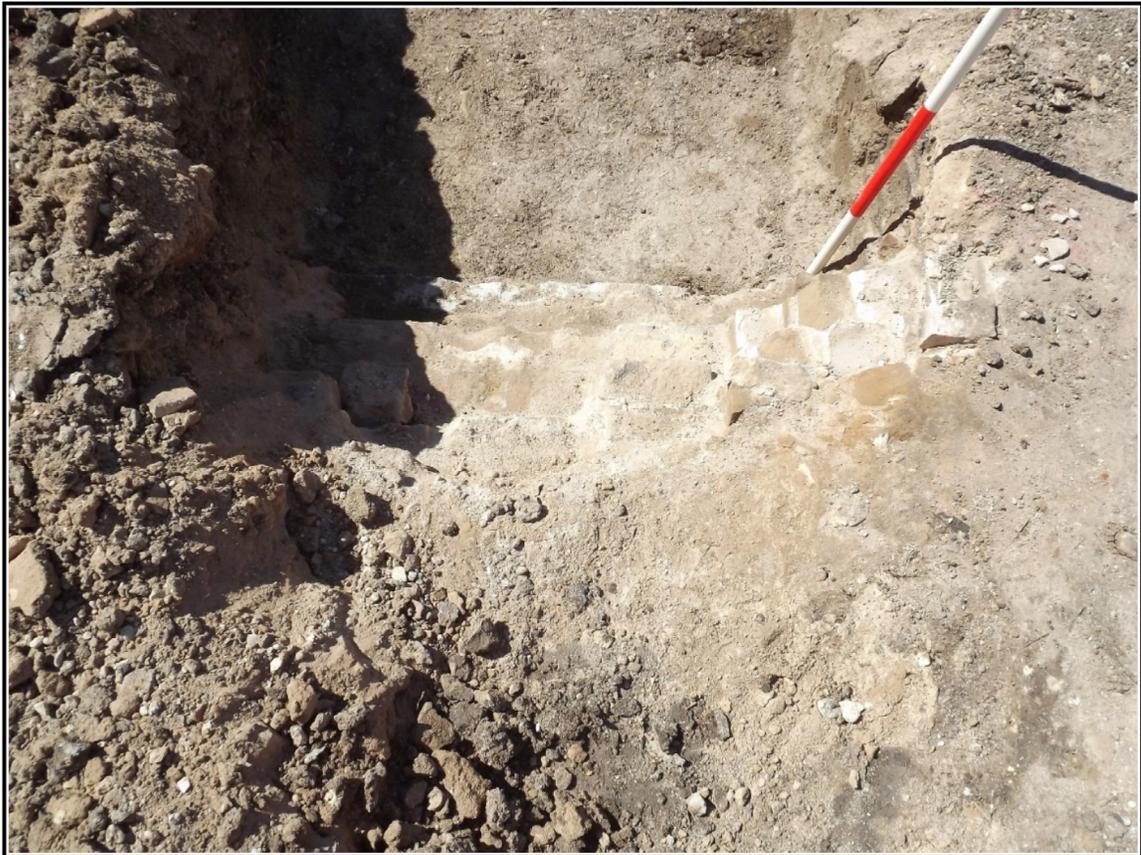
Figure 6-19. An overhead view of the brick foundation comprising 41BX2346.
