Archaeological Monitoring for the Espada Road Widening and Infrastructure Upgrades Project, San Antonio, Bexar County, Texas

Prepared by:
Center for Archaeological Research
The University of Texas at San Antonio
One UTSA Circle
San Antonio, Texas 78249
Technical Report, No. 75

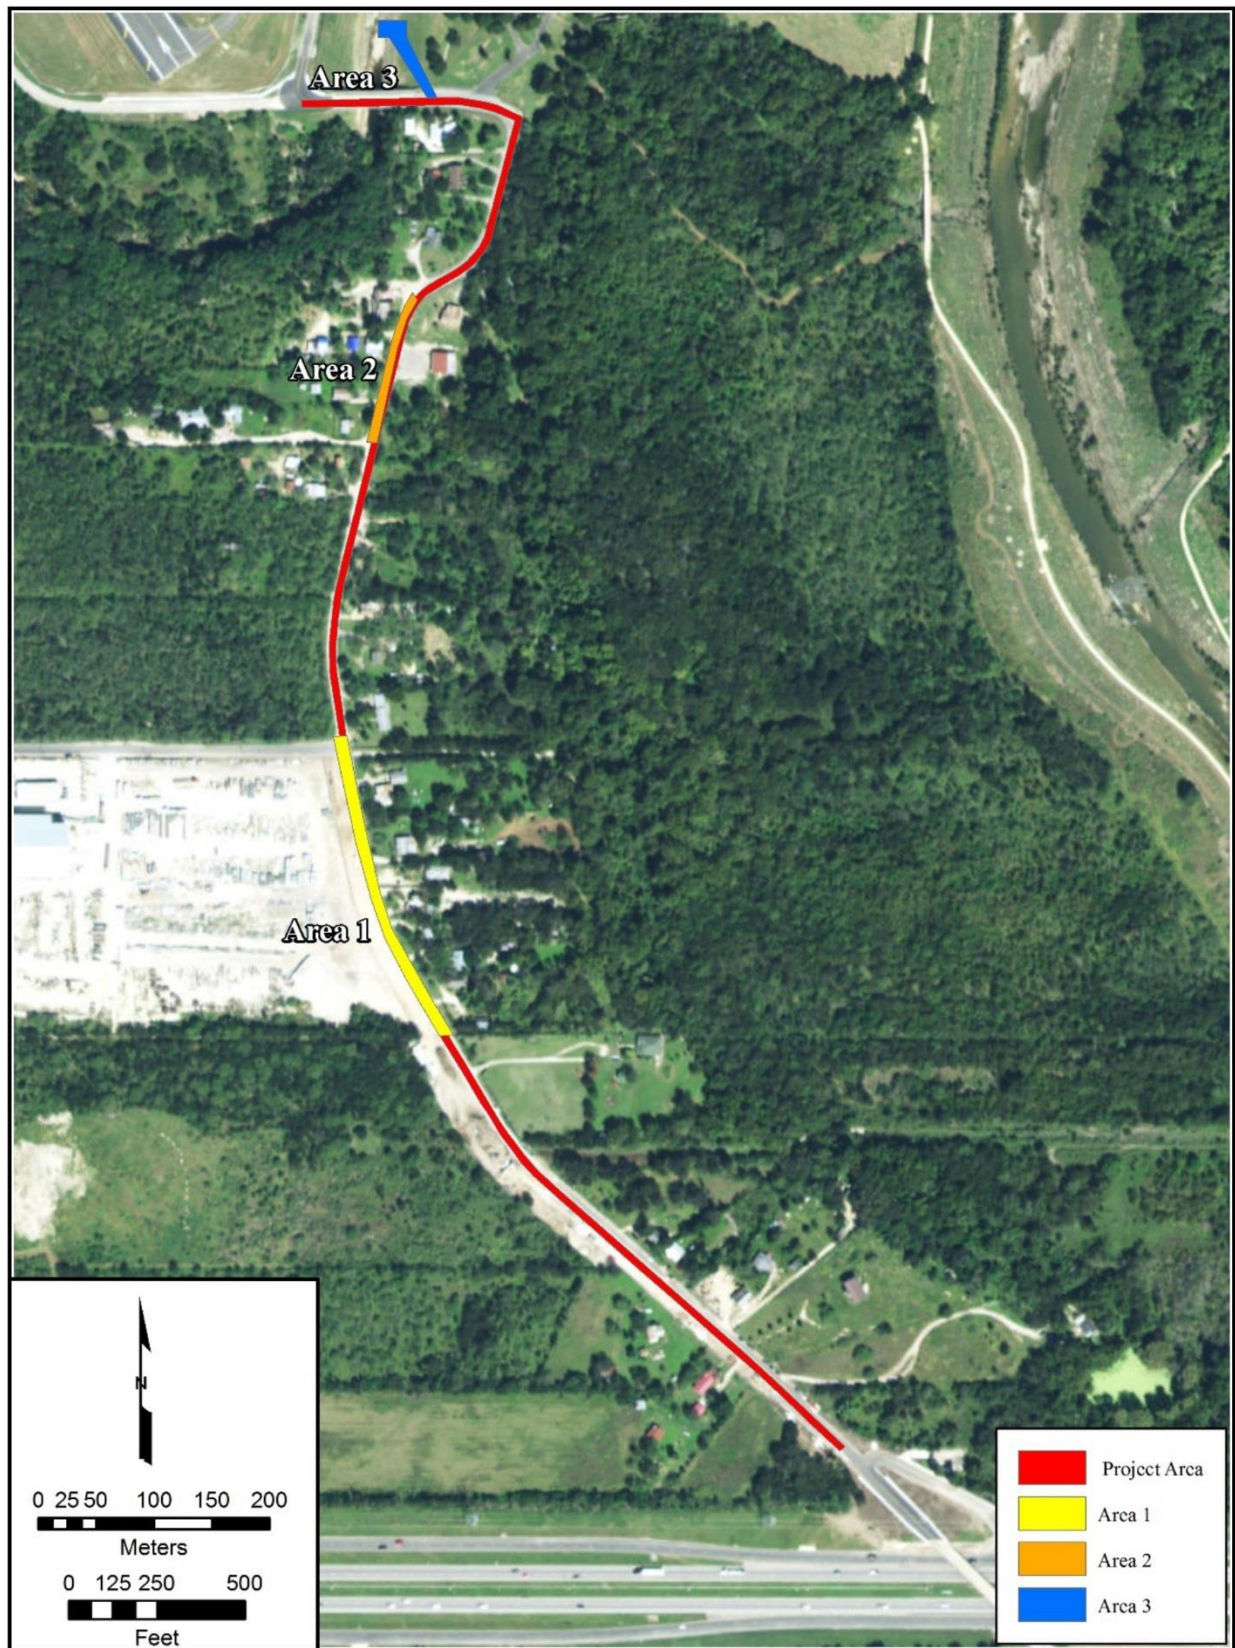
Figure 1-2. The location of the three areas defined as the APE on the satellite imagery.

The COSA's Office of Historic Preservation (OHP), in consultation with TCI, defined the project's Area of Potential Effect (APE) as the three areas of concern (Figures 1-1 and 1-2) recommended by a previous archaeological survey conducted by Atkins North America (Atkins; Smith et al. 2016). Area 1 is directly south of Rilling Road on the west side of Espada Road. An archival review conducted by Atkins found that three acequia laterals might cross into a parcel currently occupied by a concrete company (Harris and Russell 2015). Area 1 is 213 meters (m; 700 ft.) in length. Area 2 is also located on the west side of Espada Road, approximately 239 m (787 ft.) north of Rilling Road, and is 30.4 m (100 ft.) in length. Area 3 initially consisted of the monitoring for two bore pits located at the Espada Aqueduct Park (41BX281), a National Historic Landmark and Historic Civil Engineering Landmark. Due to existing utilities, the monitoring plan changed and focused on the excavation of a trench measuring 21.3 m (70 ft.) from the north side of Espada Road to the outfall at Six-Mile Creek, also known as "Piedras Creek."

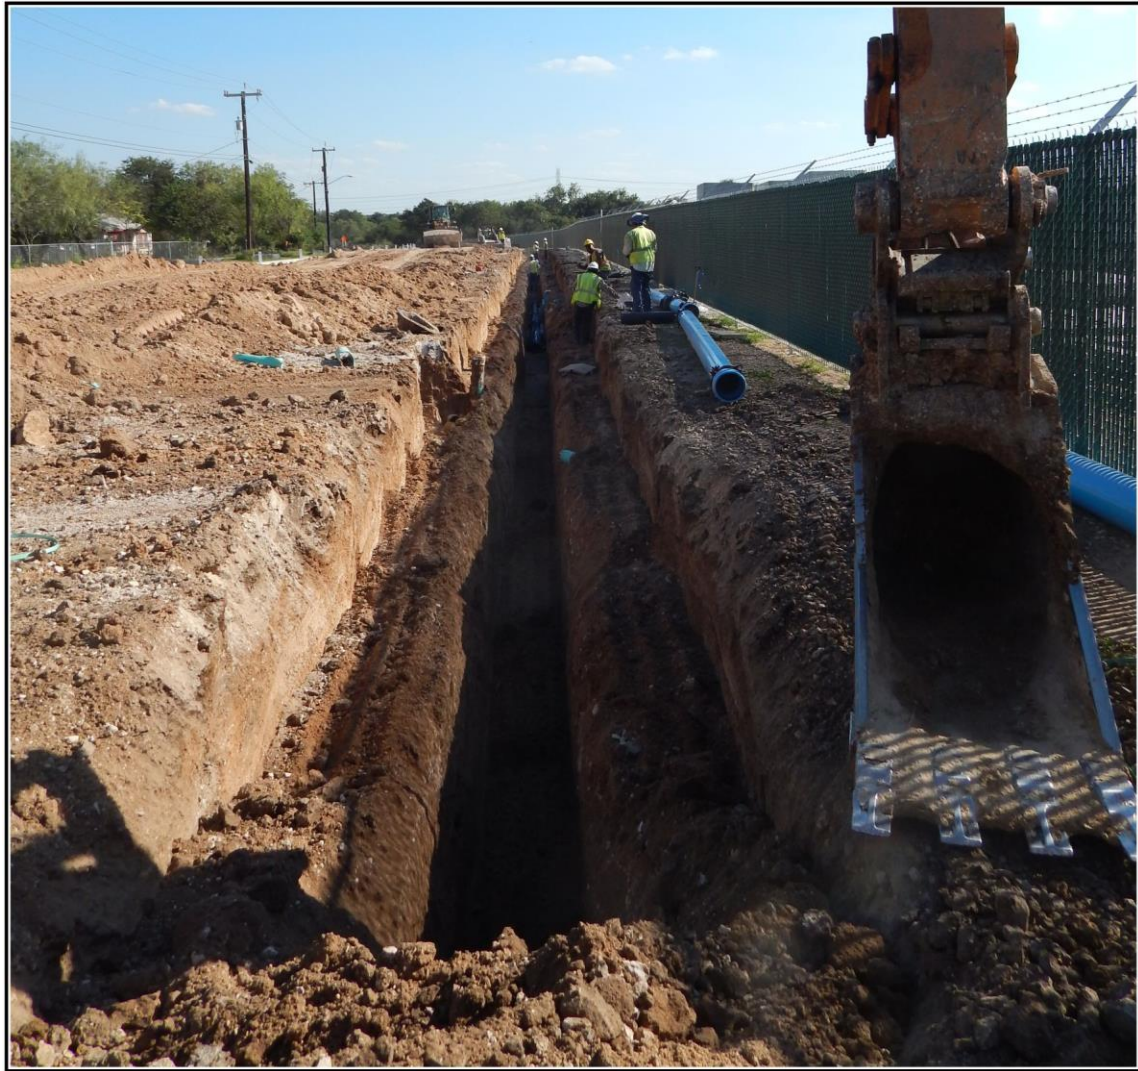
Figure 4-2. Area 1 viewed south from Rilling Road.

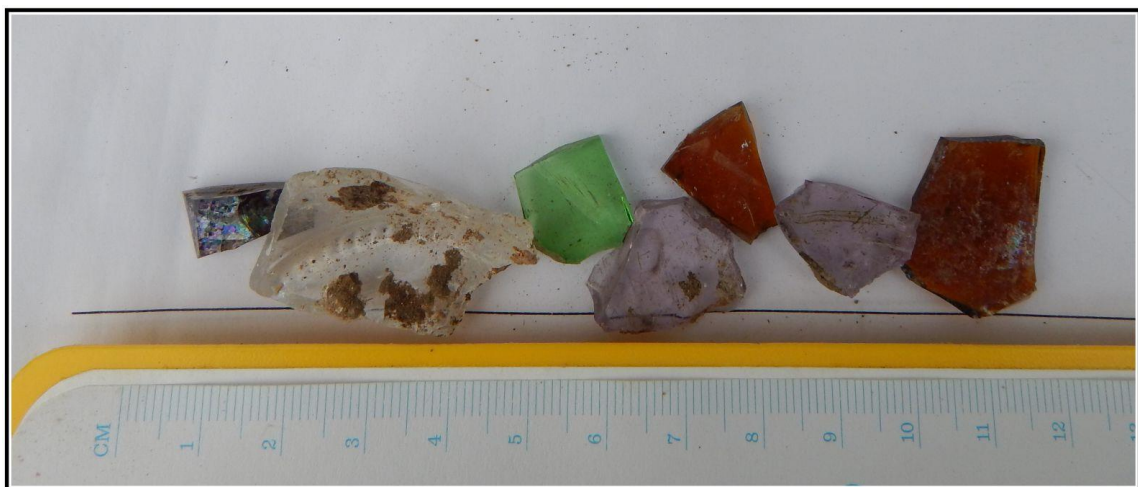
Figure 4-3. Glass artifacts observed in Area 1.

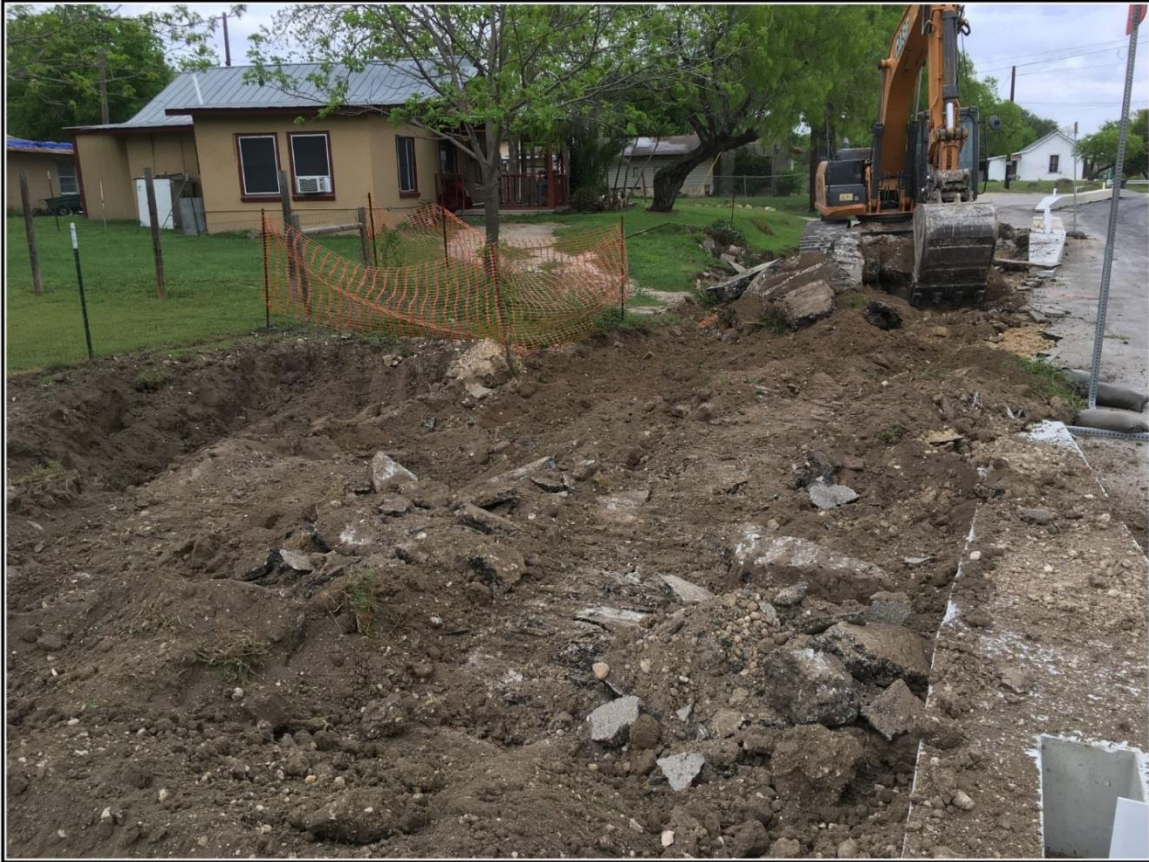
Area 2 was located at 9235 Espada Road, approximately 265 m (869.42 ft.) north of Rilling Road. The Texas Archeological Site Atlas placed the Teresa Bustillo Rivas House (41BX260), a resource recommended by Smith et al. (2016) for monitoring, within Area 2. However, Scurlock et al. (1976) recorded the site location at 9143 Espada Road. CAR communicated this discrepancy to the OHP and provided the Site Atlas administrator with the correct location. CAR archaeologists monitored Area 2 as defined by the OHP and the TCI (Figure 4-4). While the CAR did not monitor construction activities in proximity to 41X260, it did observe after the fact that the structure was not impacted by construction activities. Monitoring of Area 2 and the trenching for a water line occurred on March 28 and 31, 2017. The trench was 30.4-m (100-ft.) long, south to north, and dug to a depth of 1.6-1.8 m (5.5-6.5 ft.) below the surface (Figure 4-5). A piece of burned chert and two fragments of modern ceramic tile were observed in the backfill. No artifacts were observed in the walls or floor of the trench.

Figure 4-5. View to the northwest of excavation for waterline in Area 2.

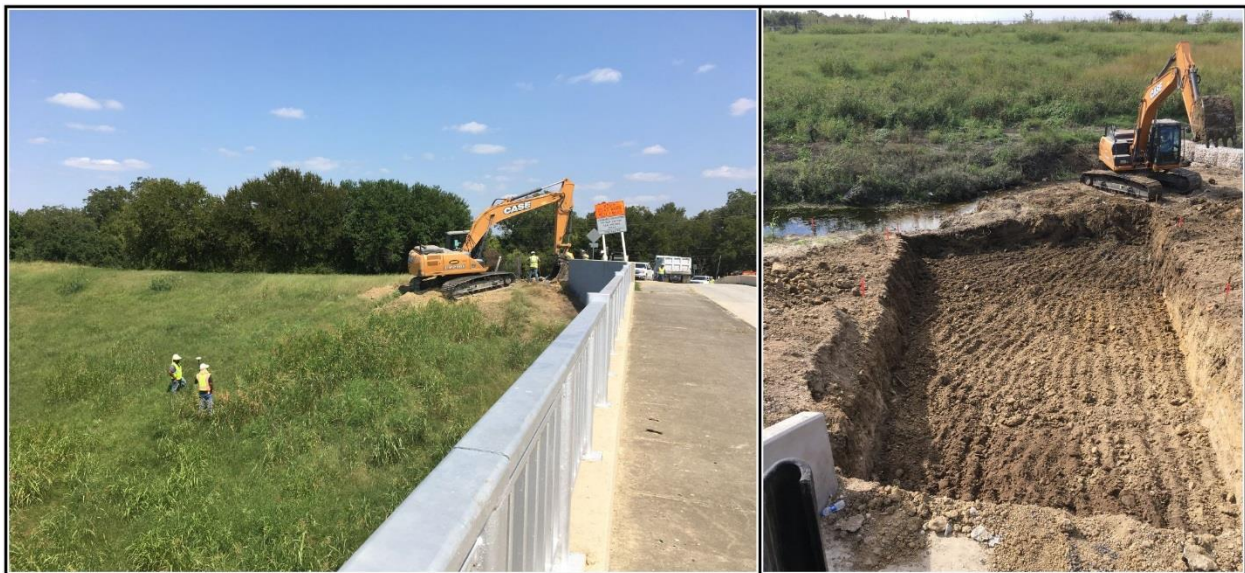
Monitoring of the trenching for the construction of the storm drain occurred on September 11-13 and October 19, 2017 (Figure 4-7). The excavated trench ran to the northwest 21.3 m (70 ft.) from the north side of Espada Road to Six-Mile Creek. The trench was approximately 3.9-m (13-ft.) deep and 1.8-m (6-ft.) wide. Sediments observed during the excavation suggest the area had been impacted by previous construction (likely the Espada *Acequia* Aqueduct Protection Project) associated with Six-Mile Creek, as referenced in a 1978 communication between the U.S. Army Corps of Engineers, Fort Worth District, and the THC (THC 2017b). Soils were a dark clay over a lighter gray clay followed by a tan layer with large boulders beneath that horizon. No artifacts or features were observed in either the trench walls or floor.

Figure 4-7. Beginning of the trench excavation for storm drain on Espada Road northwest of the Espada Acequia in Area 3 (left). The excavated storm drainage pipe outfall to Six-Mile Creek (right).
