Archaeological Excavation
of the Priest Quarters,
Mission San Francisco de la Espada,
41BX4,
San Antonio, Texas

Center for Archaeological Research
The University of Texas at San Antonio
Archaeological Survey Report, No. 295
2000

1. Type of investigation: Excavation, mitigation, data recovery and archival research.
2. Project name: Espada Southwest Corner Wall/Mission Espada Priest Quarters
3. County: Bexar.
4. Principal investigators: Robert J. Hard and C. Britt Bousman.
5. Name and location of sponsoring agency: San Francisco de la Espada/Catholic Diocese of San Antonio, 10040 Espada Road, San Antonio, Texas 78214
6. Texas Antiquities Permit No.: 2076
7. Published by the Center for Archaeological Research, The University of Texas at San Antonio, 6900 N. Loop 1604 W., San Antonio, Texas 78249-0658, 2000

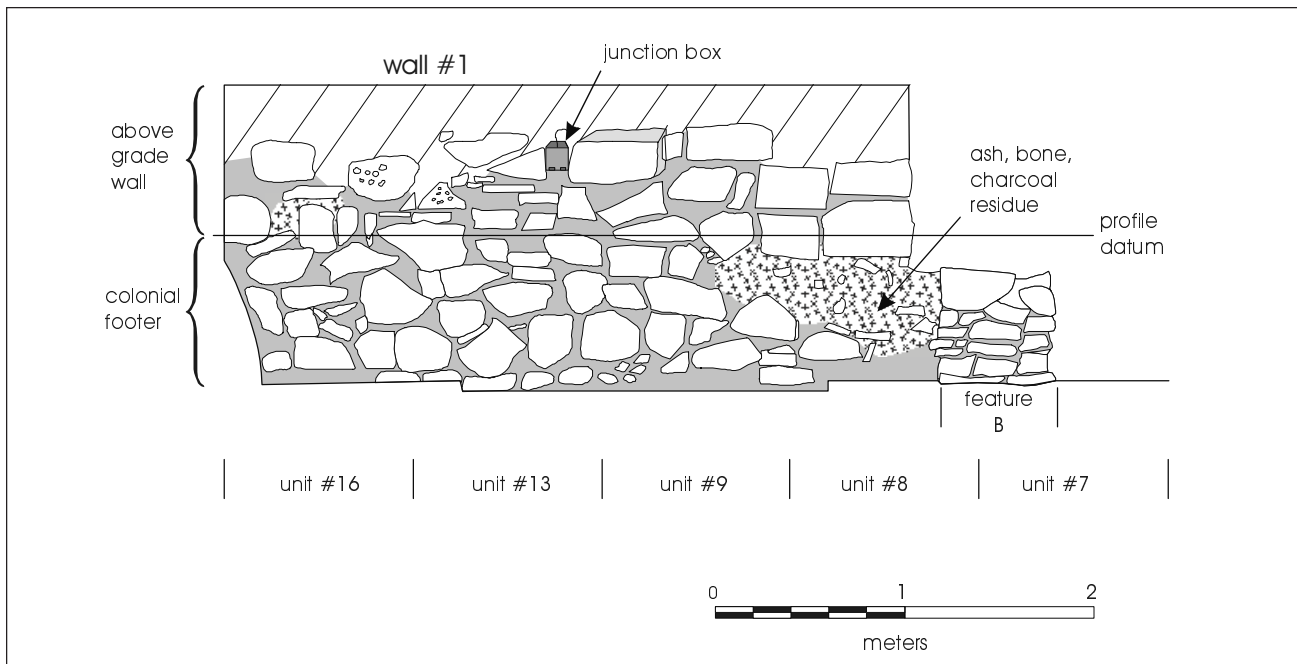
Figure 9. *Wall 1 Footer, North Profile Units 16, 13, 9, 8, and 7.*

The 1999 excavations of Units 16, 13, 9, 8, and 7, continued noting the presence of disturbed deposits along Wall 1. The unit levels were fairly consistent: Levels 1-3 (0-30 cm bs) noted disturbed loamy soils with mixed deposits; Levels 4-5 (30-50 cm bs) noted disturbed loamy soils with few artifacts; Level 6 (50-60 cm bs) located a sandy loam with either few or no artifacts; and Levels 7-9 (60-90 cm bs) noted a layer of Houston black clay with either few or no artifacts.

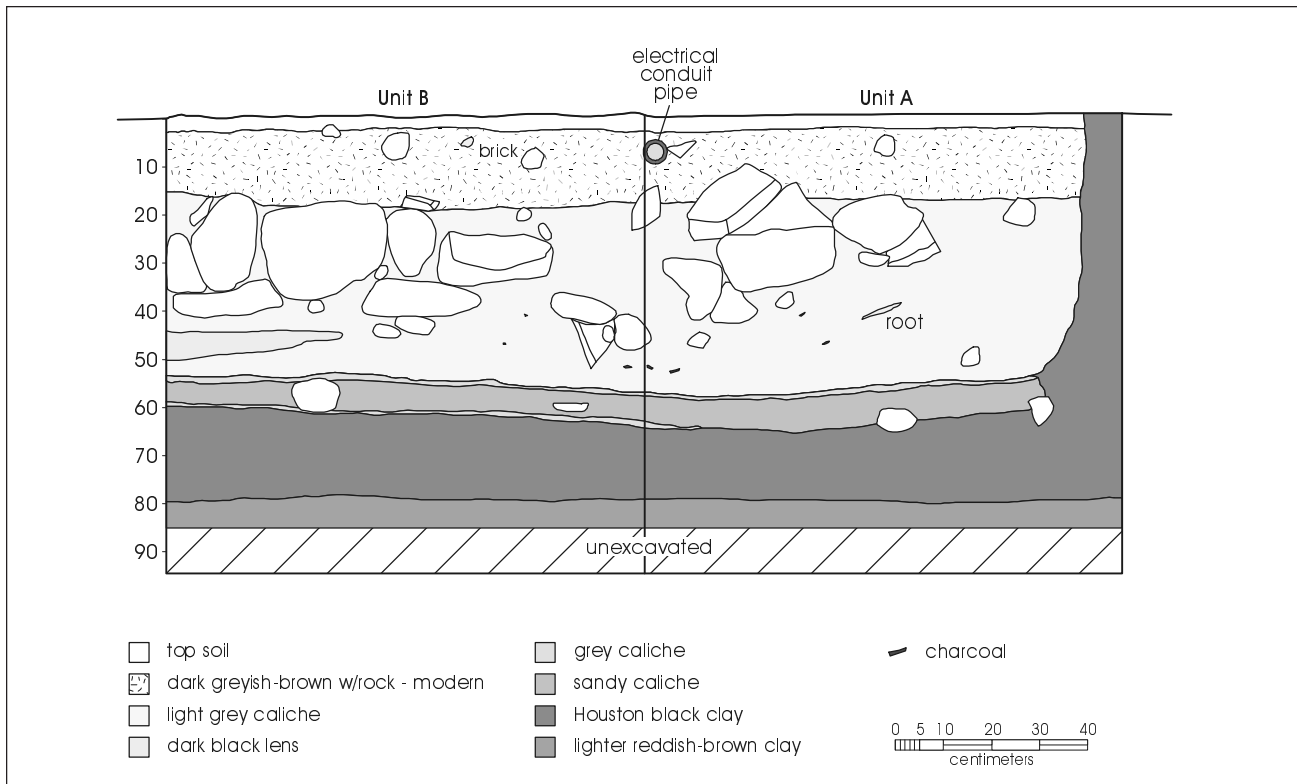
Figure 10. *Units A and B – South Profile.*

Wall rubble was found in the south wall of Units A and B, and was also picked up on the south wall of Units 16 and 13. Figure 10 serves to illustrate the disturbance encountered in the excavated units. The wall fall, or construction debris, was located between 15 and 40 cm below surface, and was oriented in an east-west direction. In 1998, Meissner mentioned this anomaly in her monitoring notes, and speculated that it might be a north to south wall alignment

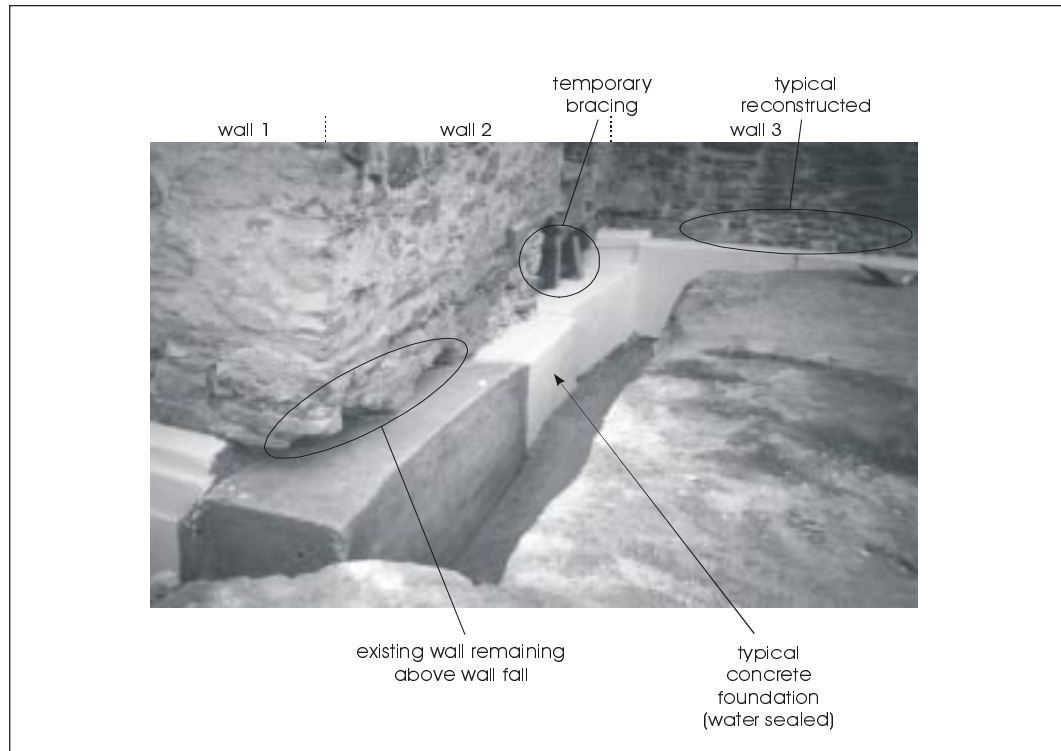
Figure 15a. *Walls 2 & 3.*
Typical Undercutting and New Concrete Foundation.

Undercutting of the foundation and installation of four-foot sections of concrete beam continued over a four-week period, and additional sections of wall foundation were lost in the process. As sections of foundation failed, the remaining stones were temporarily braced while the concrete beam was poured. Once the poured concrete section had hardened, the stones that had fallen were replaced. Some bone fragments and ceramic sherds were recovered during the undercutting, but these came from the soils along the interior of the foundations. No other features were noted during this phase of construction.

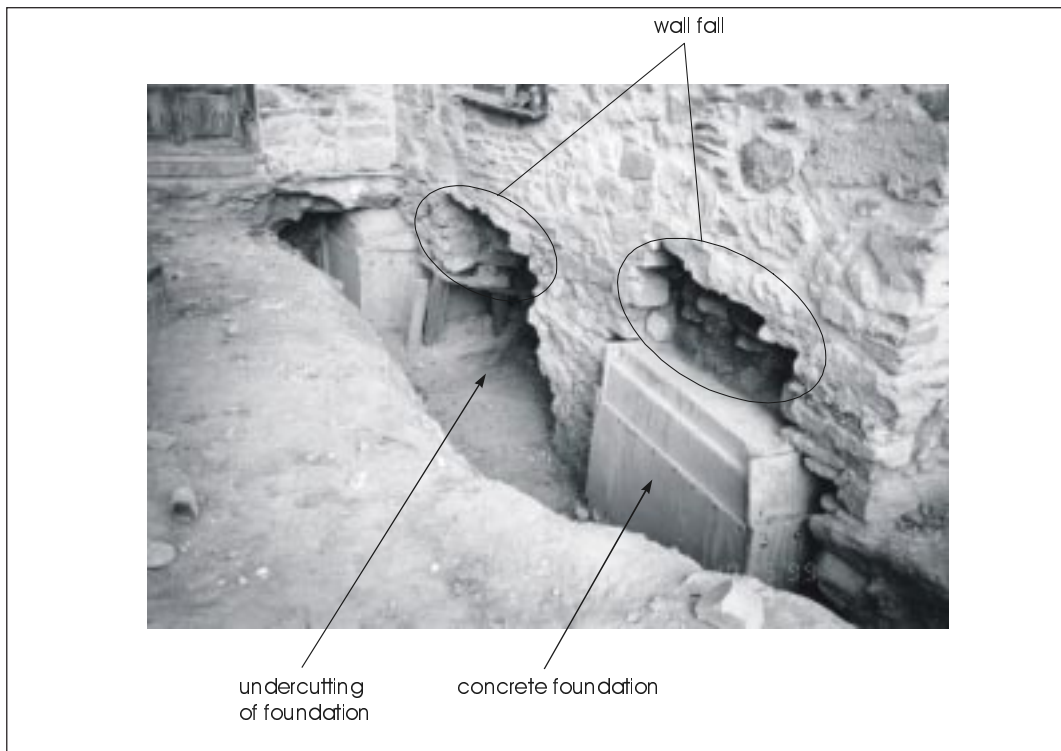
Figure 15b. *Wall 3 – Typical Undercutting and New Foundation.*
Note: Wall fall above undercutting.

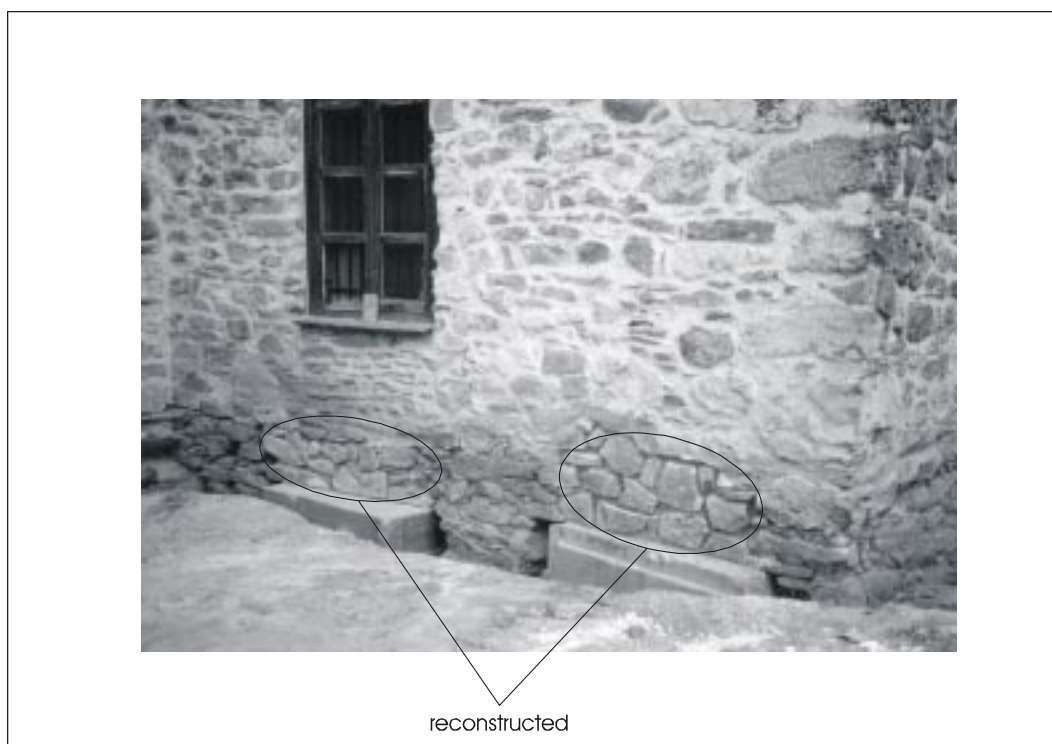
Figure 15c. Wall 3 – Typical Reconstructed Wall Fall.

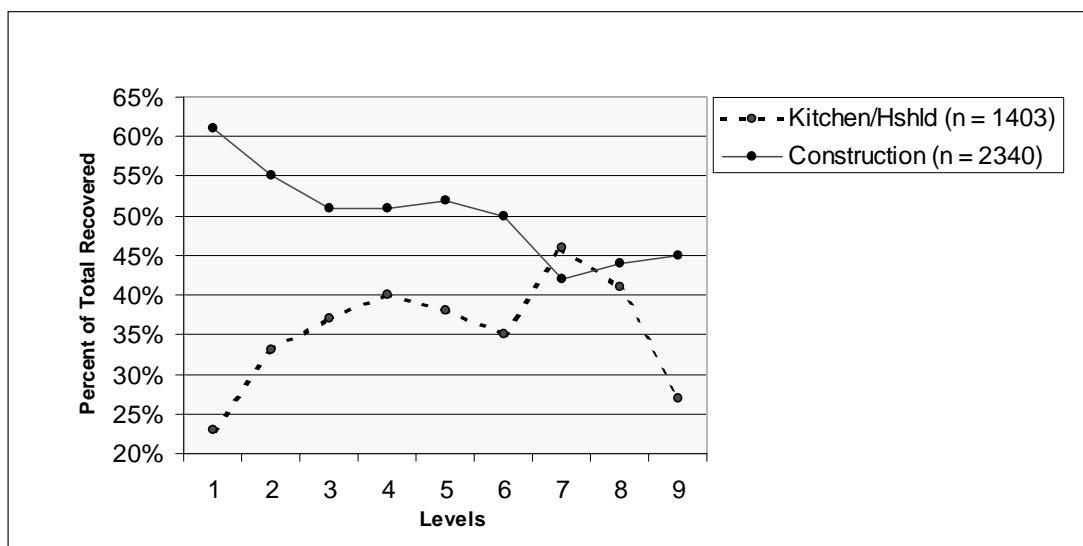
the last 60 cm excavated. The Figure 16 data also indicates that the occurrence of kitchen-related items remained relatively low, between 23% and 46%, throughout the entire 90 cm excavated.

Figure 16. Density of Kitchen and Construction Artifacts, Walls 1 and 2.

As noted in the Results section, the area along Walls 1 and 2 has been heavily impacted by construction-related activities over the years; this was clearly illustrated in Figures 16 and 18. In contrast, the area along Walls 3 and 4 has not been as heavily impacted and, as illustrated in Figure 19, the deposition appears to be somewhat intact. An analysis of the Wall 5 data failed to reveal any definite depositional patterns. This is probably owing to the comparatively smaller area excavated and the low number of artifacts recovered.

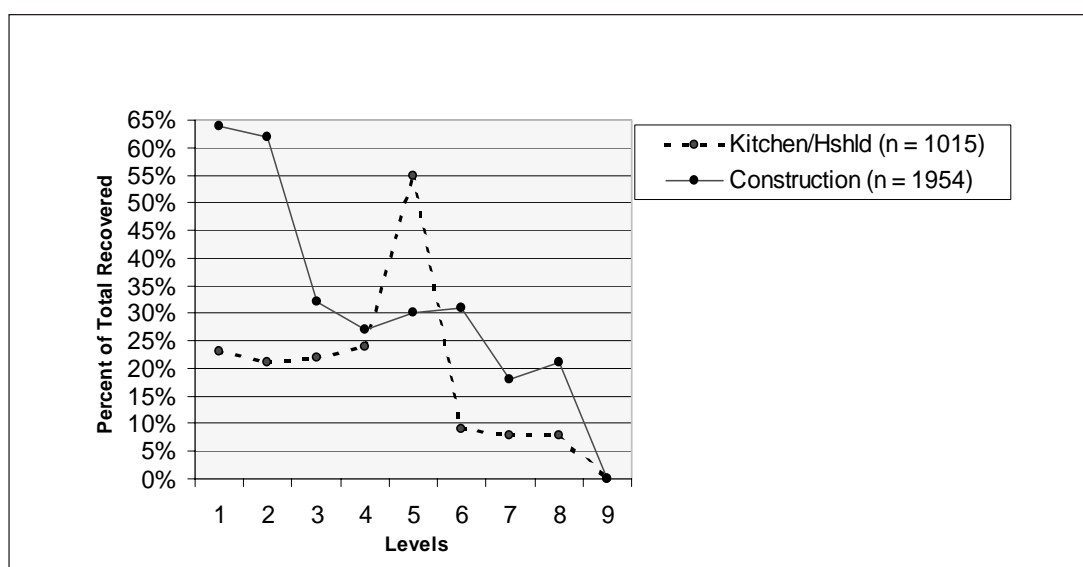
In contrast, the Figure 17 data indicates a steady decline of construction-related items between Level 1 (64%) and Level 8 (21%). If not for a sharp increase at Level 5, the data for the kitchen-related items would have also shown a steady decrease, between Level 1 (23%) and Level 8 (8%). The unit level form (Unit 3, Level 5) notes a soil disturbance along the west-end of the unit. This is probably what accounts for the large number of glass fragments (n=266) which caused the sharp increase in kitchen-related items and skewed the data for Level 5.

Figure 17. *Density of Kitchen and Construction Artifacts, Walls 3 and 4.*

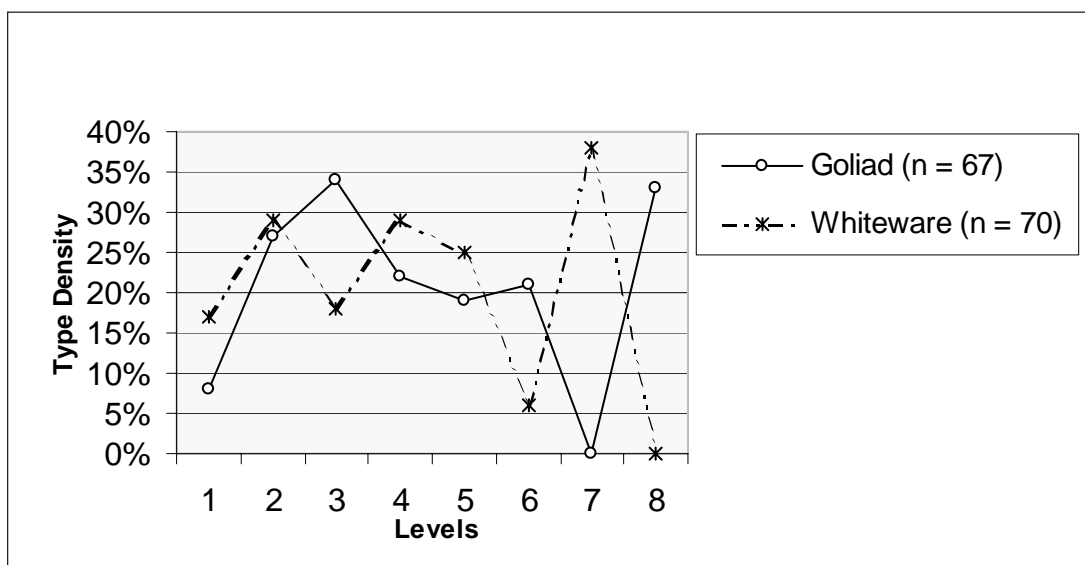
Figure 18. *Walls 1 and 2 Ceramics – Whiteware vs. Goliad ware.*

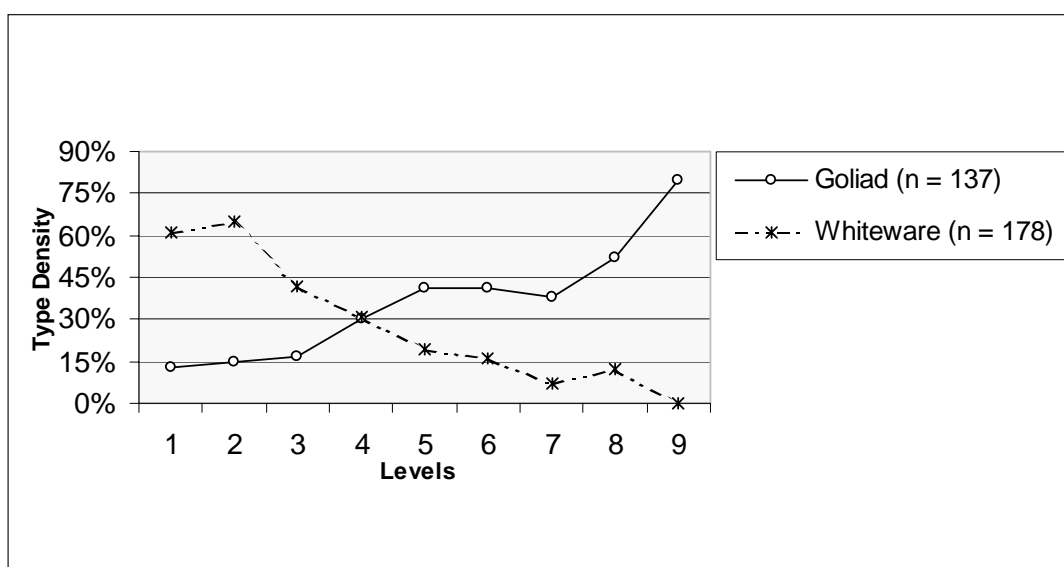
Figure 19. *Walls 3 and 4 Ceramics – Whiteware vs. Goliad ware.*

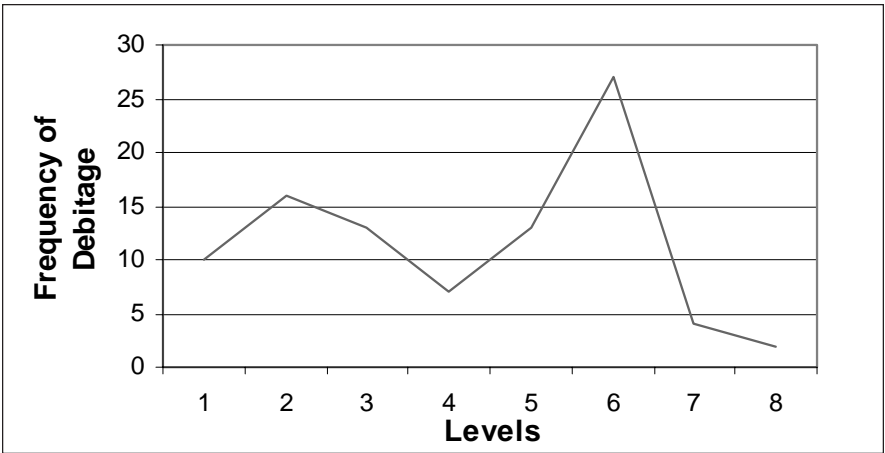
Of the 79 specimens one came from trench fill. The level by level distribution of the remaining 78 specimens has a bimodal pattern (Figure 21). A smaller peak of 13 specimens is present in Level 2 below which debitage counts decrease through Levels 3 and 4. Counts begin increasing in Level 5 peaking with 23 specimens in Level 6. At least two explanations may account for this pattern. A single occupation zone buried between 50-60 cm below surface is present at the site and the smaller debitage peak in Level 2 represents specimens translocated through post-depositional disturbance (e.g., construction activities) from the original construction of the Priest quarters. Alternatively, the two debitage peaks represent distinct occupation zones with the deeper zone potentially dating to the early part of the Late Prehistoric period (e.g., Edwards point) and the upper zone representing the Protohistoric/mission era occupation.

Figure 21. *Distribution of Unmodified Lithic Debitage by Level.*

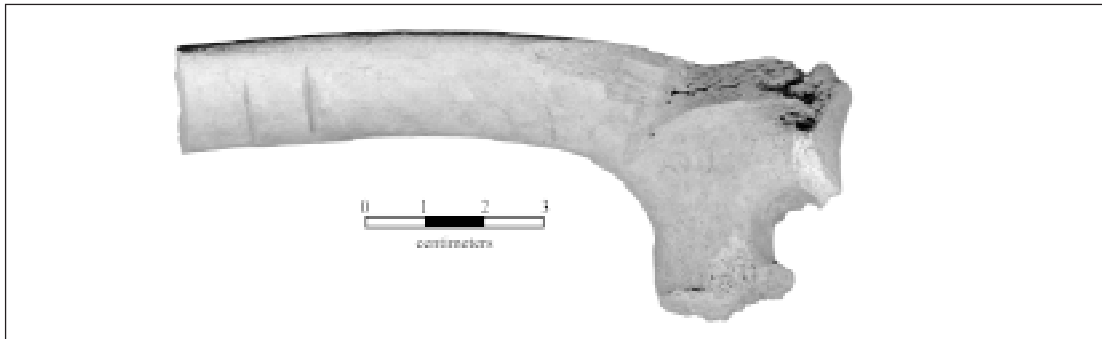
Also from Unit 3 is the proximal end of a sheep humerus, with a thin cut from the lateral side through part of the epiphysis. This cut appears to have been made by a metal tool, some time before the animal died, as there is clear evidence of healing along the edge (Figure 26).

Figure 26. *Proximal end of a sheep humerus with deep cut, shown in a lateral view turned slightly to the dorsal.* Note: Healing along edges.
