Archaeological Monitoring of the
HEB-GSA Parking Lot:
Impacts to the San Pedro Acequia

I. Wayne Cox and Brett A. Houk

Center for Archaeological Research
The University of Texas at San Antonio
Archaeological Survey Report, No. 279
1998

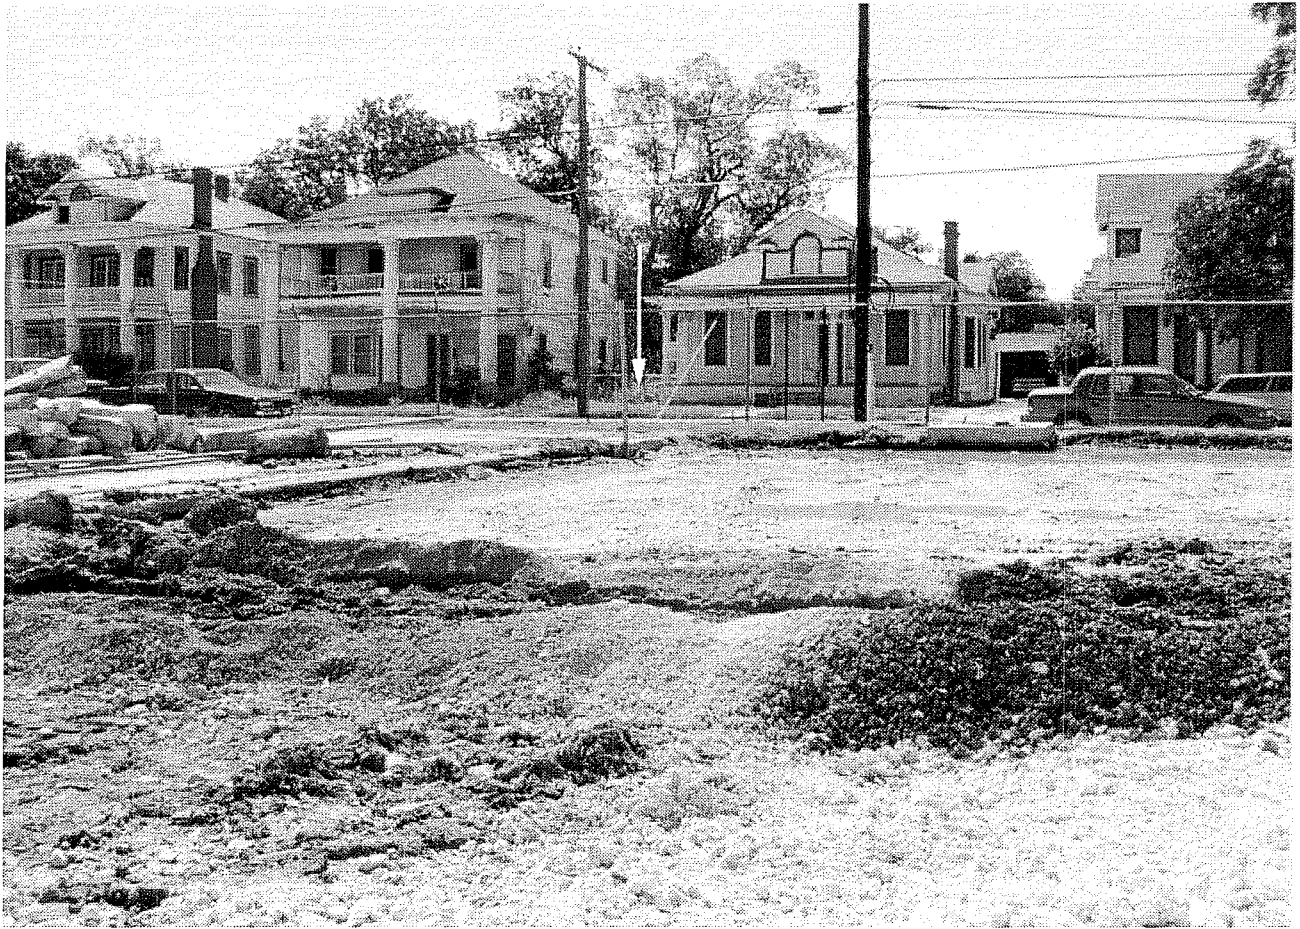
Figure 4. *Project area looking south toward Arsenal Street.* The path of the acequia across Arsenal is marked with the white arrow.

This monitoring of the San Pedro Acequia has served the purpose of further documenting the nature of the construction and course of the channel beyond the known path in this area (Figure 4) and the section excavated farther to the south at the site of the 1981 study (Frkuska 1981). The section observed during this monitoring is probably the result of the construction of 1881 to straighten the acequia as recommended by the Ditch Commissioner to the City Council (CCM, E:311). CAR recommends that the monitoring-level investigations have mitigated the impacts to the acequia. Since all further work for this project is to be surface in nature, no further archaeological investigations are recommended at this time. However, should future work be undertaken in further developments additional monitoring should be considered.
