# Archaeological Monitoring of Geotechnical Boring Associated with the Alamo Museum in Alamo Plaza, San Antonio, Bexar County, Texas

Texas Antiquities Permit No. 9125

*Prepared by:*  
Center for Archaeological Research  
The University of Texas at San Antonio  
One UTSA Circle  
San Antonio, Texas 78249  
Technical Report, No. 88

© May 2020

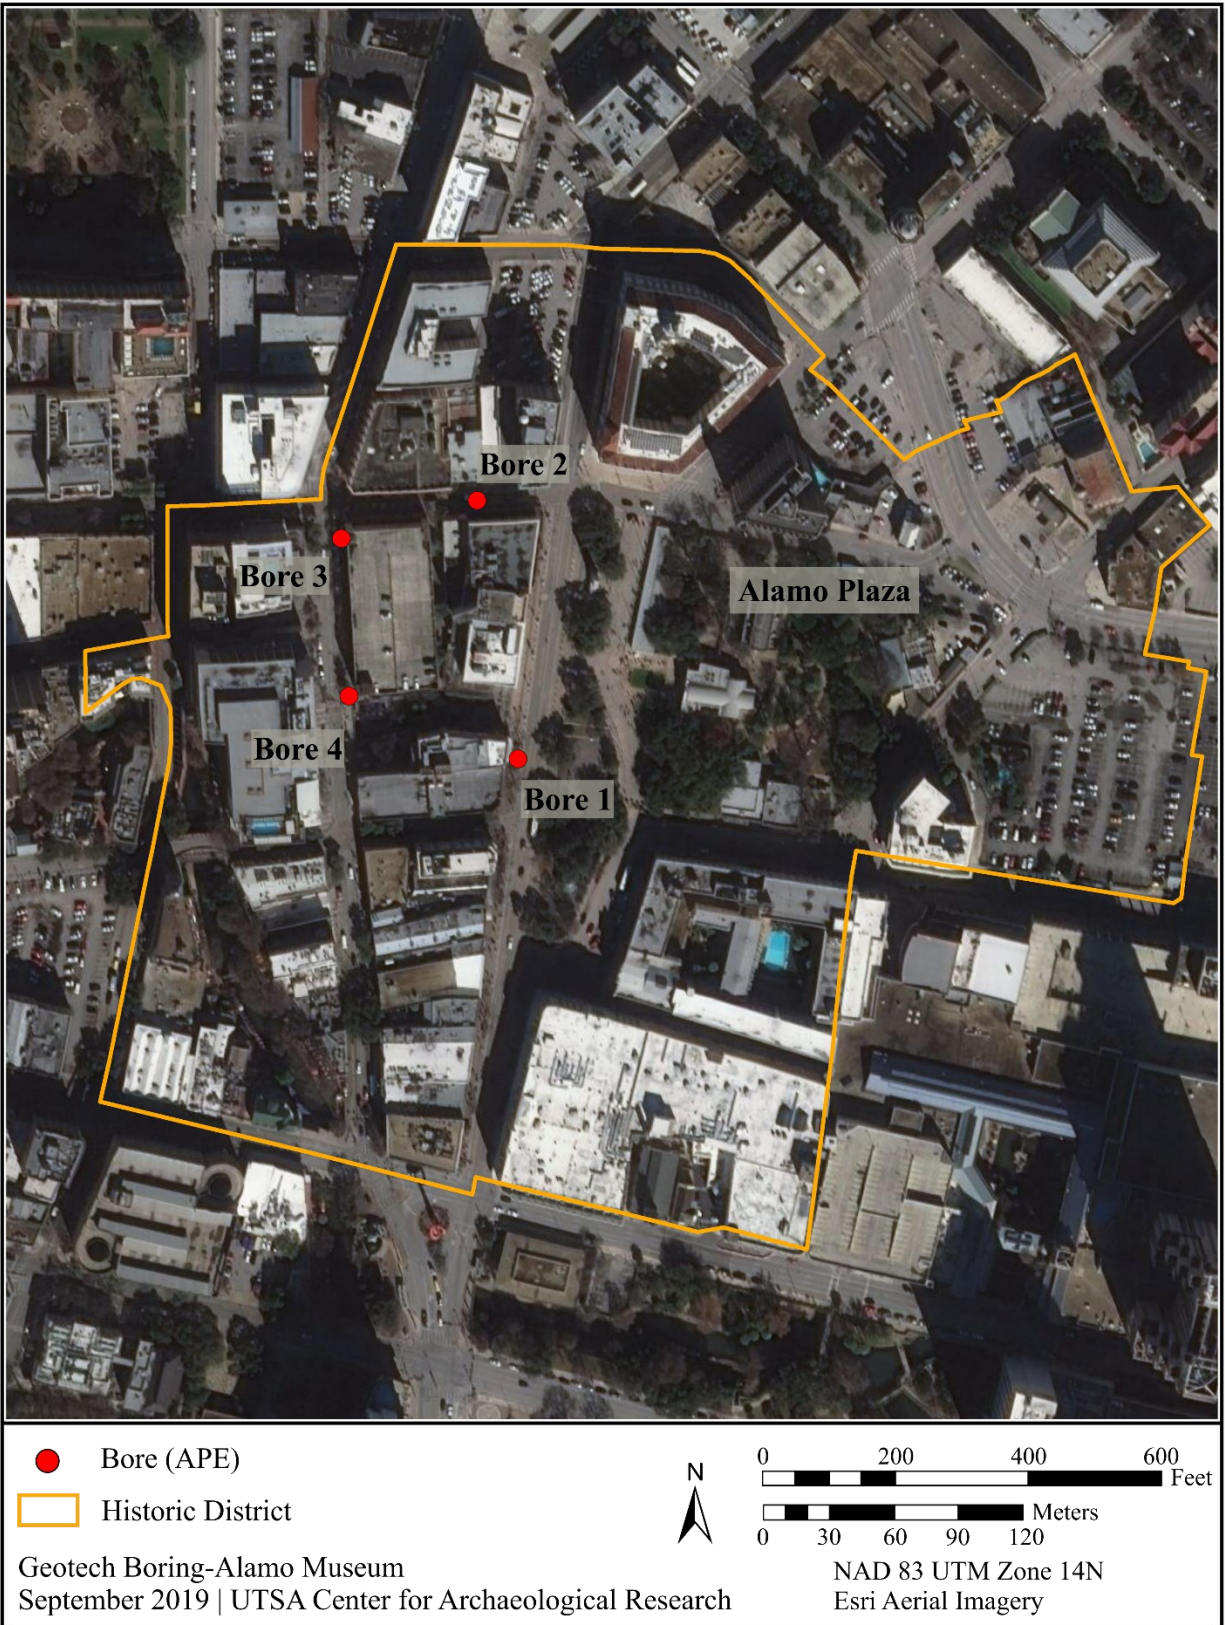
The bore holes are located within the Alamo Plaza Historic District (Figure 1-1). The district includes Alamo Plaza, located immediately to the west of the Alamo (41BX6), and commercial enterprises that developed in and around the Plaza (COSA 2020). The Alamo originally functioned as the third and final location of Mission San Antonio de Valero. The site is a State Antiquities Landmark (SAL), listed on the National Register of Historic Places, and designated a UNESCO World Heritage Site. Recently, a notice of existence of an abandoned or previously unknown cemetery at the Alamo was filed pursuant to Section 711.011 of the Texas Health and Safety Code. Therefore, any improvements to the facilities and surrounding complex that result in ground disturbing impacts need to be evaluated to ensure that they do not negatively impact significant cultural deposits and/or human remains.

Figure 1-1. Alamo Plaza Historic District (COSA-OHP 2020), with location of the bores shown in red on satellite imagery.

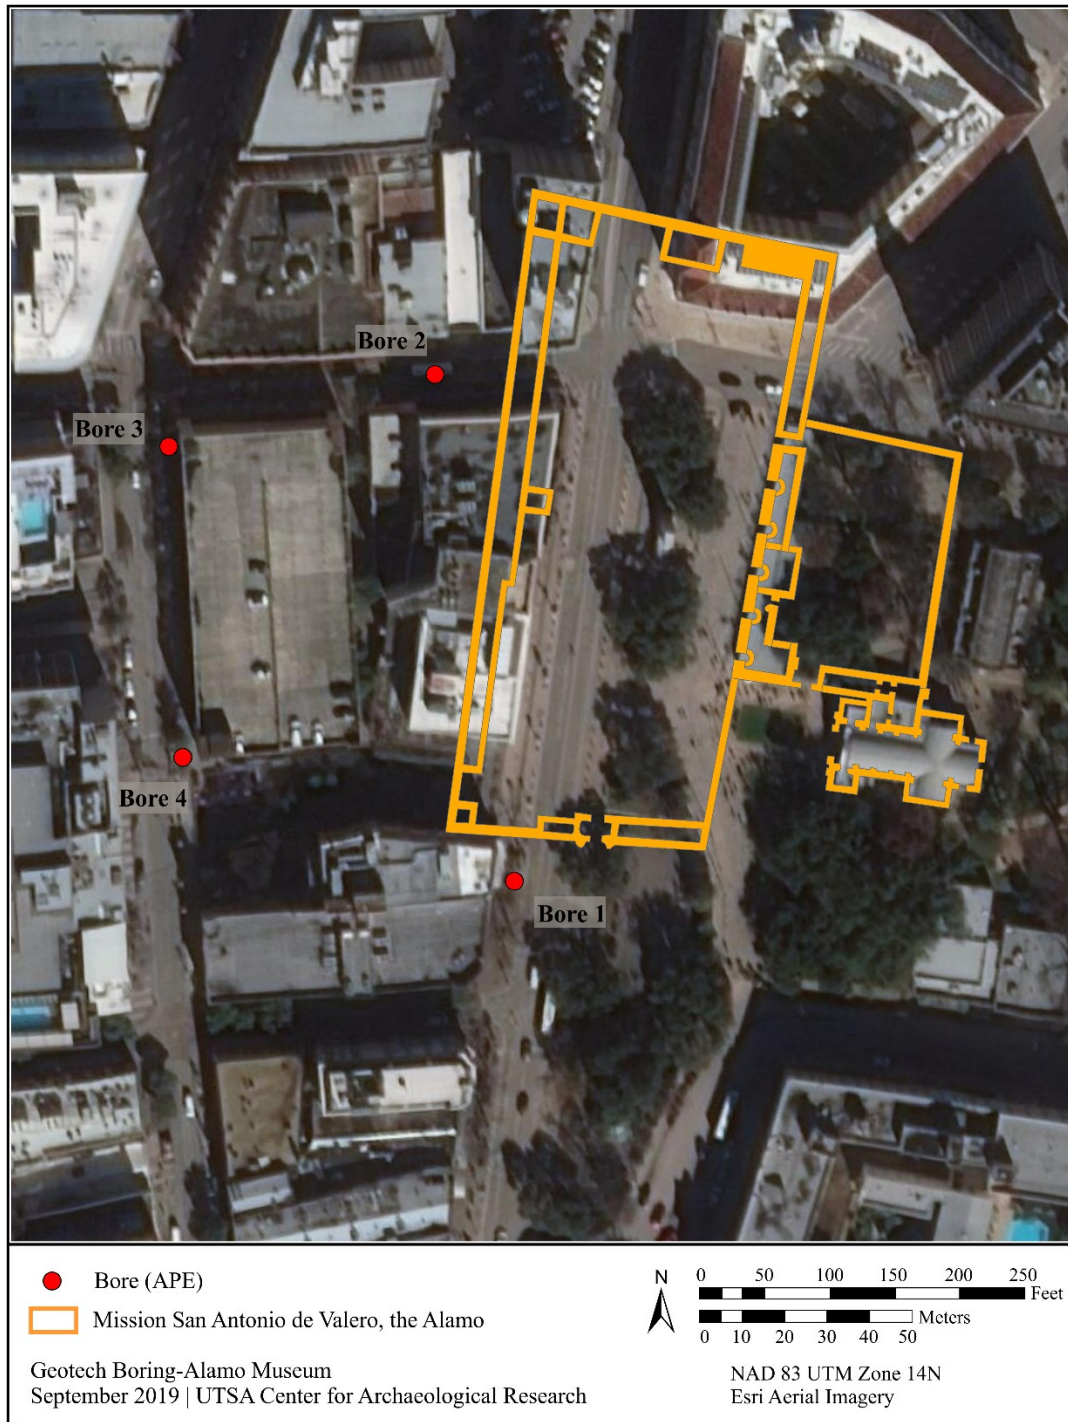
The APE was less than 0.004 hectare (0.01 acre) and consisted of the four geotechnical bore located along the 300 block of Alamo Plaza, on the 500 block of E. Houston Street, and on the 100 block of Losoya Street. The bores were on the street approximately 50 cm (19.7 in.) from the sidewalk (Figure 1-2).

*Figure 1-2. Location of the APE on satellite imagery.*

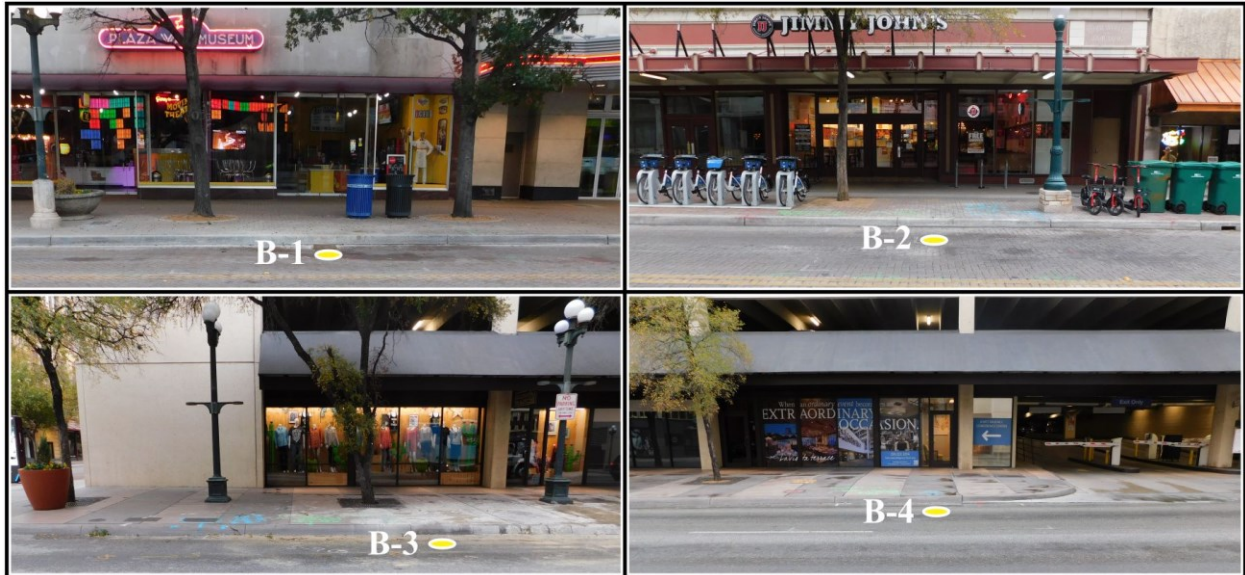
In November 2019, CAR staff monitored four geotechnical bores adjacent to Alamo Plaza. Bore B-1 was on the 300 block of Alamo Plaza, B-2 on the 500 block of E. Houston Street, and B-3 and B-4 on the 100 block of Losoya Street (Figure 4-1).

*Figure 4-1. Locations of B-1, B-2, B-3, and B-4.*

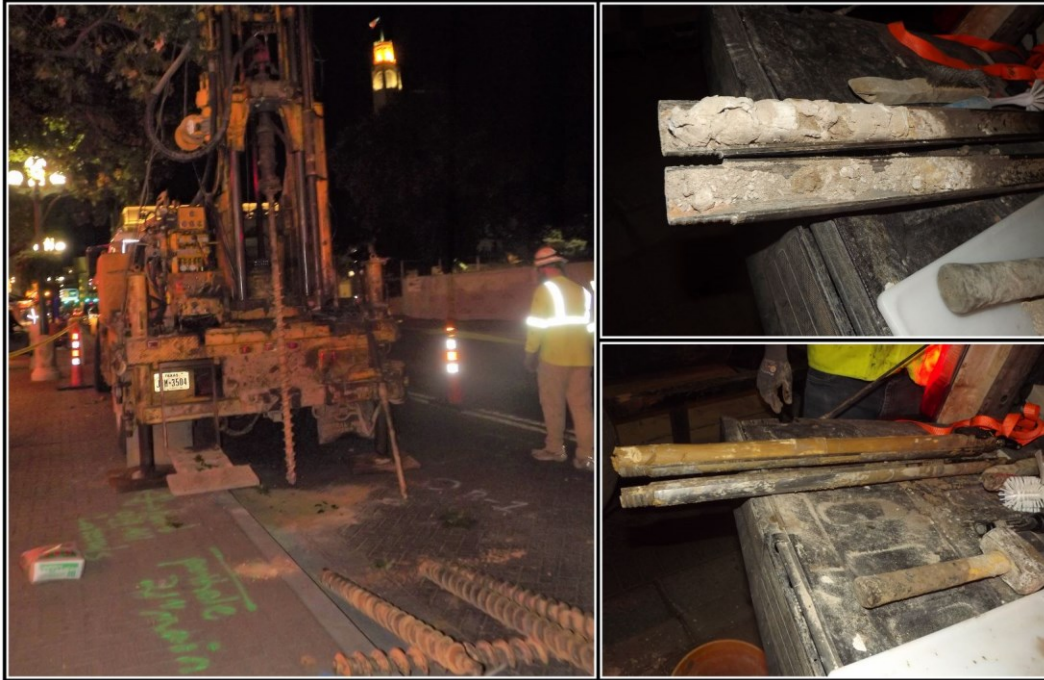
All boring occurred on the street, so that the initial auguring went through a 15.2-22.8 cm (6-9 in.) layer of asphalt pavement and concrete underlayment. The core samples were extracted using a truck-mounted rotary drill rig. This mechanical process involved a sequence of drilling and then hydraulically impelling a split-barrel sampling spoon in 1.5 m (5 ft.) segments. Figures 4-2 and 4-3 show the samples as they are in the process of being collected from the split-barrel sample spoon. Figure 4-2 shows geotechnical boring sample B-1 in front of 301 Alamo Plaza. Figure 4-3 shows geotechnical boring sample B-3 in front of 102 Losoya Street.

*Figure 4-2. Boring of B-1 in progress; sample 1 (top right) and sample 7 (bottom right).*

With the exception of B-3, the other three core samples were composed of light tan to light gray clays to a depth of 3 m (10 ft.). A white marl was recovered from the B-3 samples to a depth of 3 m (10 ft.). Silty gravelly clays were recovered from between 3-6 m (20 ft.) in all four bores.

CAR monitoring ceased at 6.1 m (20 ft.), a depth well below culturally sterile soils. No cultural material was observed during the drilling/sampling activities. Terracon submitted a separate geotechnical report to TCI.

The extracted soil samples were examined for cultural material. No cultural deposits were encountered during this project. However, given the restricted sample size and intrusive means of securing the samples, CAR recommends that any additional ground disturbances should be archaeologically monitored and/or tested. The THC concurs with CAR's recommendation that any additional ground disturbances in this area should undergo archeological investigation.

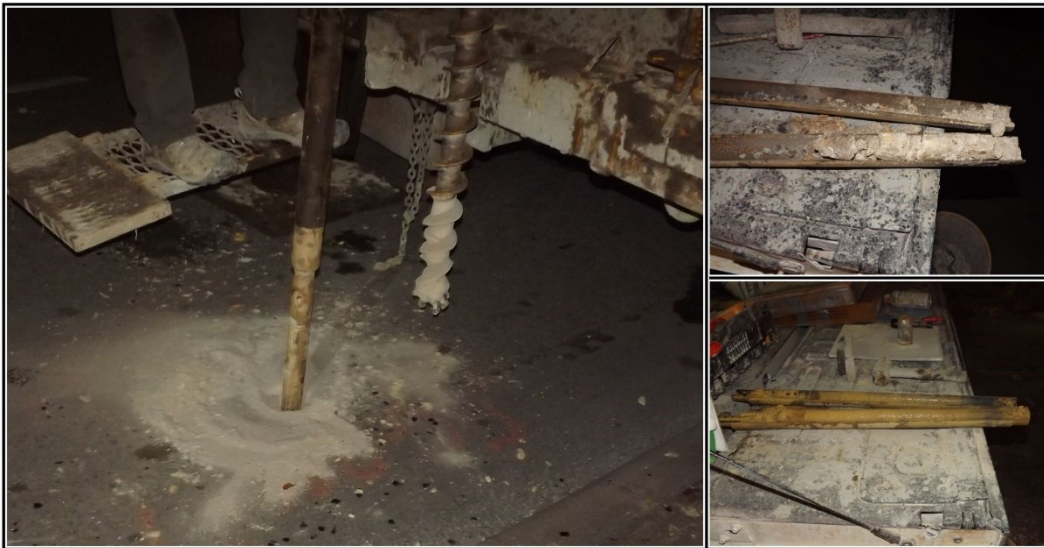
*Figure 4-3. Boring of B-3 in progress; sample 1 (top right) and sample 7 (bottom right).*
