Archeological Testing Associated with the Stabilization of the Convento at Mission San Juan Capistrano (41BX5), San Antonio, Bexar County, Texas

Center for Archaeological Research
The University of Texas at San Antonio
Archaeological Report, No. 358
©2005

Texas Antiquities Committee Permit No. 3655

Prepared for:
National Park Service
San Antonio Missions National Historical Park
San Antonio, Texas

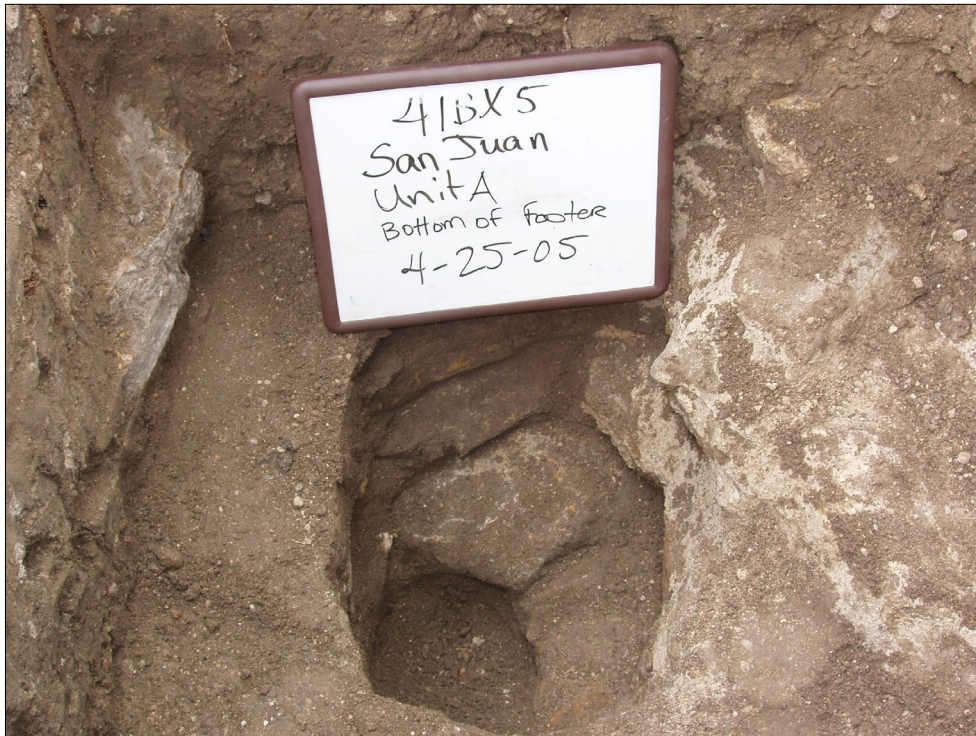
Figure 3-2. Shovel test excavated north of the footer in Unit A.

On April 25, 2005, the CAR crew returned to excavate an exploratory shovel test within Unit A to determine the depth of the footer (Figure 3-2). The shovel test measured approximately 50 cm in diameter. Level forms were not kept and the soil was not screened. Just below the footer, at about 90 cmbd, a course of stones was encountered that did not appear to be connected to the footer. The bottom of the stones was reached at 100 cmbd (40 cm below the terminal depth of the initially excavated unit).

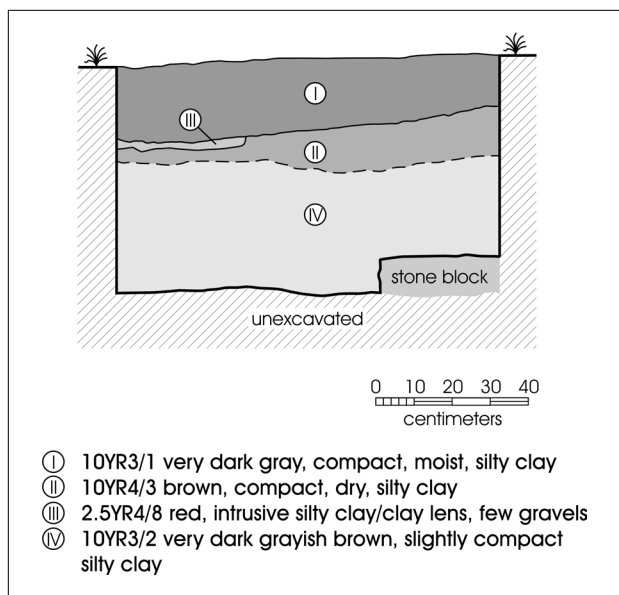
Figure 3-3. Profile of the south wall of Unit B.

Unit B was located along the east side of the convento (see Figure 2-1). This unit contained four stratigraphic zones. A cut-stone step feature was located along the west margin of the unit at 53–54 cmbd. It extended to the terminal depth of the unit, 60 cmbd (Figure 3-3). Stratigraphic Zone I consisted of a dark gray (10YR 3/1) moist silty clay. The second stratigraphic zone was a brown (10YR 4/3) dry silty clay. The third zone encountered in Unit B was a thin lens of red (2.5YR 4/8) clay that was not evident in the profile of the west wall. Zone IV consisted of a dark grayish brown (10YR 3/2) silty clay. Level 1 (0–20 cmbd) contained Zones I and II, while Level 2 (20–40 cmbd) consisted of Zones II, III and IV. The entirety of Level 3 (40–60 cmbd) consisted of Zone IV.

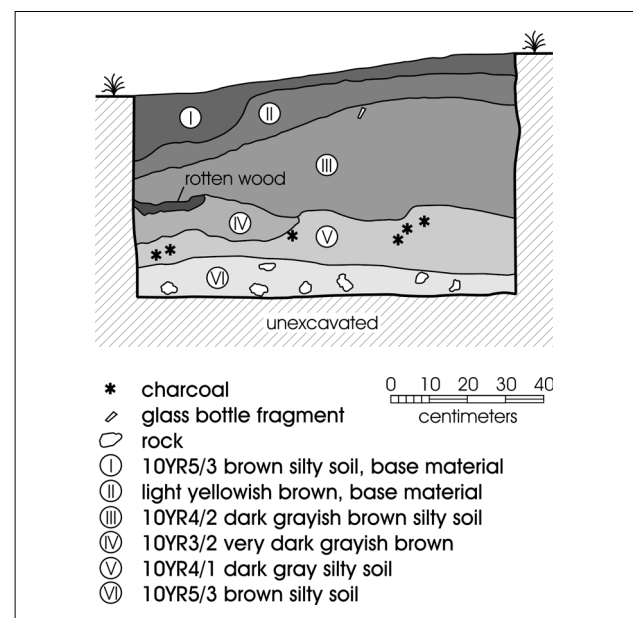
Figure 3-5. Profile of the north wall of Unit C.

Unit C was located on the northwest side of Room 19 (see Figure 2-1). Six stratigraphic zones were identified in the unit. Zones I and II consisted of a gravel fill, while Zones III through VI ranged from gray to brown silts (Figure 3-5). Level 1 consisted of stratigraphic Zones I and II, while Level 2 contained Zones III and IV. Level 3 (40-60 cmbd) included depositional Zones V and VI. Two pipes were encountered in Level 2 (20-40 cmbd). One was a 1-inch gray PVC pipe found at 30 cmbd (Figure 3-6). The second, a 2.5-inch gray PVC pipe, was encountered at 37 cmbd. Both pipes ran through the unit in an east-west direction and appeared to continue under the wall of Room 19. Directly under the pipes was a layer of ash in the eastern-most half of the unit that was disturbed matrix from the pipe installation. Excavation of this unit was terminated at 60 cmbd.

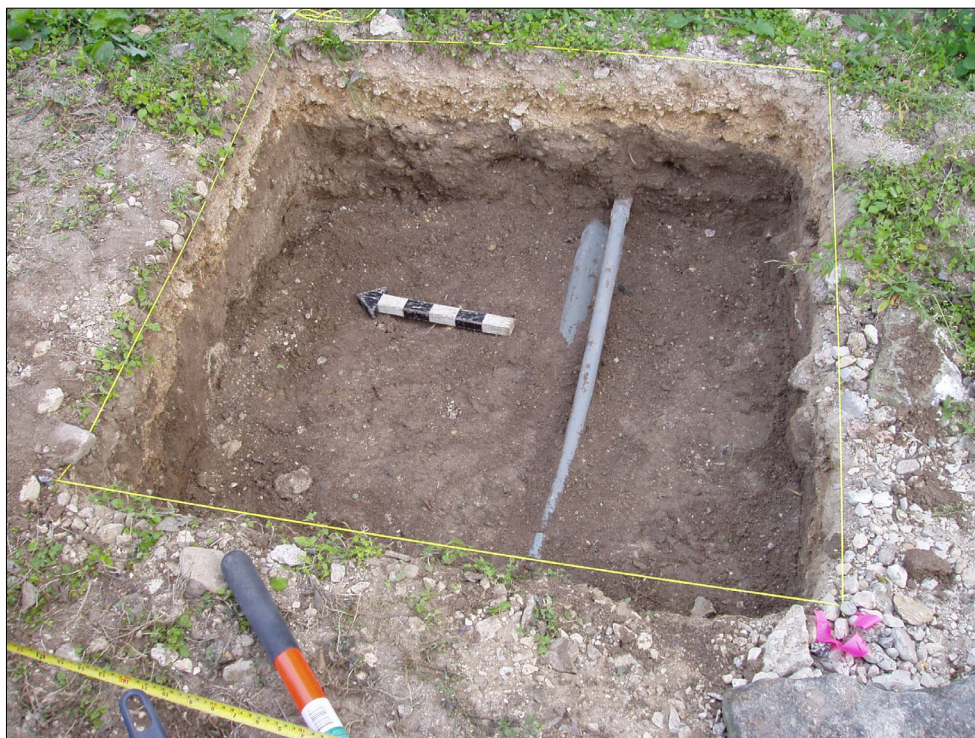
Figure 3-6. Pipes exposed in Unit C.

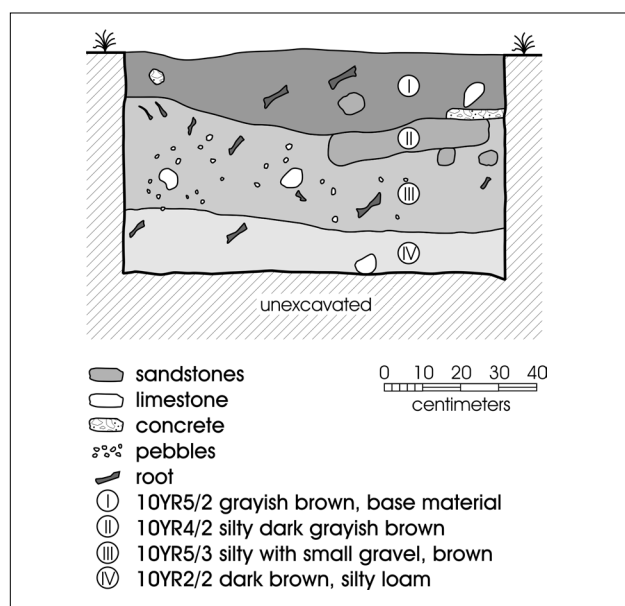
Figure 3-7. Profile of the east wall of Unit D.

Unit D was located on the south side of Room 21/Room 22 (see Figure 2-1). Four depositional/stratigraphic zones were defined in this unit. The first zone, contained within excavation Level 1 (0–20 cmbd), was heavily disturbed (Figure 3-7). The grayish brown (10YR 5/2) fill contained numerous chunks of concrete and sandstone construction refuse. The sandstone foundation of the building was exposed along the north wall of the unit during excavation. The second zone, which spanned Level 2 (20–40 cmbd) and extended into the top of Level 3 (40–60 cmbd), continued to exhibit signs of disturbance, although the matrix became less disturbed toward the bottom of the zone. The matrix in this zone was comprised of brown silty soil with small gravel inclusions. Stratigraphic Zone III consisted of a silty brown matrix and was contained within Level 2. The fourth stratigraphic zone included the majority of Level 3

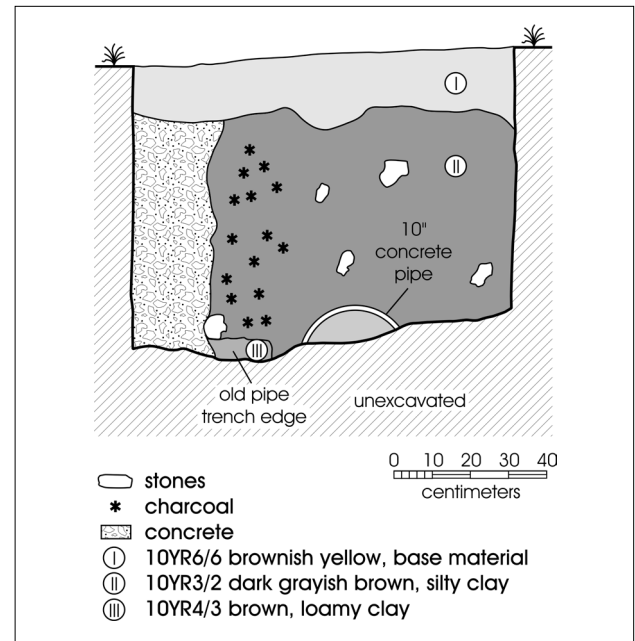
Figure 3-8. Profile of the west wall of Unit E.

Unit E was placed on the west side of the convento and abutting the north side of one of the buttresses (see Figure 2-1). Four stratigraphic zones could be distinguished in this unit. Zone I consisted of brownish yellow (10YR 6/6) fill that reached a maximum thickness of 18 cm and was entirely contained within Level 1. Beneath the fill, a layer of concrete that adjoined the buttress was noted along the south edge of the unit. It extended into the south portion of the unit approximately 20 cm (Figure 3-8). The remainder of the soil in the unit (Levels 2–4, 20–80 cmbd) consisted of a dark grayish brown silty clay with charcoal and stone inclusions. Stratigraphic Zone II extended through Levels 2–4, while Zone III was contained within Level 4. A 10-inch

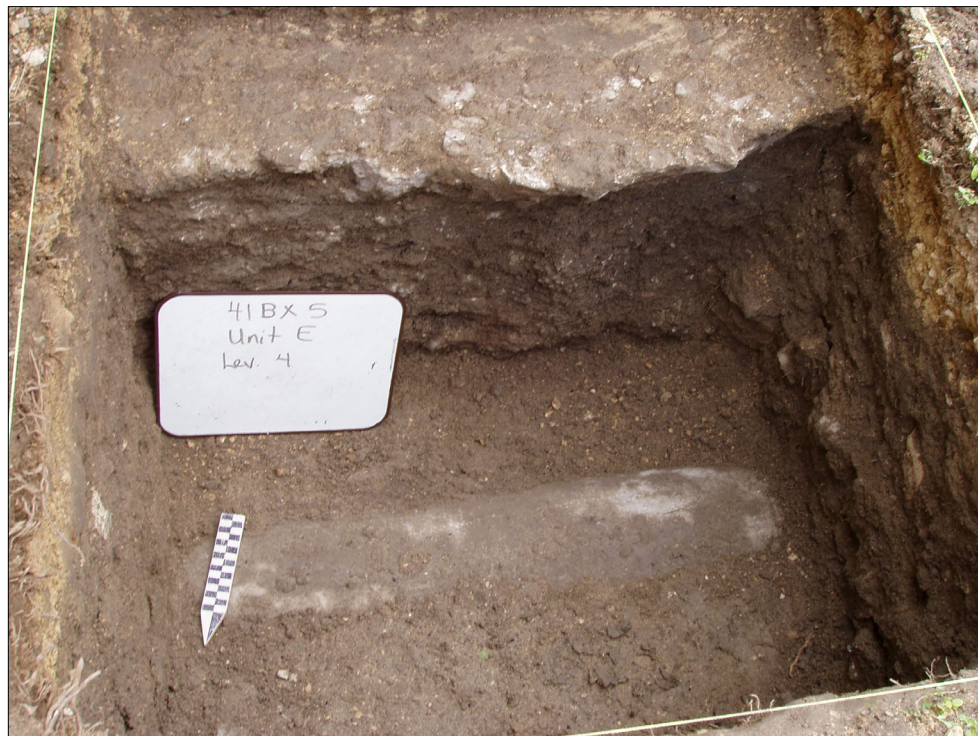
Figure 3-9. Pipe running parallel to buttress in Unit E.

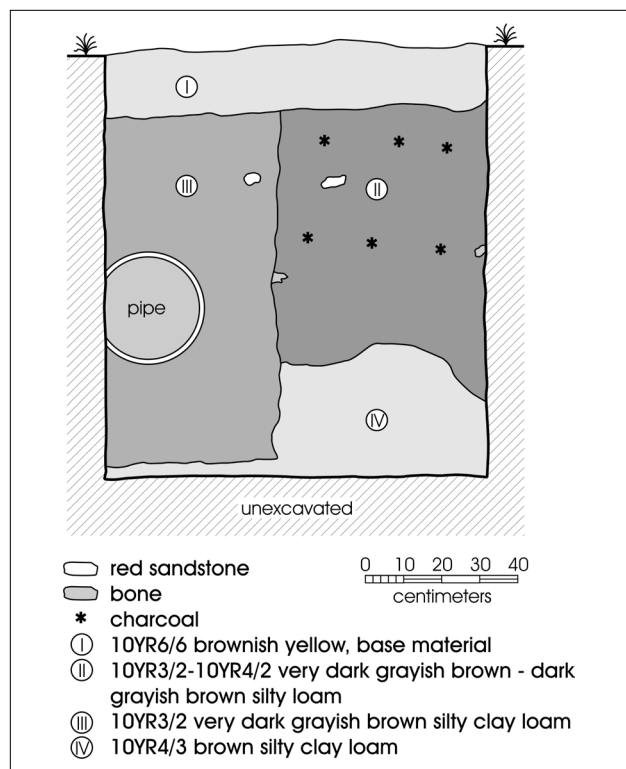
Figure 3-10. Profile of the north wall of Unit F.

(20-120 cmbd). It had very straight demarcation lines and ended in a flat surface, and represented trench fill (Figure 3-10). It consisted of dark (10YR 3/2) silty clay loam. A pipe was encountered at 54 cmbd and extended to a depth of 80 cmbd (Figure 3-11) within the trench fill (Zone III). Underneath the undisturbed matrix was a brown (10YR 4/3) silty clay loam which, on the west side of the unit, was contained within Level 6. Zone IV was contained within Levels 5 and 6 on the east side of the unit. The bottom of the buttress was encountered at 110 cmbd.

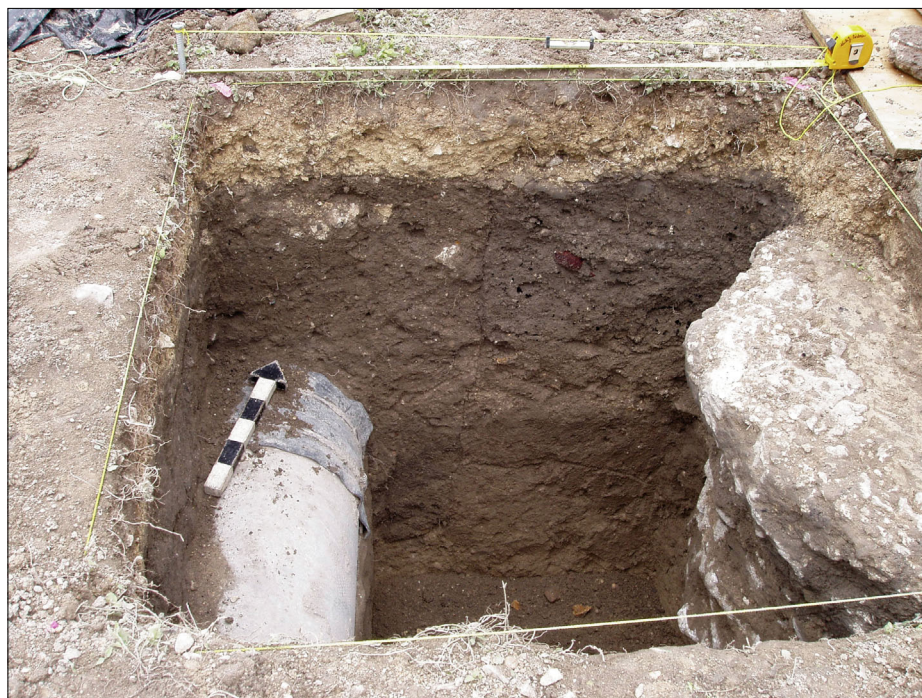
Figure 3-11. Pipe and buttress exposed in Unit F.

Finally, the excavation of Units E and F exposed the sub-surface portion of one of the buttresses of the convento. The condition of the building material is good and requires no improvements. In addition, and more importantly, it was determined that the buttresses serve no load-bearing functions and are strictly decorative. Therefore, at this time, no additional work will be carried out that will impact any of the buttresses surrounding the convento.

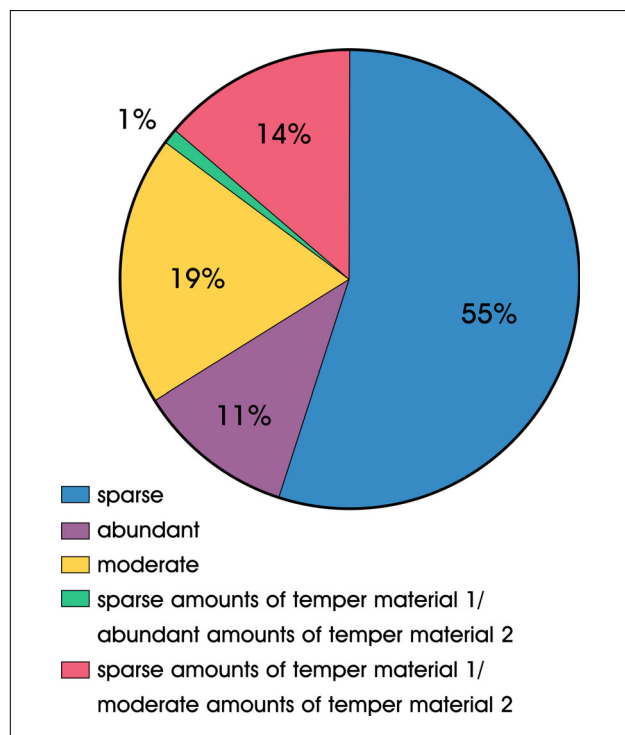
Figure 5-2. Percentages of temper material density in Goliad ceramics.

temper, and 19% contained moderate amounts of temper (Figure 5-2). In cases when bone was not the only tempering agent, but sand and/or sandstone were also included, sandstone was significantly more common than sand.

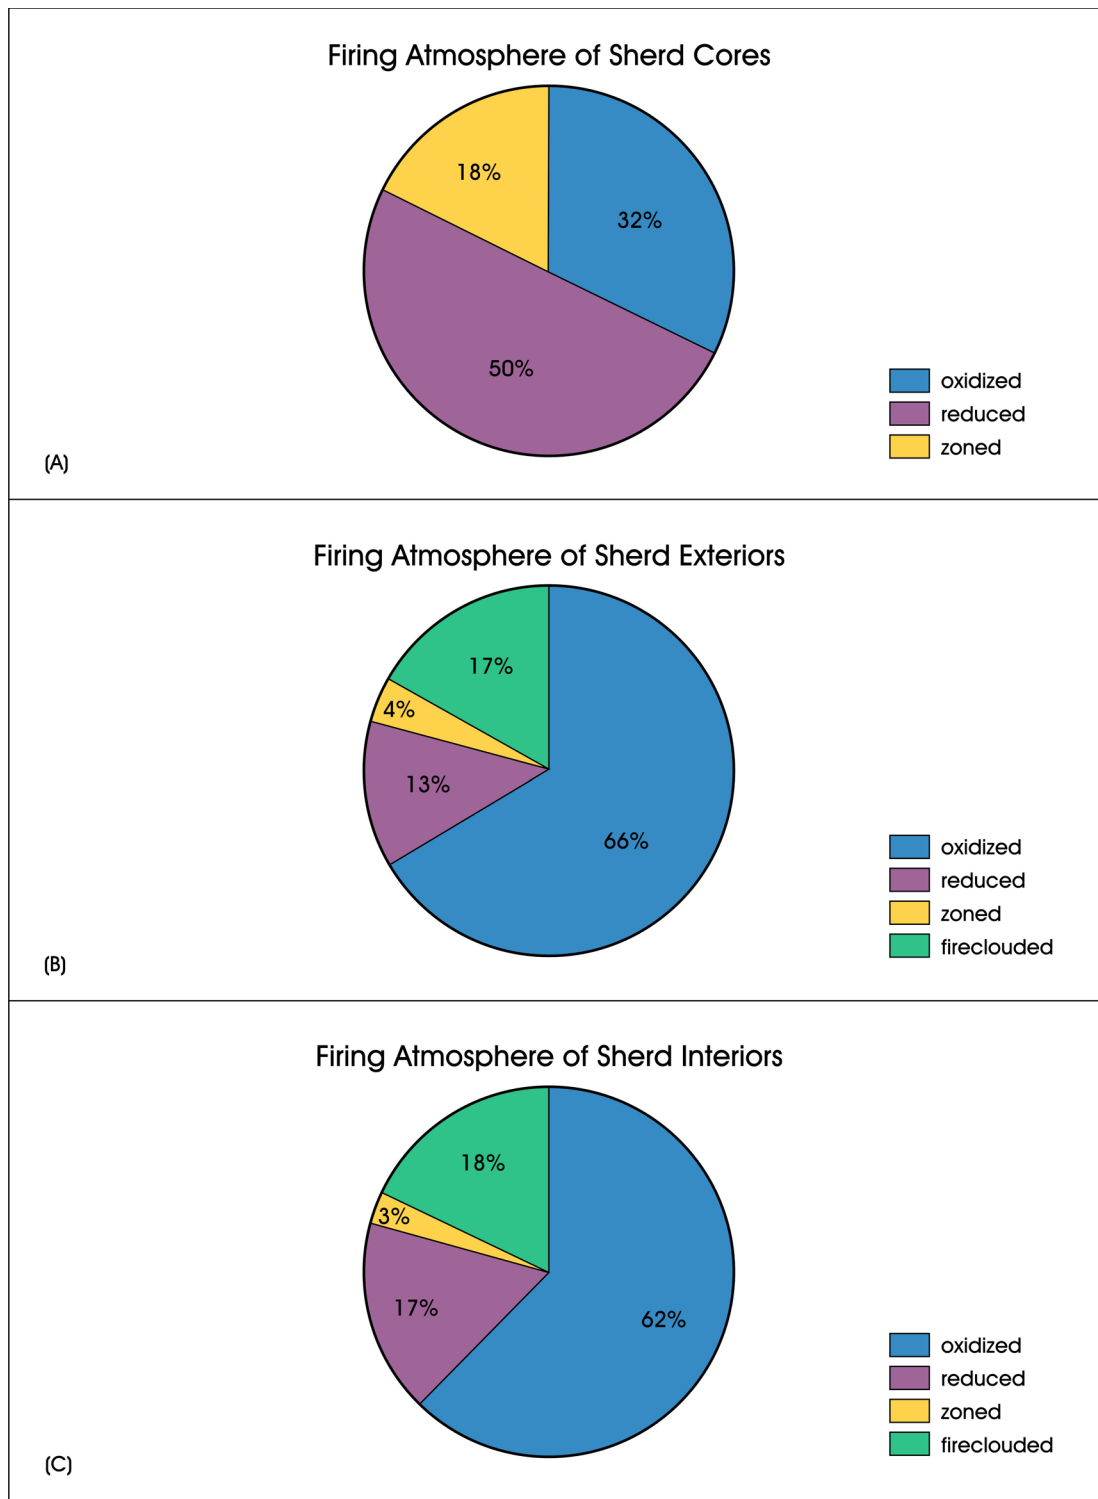
Figure 5-3. The firing atmosphere of Goliad sherd cores, exteriors and interiors (percentages).

The firing atmosphere was determined by examining the color of the vessel sherd. It is assumed that the potters of Goliad wares used an open fire technique. Typically, open fires are used for low-fired, unglazed wares, and there is considerable variation in the temperature with this technique (Rice 1987:156). The colors of brown, gray or black signal reduced firing, which indicates insufficient oxygen. This atmosphere usually occurs in low-temperature or short-period firing. Lighter-colored sherds, such as red and orange, indicate oxidization, which is characterized by sufficient oxygen in the firing atmosphere. Examination of the sherd cores shows a higher percentage (50%) were reduced, followed by oxidized 32%, and a very small percentage were zoned (18%; Figure 5-3a). A majority of the sherds analyzed had oxidized exterior surfaces (66%; Figure 5-3b), while the remainder exhibited fireclouded (17%), reduced (13%), and zoned (4%) exterior surfaces. The interiors of the sherds had a higher percentage of oxidized surfaces (62%), followed by fireclouded (18%) and reduced (17%) surfaces (Figure 5-3c). Alteration of the vessel color can also occur during its use and the post-depositional environment (Rice 1987).

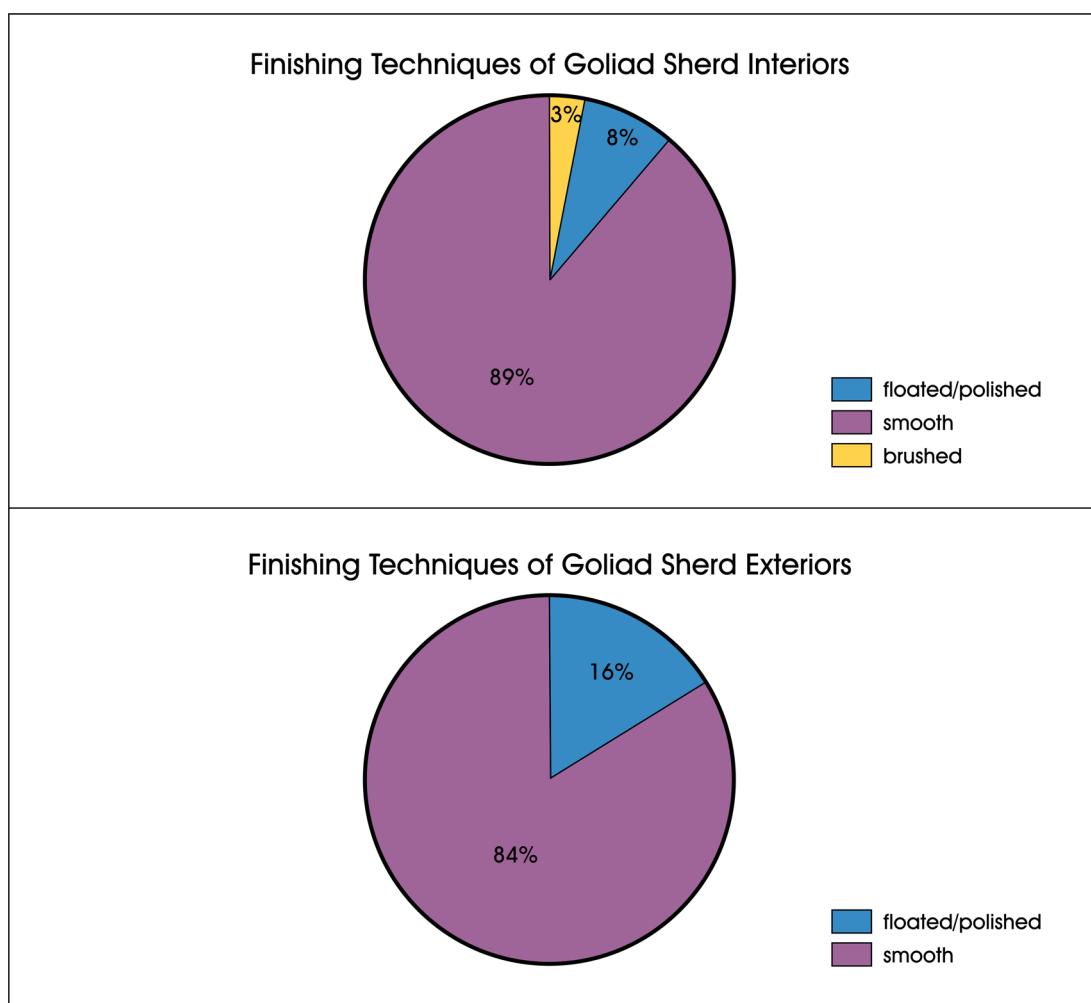
Figure 5-4. Finishing techniques of Goliad sherd interior and exterior surfaces (percentages).

The finishing and decoration of Goliad sherds was noted for both the interior and exterior portions of the sherds (Figures 5-4 and 5-5). The majority of sherd interiors (89%) and exteriors (84%) were recorded as smooth (Figure 5-4). The terms floated and polished were used to indicate sherd surfaces that were smoothed intentionally (Ulrich et al. 2005). Sixteen percent of sherd exteriors exhibited signs of polishing or floating, while this finishing technique only appeared on 8% of sherd interiors. Minimal decoration was seen on the examined sherds (Figure 5-5). One rim sherd was painted on the interior with red paint. Eight percent of the sherds had evidence of smudging on the interior, which is a characteristic of open firing (Rice 1987:158). Asphaltum, which may have been applied for decoration or mending purposes, was evident on the exterior of 3% of the sample sherds. Goliad ceramics at Mission Espíritu Santo rarely had decorated surfaces compared to Mission Rosario ceramics (Ricklis 2000; Ulrich et al. 2005). Forty-three percent of the Goliad ceramics sample from Rosario displayed asphaltum decoration (Ricklis 2000:106).

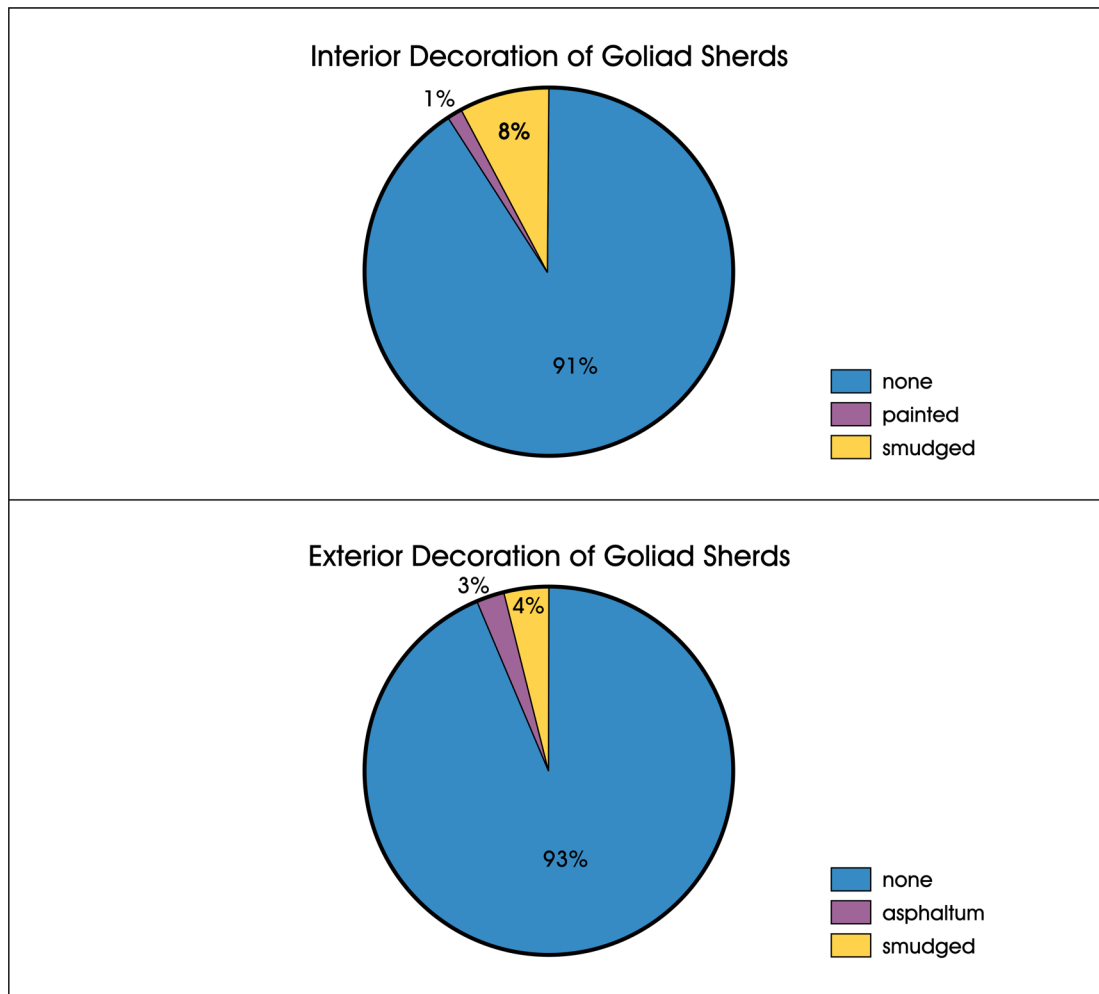
Figure 5-5. *Decoration of Goliad sherd interior and exterior surfaces (percentages).*
