Archaeological Monitoring for Fiber Optic Cable in Multiple Locations near Downtown San Antonio, Bexar County, Texas

Texas Antiquities Permit No. 9060

Prepared by:
Center for Archaeological Research
The University of Texas at San Antonio
One UTSA Circle
San Antonio, Texas 78249-1644
Technical Report, No. 91

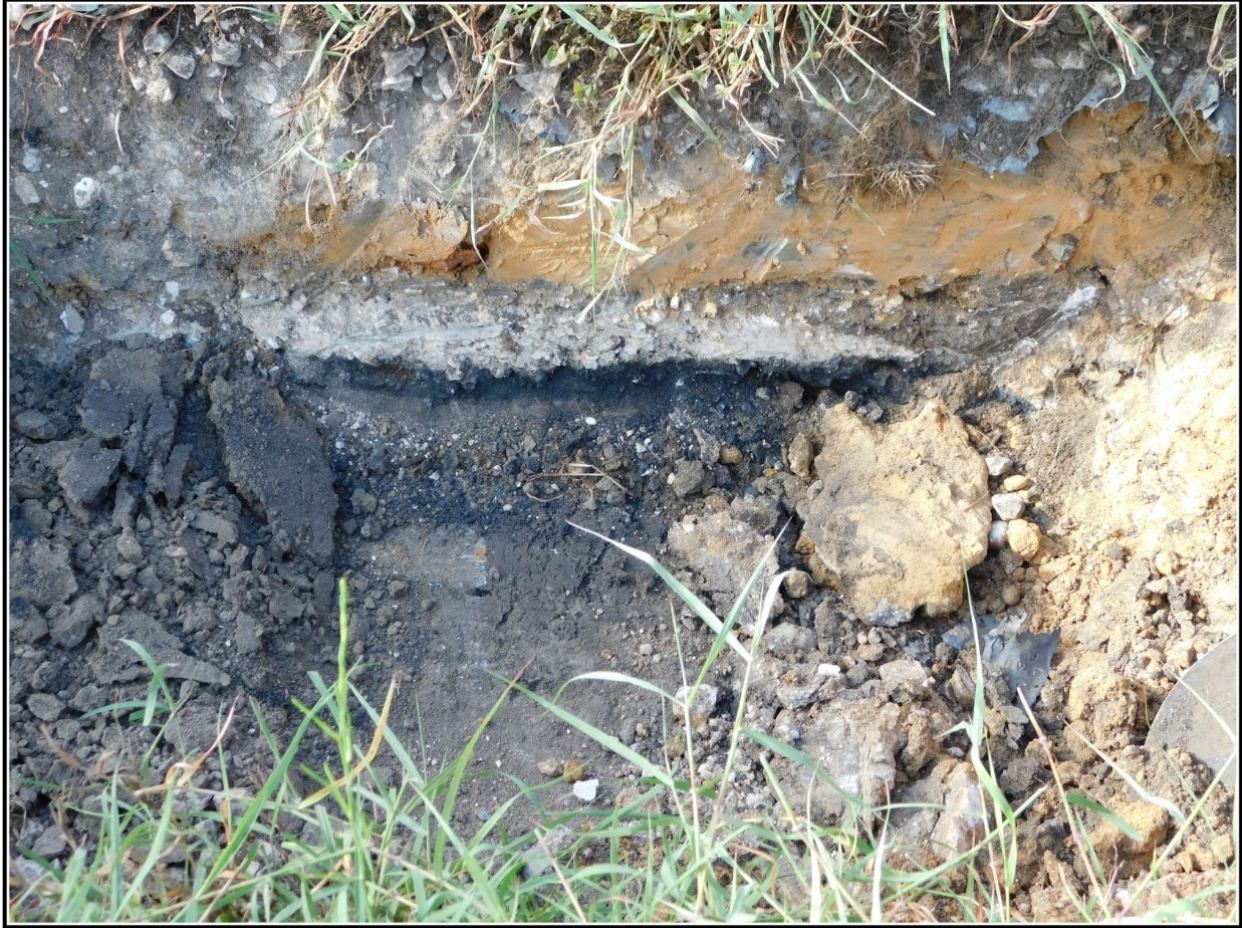
Figure 4-2. Pit excavation within Project Area 1 near Zircon and Laredo.

Monitoring occurred in primarily three areas. The first area begins at the I-10W frontage road and continues north along N. Laredo Street to Zircon Street (Figure 4-2). CAR monitored five pits on September 9 and 12, 2019. The pits measured 2.3 m (7.5 ft.) long, 1 m (3 ft.) wide, and 1.2 m (4 ft.) deep. CAR screened fill from two of the five excavated pits. No artifacts were recovered. The remaining three pits were in disturbed contexts and not screened.

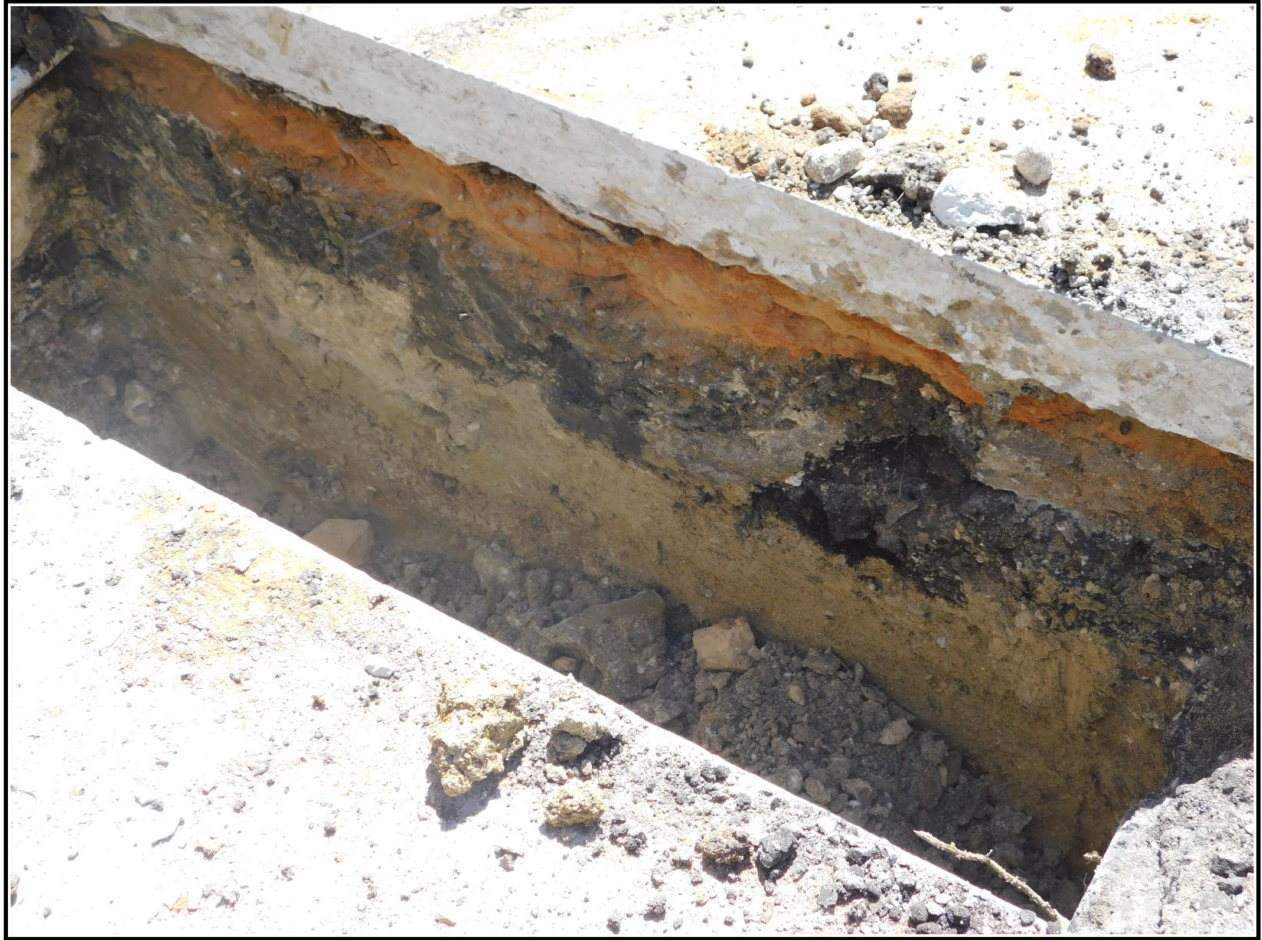
Figure 4-4. Pit excavation within Project Area 2 near Flores Street and Park Court.

CAR monitored two pits in the second area on the west and east side at the intersection of N. Flores Street and Park Court on September 25, 2019 (Figure 4-4). These pits are located outside of Project Area 2. The COSA-OHP and the THC was informed of this error on February 1, 2021 and the area was added to Project Area 2. The west side pit measured 1.21 (4 ft.) long, 0.01 m (3 ft.) wide, and 1.21 (4 ft.) deep. Fill from this pit was not screened due to the presence of a utility, rebar, and asphalt. The east side pit measured 1.21 m (4 ft.) long, 0.6 m (2 ft.) wide, and 1.21 (4 ft.) deep. Asphalt was also observed in this pit, and the fill from it was not screened.

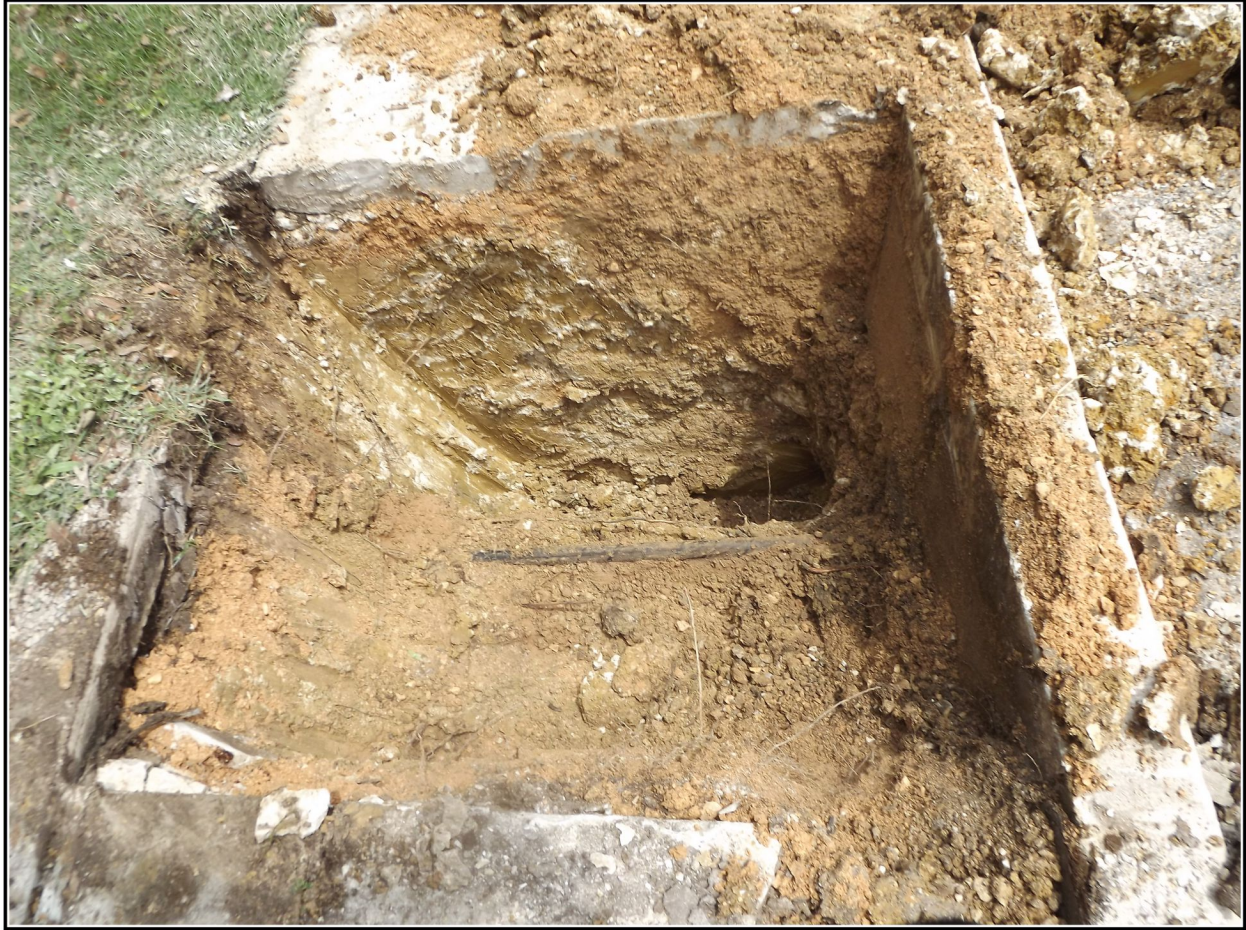
Figure 4-6. Excavation within Project Area 4 on Euclid St.

The first area is located on E. Park Avenue between E. Euclid Street and E. Elmira Avenue. From north to south, CAR monitored the excavation of six pits on April 9, 2020. Three pits were excavated on E. Euclid Street from west to east (Figure 4-6). The first two pits on the west side of the street were approximately 1.20 m (4 ft.) long, 1.25 cm (4 ft.) wide, and 1.0-1.35 m (3-4 ft.) deep. The soils from the two pits were mottled, and utilities were found in both pits. A third pit on the west side of street measured 2.1 m (7 ft.) long, 0.70 m (2 ft.) wide, and 0.93 cm (3 ft.) deep. The soil was dark brown silty clay. A sample was

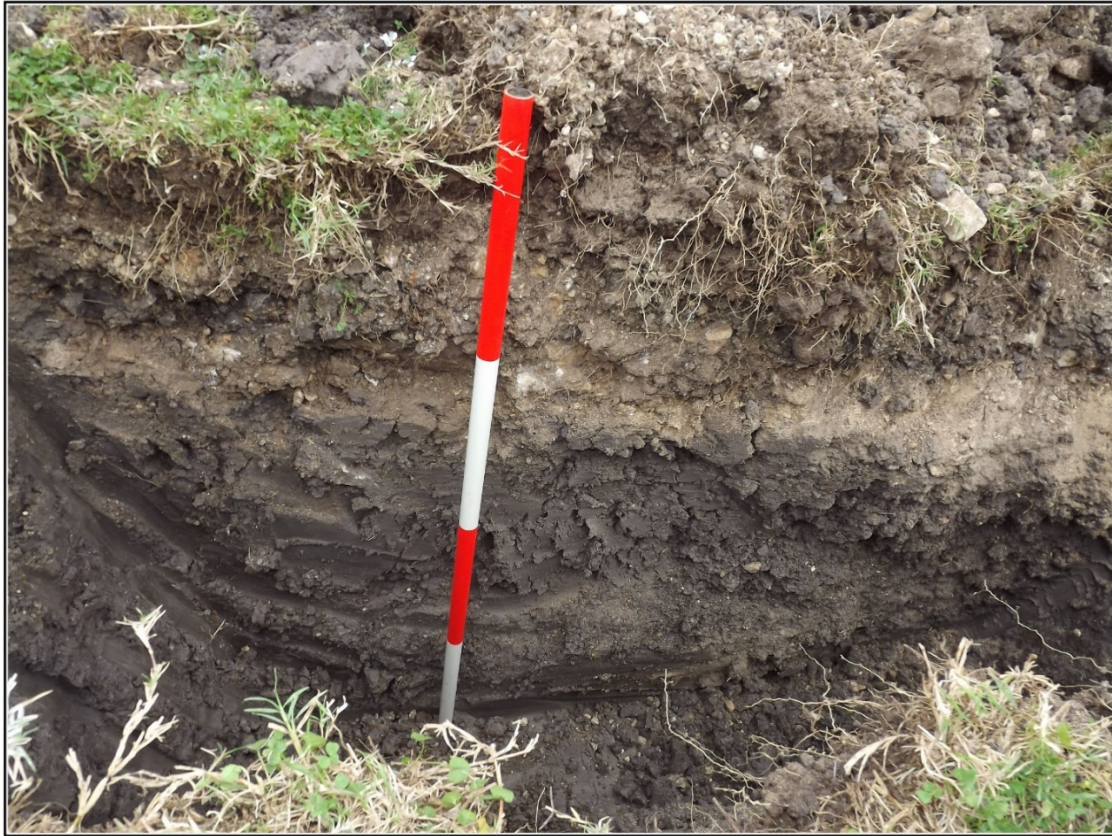
Figure 4-8. Excavation within Project Area 6 on San Marcos Street.

CAR monitored the excavation of seven pits and one trench in Project Area 6. No artifacts were collected, and no features were documented. All excavations contained modern debris, construction material, added fill, and/or active utility lines. Therefore, no matrix samples were screened from any of the excavations. There was no indication of the Alazán Ditch at the Perez Street and S. San Marcos Street intersection. The ditch may be located elsewhere, be more deeply buried than the extent of excavations, or may have been impacted at this location by construction.

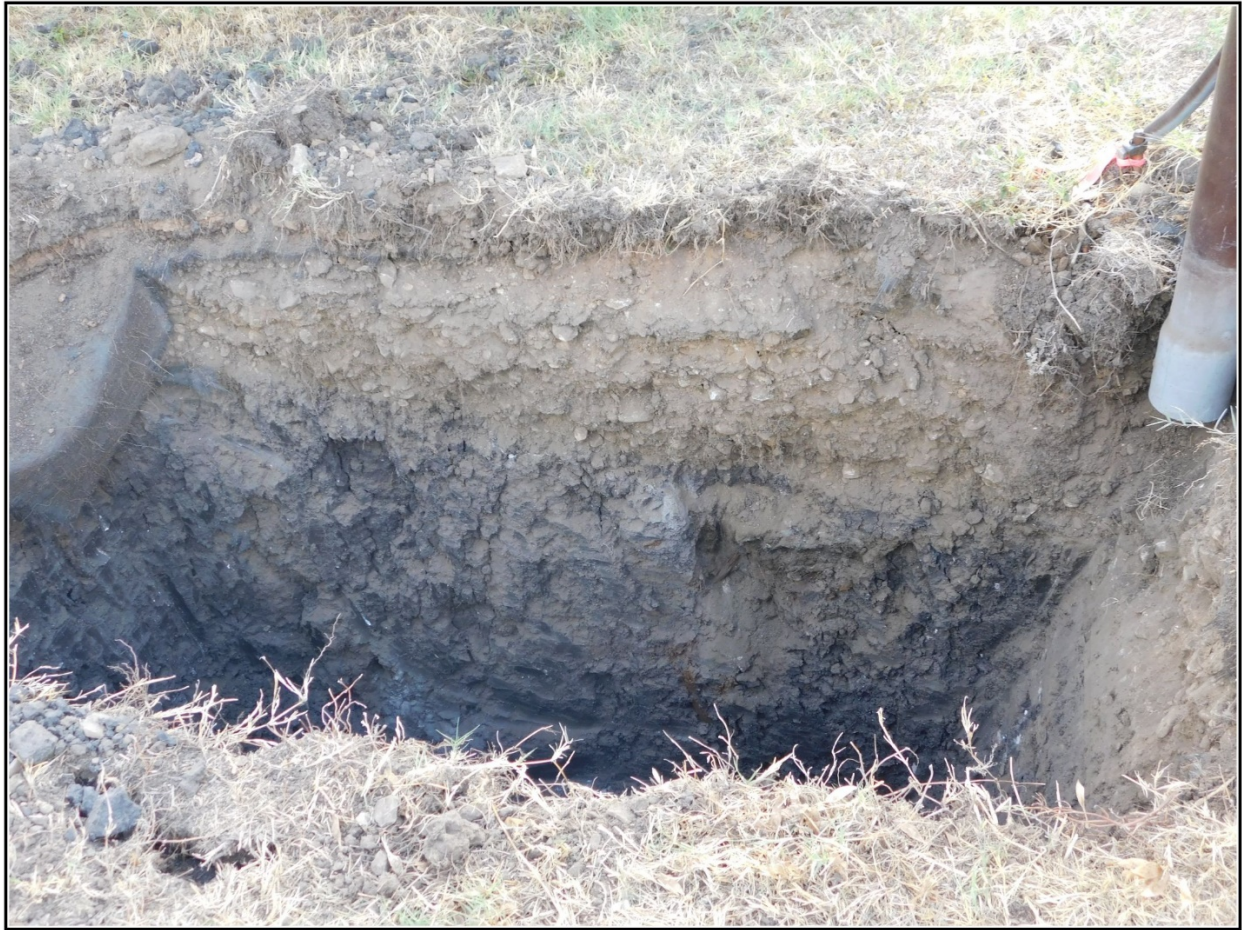
Figure 4-10. Excavation within Project Area 7 on Martin Street.

Two pits were excavated and monitored on September 13, 2019, at the intersection of W. Martin and N. Comal streets (Figure 4-10). The pits measured 2.3 m (7.5 ft.) long, 1 m (3 ft.) wide, and 1.2 m (4 ft.) deep. The fill was not screened from either pit because both contained existing utilities.

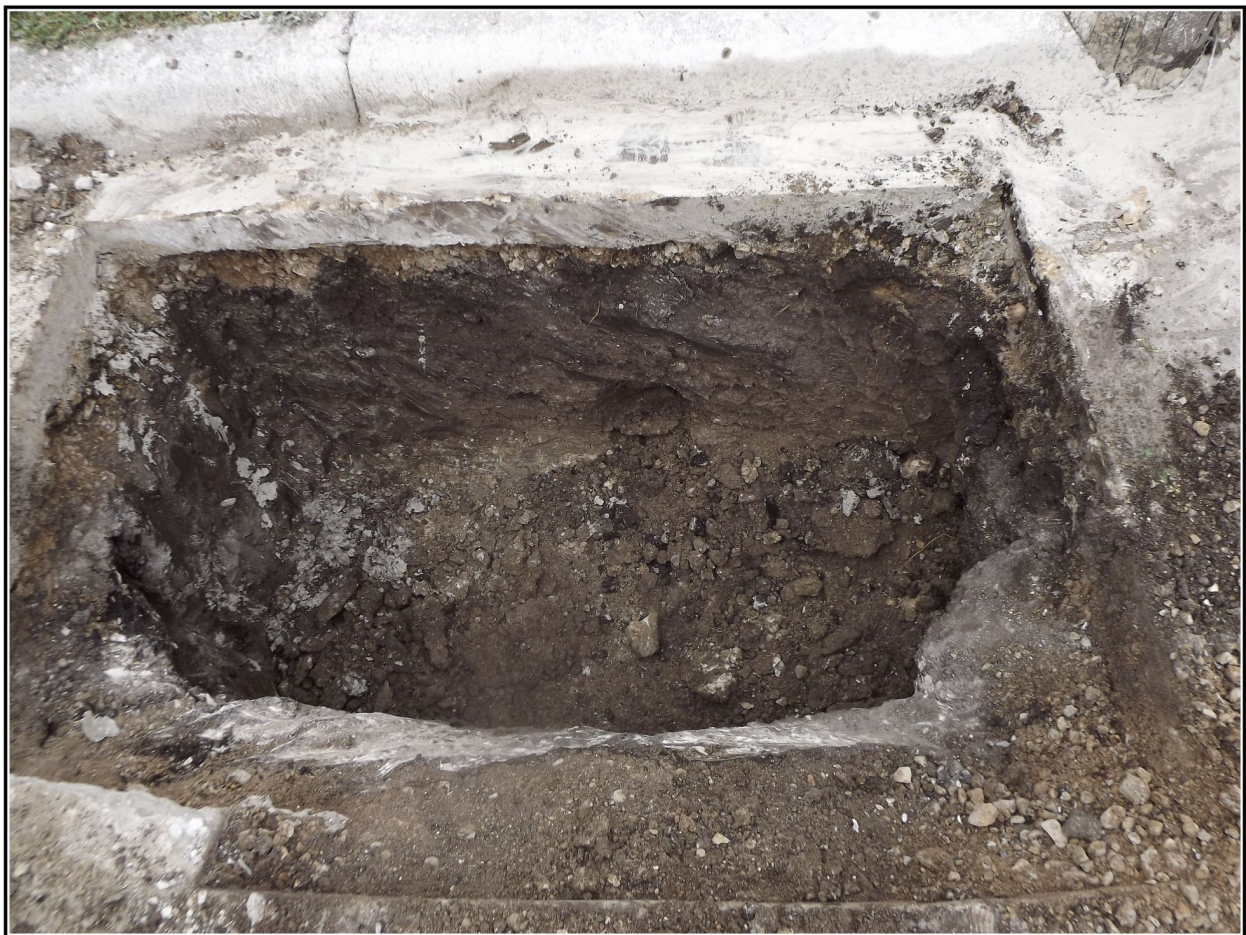
Figure 4-16. Excavation within Project Area 8-4 located on Guadalupe Street.

The project began on the north frontage road of Guadalupe Street with the excavation of five pits (Figure 4-16). The pits measured 0.9 m (3ft.) long, 0.9 m (3 ft.) wide, and 1.2 m (4 ft.) deep. One of the pits was hydro vacuumed. No fill from the pits was screened due to evidence of prior disturbance. Two of the pits contained yellow sandy clay over brown clay, and two contained red sandy clay over brown clay. No artifacts or features were noted. A trench and two pits were also excavated at the southwest corner of S. Frio Street and El Paso Street. Multiple underground utilities were marked at this location. The trench is 9 m (30 ft.) long and 1 m (3 ft.) deep. The width was not recorded. The soil profile showed evidence of multiple impacts from utility trenches. No artifacts or features were recorded, and the fill was not screened. The first pit was 1 m (3 ft.) long, 1 m (3 ft.) wide, and 1 m (3 ft.) deep, in a disturbed context. The second pit was 2 m (6.5 ft.) long, 1 m (3 ft.) wide, and 1 m (3 ft.) deep. The upper 30 cm (12 in.) was a light brown clay over construction fill. No artifacts or features were recorded, and the fill was not screened.
