**Archaeological Testing and Monitoring for a  
Proposed Drainage Channel at Mission San  
Juan Capistrano, San Antonio, Texas**

Texas Antiquities Permit No. 1748

©copyright 1998  
Center for Archaeological Research  
The University of Texas at San Antonio  
Archaeological Survey Report, No. 283

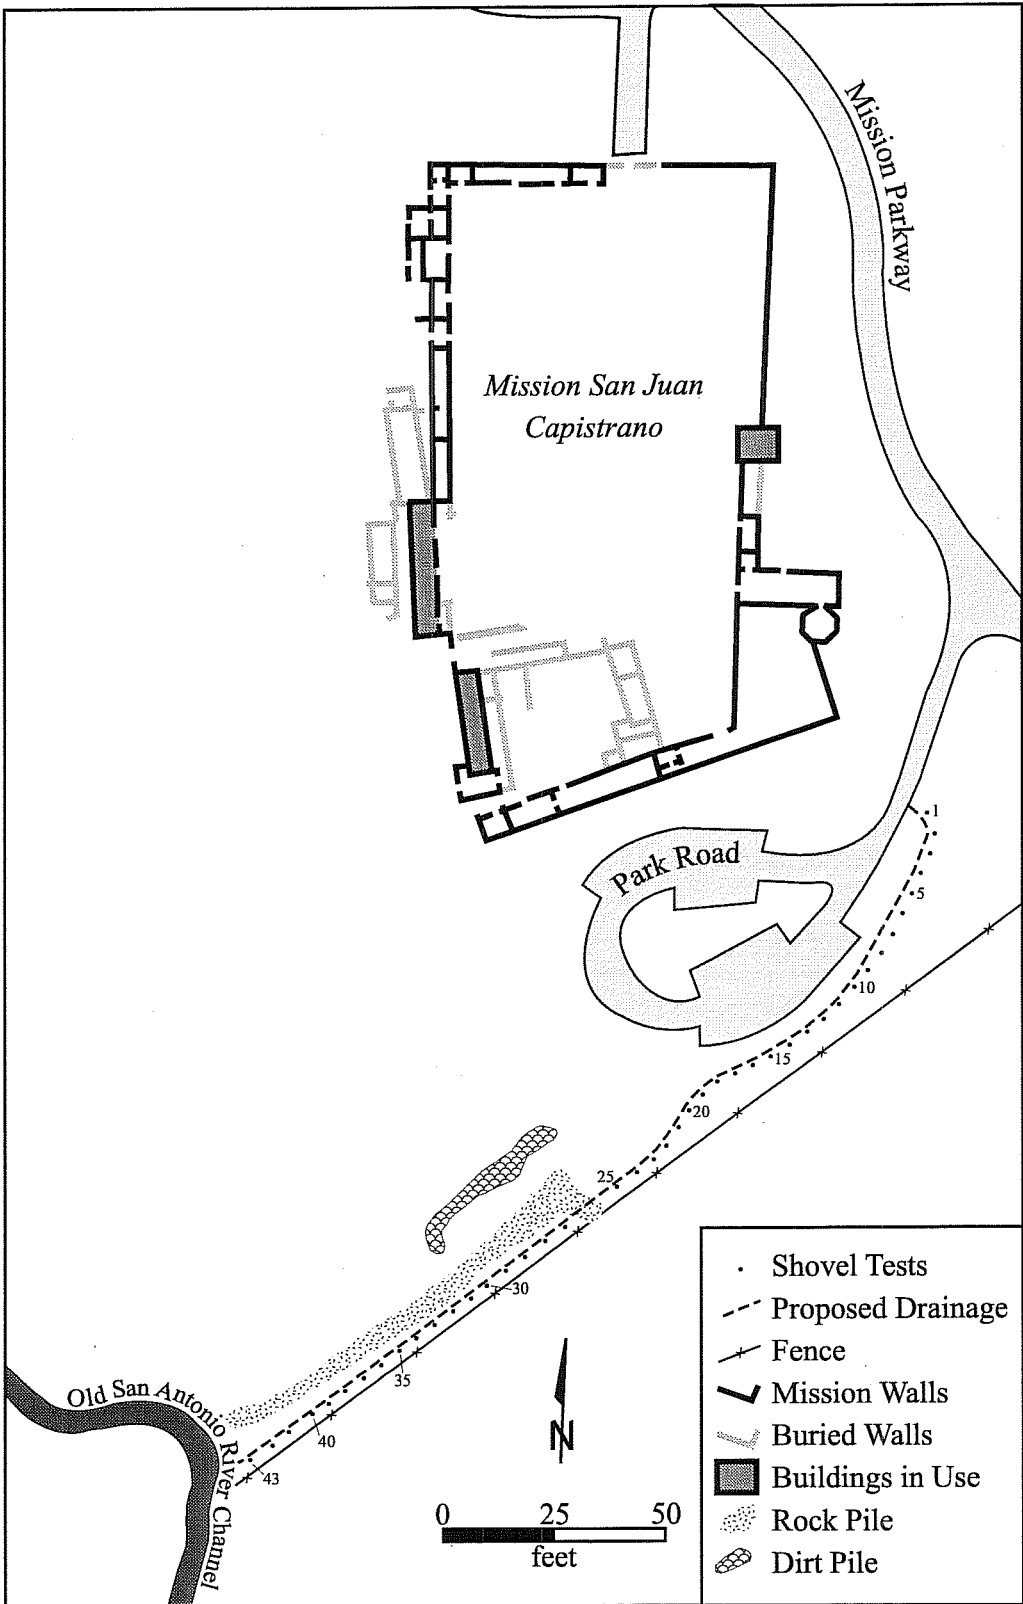
Figure 2. Plan view of Mission San Juan Capistrano.

Forty-three shovel tests (STs) were excavated at five-meter intervals along the route of the drainage channel (Figure 2). STs 26 and 27 were not excavated because of a large amount of gravel and caliche stockpiled on the surface of this portion of the route. The tests were excavated in 15-cm levels to a maximum depth of 60 cm below the surface. Soils were screened through ¼-inch wire mesh. Shovel-test locations were plotted on a site map generated from the engineering plan provided by NPS.
