**TESTING OF THE SAN JOSE MISSION ACEQUIA,
SAN ANTONIO MISSIONS NATIONAL HISTORICAL PARK,
BEXAR COUNTY, TEXAS**

Texas Antiquities Committee Permit No. 1007

**Center for Archaeological Research
The University of Texas at San Antonio®
Archaeological Survey Report, No. 207
1991**

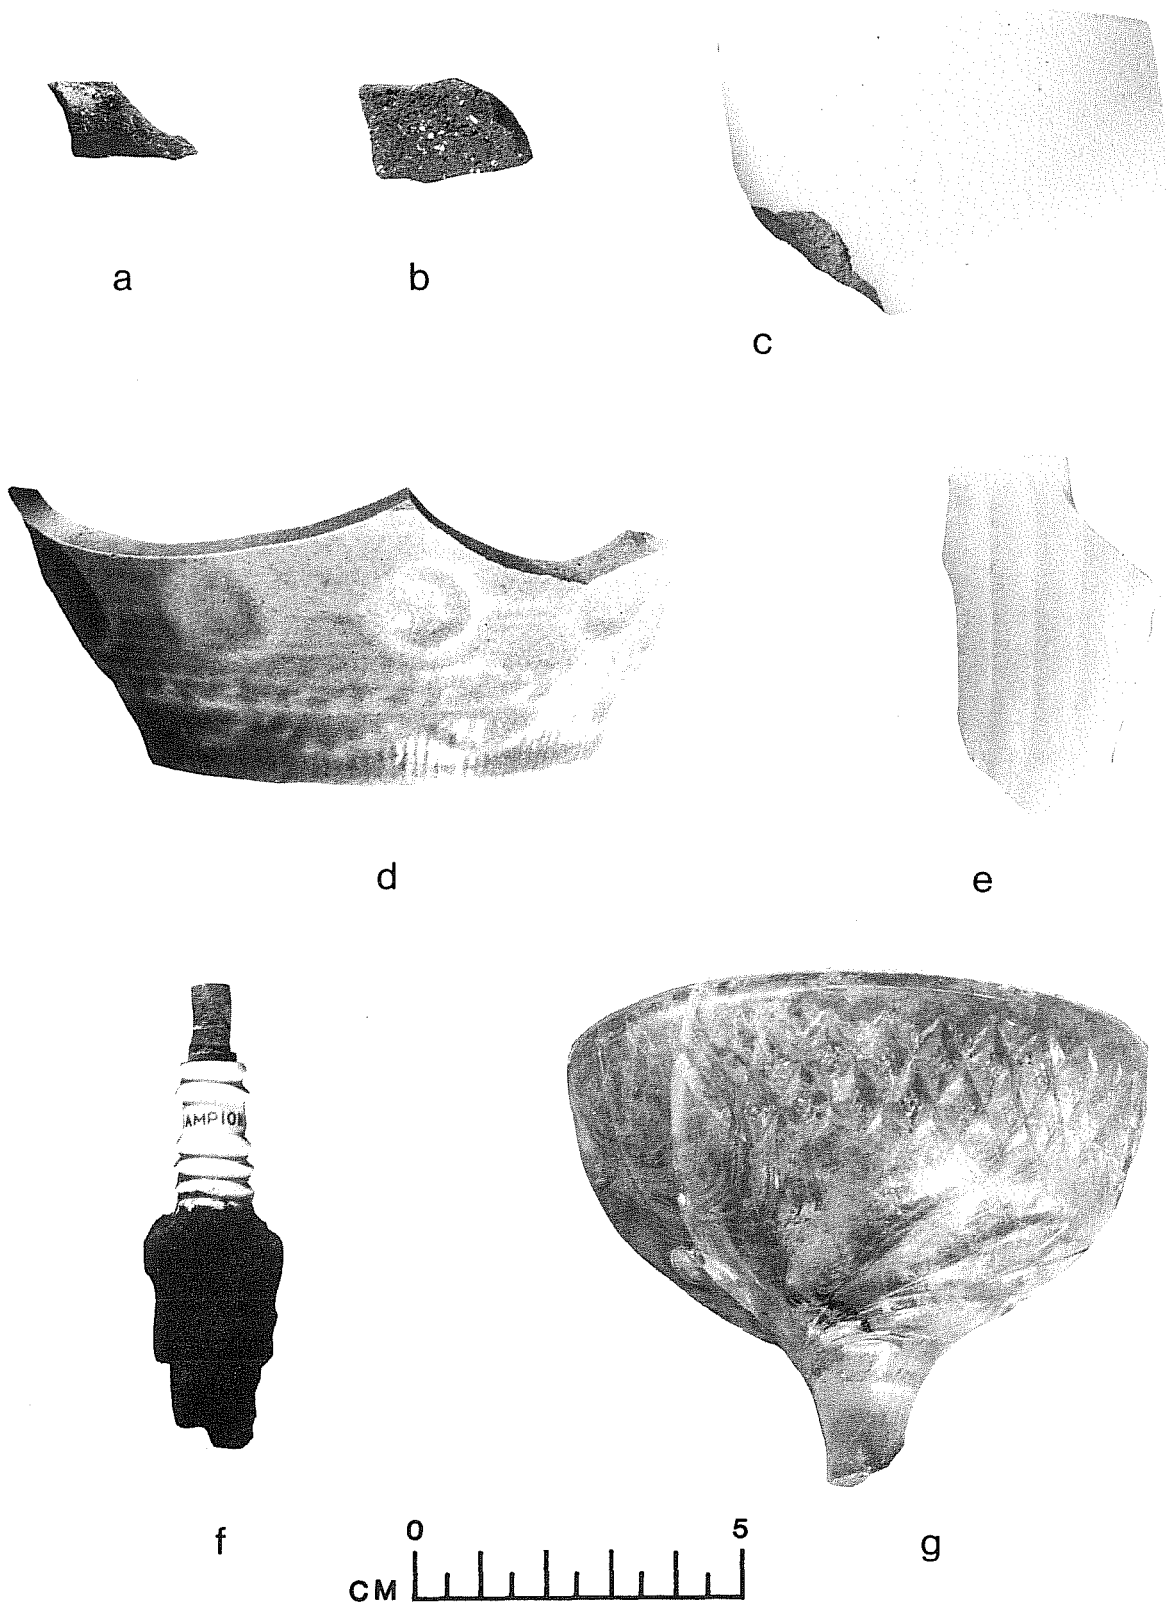
Figure 4. *Artifacts.* a,b, *Goliad* ware, Test Trench 3; c, whiteware cup, Test Trench 1; d, stoneware bowl, Test Trench 3; e, fluted glass vase, Test Trench 1; f, spark plug, Test Trench 3; g, goblet, Test Trench 3.

Artifacts recovered were in the top two feet of fill and included the following: five whiteware cup sherds, 20th century (Fig. 4,c); six glass container

sherds, brown, green, and clear, beer and soda; one ribbed white glass vase sherd (Fig. 4,e); one animal bone fragment, probably cow; one tin can top; one golf club head; one molded black plastic fragment; and one mirror glass fragment. These all appear to be related to post-1900 occupation in this area.

The stratification within the trench was similar to that found in Trenches 1 and 2, with the addition of a layer of humus-stained loam at the surface that was not clearly visible in the two previous trenches (Fig. 6). The same irregular outline of the ditch was visible where it was cut into the caliche gravel subsoil as was observed by the SDHPT crew (Henderson and Clark 1984:Figs. 11 and 12). In addition, the very bottom of the ditch yielded a sherd of Indian-made *Goliad* ware and a few bone fragments, similar to the artifacts found farther south in the ditch in 1984 (Henderson and Clark 1984:Fig. 11). The only other artifacts found were in the first stratum: one stoneware bowl sherd, blue-spattered design (Fig. 4,d); three pale green glass goblet sherds (Fig. 4,g); three clear glass bottle sherds; one spark plug "CHAMPION H-10" (Fig. 4,f); and one window glass fragment.

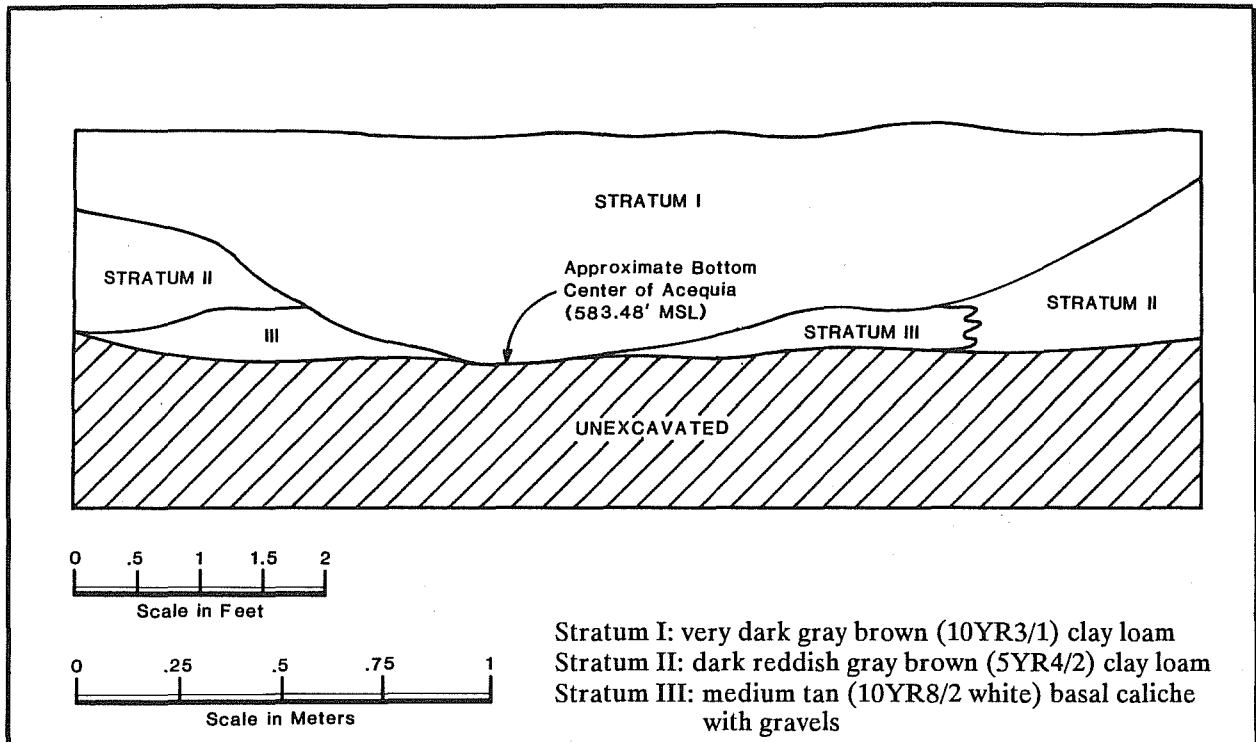
Figure 5. Profile of North Wall of Test Trench 2.

Trench 2 was located ca. 70 feet (21.3 m) north of Trench 1. The outline of the ditch was clearly visible in the profile of the trench (Fig. 5). The same soil strata were encountered as in Trench 1. At this point, the ditch appeared to be about 10 feet (3 m) wide and 20 inches (51 cm) deep, measured from the present surface.
